Inspection Photos
Location Name: Vera L Mccannon 1
Location ID: 159787

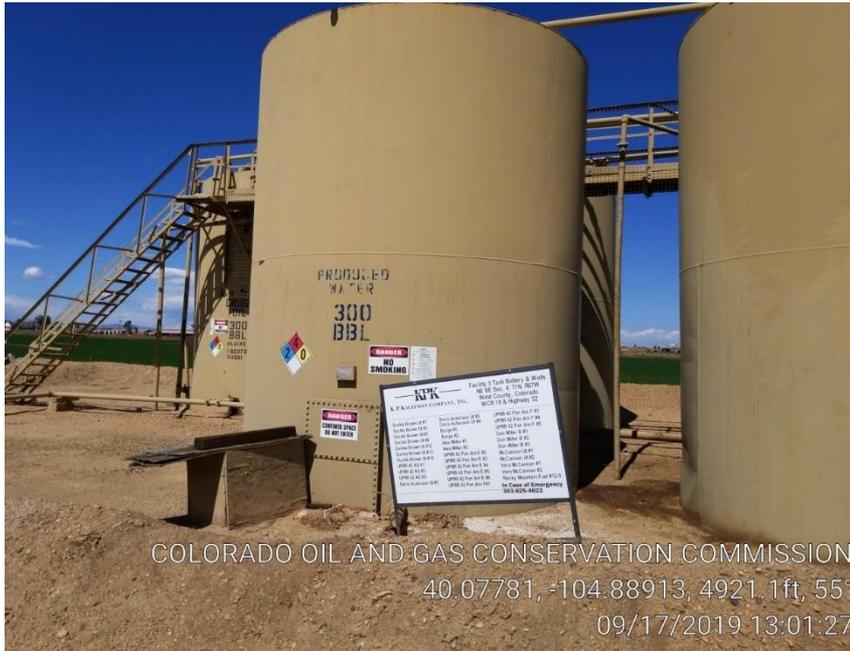
Pic 3 Multiple wells going to site

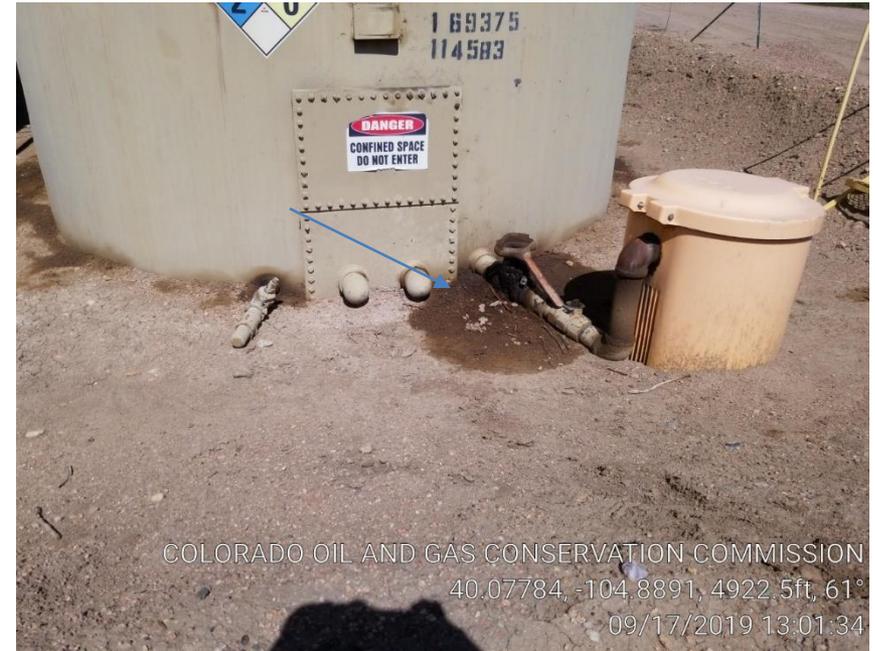
Pic 4 Stained soil/mechanical issues

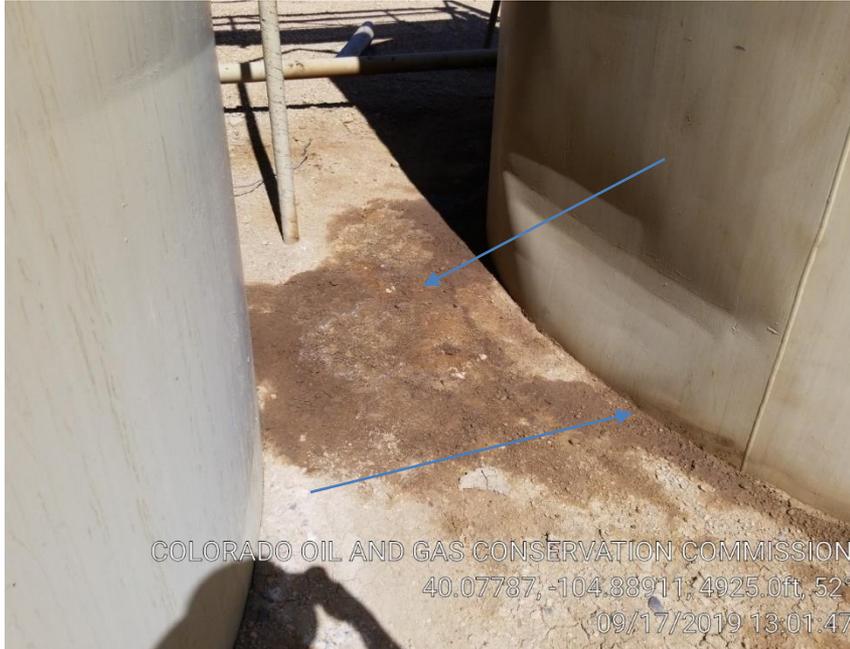
Pic 5 stained soil/possible leak on bottom of tank

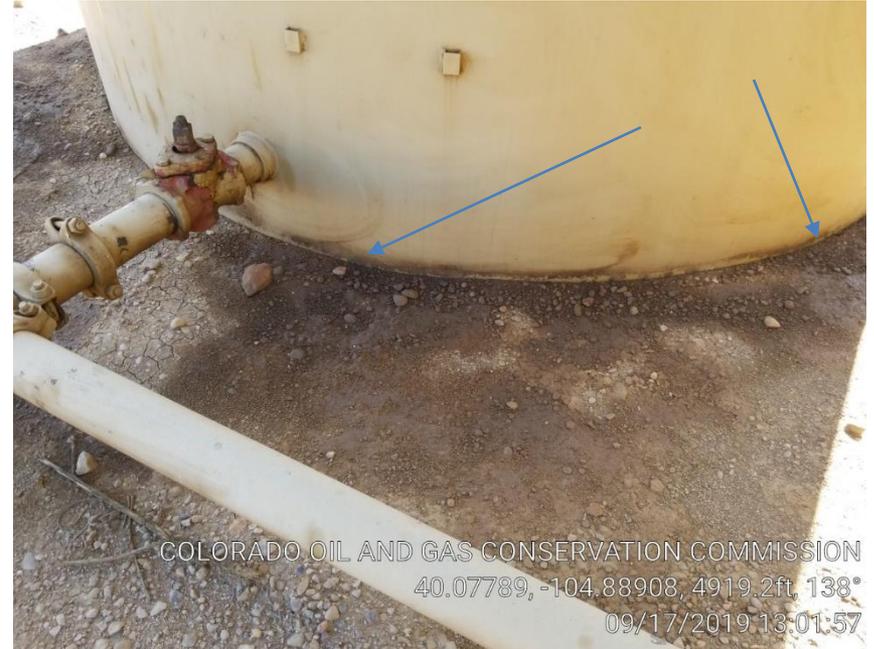
Pic 6 stained soil/possible leak on bottom of tank

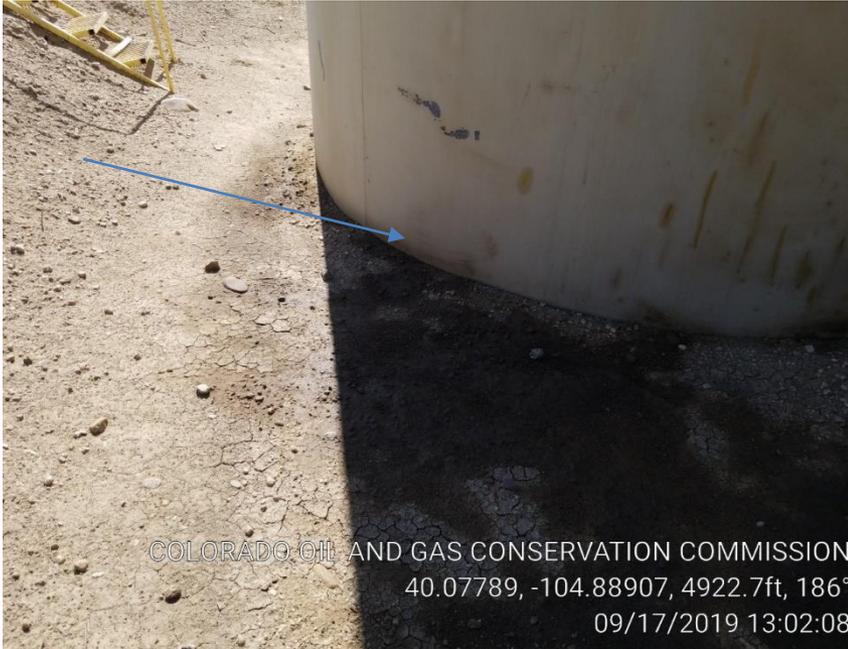
Pic 7 stained soil/possible leak on bottom of tank

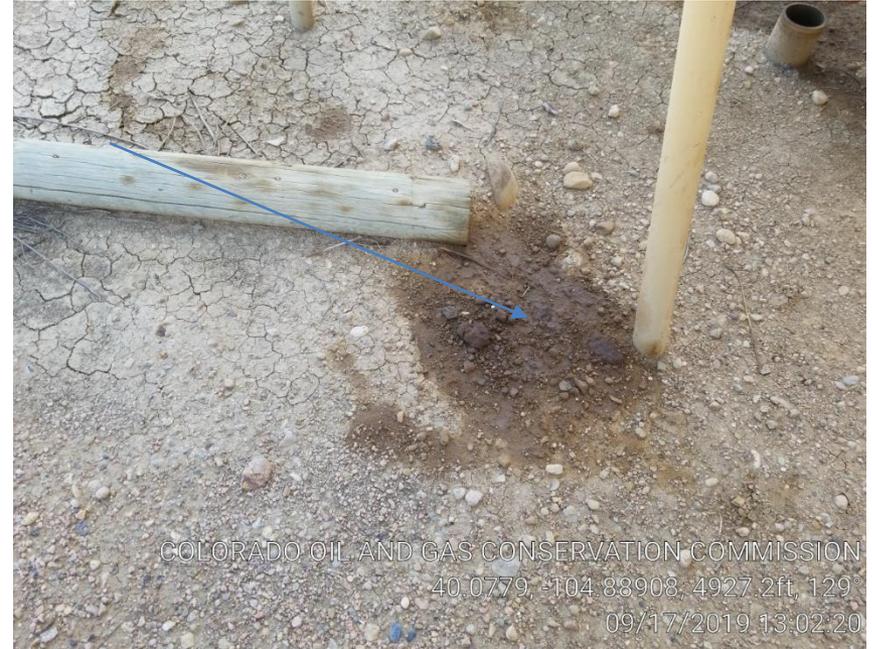
Pic 8 stained soil/possible leak on bottom of tank

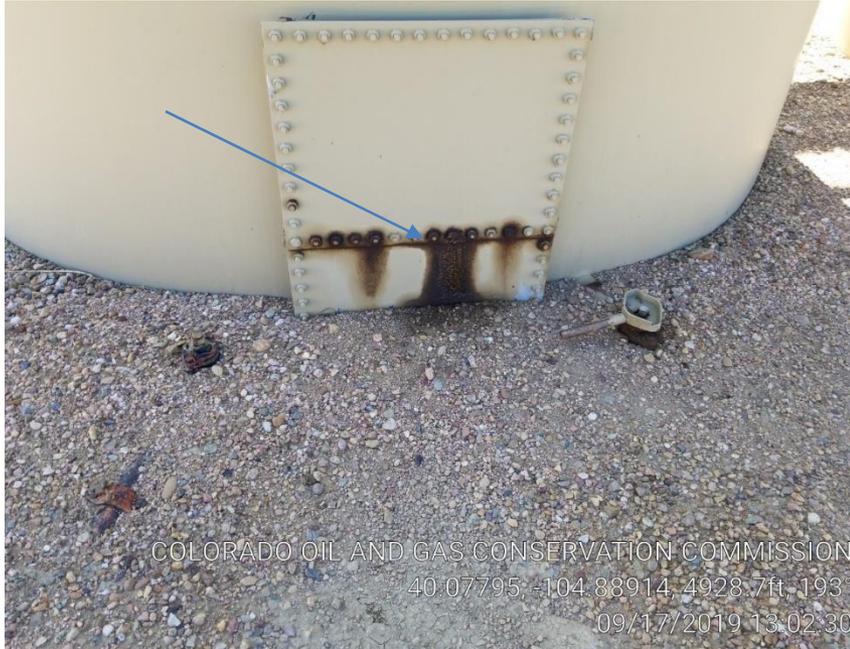
Pic 9 mechanical conditions/stained soil

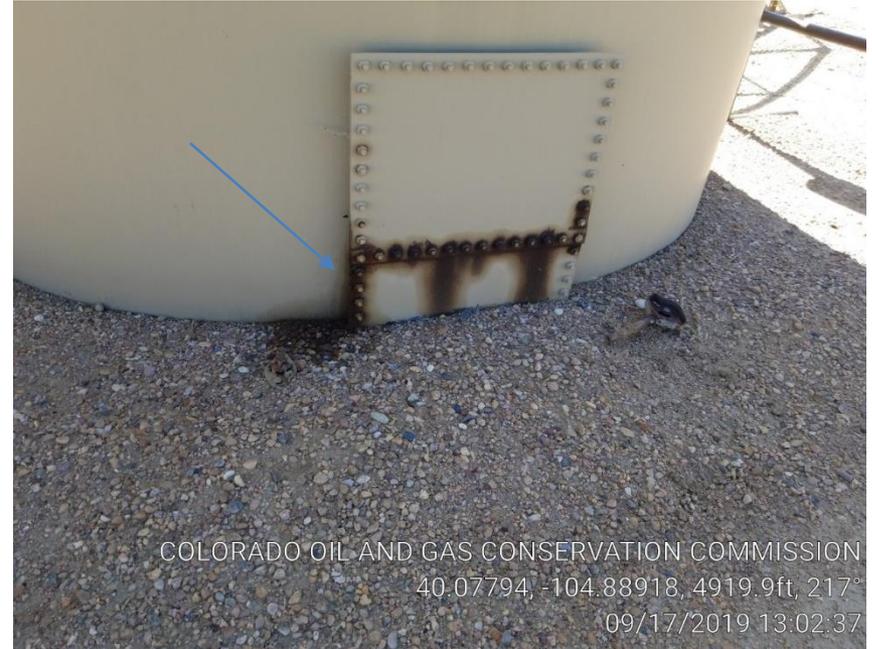
Pic 10 mechanical conditions/stained soil

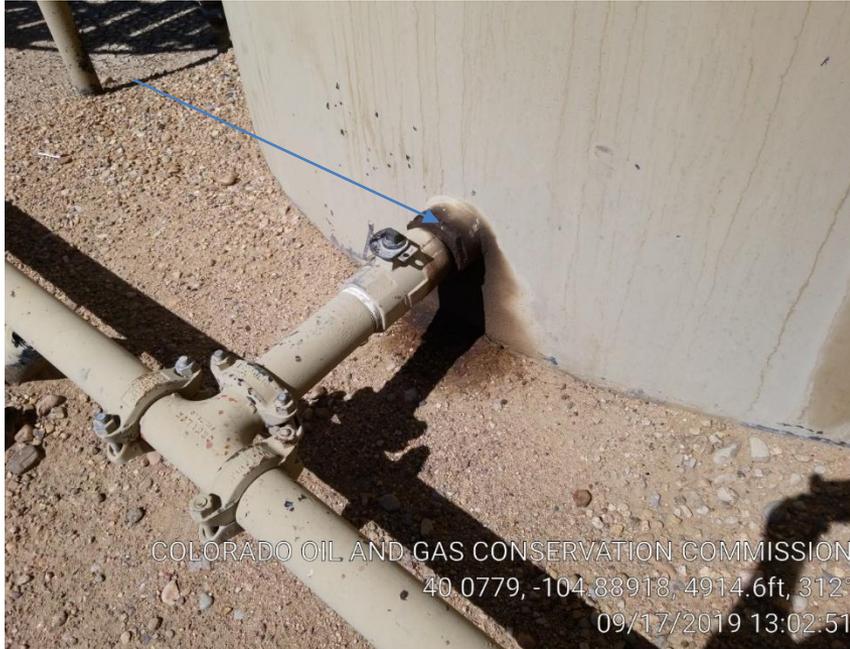
Pic 11 stained soil/mechanical conditions

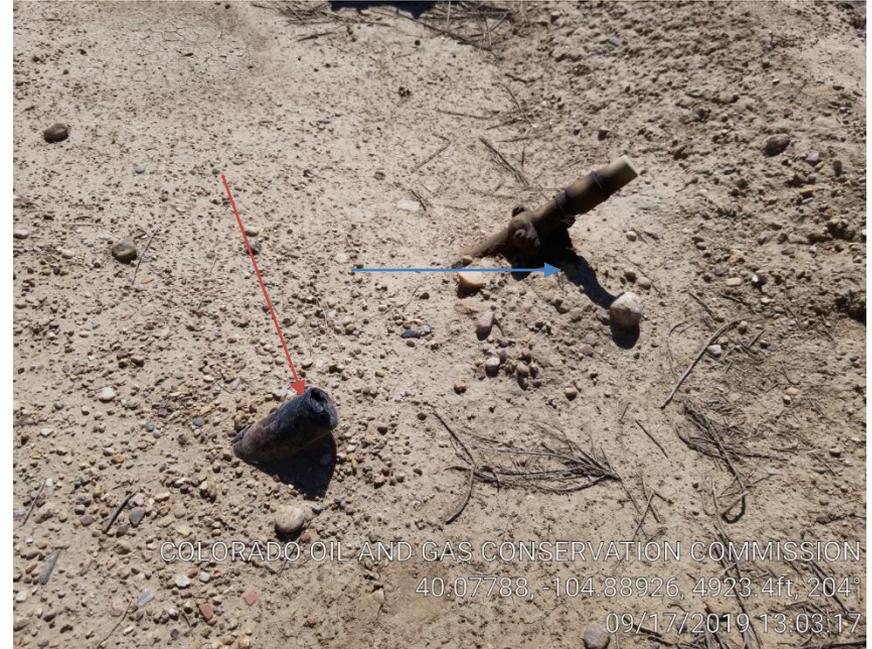
Pic 12 unused not LOTO riser/stained soil

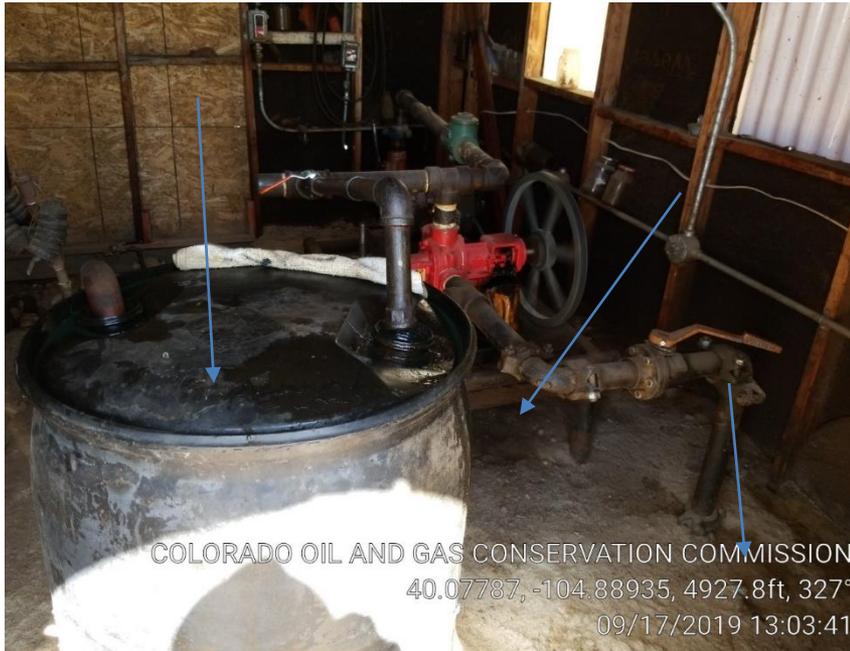
Pic 13 storage of chemicals/no BMP/stained soil

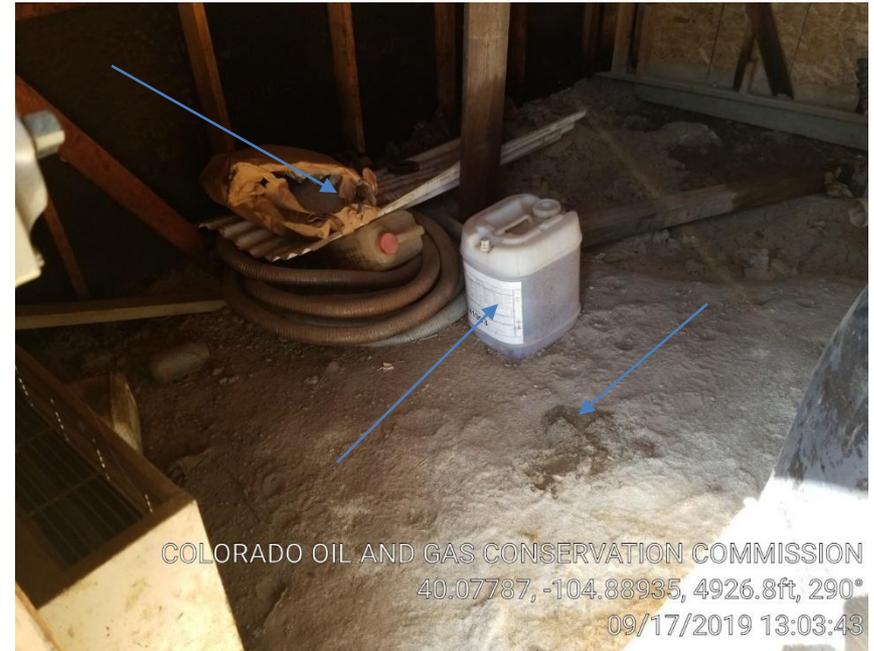
Pic 14 storage of chemicals/no BMP/storage of unused equipment/stained soil

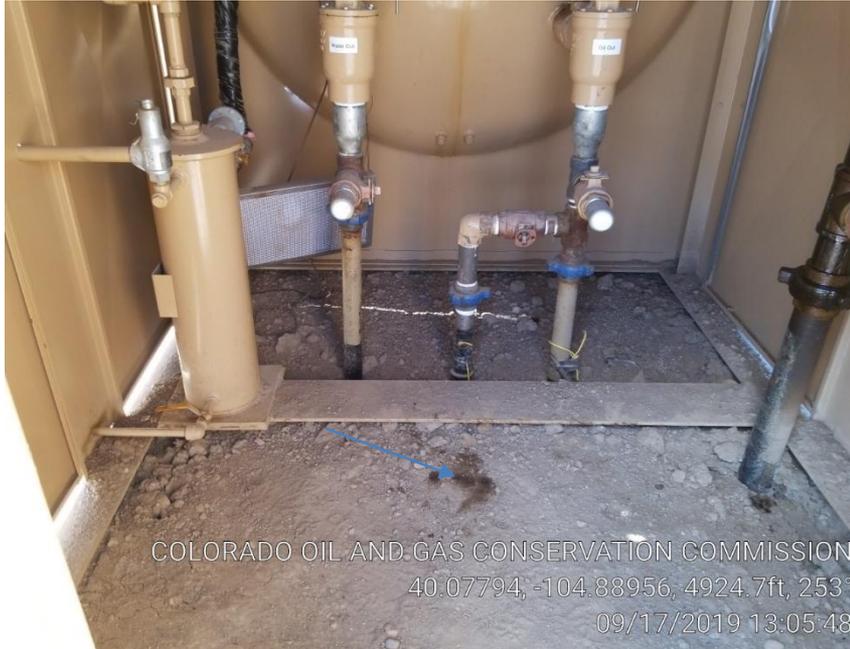
Pic 17 stained soil/mechanical conditions

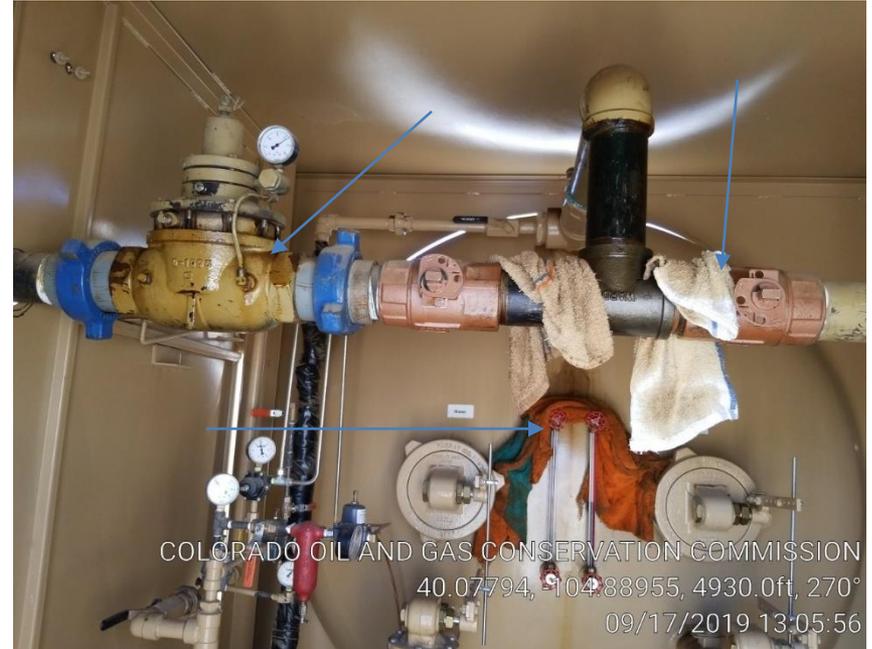
Pic 18 mechanical conditions in separator house
