Inspection Photos
Location Name: UPRR 42 Pan Am AF #2
Location ID: 318387

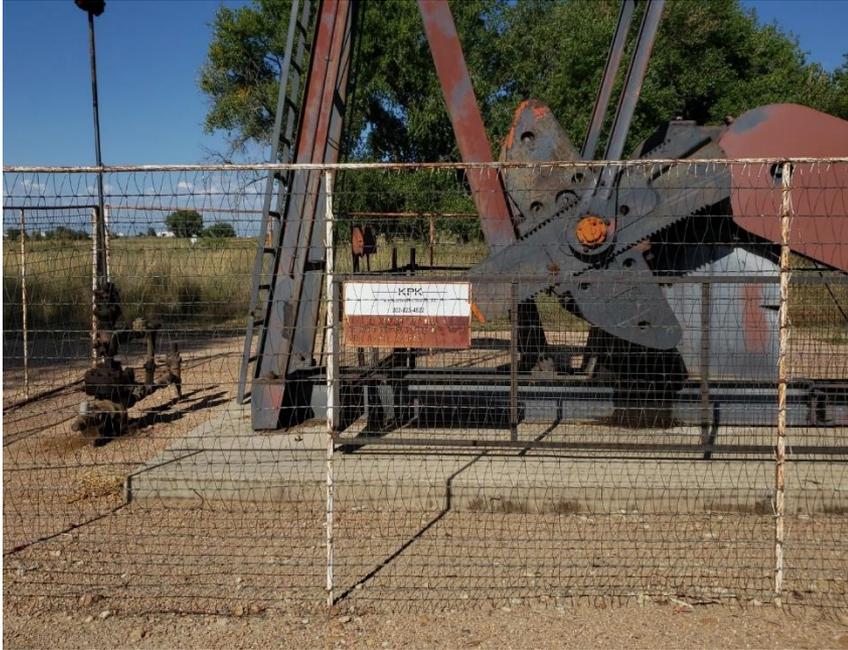
Photo #1 WH sign faded

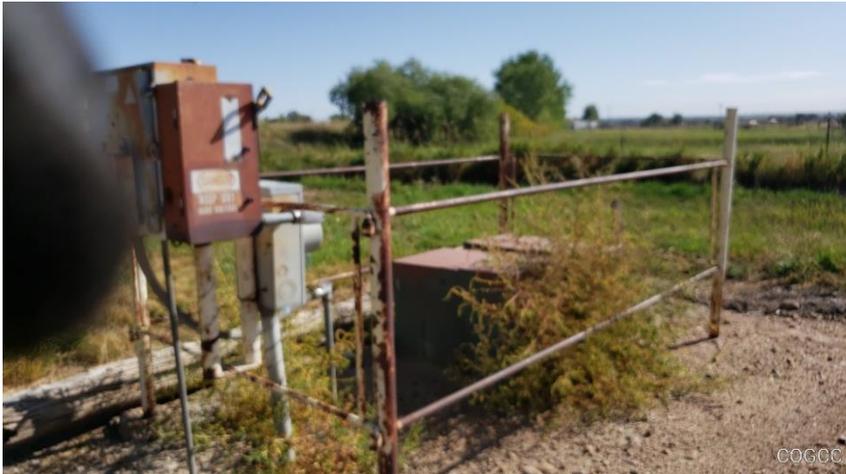
Photo #3 Weeds growing around Electric transformer.

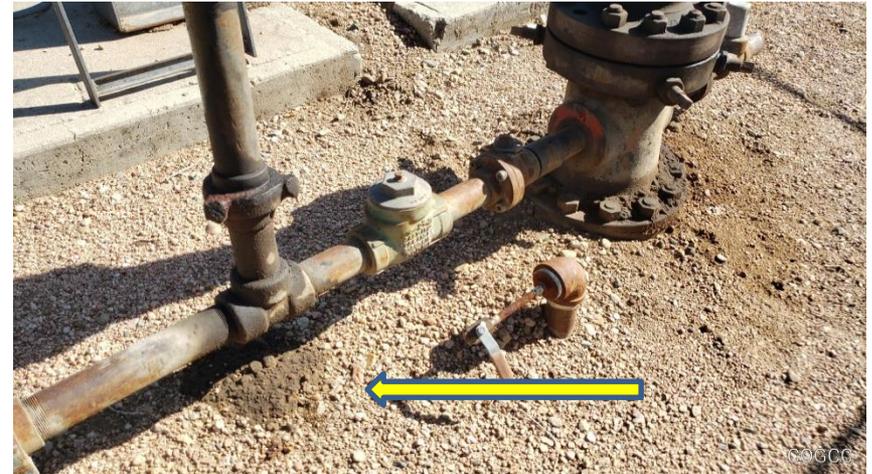
Photo #4 Stained soil under flow line

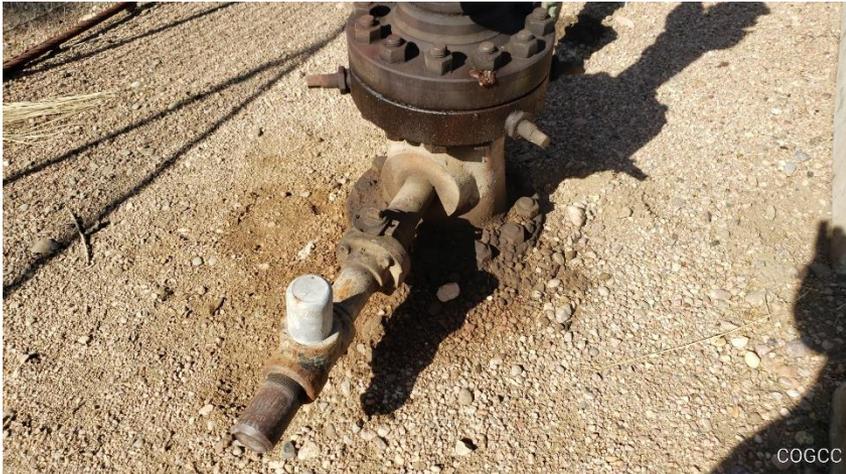
Photo #5 Stained soil around WH

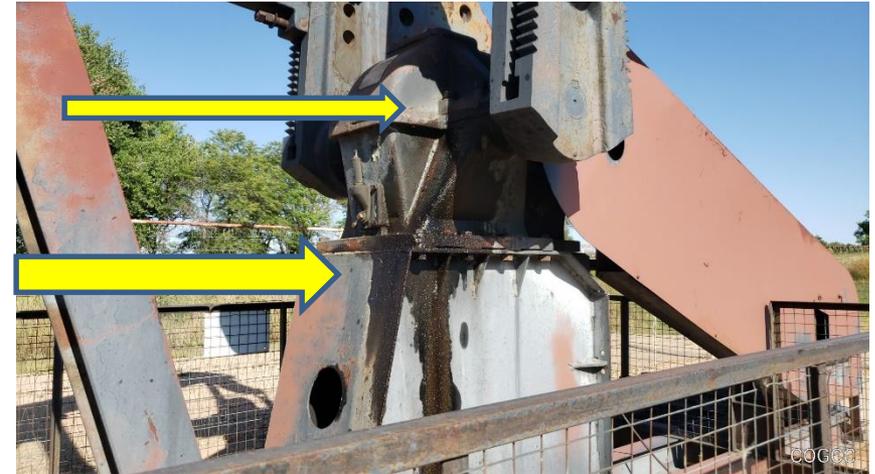
Photo #6 PU appears to have leaking gasket
