KP Kauffman - COGCC Inspection Photos
Location: Thomas L. Russell B #1 Flowline Spill
Spill ID #467496

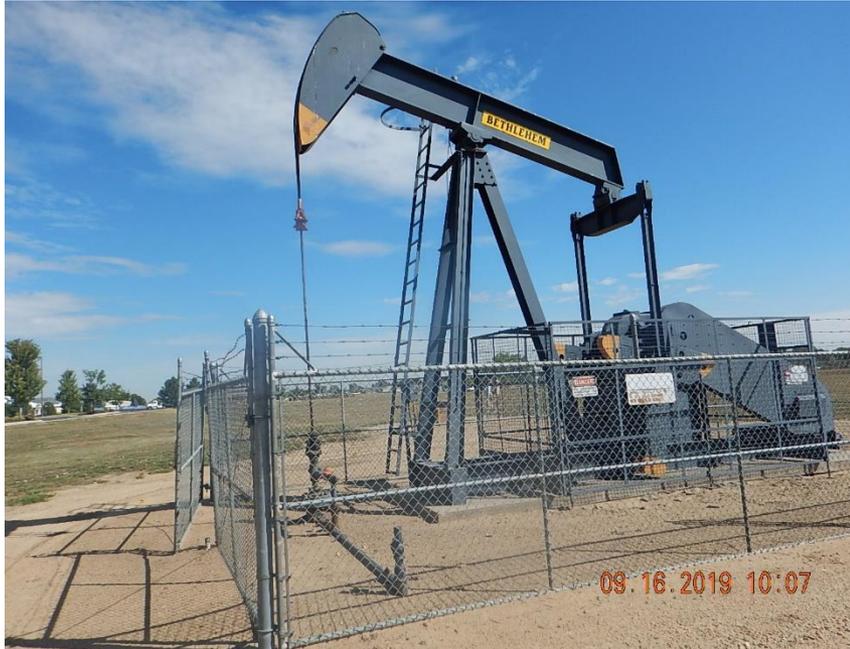
Wellhead, Pump Jack and Signage

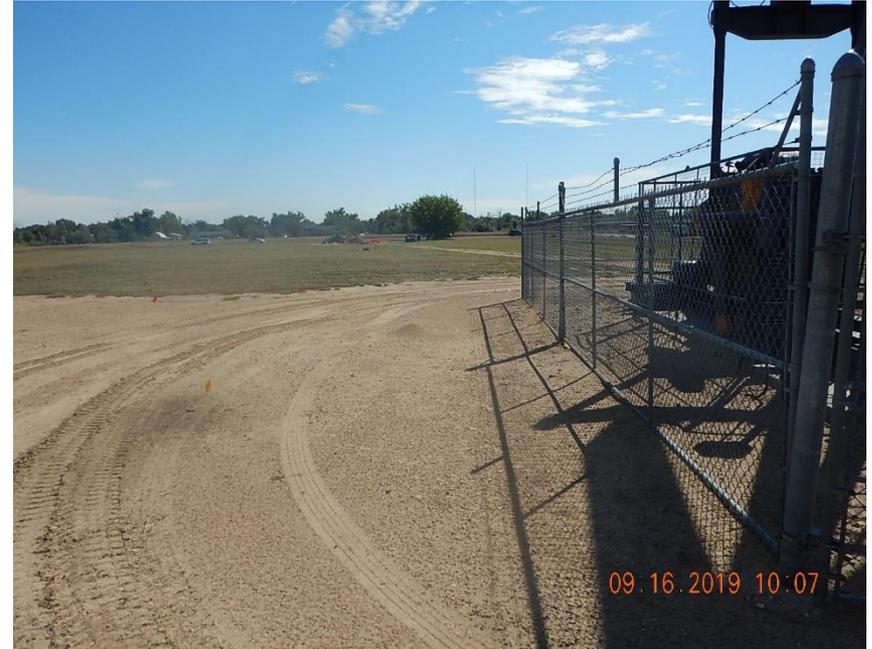
View from Thomas L. Russell B 1 well (API 123-07574) east to the spill/ release point and excavation.

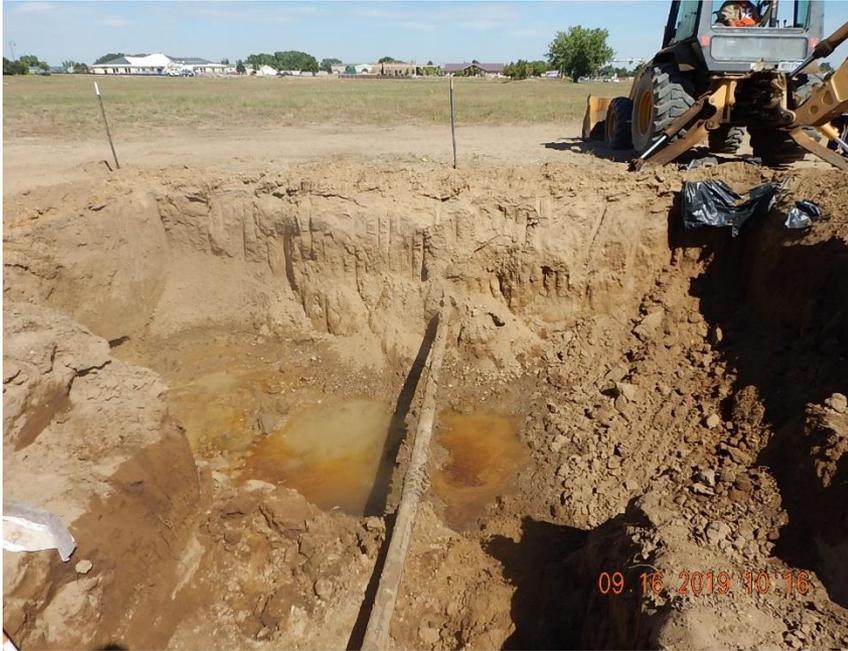
View of the excavation and 4" Carbon Steel crude oil consolidation flowline exposed in excavation. Impacts to ground water can be seen. (view to North)

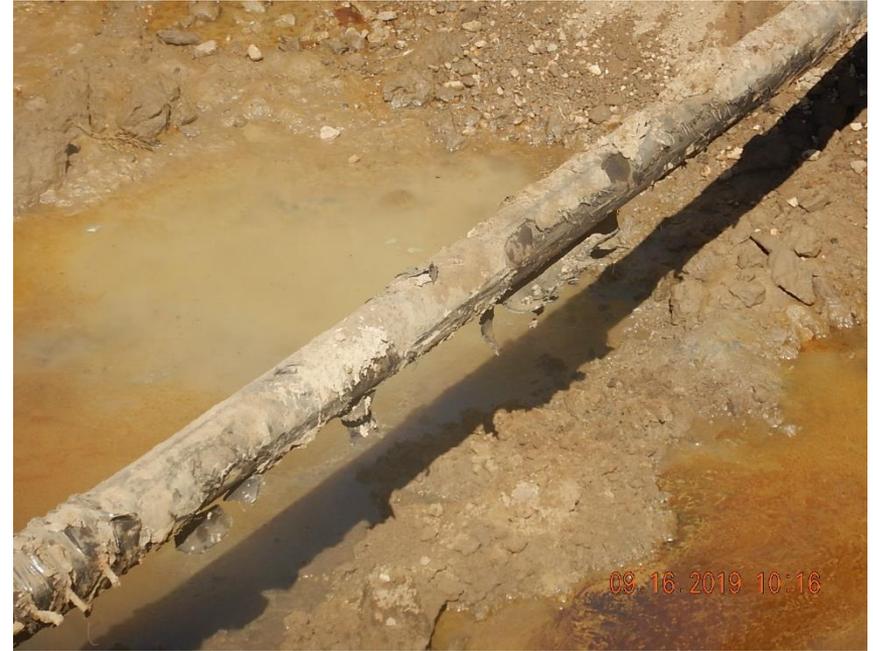
Close up view of flowline at the point of failure (coating is hanging down). A clamp was observed where a historical repair was completed.

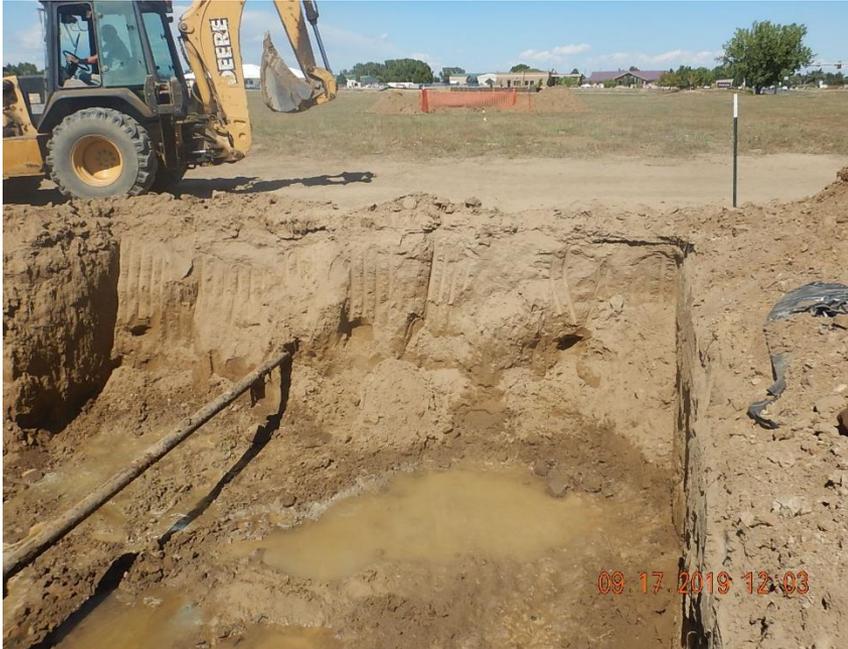
View to North from the excavation at point of release to the excavation completed approximately 150' to the North.

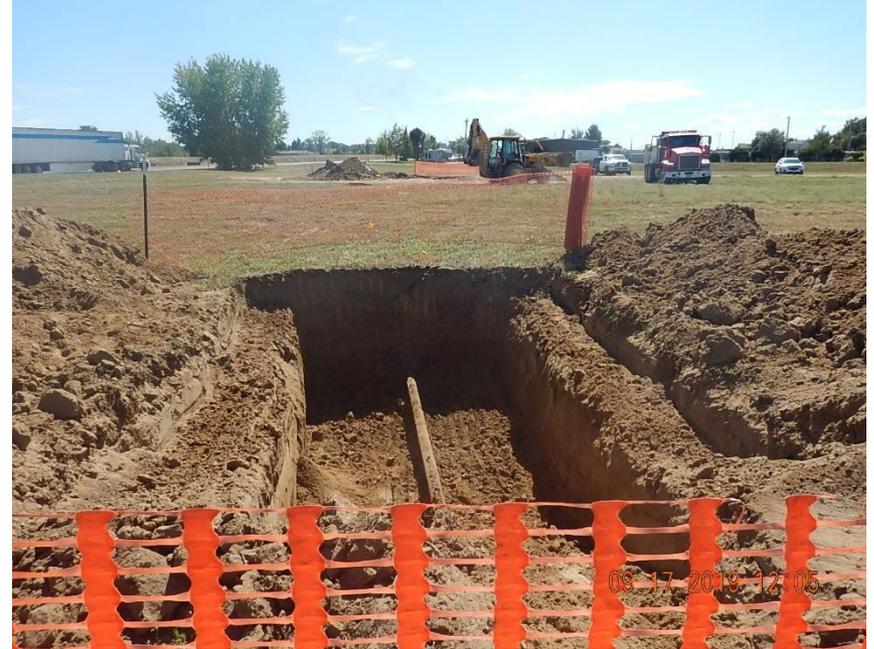
View from the excavation completed to expose the crude oil consolidation line for the repair to the south excavation where the spill occurred.
