Inspection Photos
Operator Name: Caerus Piceance LLC
Location ID: 334069

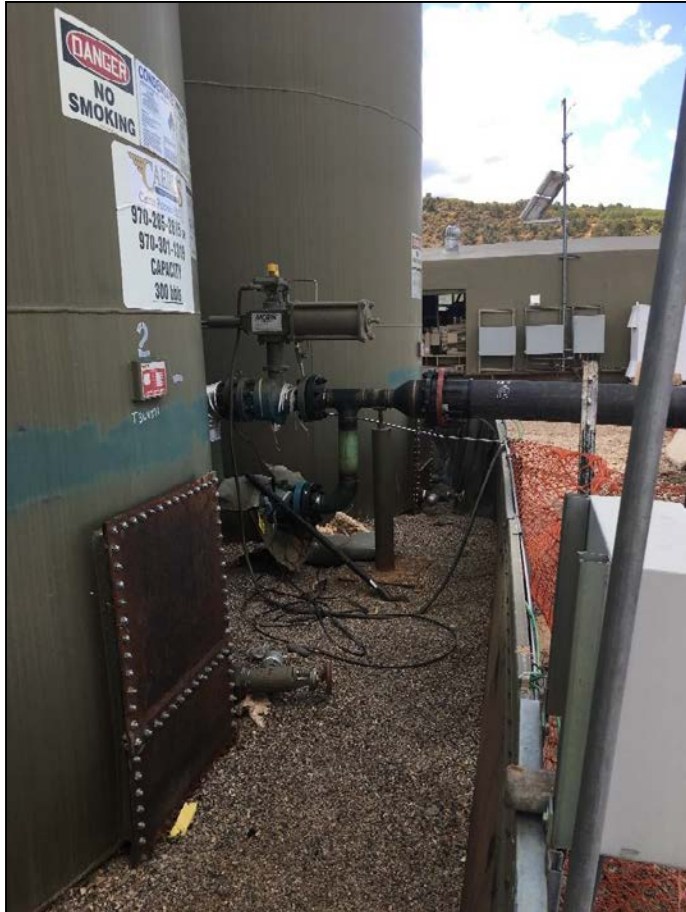
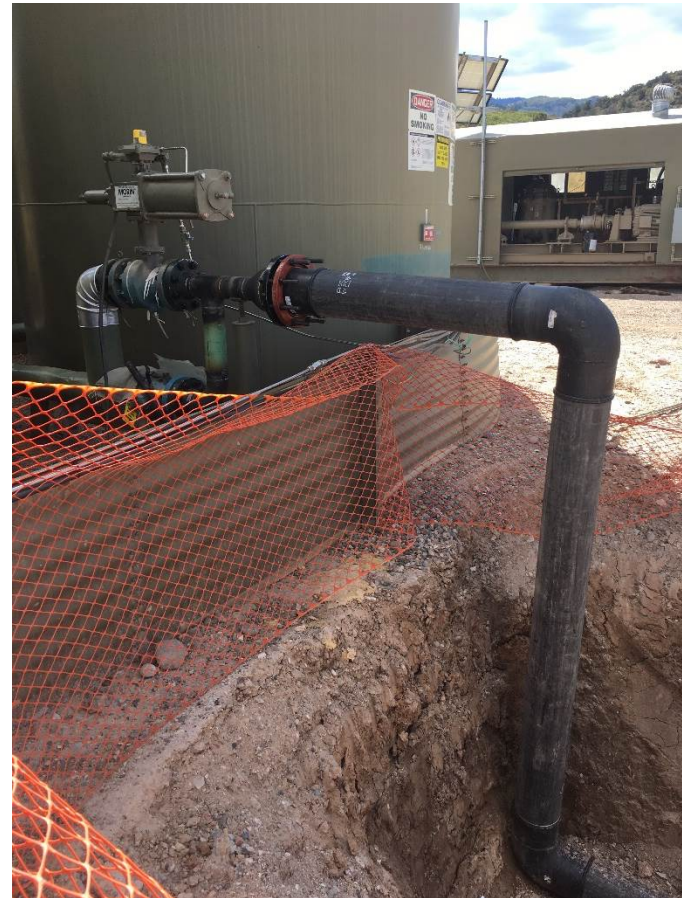
Flowline repaired and is in service.

Carbon to poly

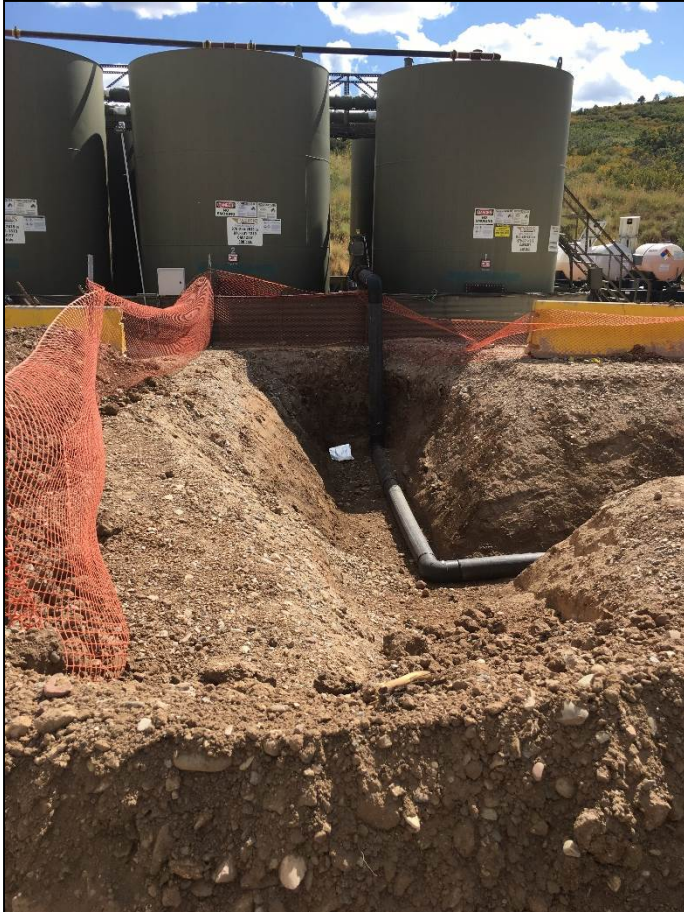
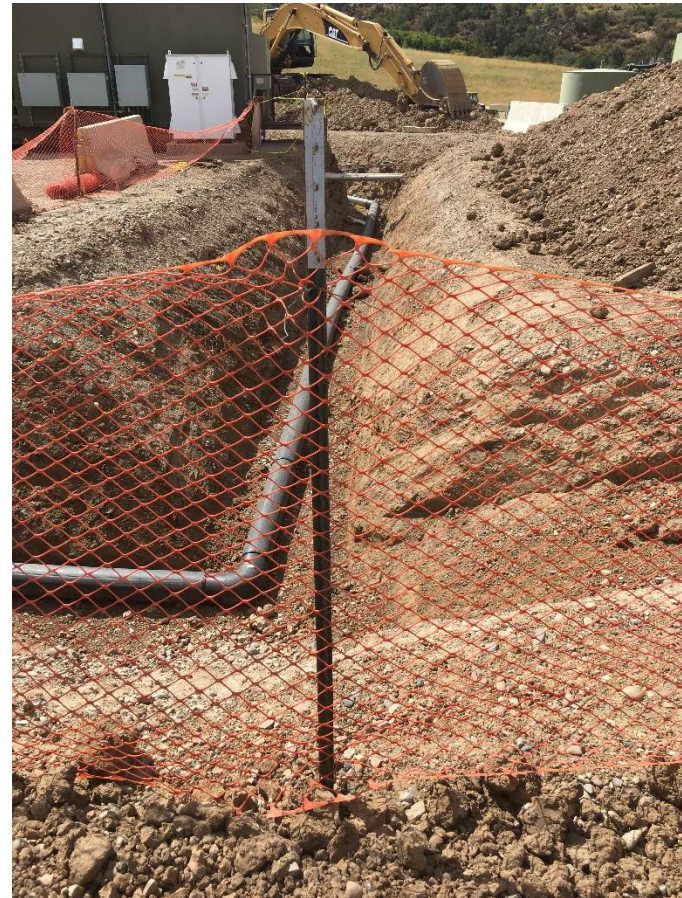
New Flowline installed

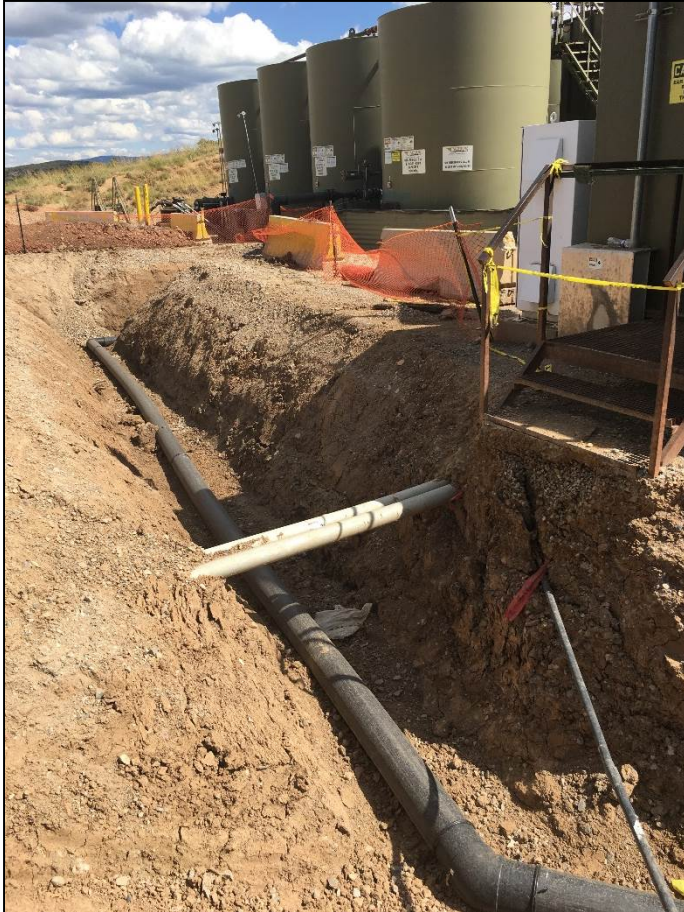
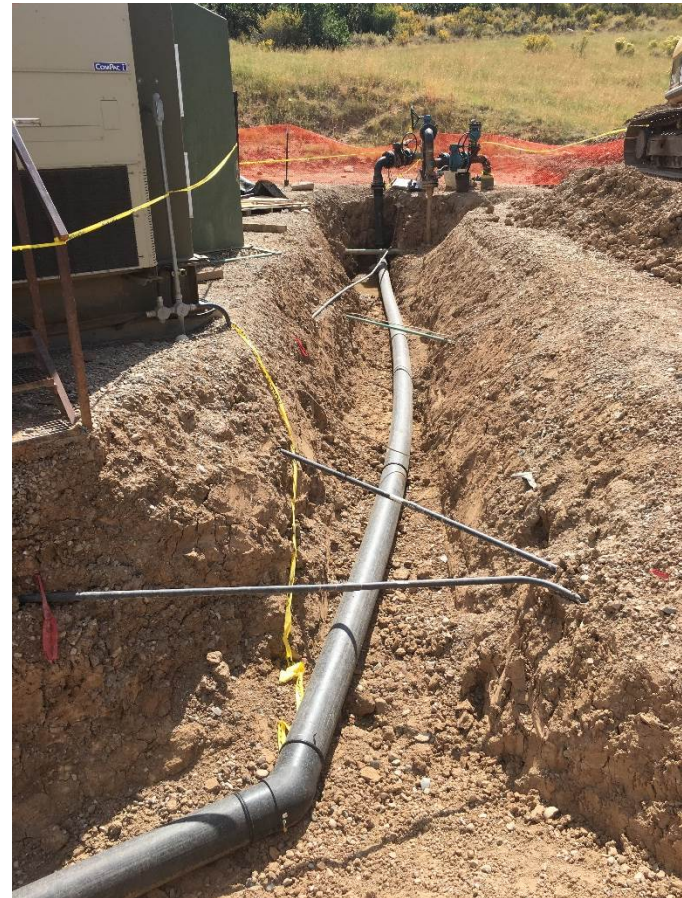
New Flowline Installed
