Inspection Photos
Operator: BP America
Location/API #: 067-07002
Date: 9-10-2019

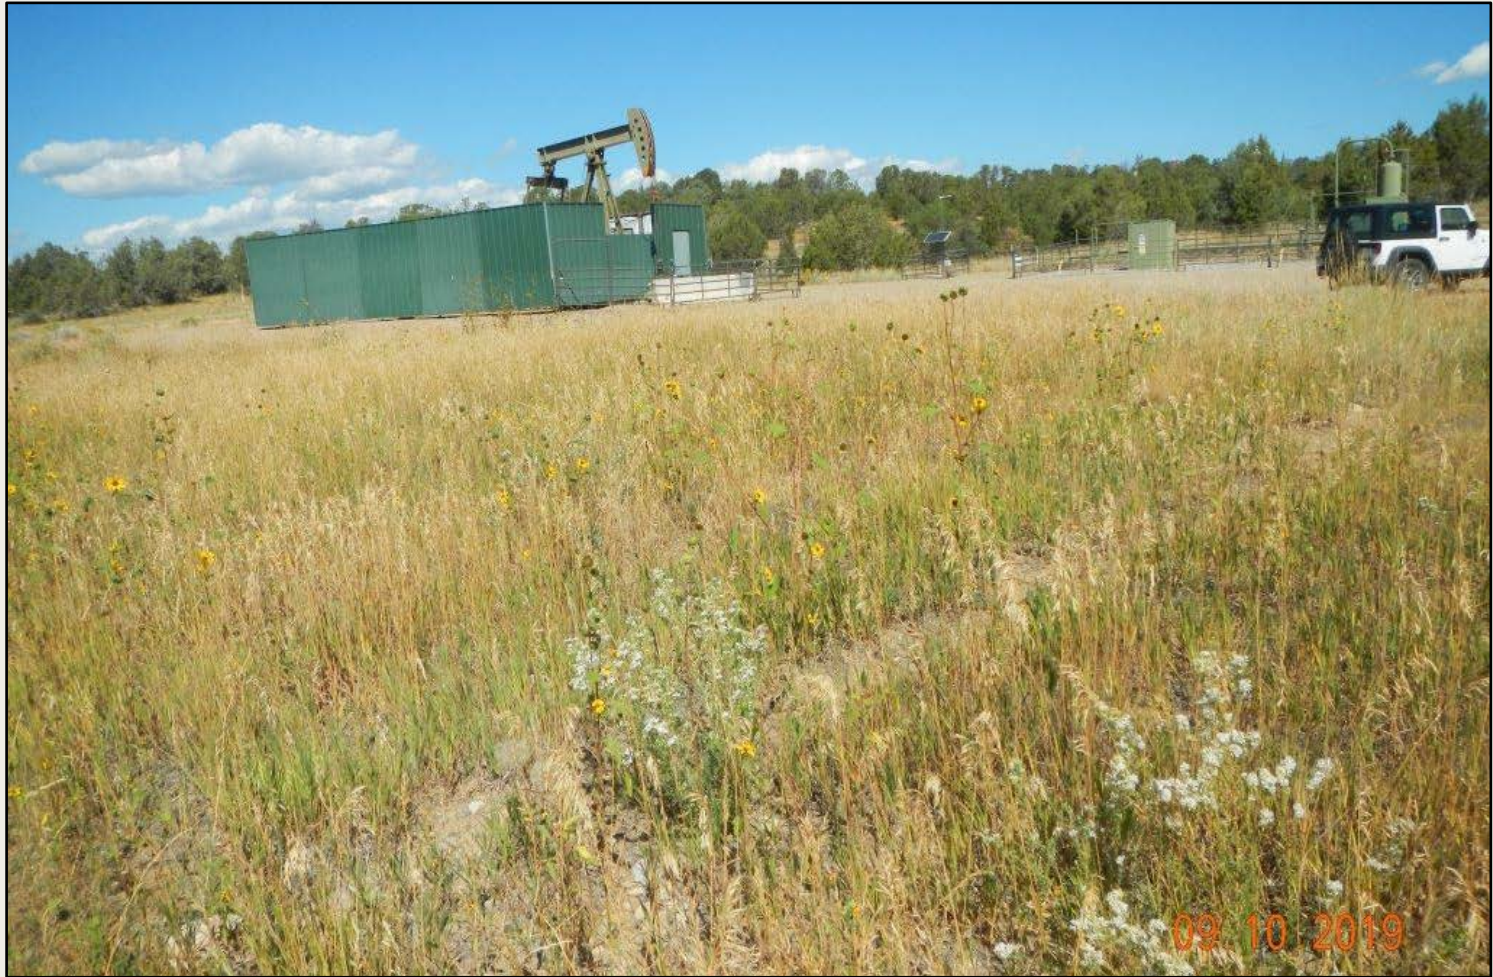
Photo 1. View of the project area from the southeastern edge facing center.

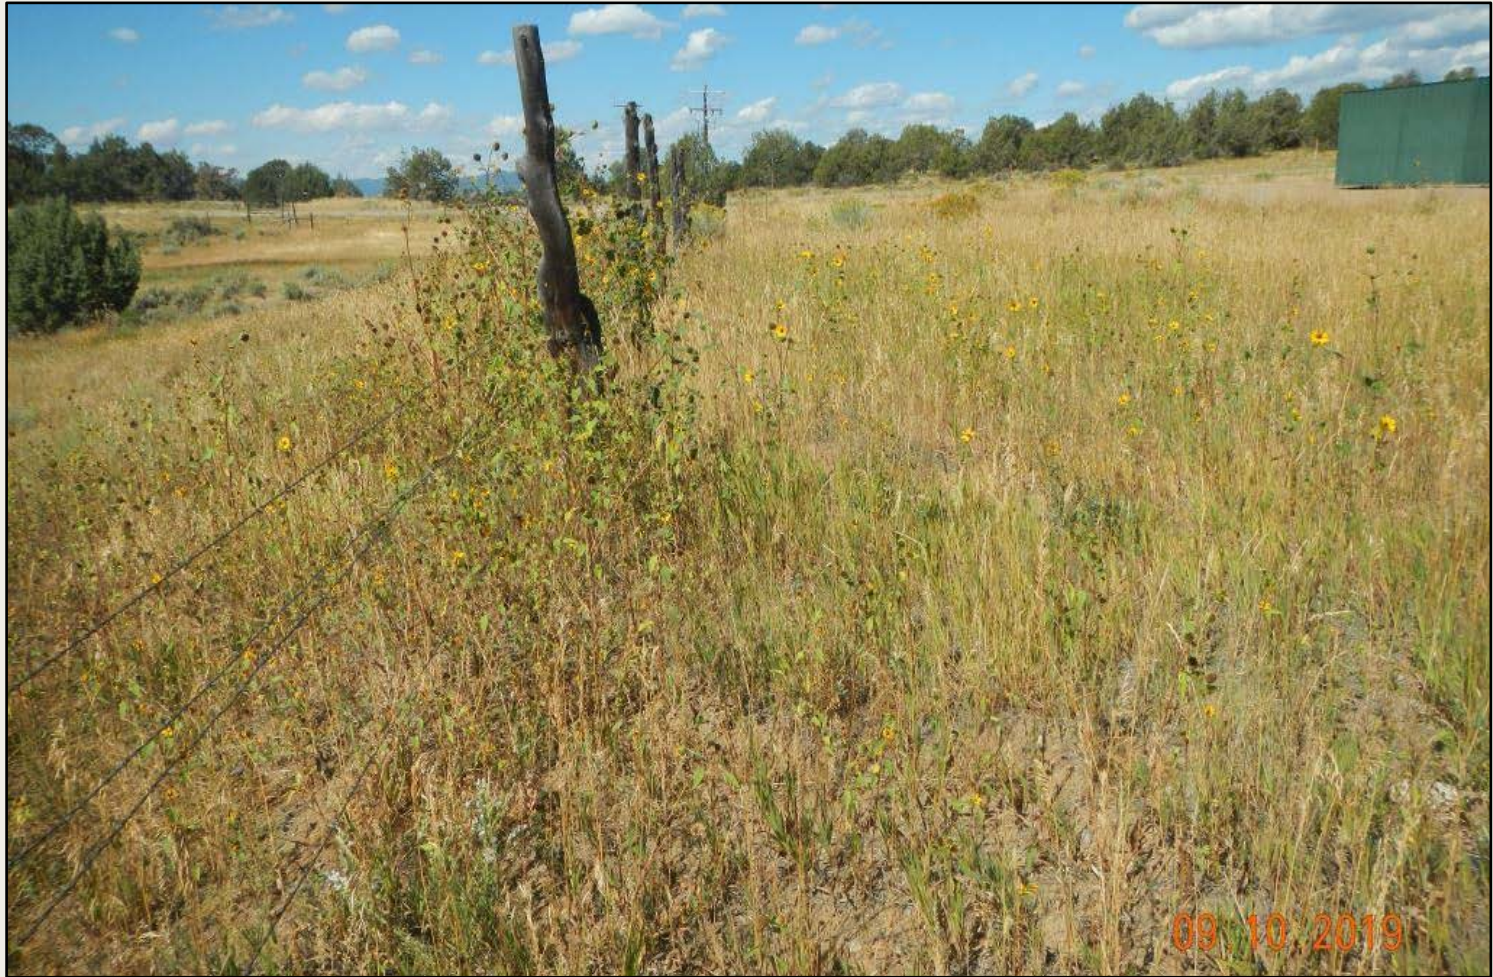
Photo 2. View of the southern fill slope from the southeastern edge facing westward. Revegetation is progressing with smooth brome and western wheatgrass.

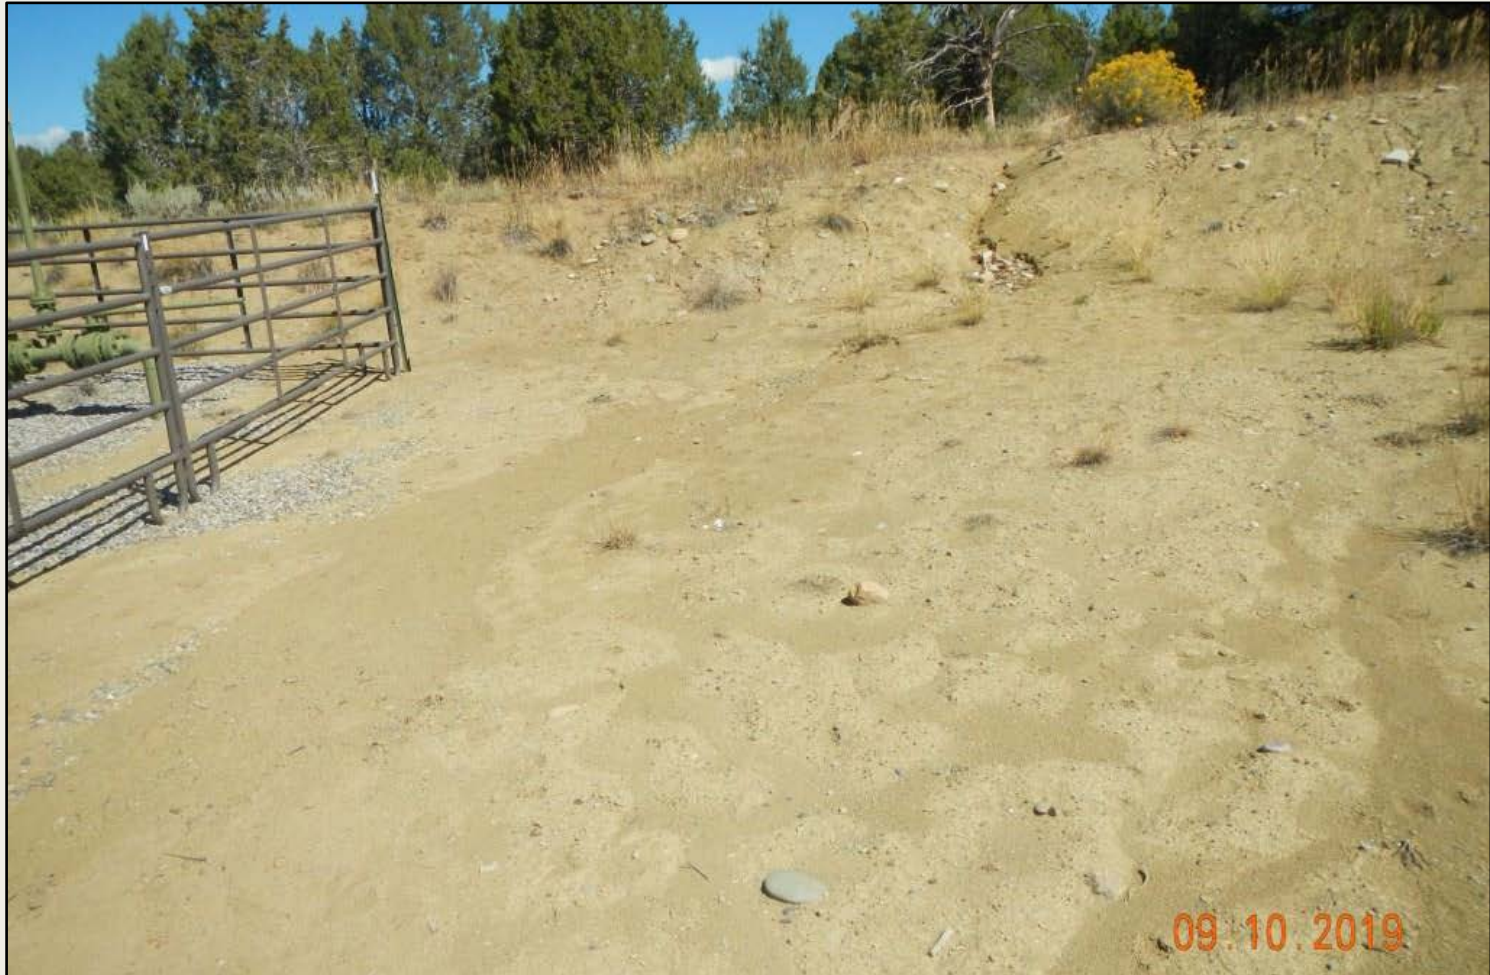
Photo 3. View of erosion and sediment run-on in the northeastern project area. Soils on northeastern cut-slopes are largely bare and need revegetation.

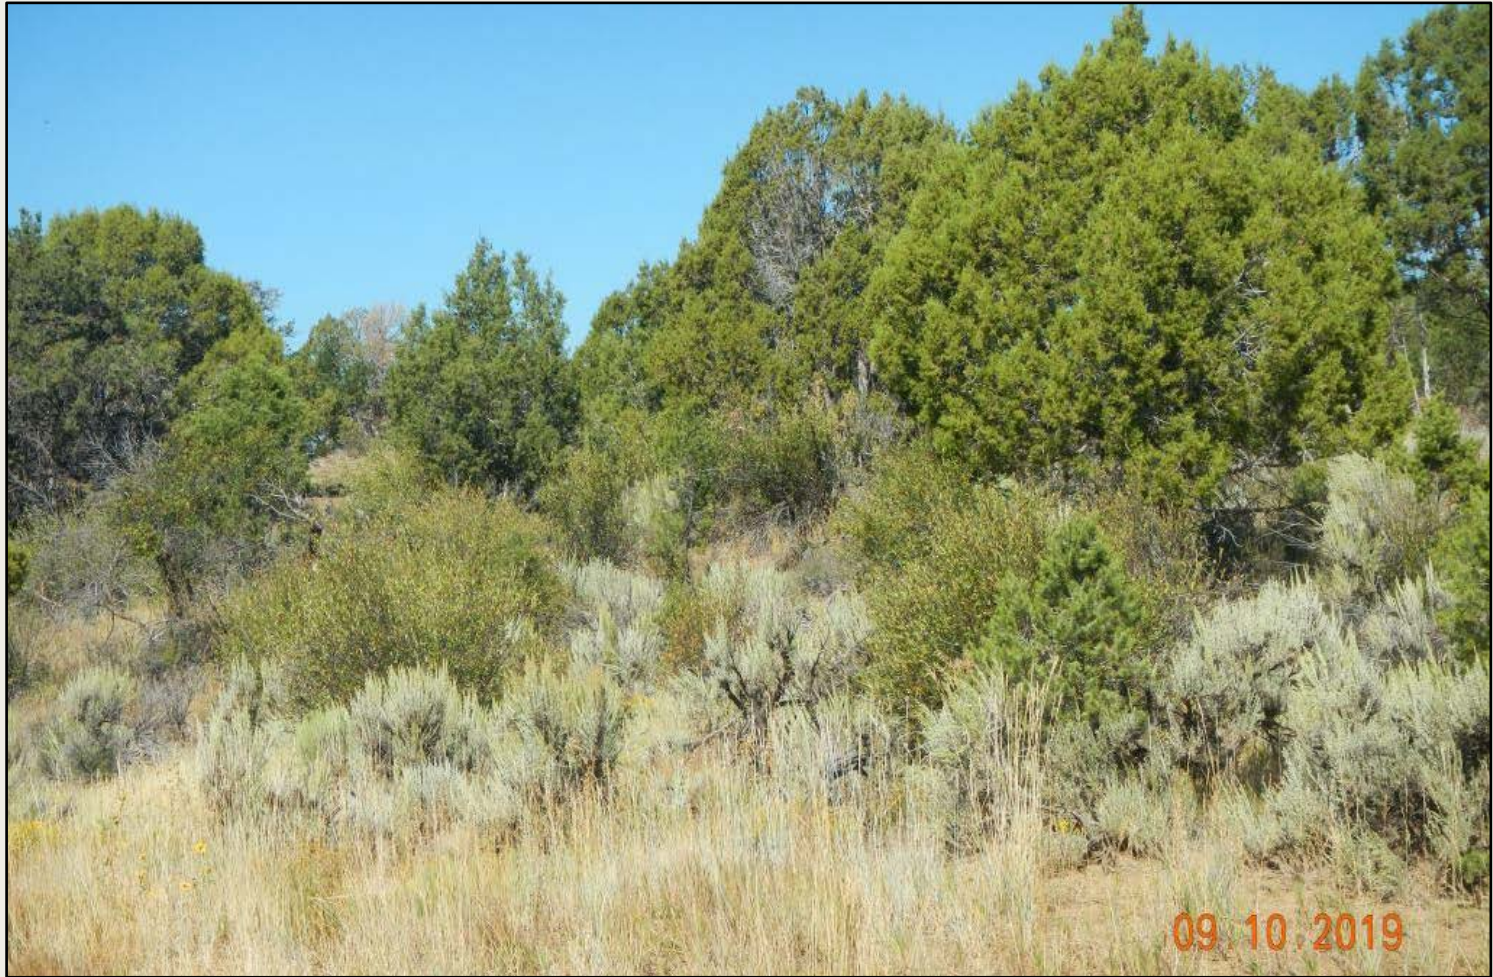
Photo 4. View of reference area vegetation facing westward. Vegetation is comprised of mixed pinyon juniper, squaw apple, and sagebrush shrubland.
