Inspection Photos
Operator: Hilcorp Energy
Location/API #: 067-08231
Date: 9-10-2019

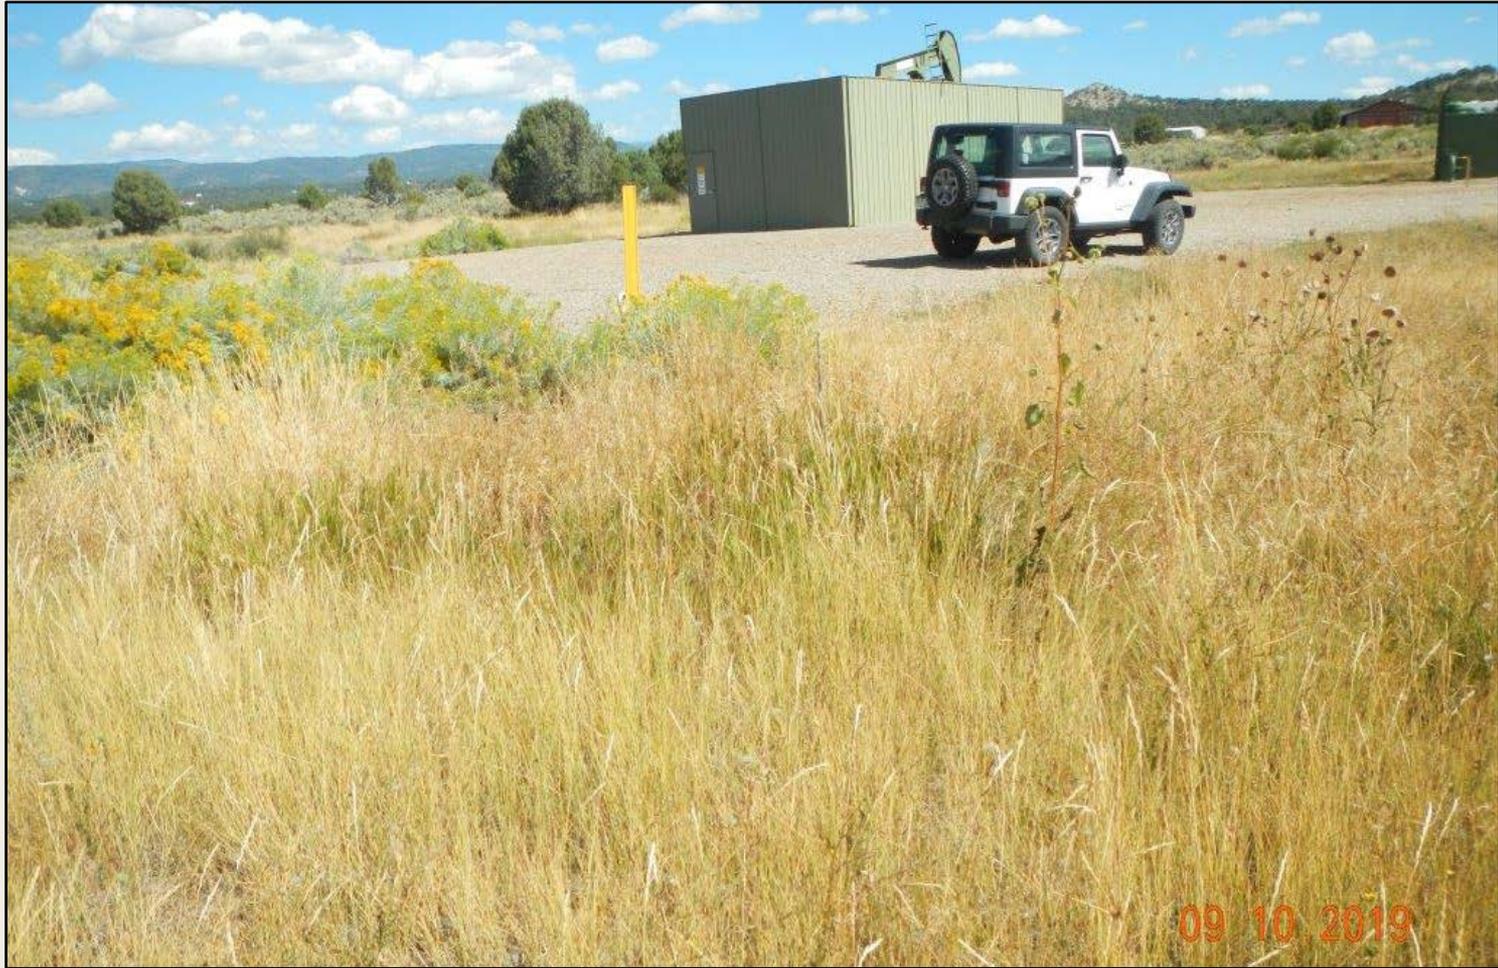
Photo 1. View of the project area from the southwestern edge facing center.

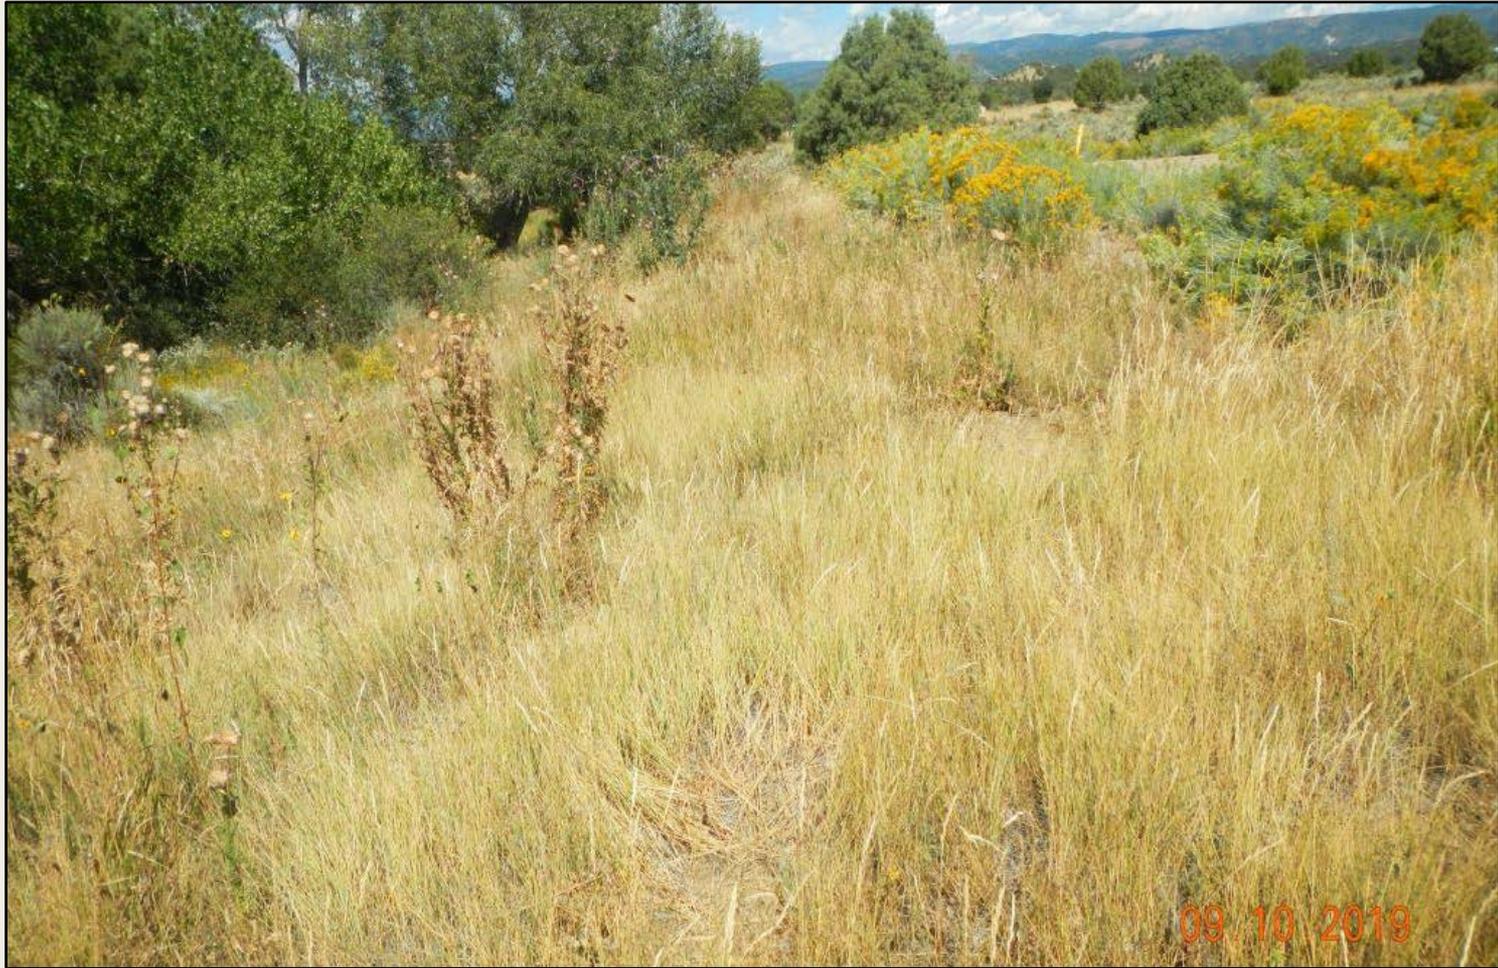
Photo 2. View of the western fill slope from the southwestern edge facing northward. Revegetation is progressing largely with western wheatgrass and smooth brome.

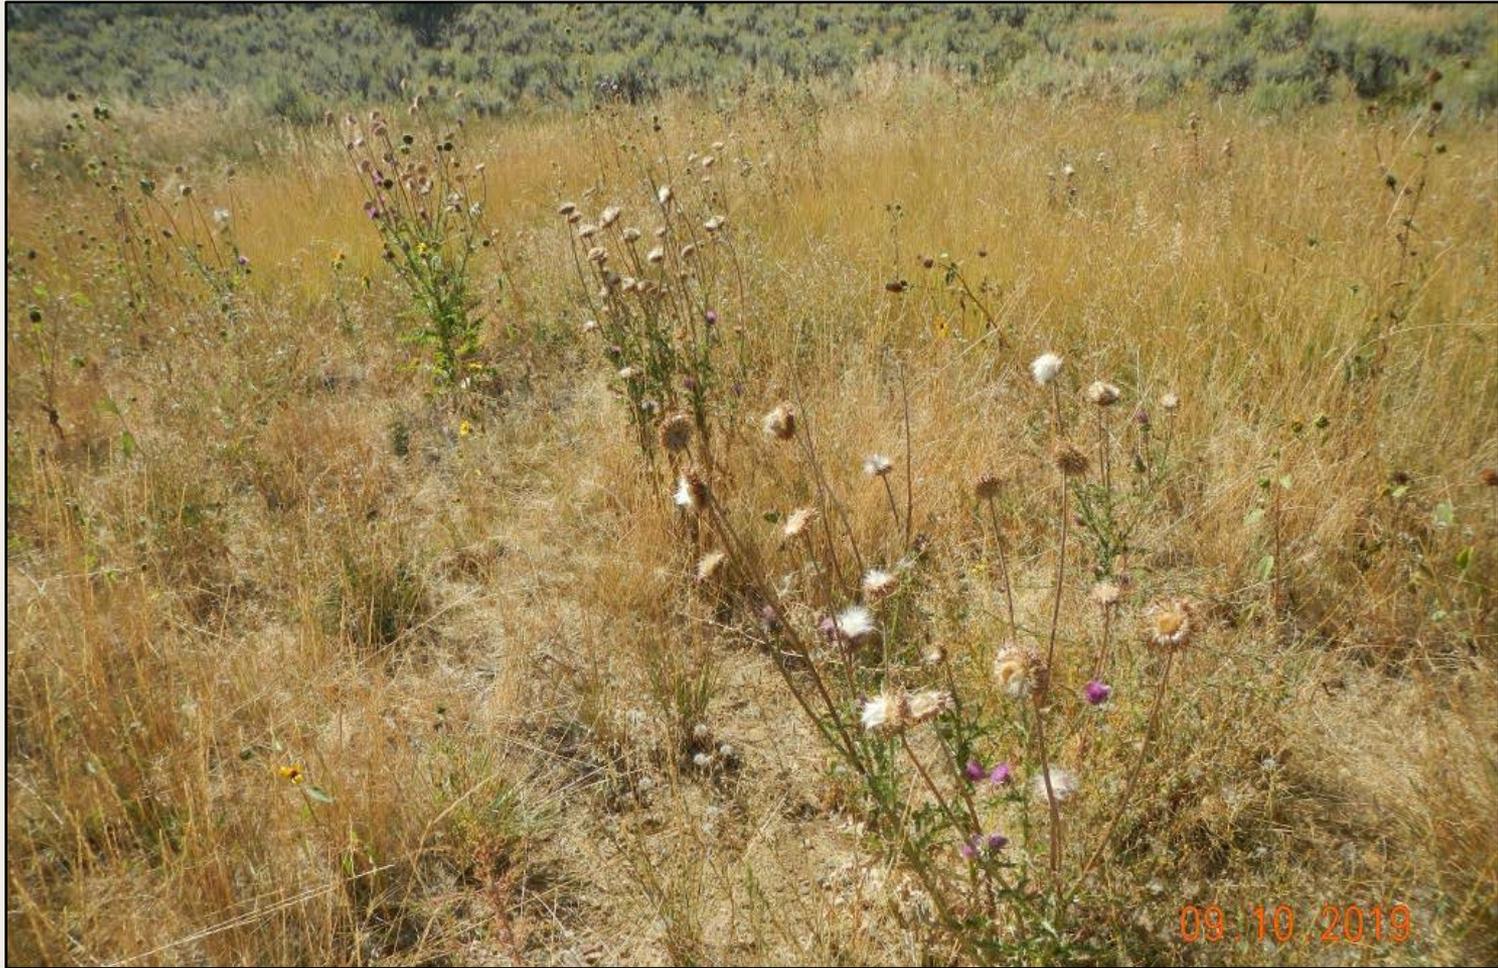
Photo 3. View of flowering musk thistles within the interim reclamation area.

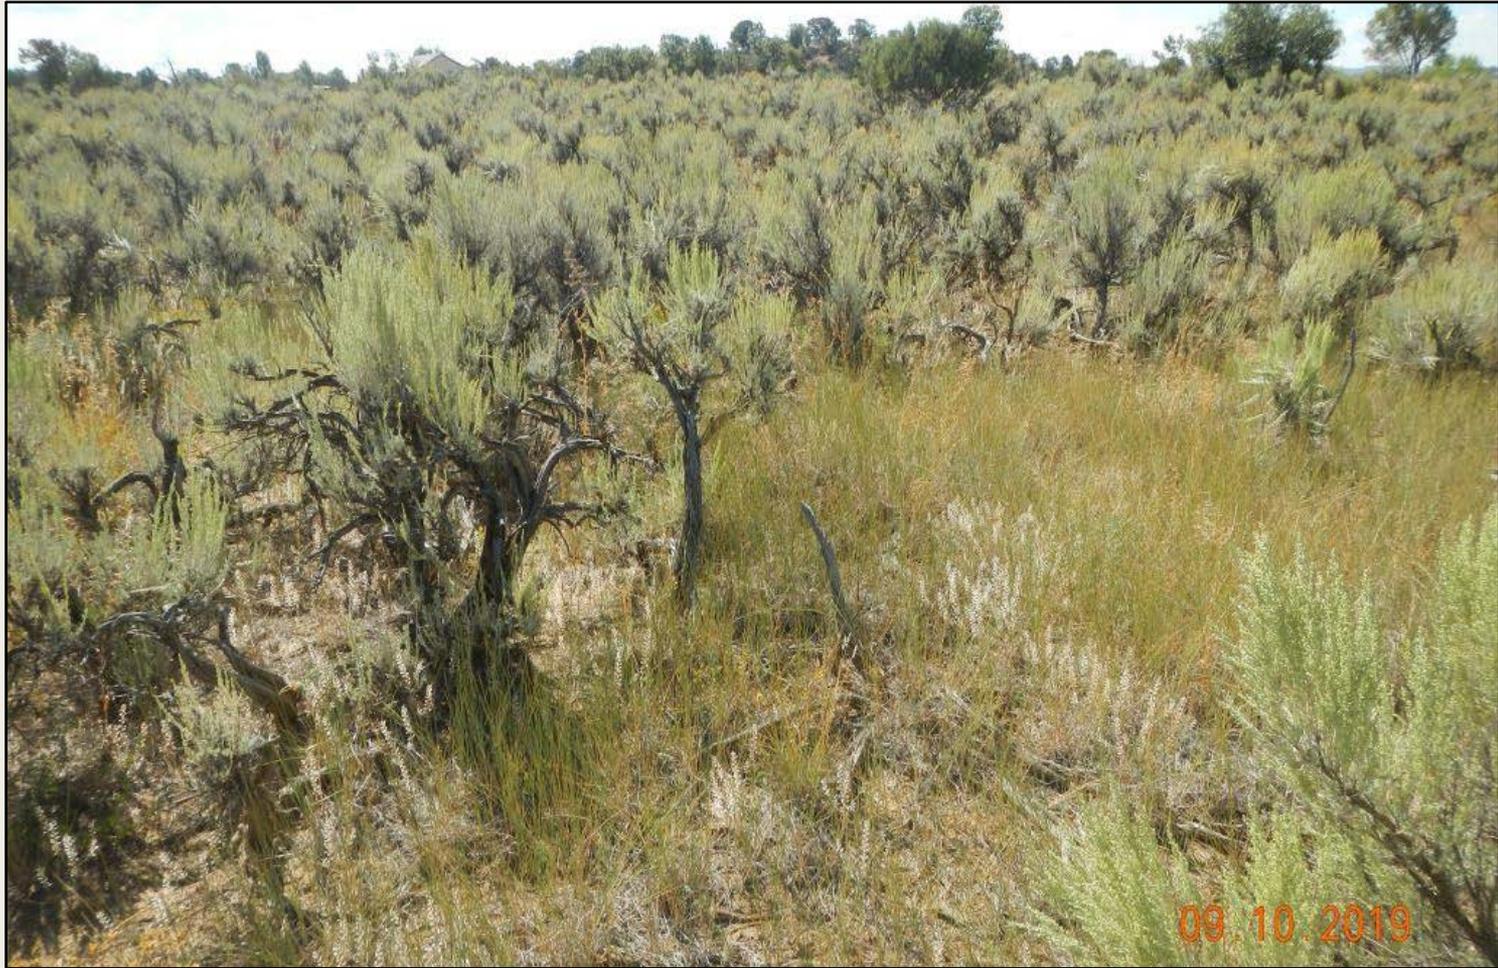
Photo 4. View of reference area vegetation facing southward. Vegetation is comprised of sagebrush shrubland.
