Inspection Photos

API: 05-071-07989

Operator: TIMBER CREEK OPERATING LLC

Inspection Date: 9/19/2019

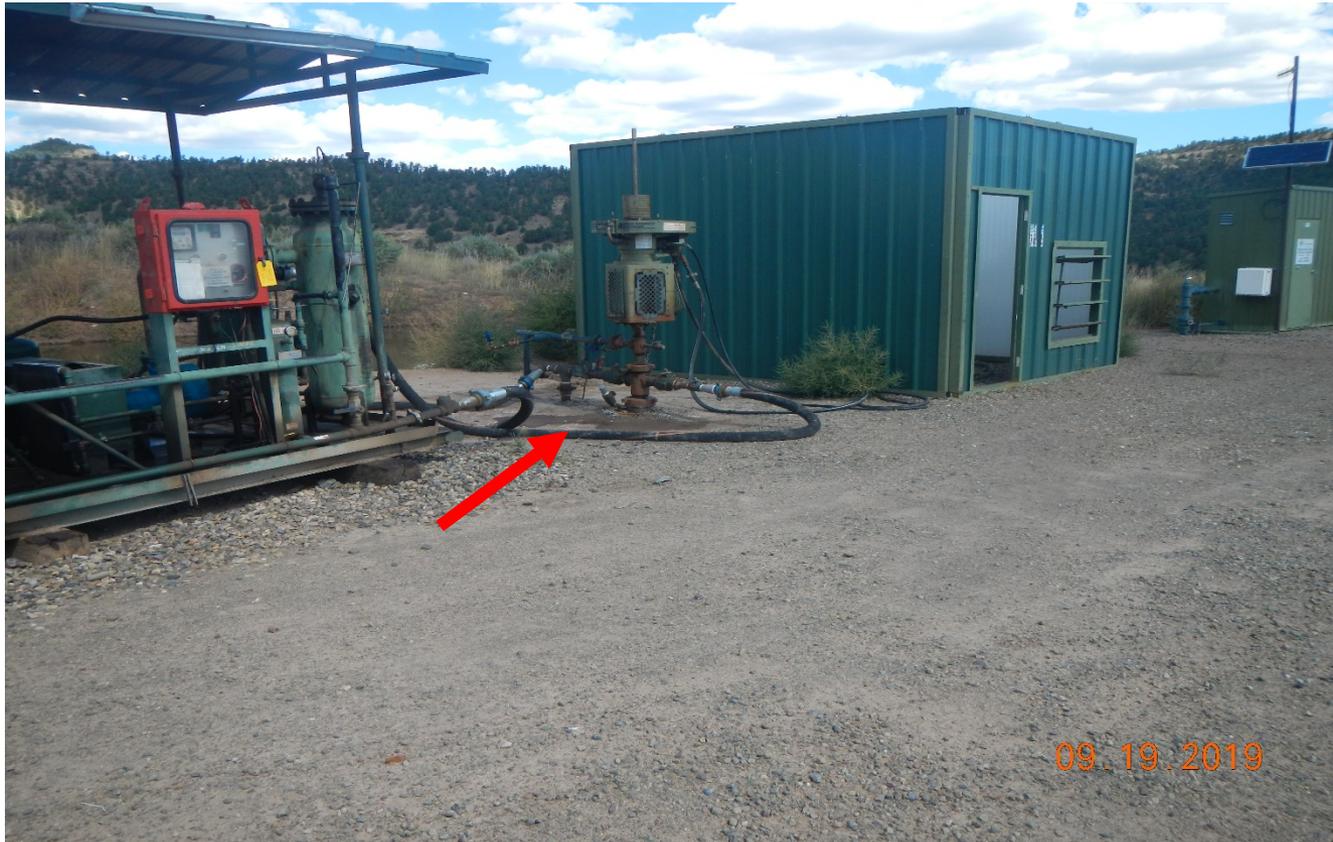
Photo 1. Facing toward the wellhead. There was signs that the well was recently leaking.

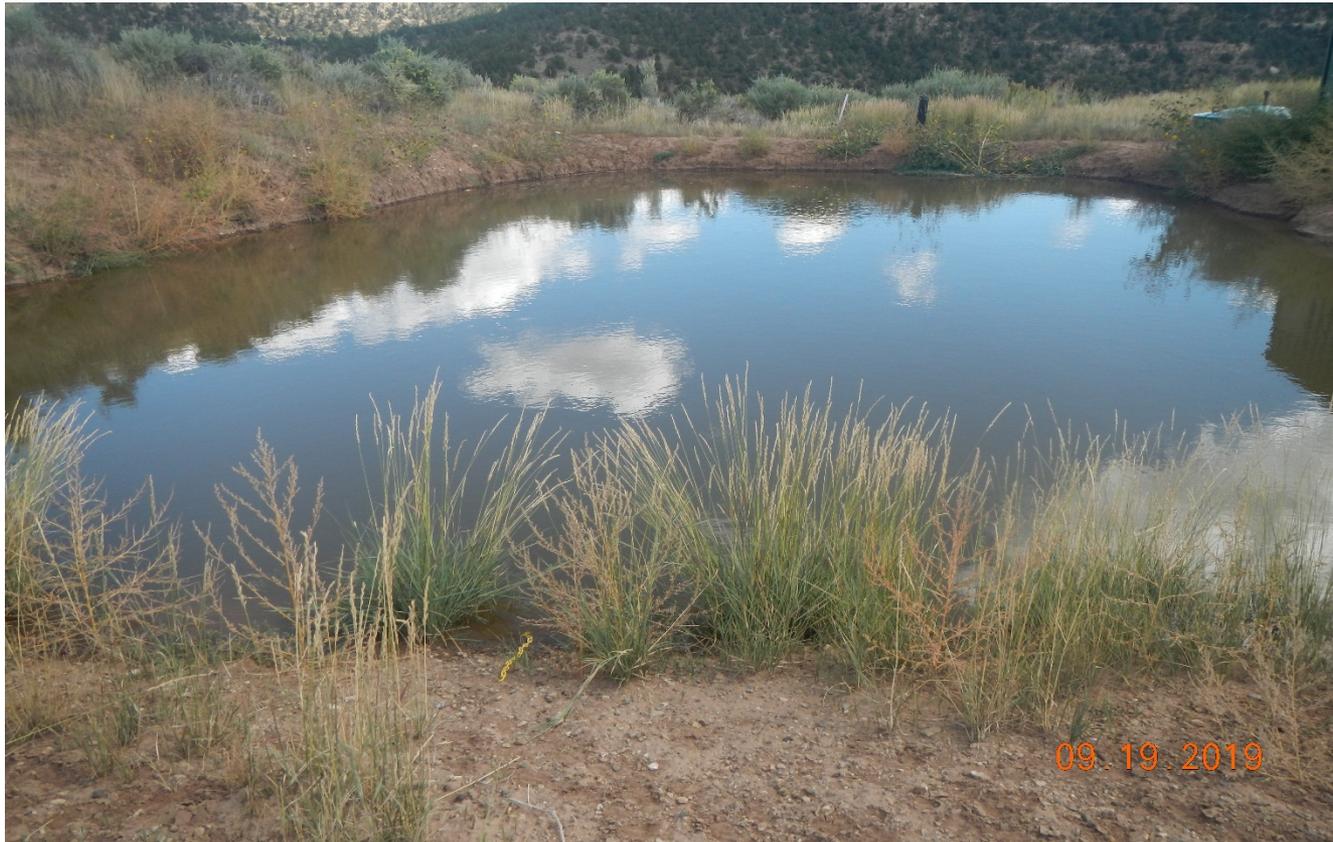
Photo 2. Water level at pit is at 2ft freeboard and needs to be lowered.

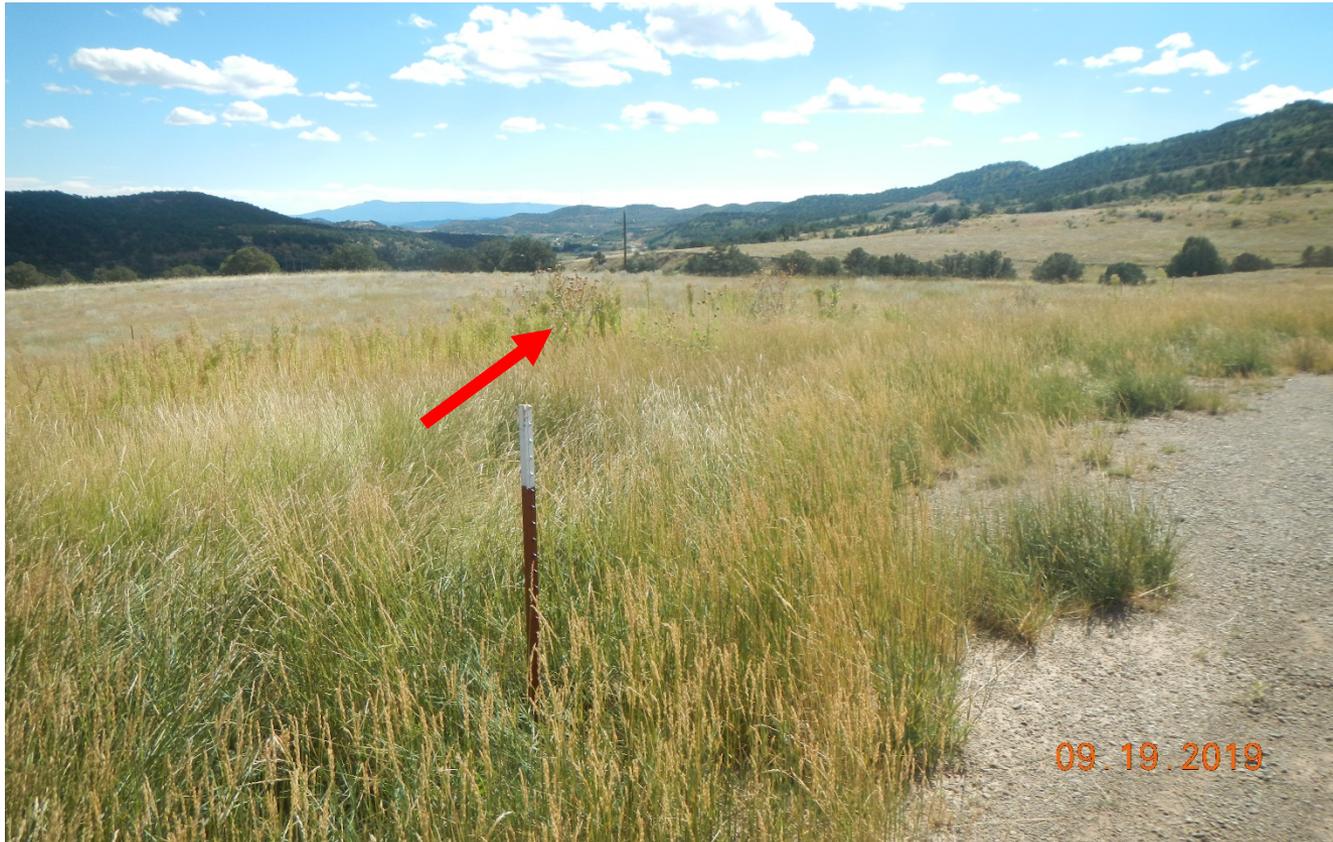
Photo 3. Facing east at the interim reclamation area. There were noxious weeds (Scotch thistle) found around the location.
