Inspection Photos

API: 05-071-06411

Operator: TIMBER CREEK OPERATING LLC

Inspection Date: 9/19/2019

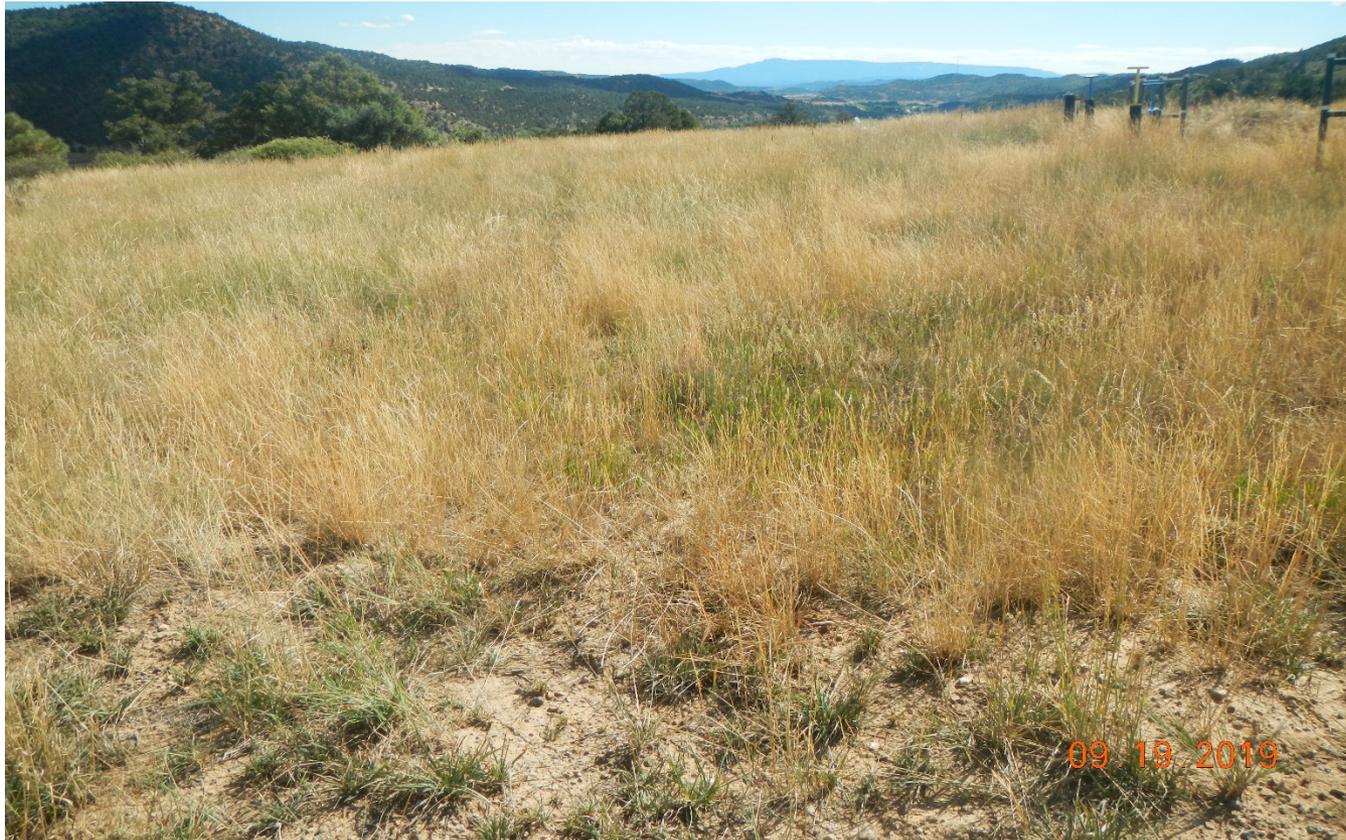
Photo 1. Facing east toward the location. West of the well site. Perennial vegetation is well established in this area.

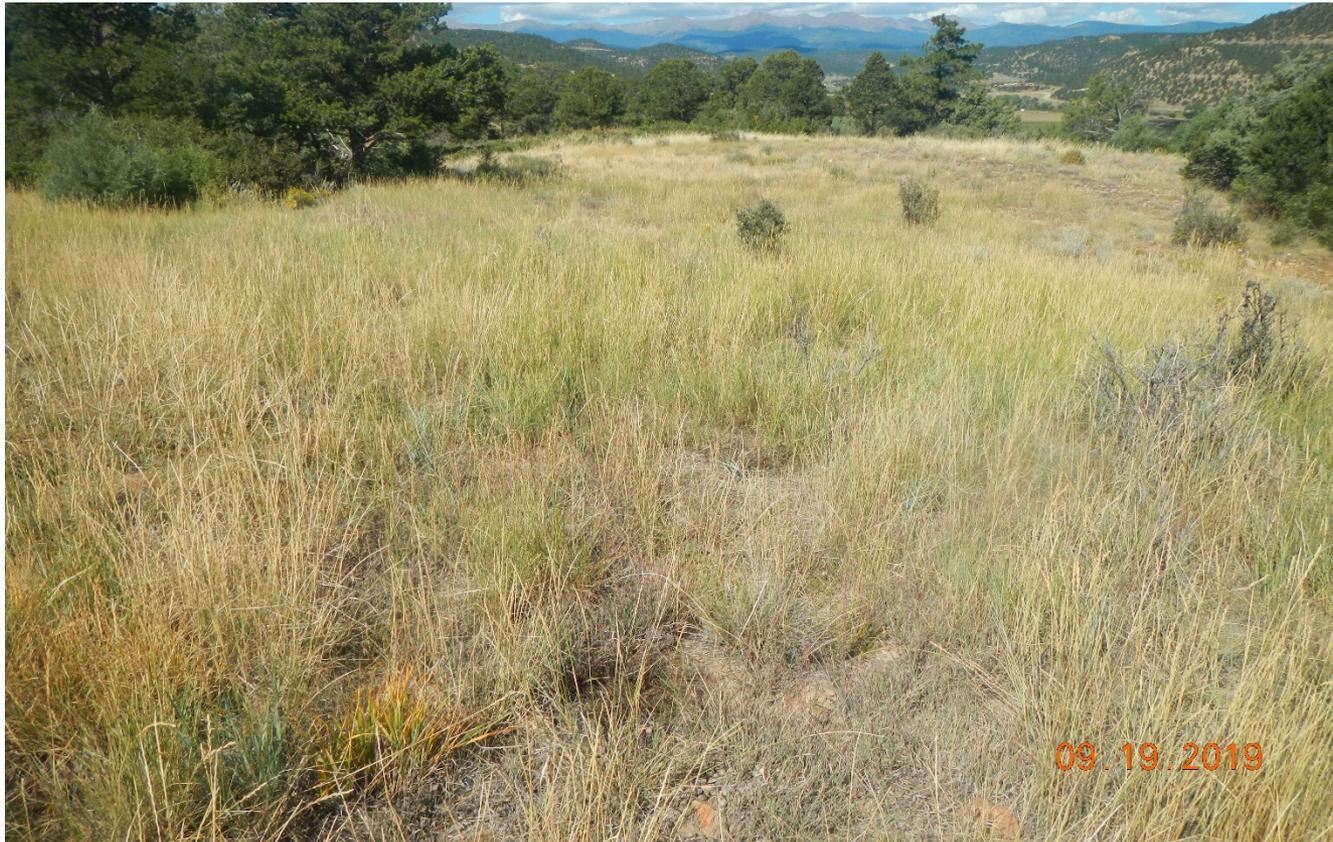
Photo 2. Facing west toward the location. West of the well site. Perennial vegetation is well established in this area.

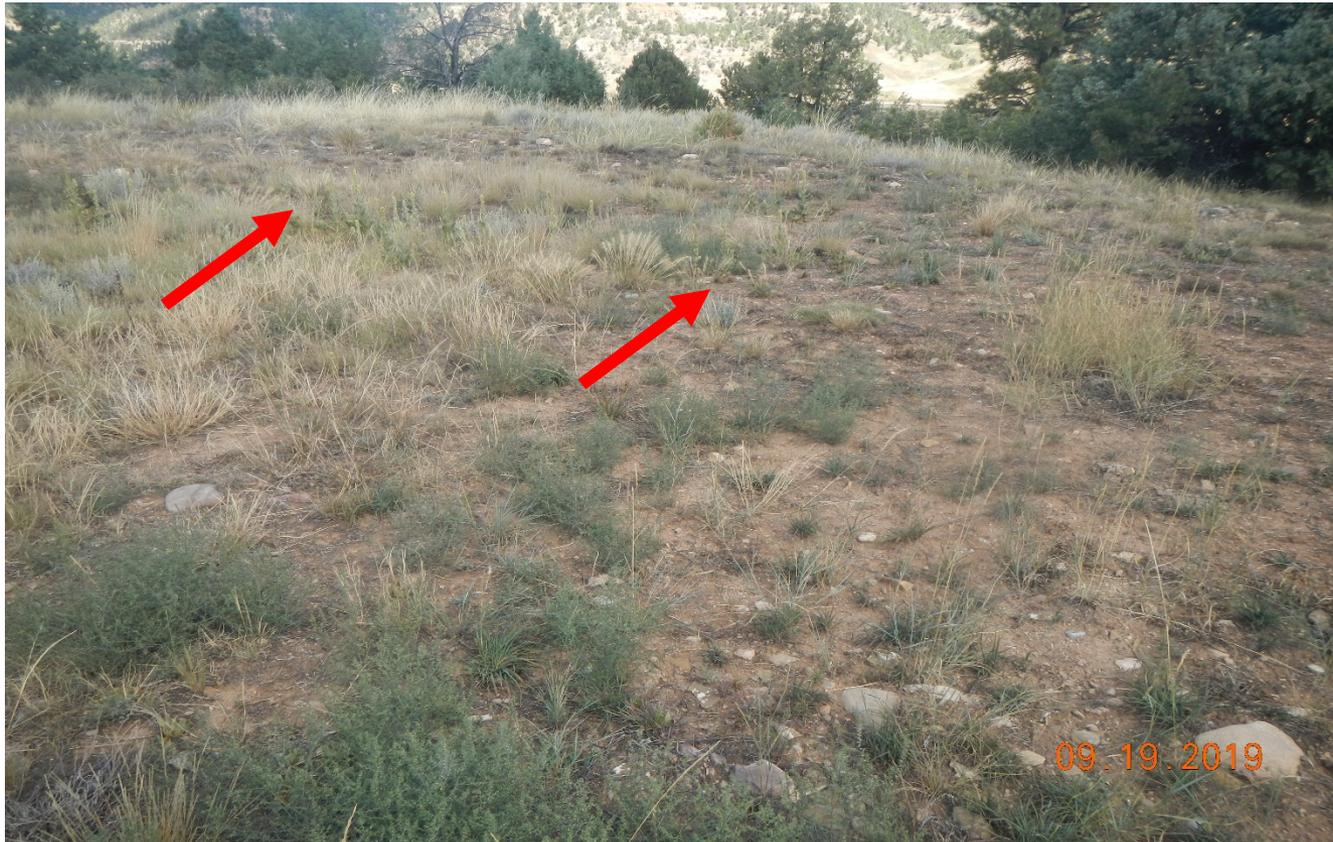
Photo 3. There are some noxious weeds that have grown at the eastern side of location. Common mullien.

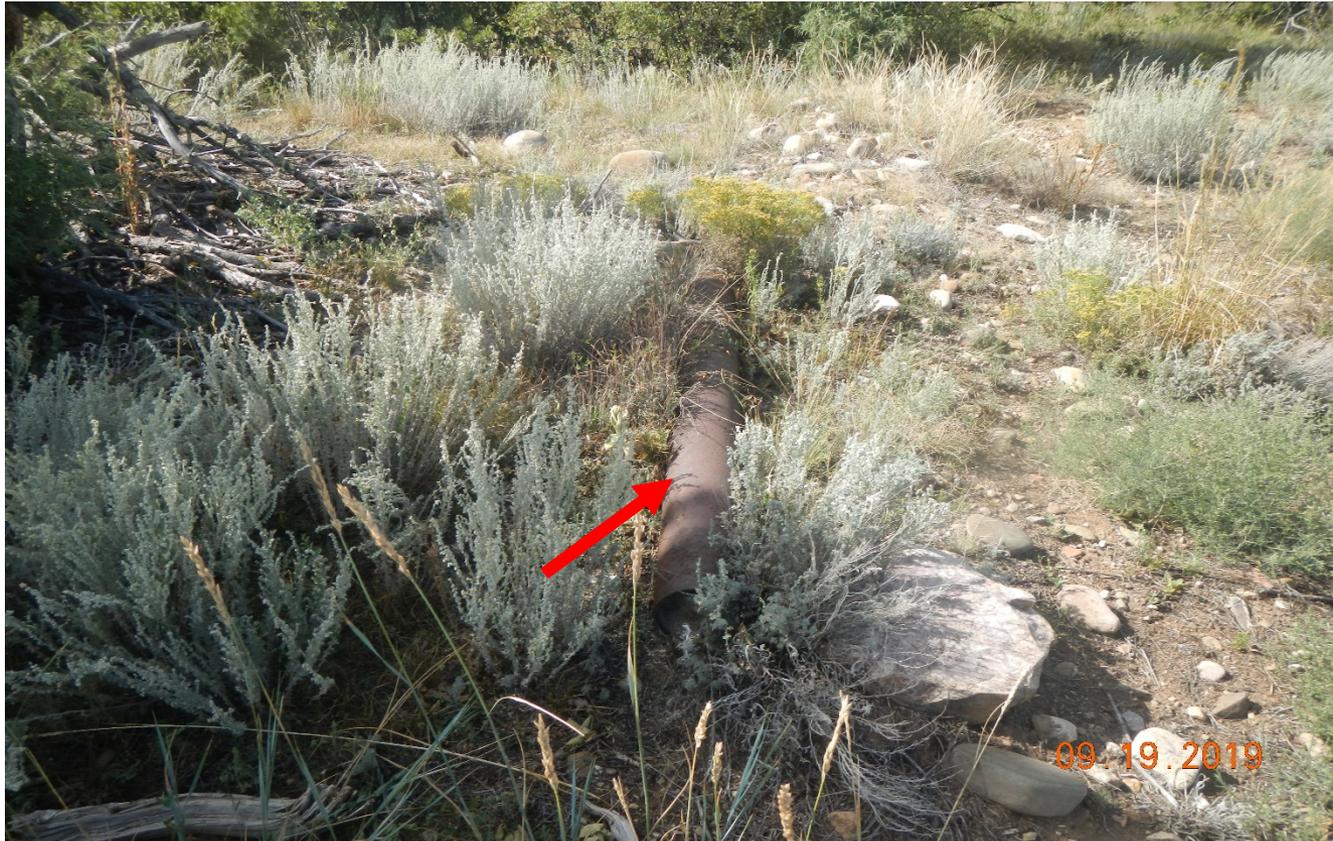
Photo 4. There is a metal pipe that remains at the east side of the location.
