Inspection Photos

API: 05-071-06436

Operator: TIMBER CREEK OPERATING LLC

Inspection Date: 9/19/2019

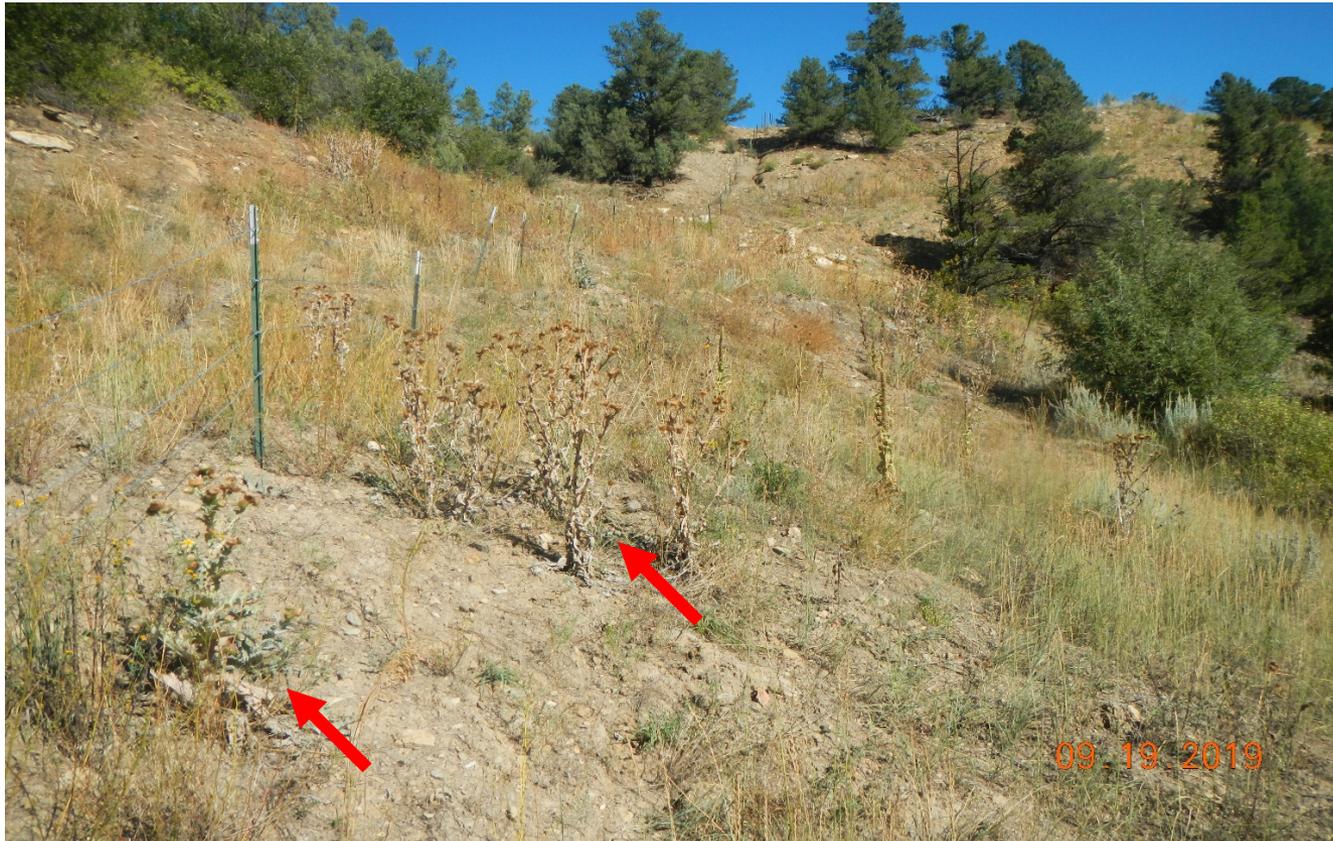
Photo 1. Facing west toward the reclaimed access road from the bottom of the canyon. There are numerous noxious weeds in this area.

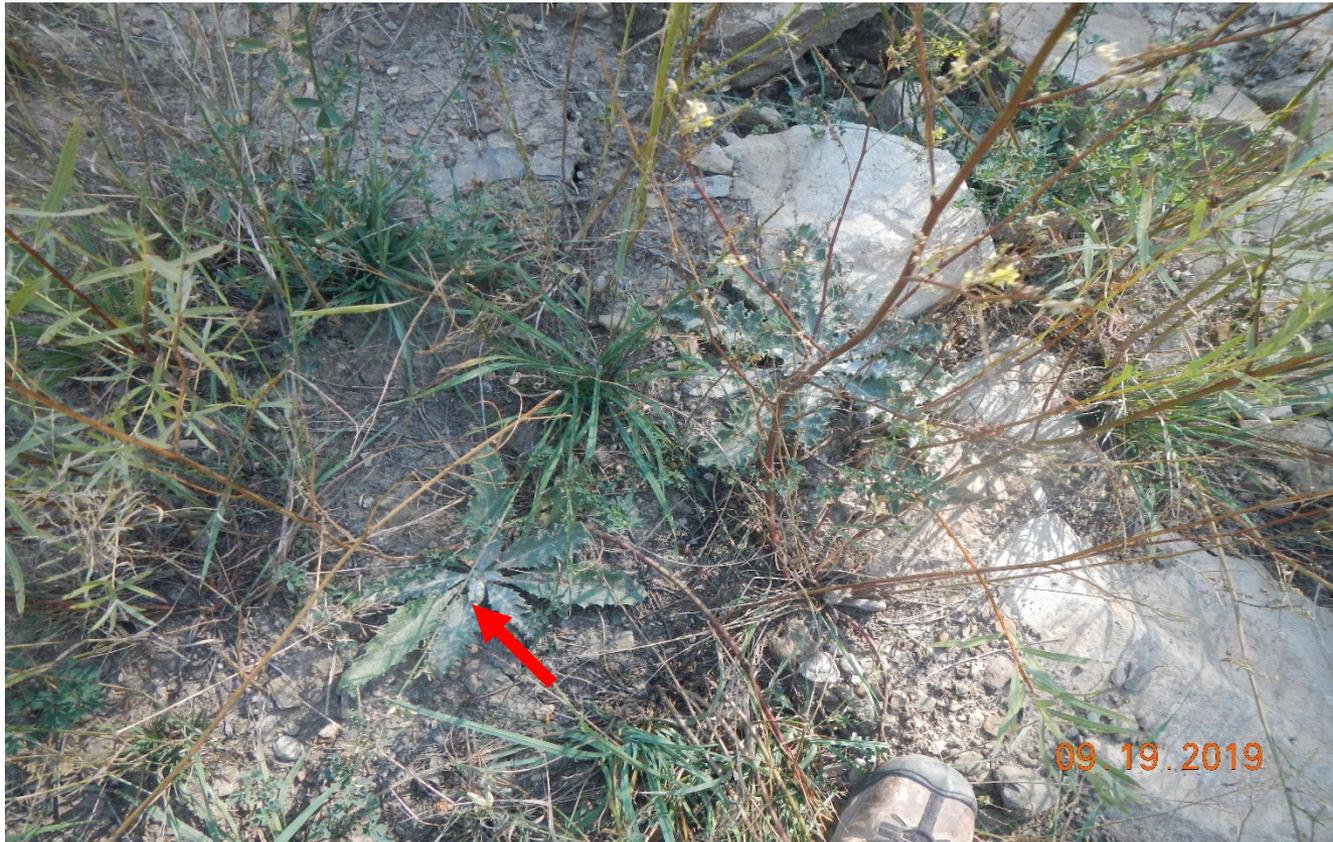
Photo 2. There are Scotch thistle rosette that need to be controlled.

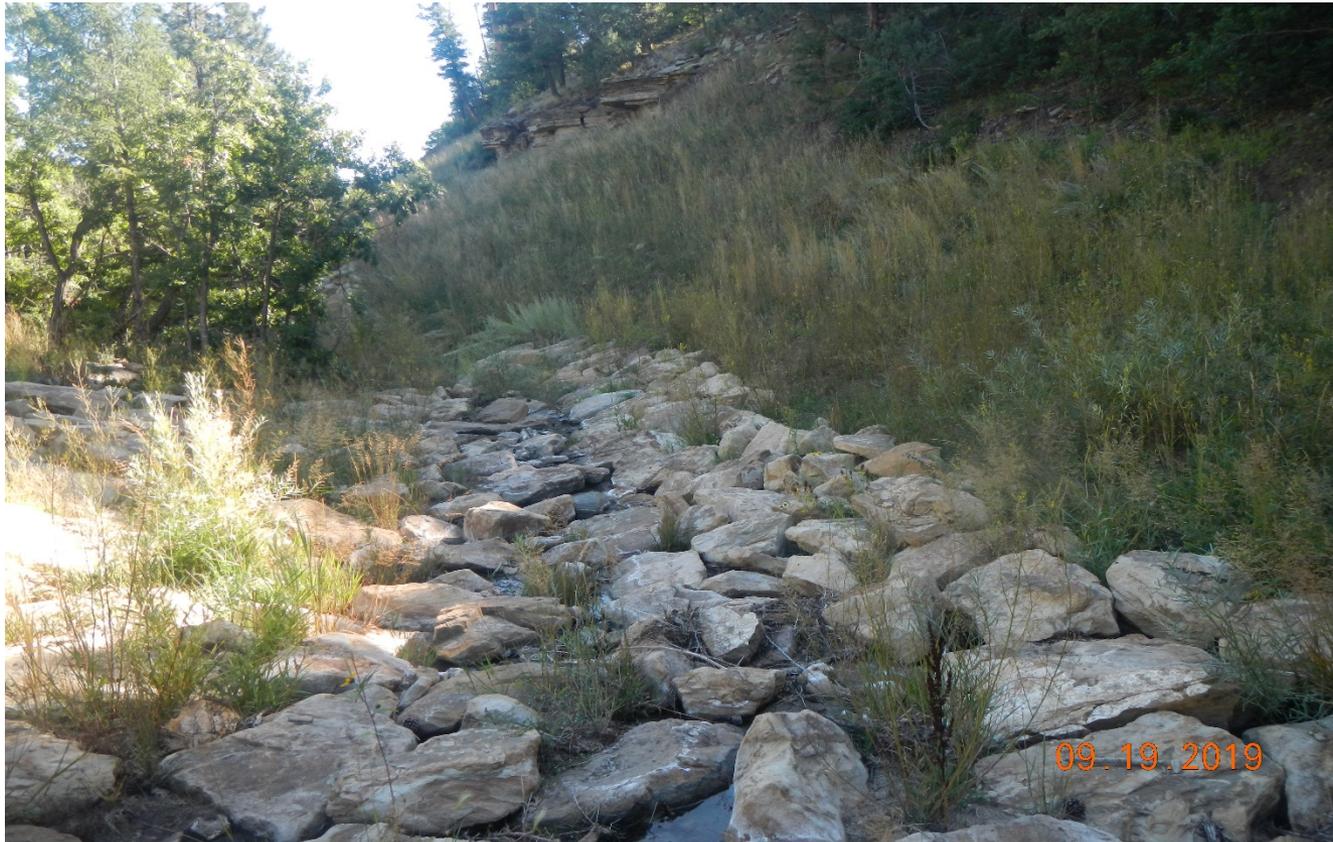
Photo 3. Facing east toward the reclaimed access road from the bottom of the canyon.

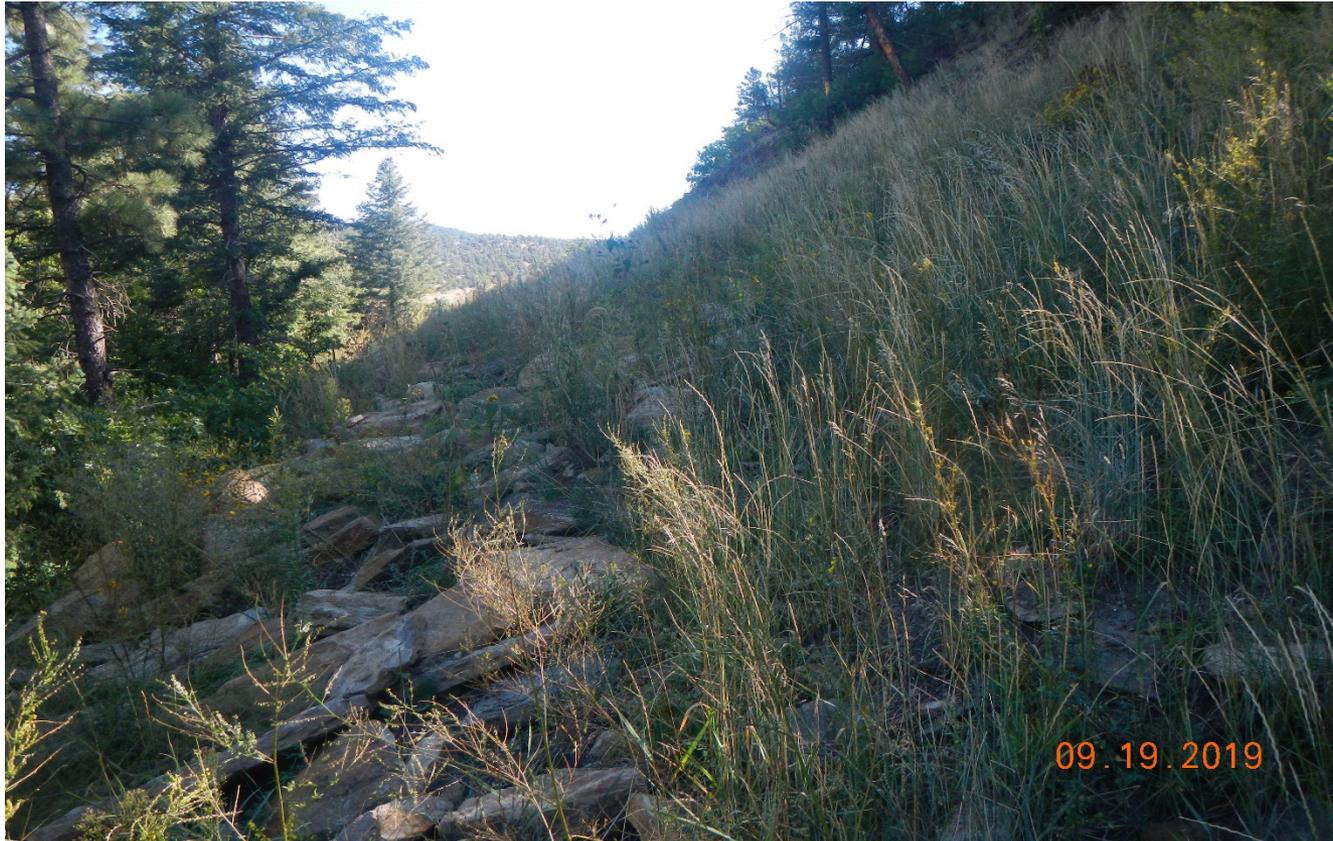
Photo 4. Facing northeast along the reclaimed access road. Vegetation is establishing well.

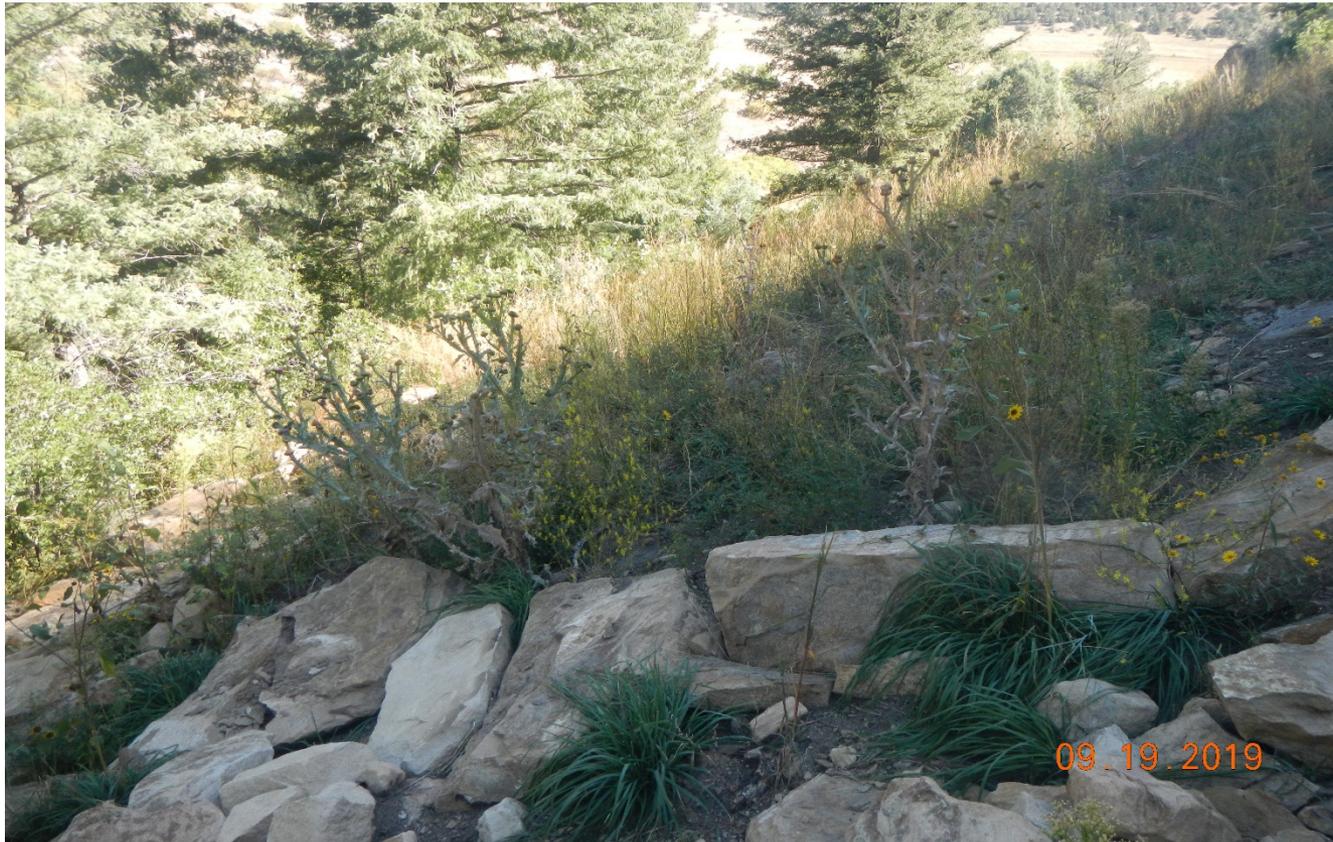
Photo 5. There are noxious weeds along the road which have developed seed heads.

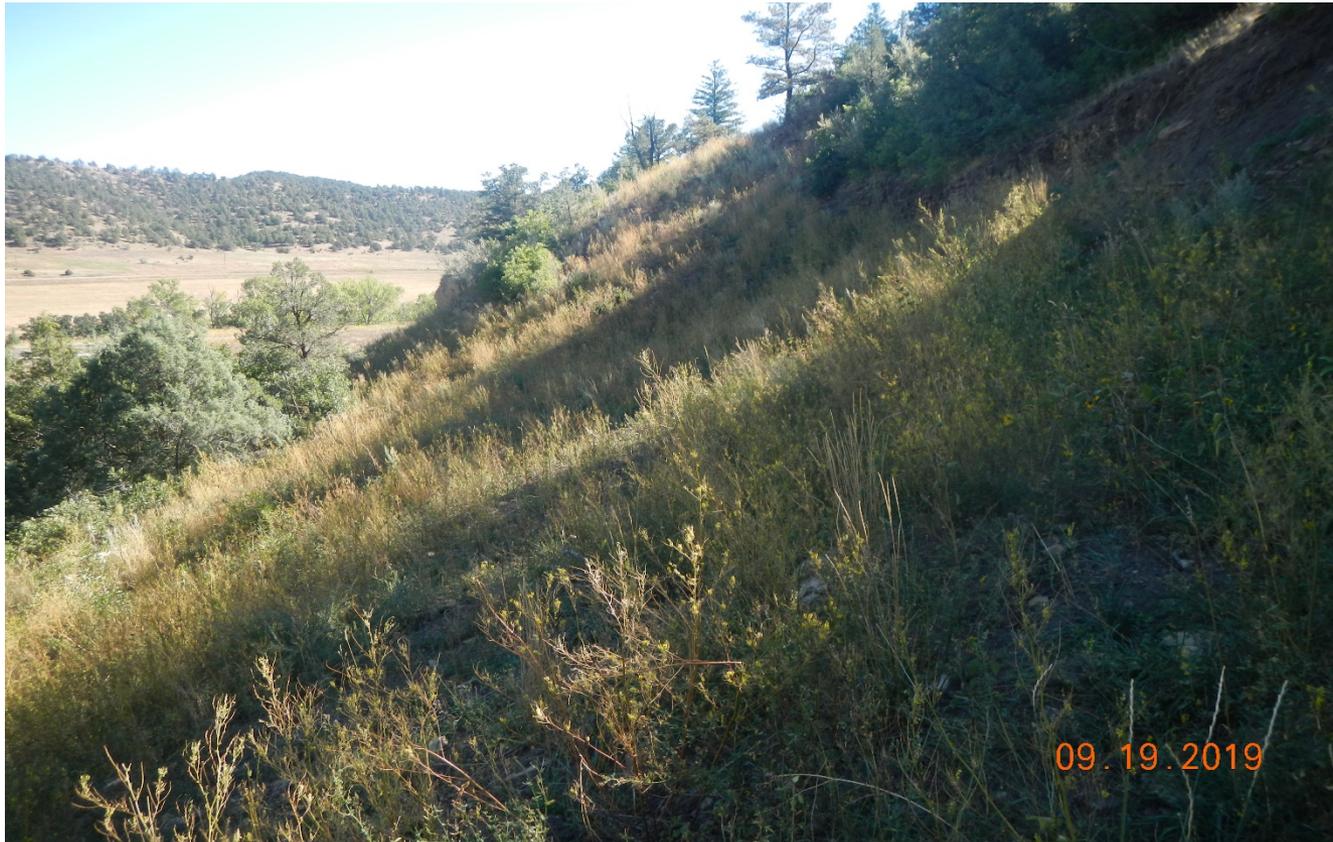
Photo 6. Facing northeast along the reclaimed access road. Vegetation is establishing well. There is a dominance of Yellow clover in this area.
