Construction and Stormwater Inspection

September 17, 2019

Operator: BAYSWATER EXPLORATION AND PRODUCTION LLC - #10261

Location ID: 466071

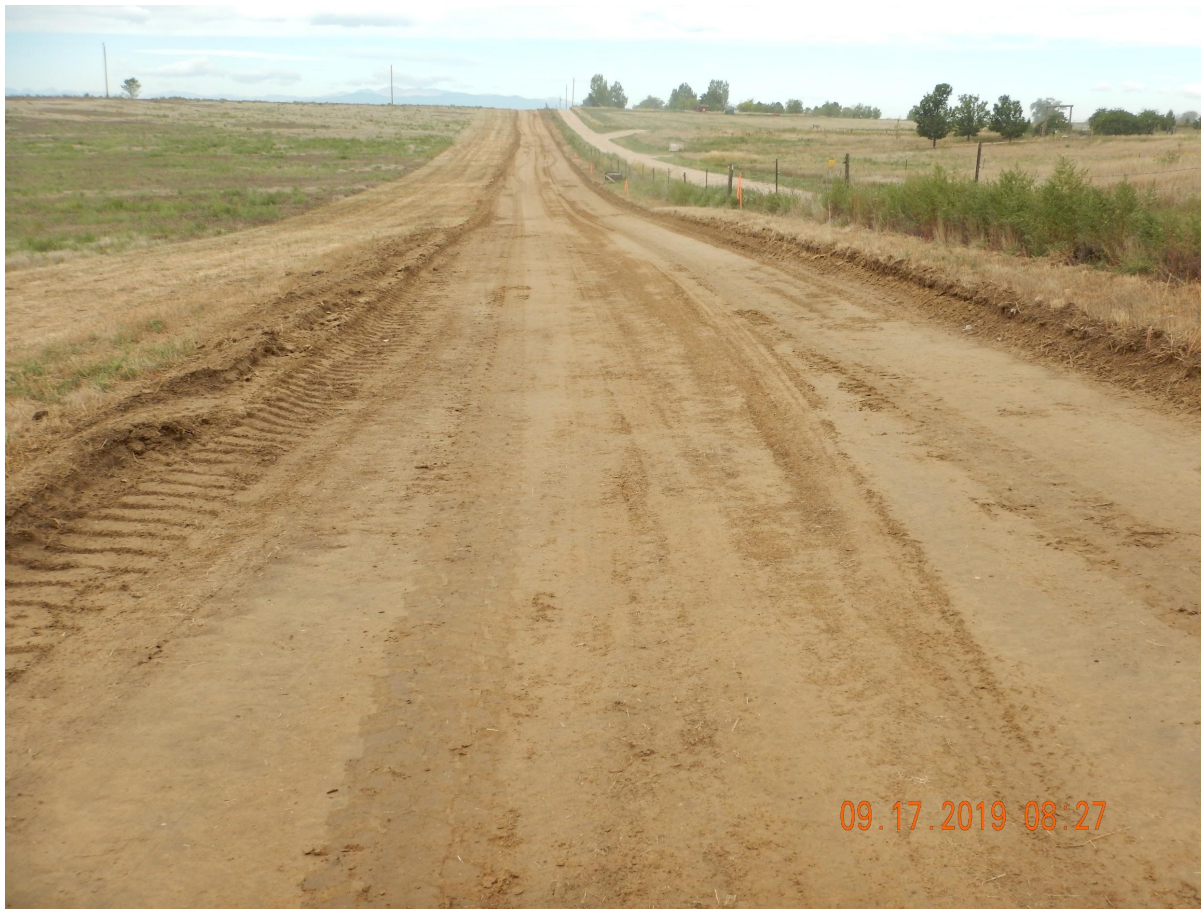
Photo 1. Photo taken from the eastern portion of the access road, facing West. Photo illustrates the Operator has salvaged some topsoil along the access road and has stored it at the location.

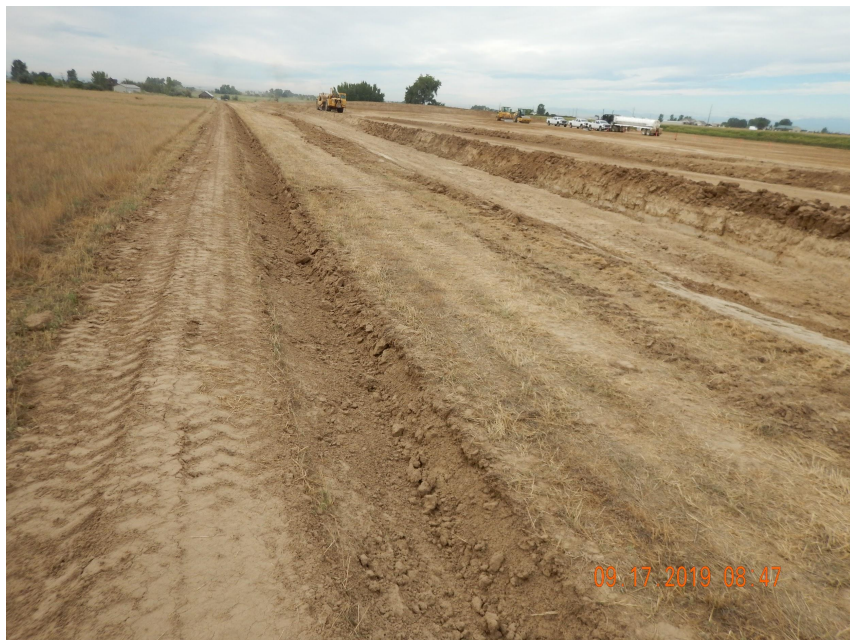
Photo 2. Photo taken from the eastern perimeter of the location, facing South. Photo illustrates a ditch and berm BMP which has been installed around the entire perimeter of the location.

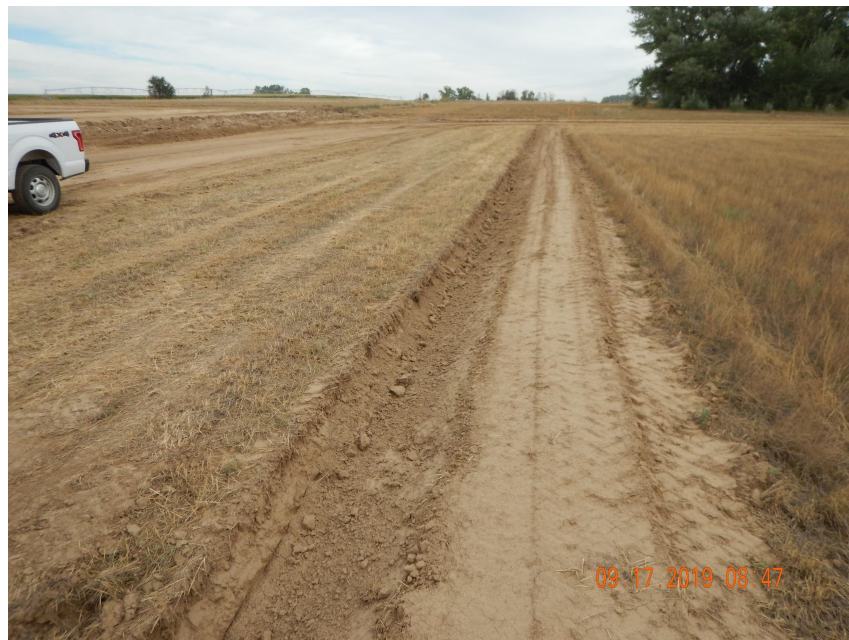
Photo 3. Photo taken from the eastern perimeter of the location, facing North. See comments under Photo 2.

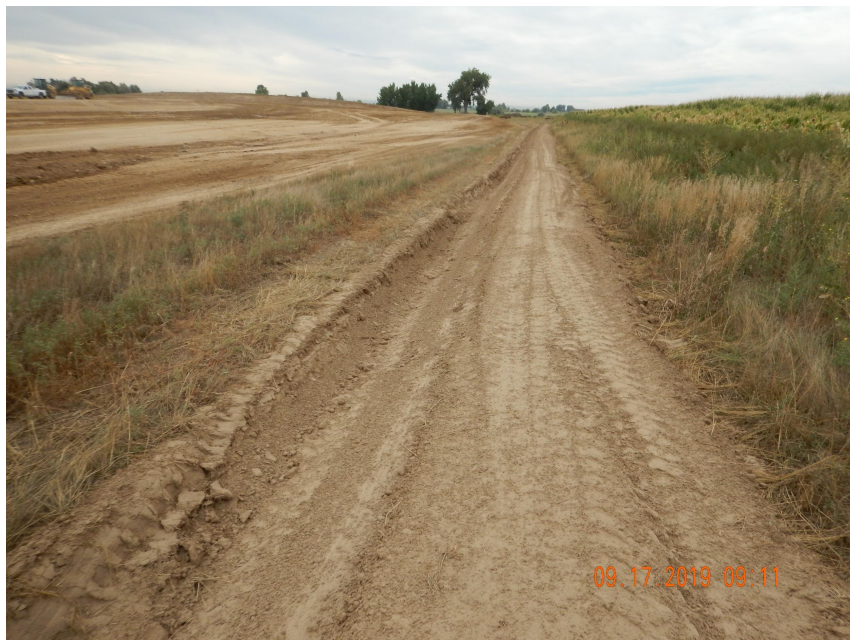
Photo 4. Photo taken from the western perimeter of the location, facing South. See comments under Photo 2.

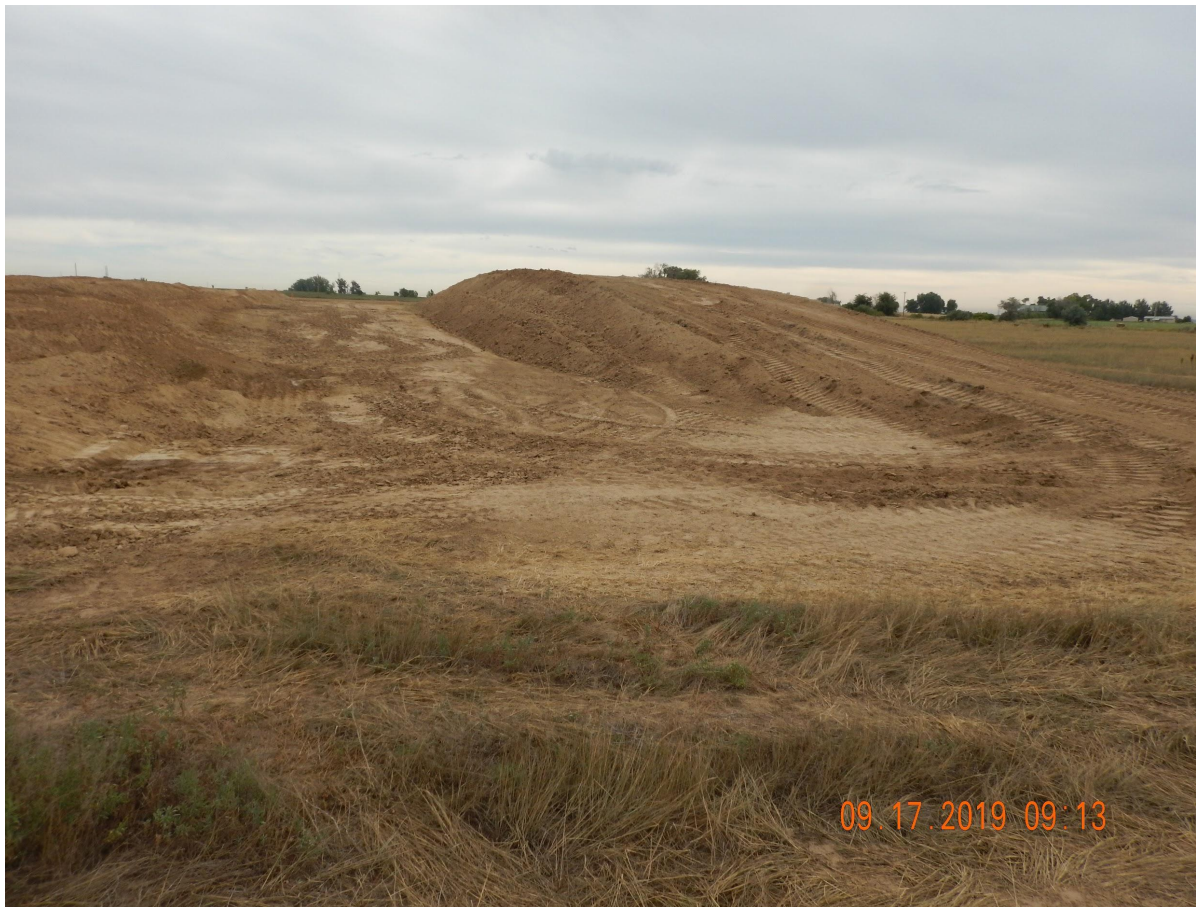
Photo 6. Photo taken from the southeastern perimeter of the location, facing East. Photo illustrates the topsoil stockpile.

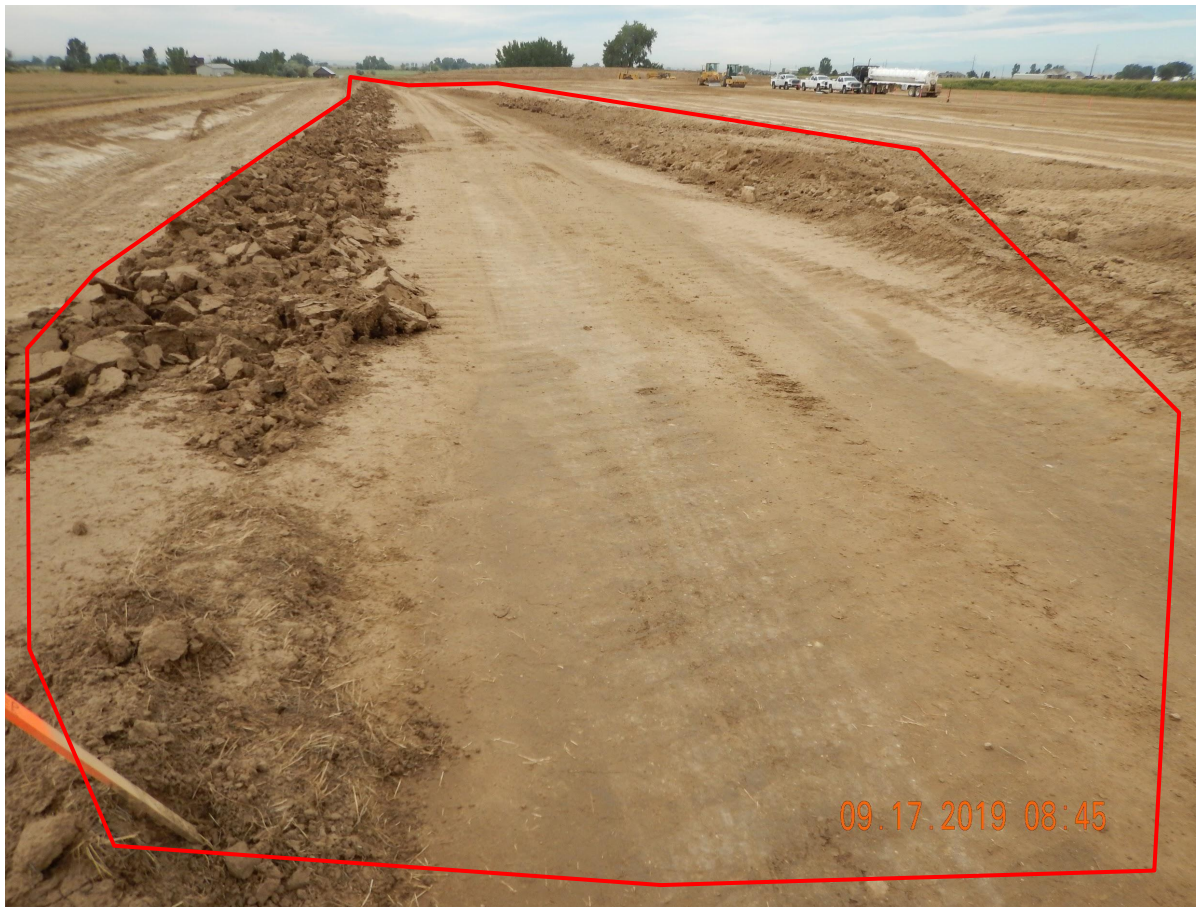
Photo 7. Photo taken from the northeastern location, facing South. Photo is illustrating topsoil (all within the red line) that was scraped by the Operator and used as fill material on the eastern production pad. Photo 8 illustrates the scraping operation.

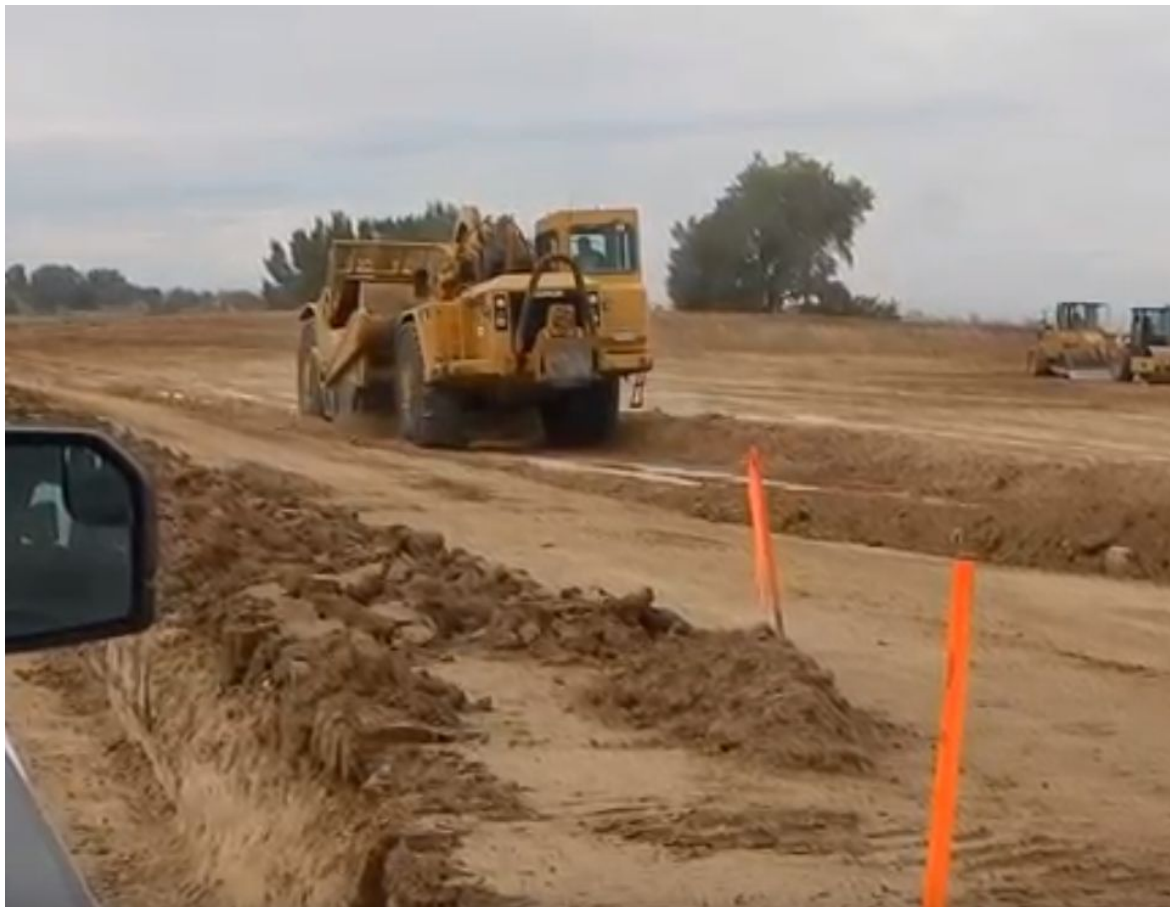
Photo 8. Photo taken from the northeastern location, facing South. Photo is illustrating the Operator scraping topsoil which was placed on the eastern production pad as fill material. Photo 9 illustrates topsoil that was placed on the eastern production pad as fill material.

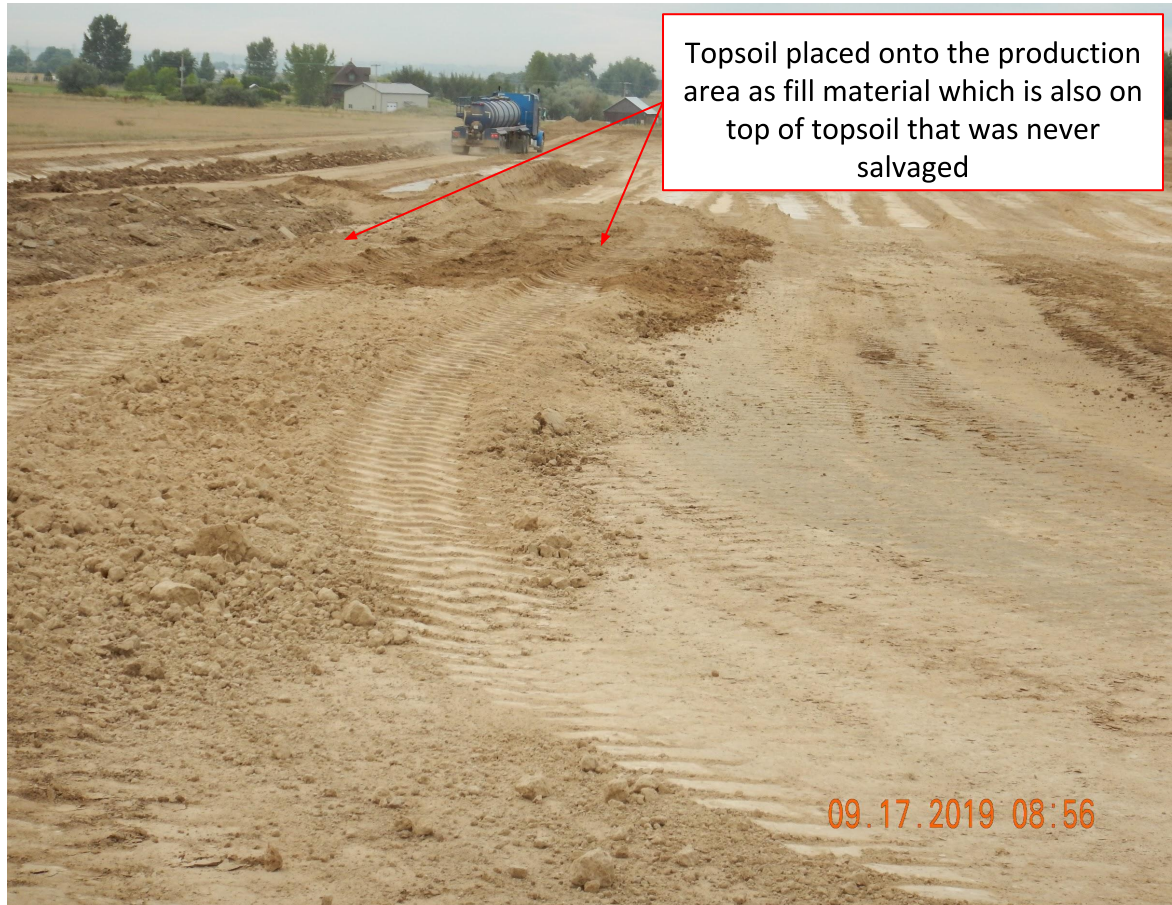
Photo 9. Photo taken from the eastern production pad, facing South. Photo illustrates topsoil that was placed on the eastern production pad as fill material. Photo also illustrates topsoil that remains unsalvaged from the production pad. Upon discovery of this observation, COGCC staff stop operations to consult with the contractor. Contractor confirmed that the soil material illustrated above (topsoil) was being used as fill material. Then, a second contractor later claimed that topsoil was still going to be salvaged from the production pad. Those two statements contradict each other. Why would fill material (topsoil) be placed onto an area that still had to be salvaged.

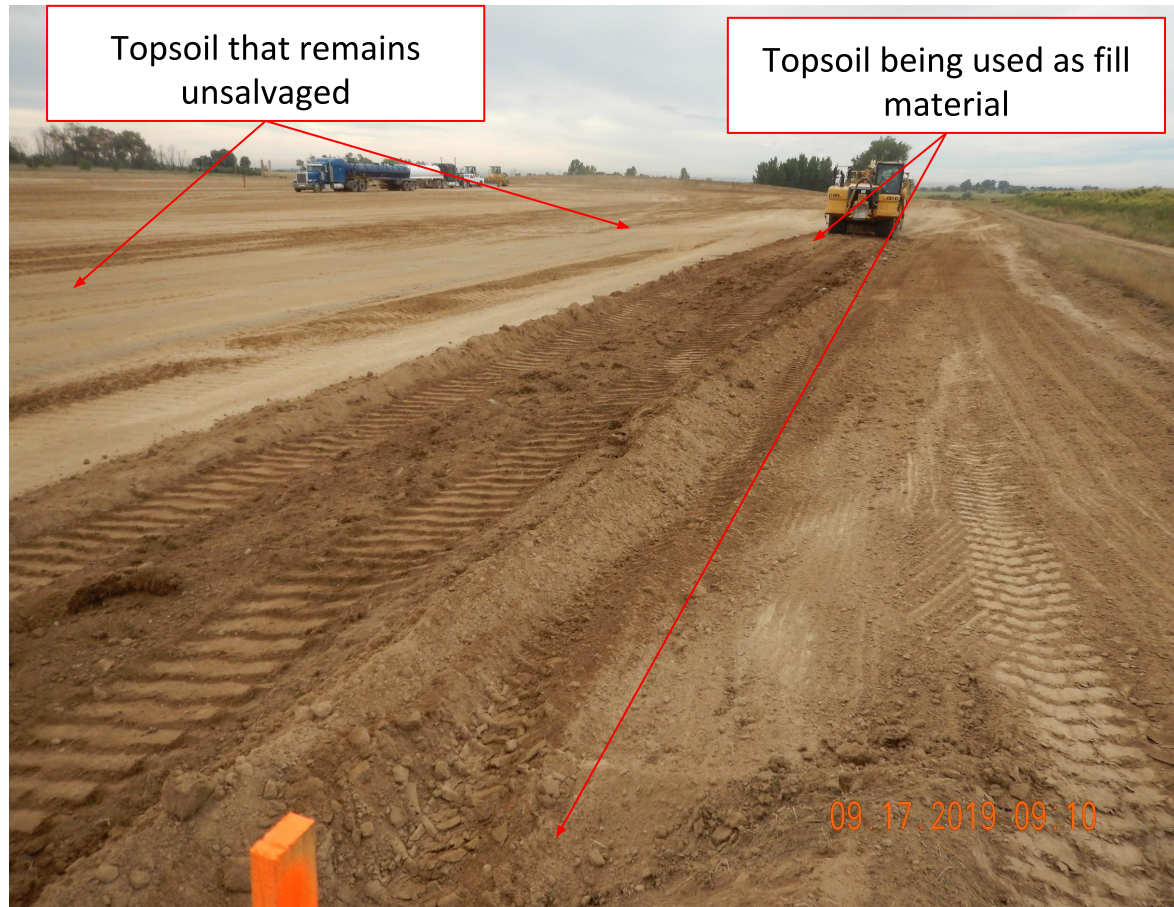
Photo 10. Photo taken from the northwestern well pad location, facing South. Photo illustrates the Operator placing topsoil on the northwestern well pad as fill material. Photo also illustrates topsoil that remains unsalvaged from the well pad.

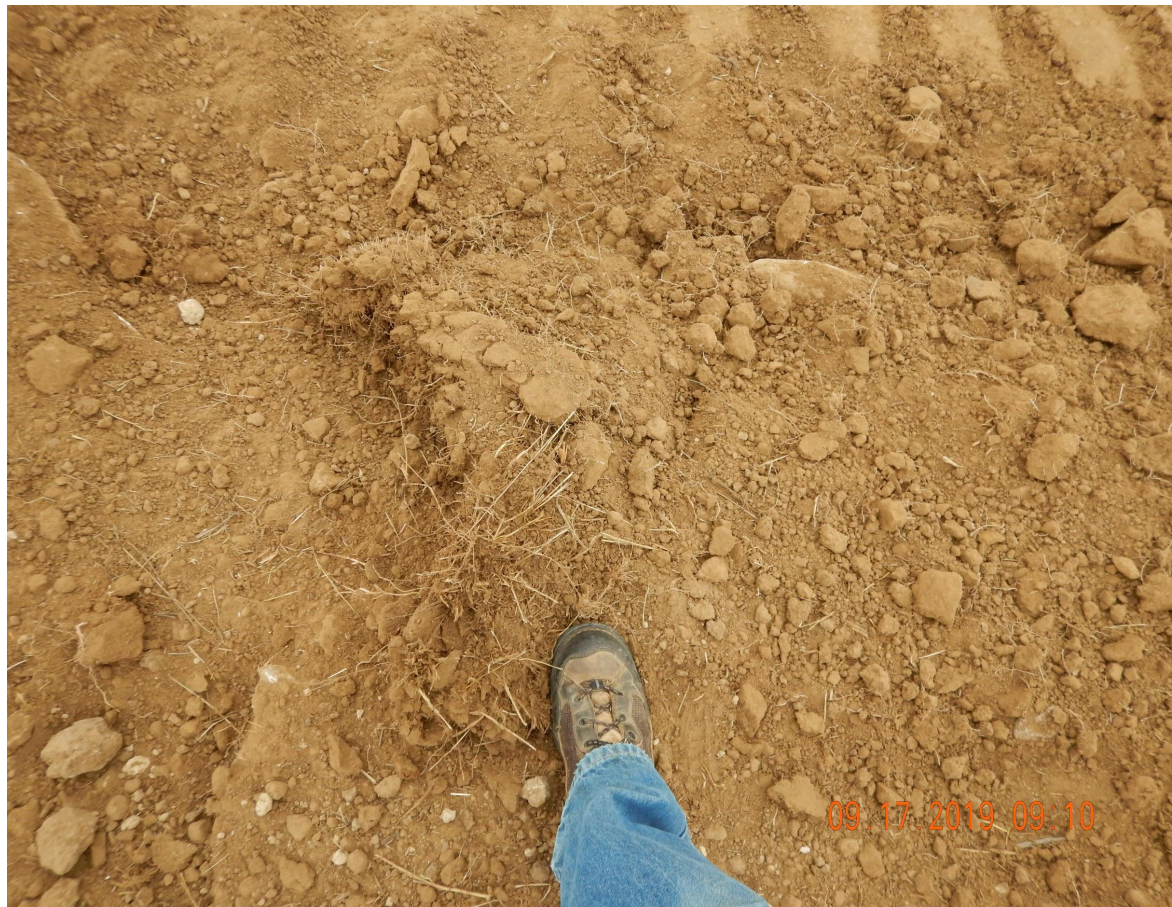
Photo 11. Close up photo taken from the northwestern well pad location. Photo illustrates characteristics (root growth) of the topsoil horizon as confirmation of topsoil being used as fill material.
