Interim Reclamation and Stormwater Inspection

September 17, 2019

Operator: BAYSWATER EXPLORATION AND PRODUCTION LLC - #10261

Inspection Photos
Location Name: Hester Farms II /31-H Pad
Location ID: 456151

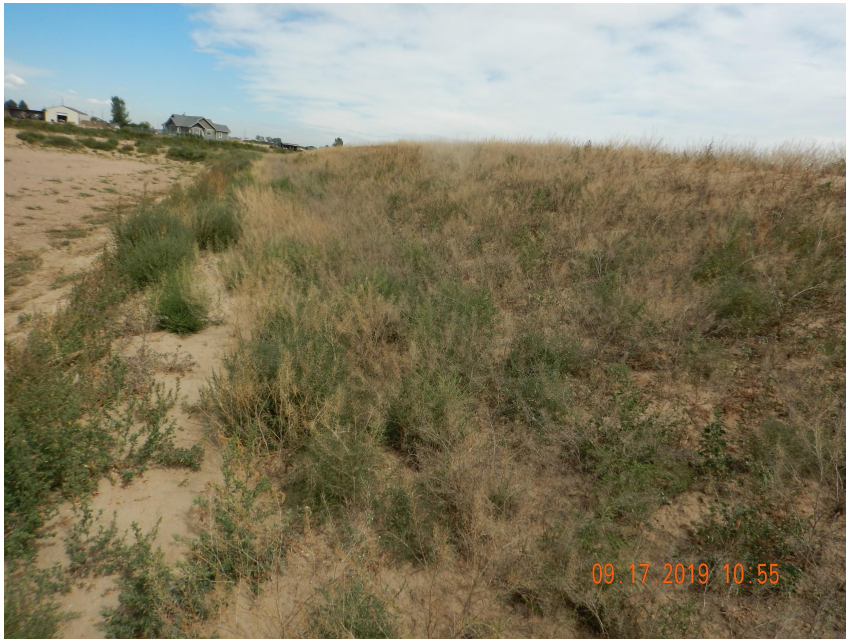
Photo 1. Photo taken from the southern topsoil stockpile, facing North. Photo illustrates Operator has failed to prevent weed establishment on the topsoil stockpile per Rule 1002.c. Also, this topsoil stockpile is from the well location. Operator has failed to salvage topsoil from the production facility. Refer to photos 10-12.

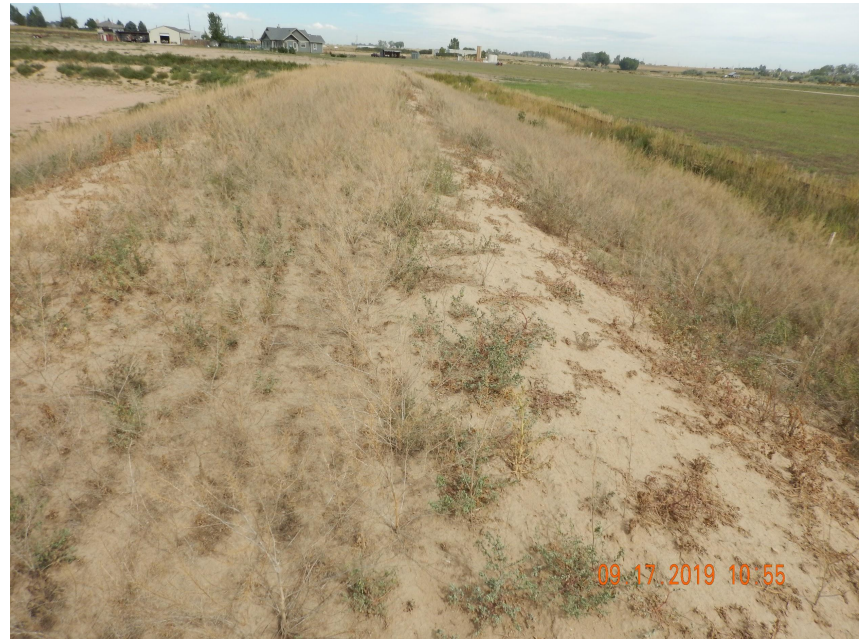
Photo 2. Photo taken from the southern topsoil stockpile, facing North. See comments under Photo 1.

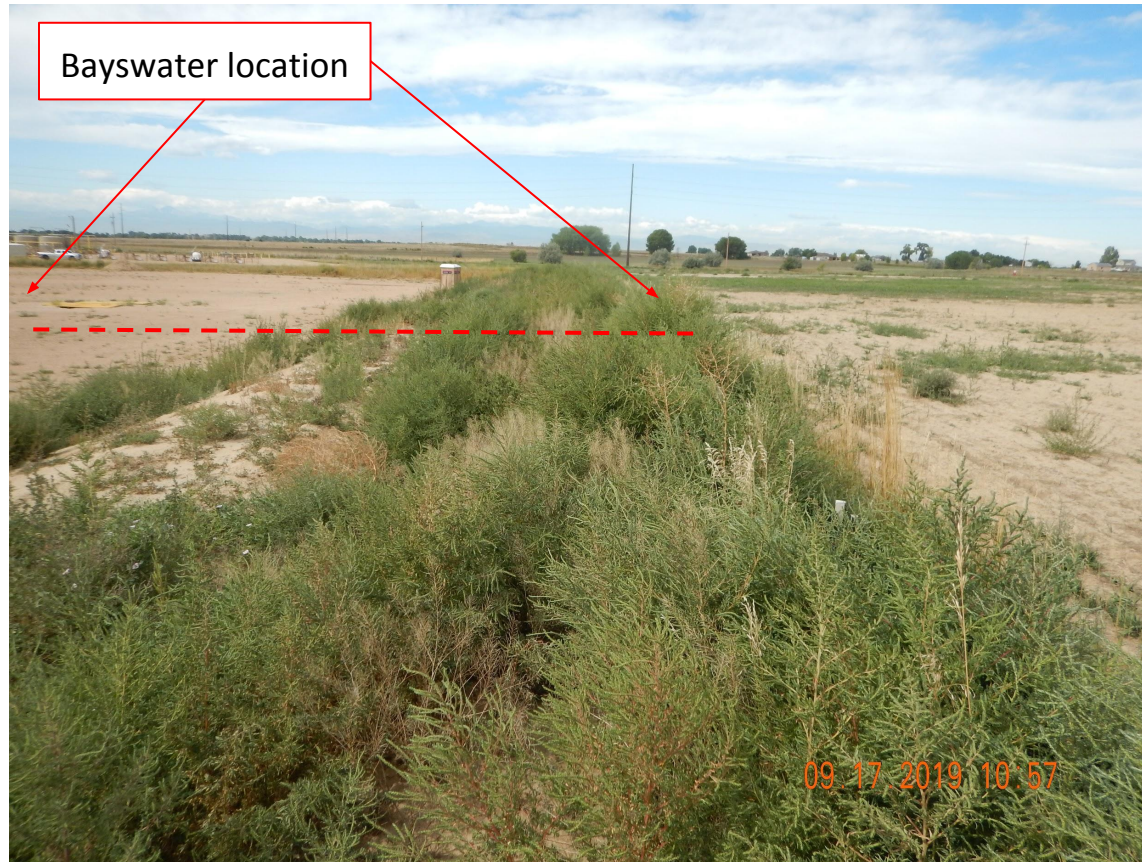
Photo 3. Photo taken from the northeast perimeter of the well location, facing West. Photo illustrates the Operator has failed to control and manage undesirable and noxious weeds on cropland.

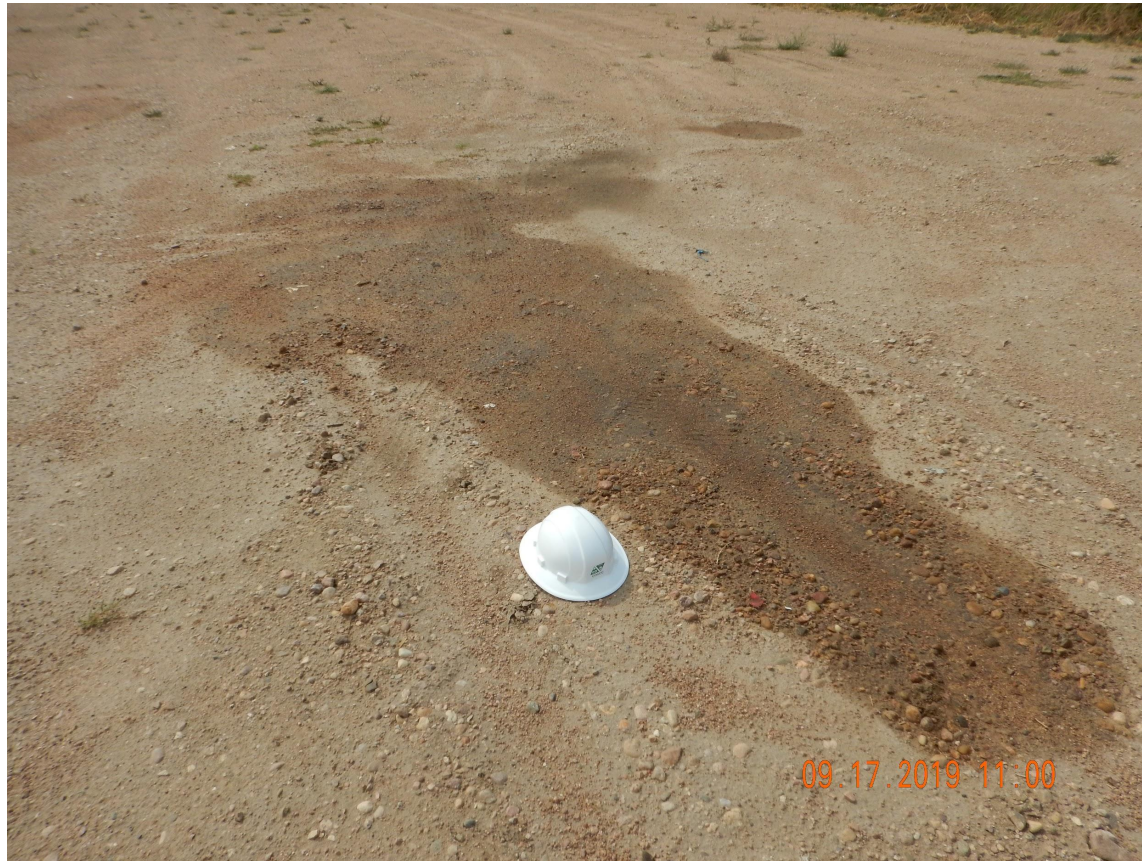
Photo 4. Photo taken from the northern well location. Photo illustrates a localized area of staining that the Operator has failed to clean up per Rule 907.e.

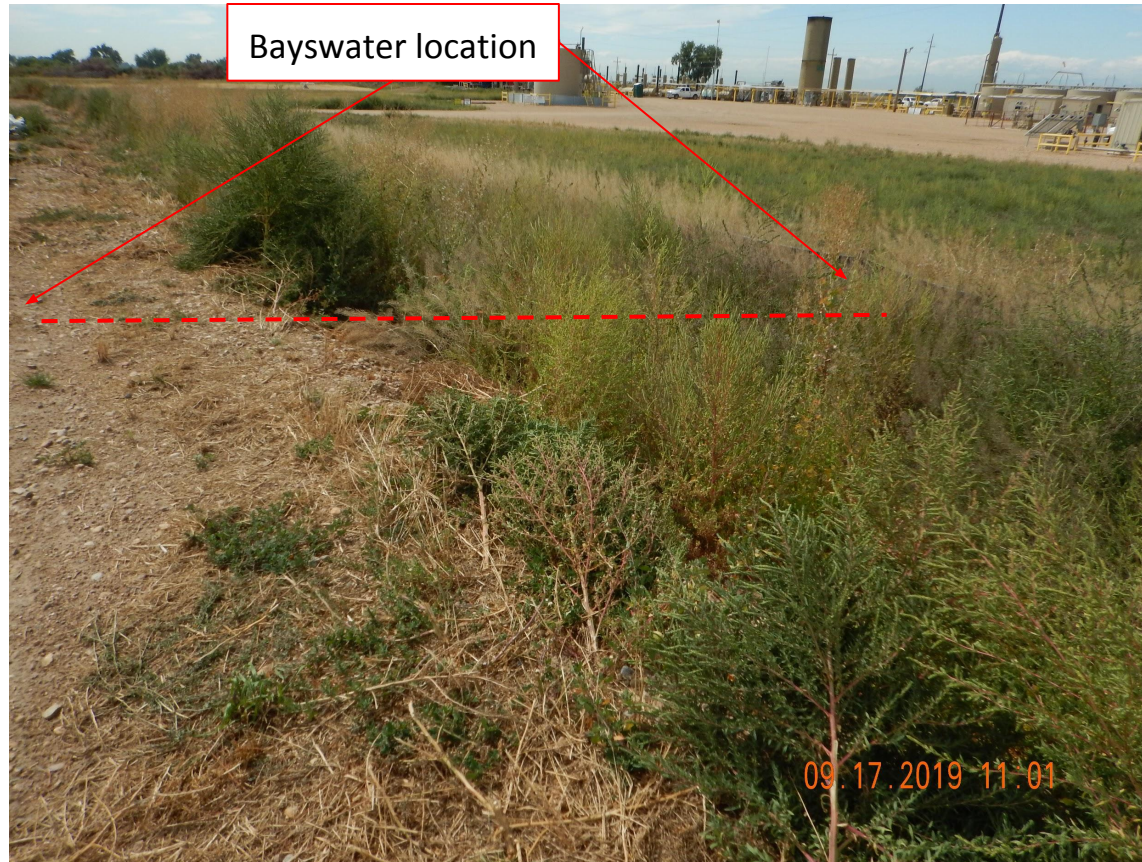
Photo 5. Photo taken from the western well location, facing Southwest. See comments under Photo 3 regarding weeds.

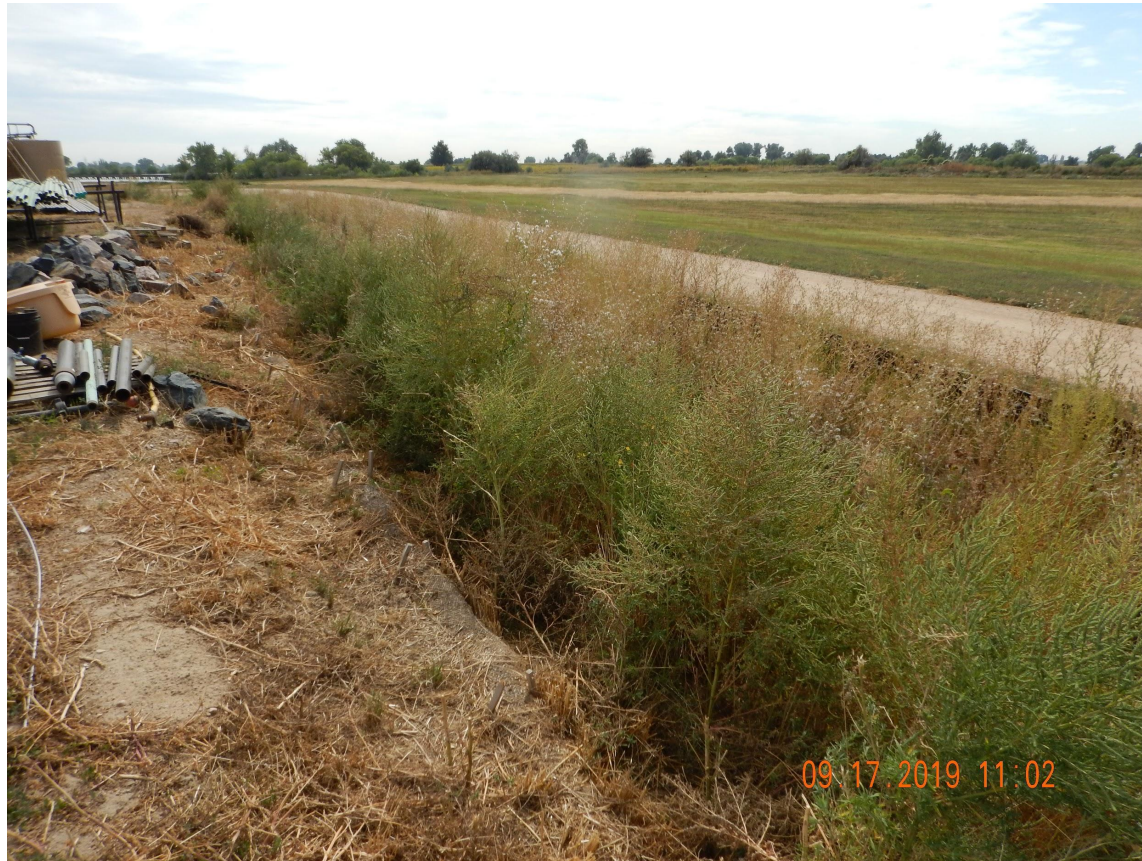
Photo 6. Photo taken from the southern well location, facing East. Photo illustrates unused equipment be stored on location and unmanaged weeds.

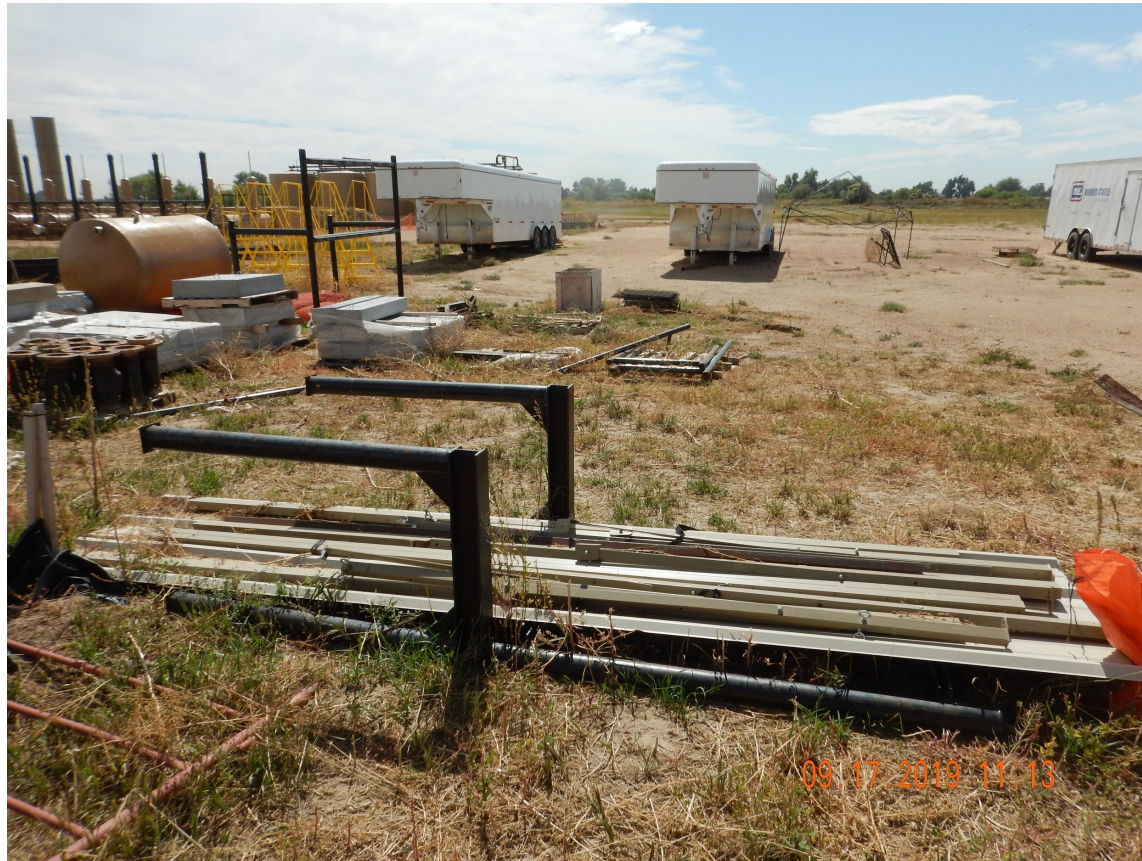
Photo 7. Photo taken from the southeastern well location, facing South. Photo illustrates unused equipment being stored on location.

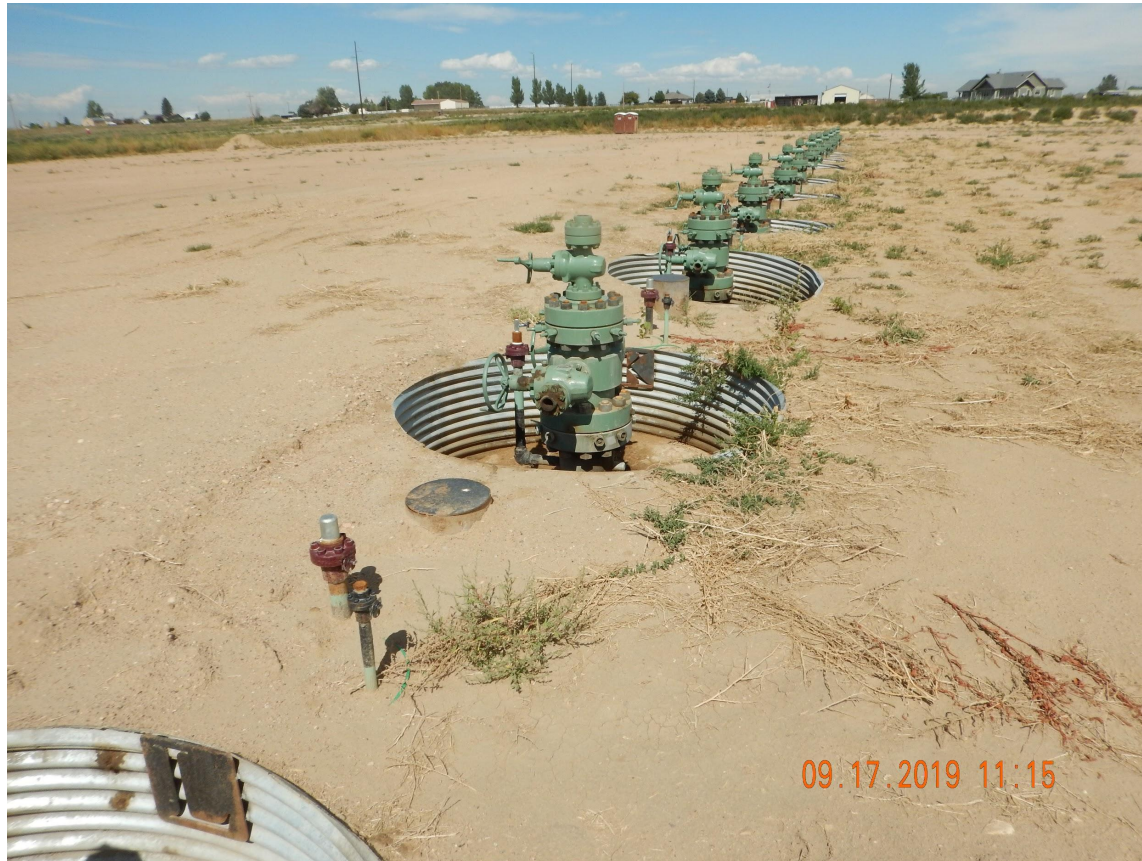
Photo 8. Photo taken from the wellhead area, facing North. Operator has failed to put cellar covers around the wellheads for public safety per Rule 605.c. This is also a safety hazard for wildlife.

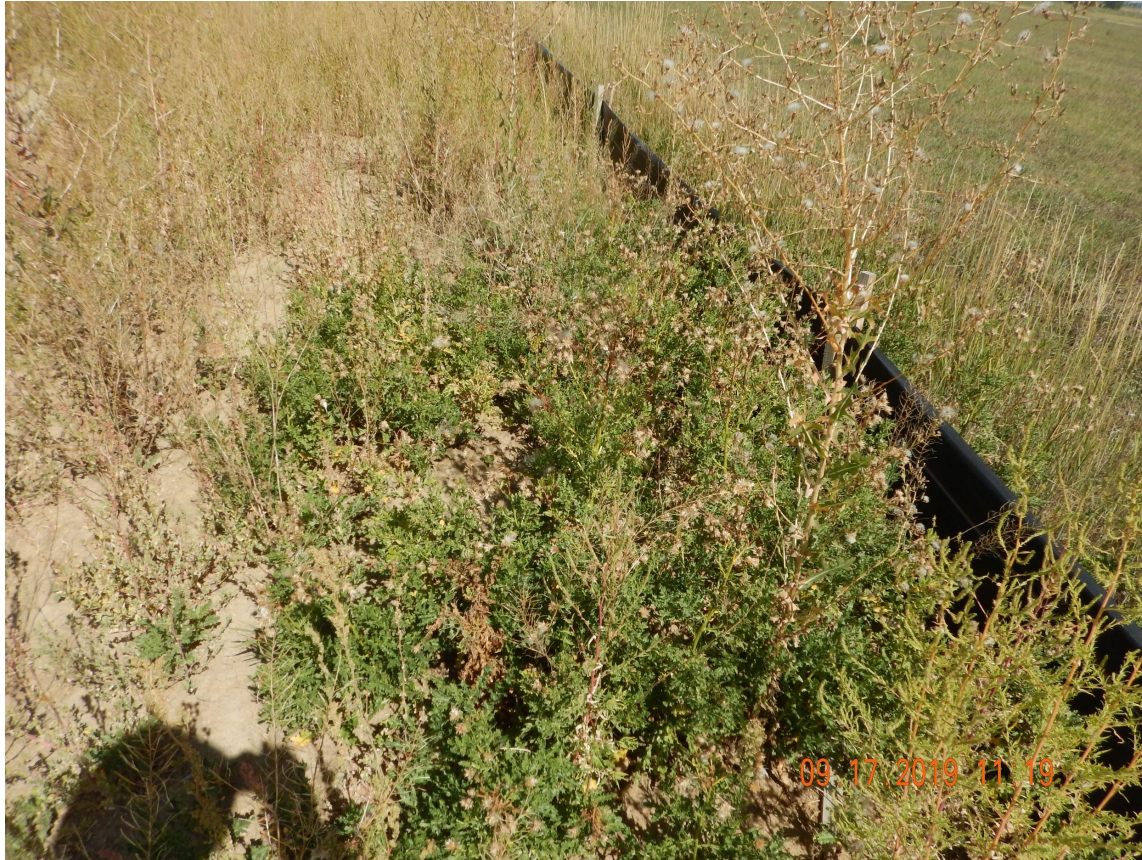
Photo 9. Photo taken from the southeastern perimeter of the well pad, facing North. Photo illustrates unmanaged Canada thistle.

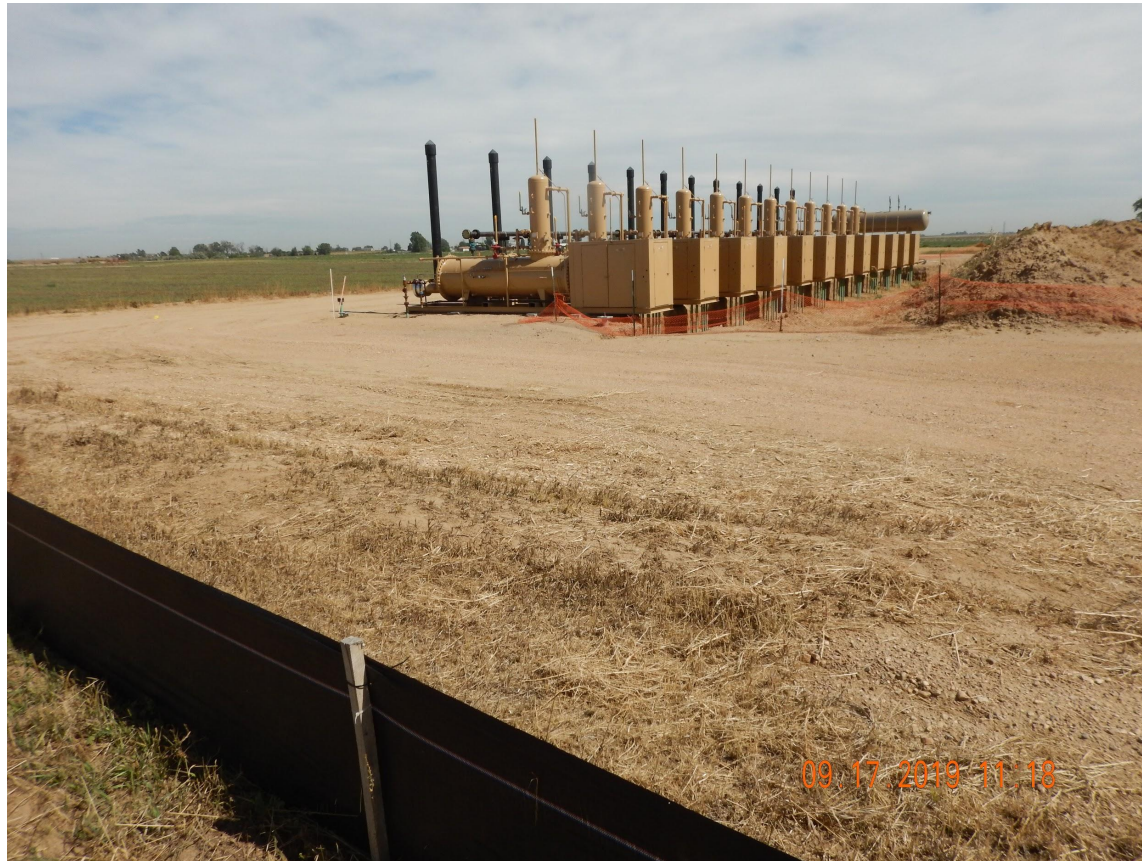
Photo 10. Photo taken from the western production facility, facing East. COGCC staff has evidence from the previous inspection and current conditions to illustrate the Operator failed to salvage topsoil from the production facility. There was no observed topsoil stockpile around the production facility.

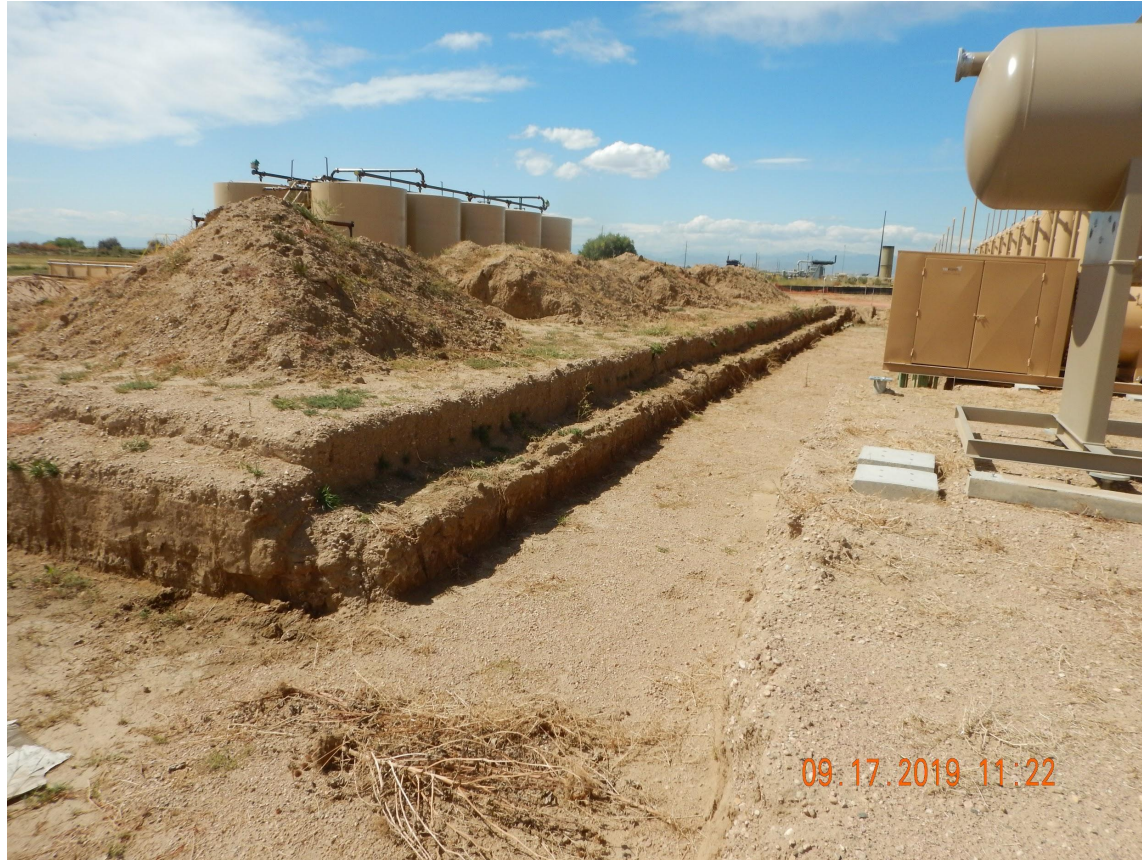
Photo 11. Photo taken from the excavated area within the production facility, facing West. Refer to the following photo demonstrating the Operator didn't salvage any topsoil from the production facility.

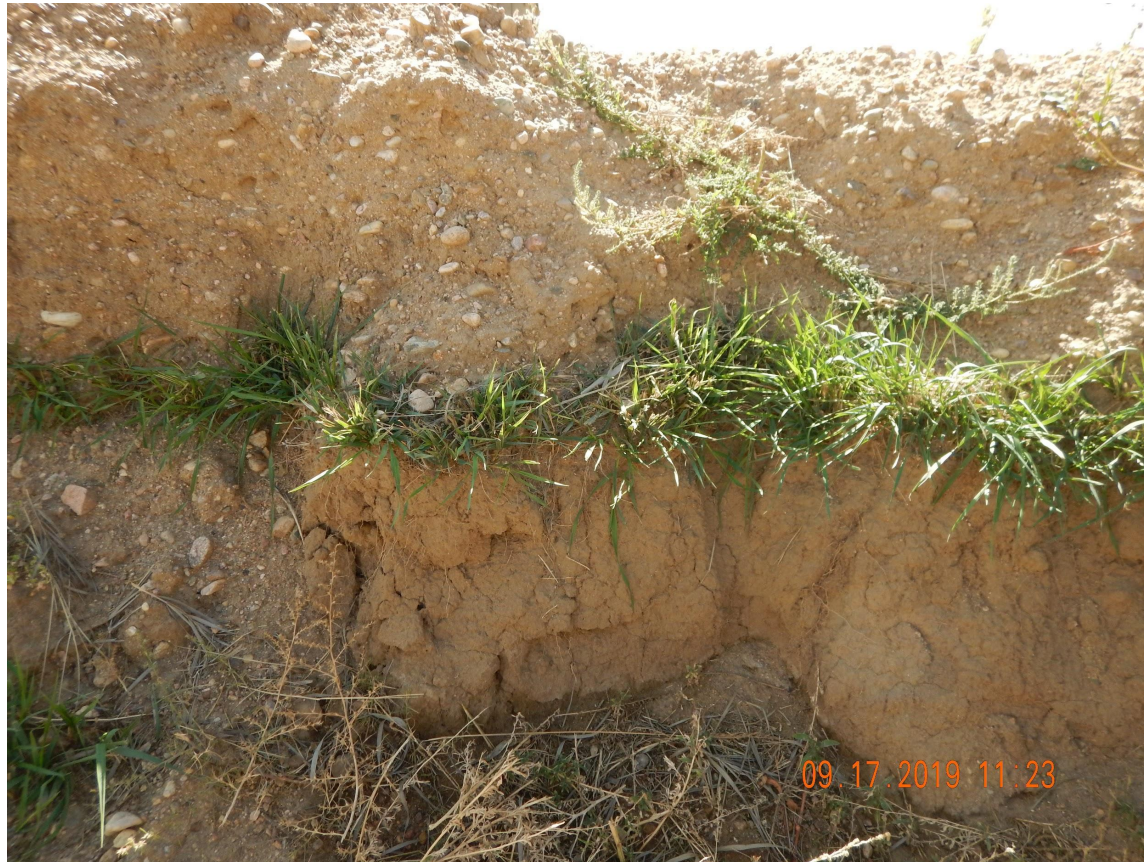
Photo 12. Photo taken from the excavated area within the production facility. Photo illustrates ~2 feet of material was placed on top of the original contour without first salvaging topsoil. Smooth brome is shown growing out from the original contour which demonstrates the Operator didn't salvage any topsoil.

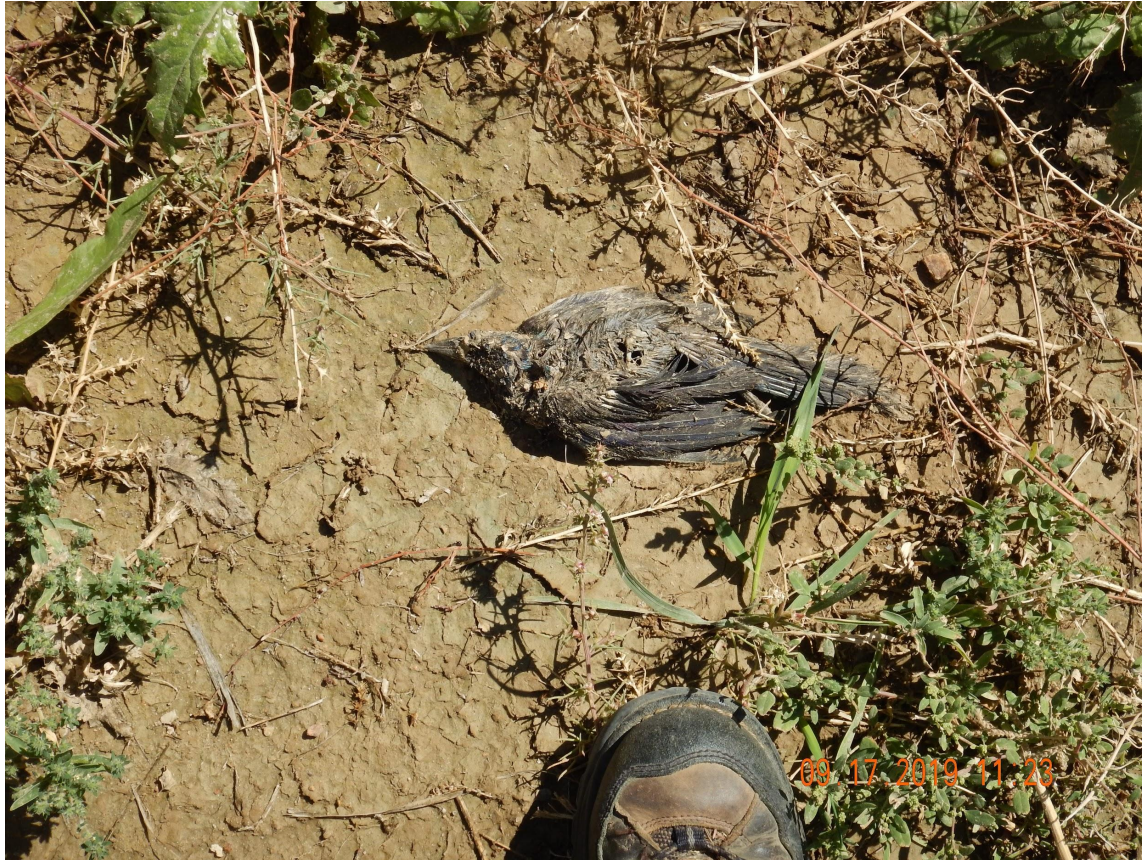
Photo 13. Photo taken from the excavated area. Photo illustrates a dead bird.
