# Inspection Photos

Operator: Hilcorp Energy  
Location/API #: 067-09742  
Date: 9-16-2019

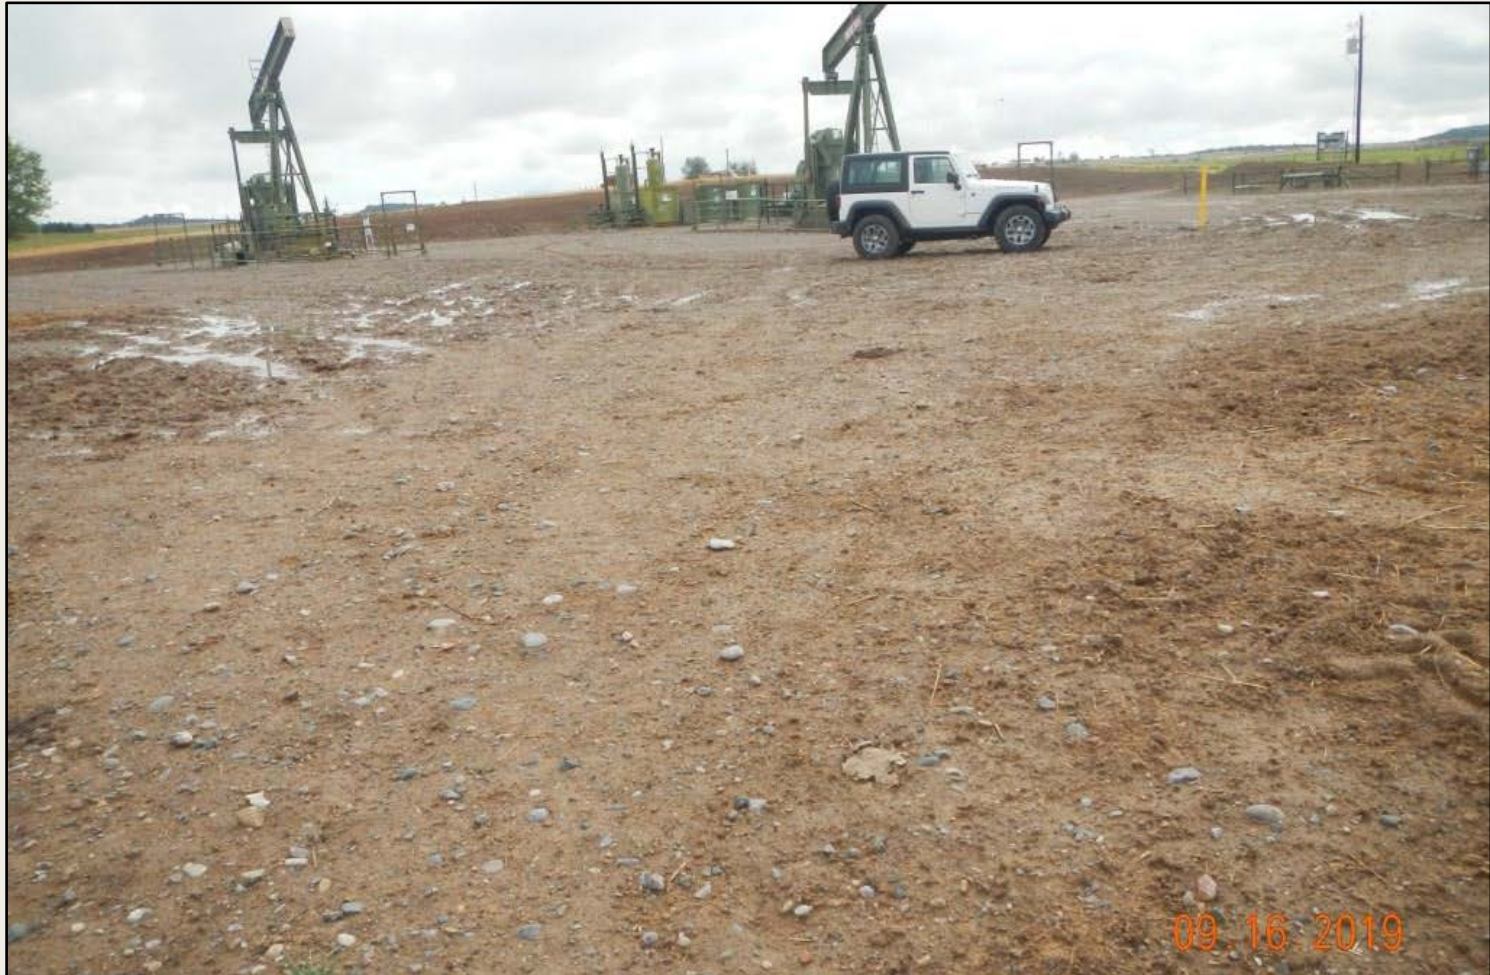
Photo 1. View of the project area from the northwestern corner facing center.

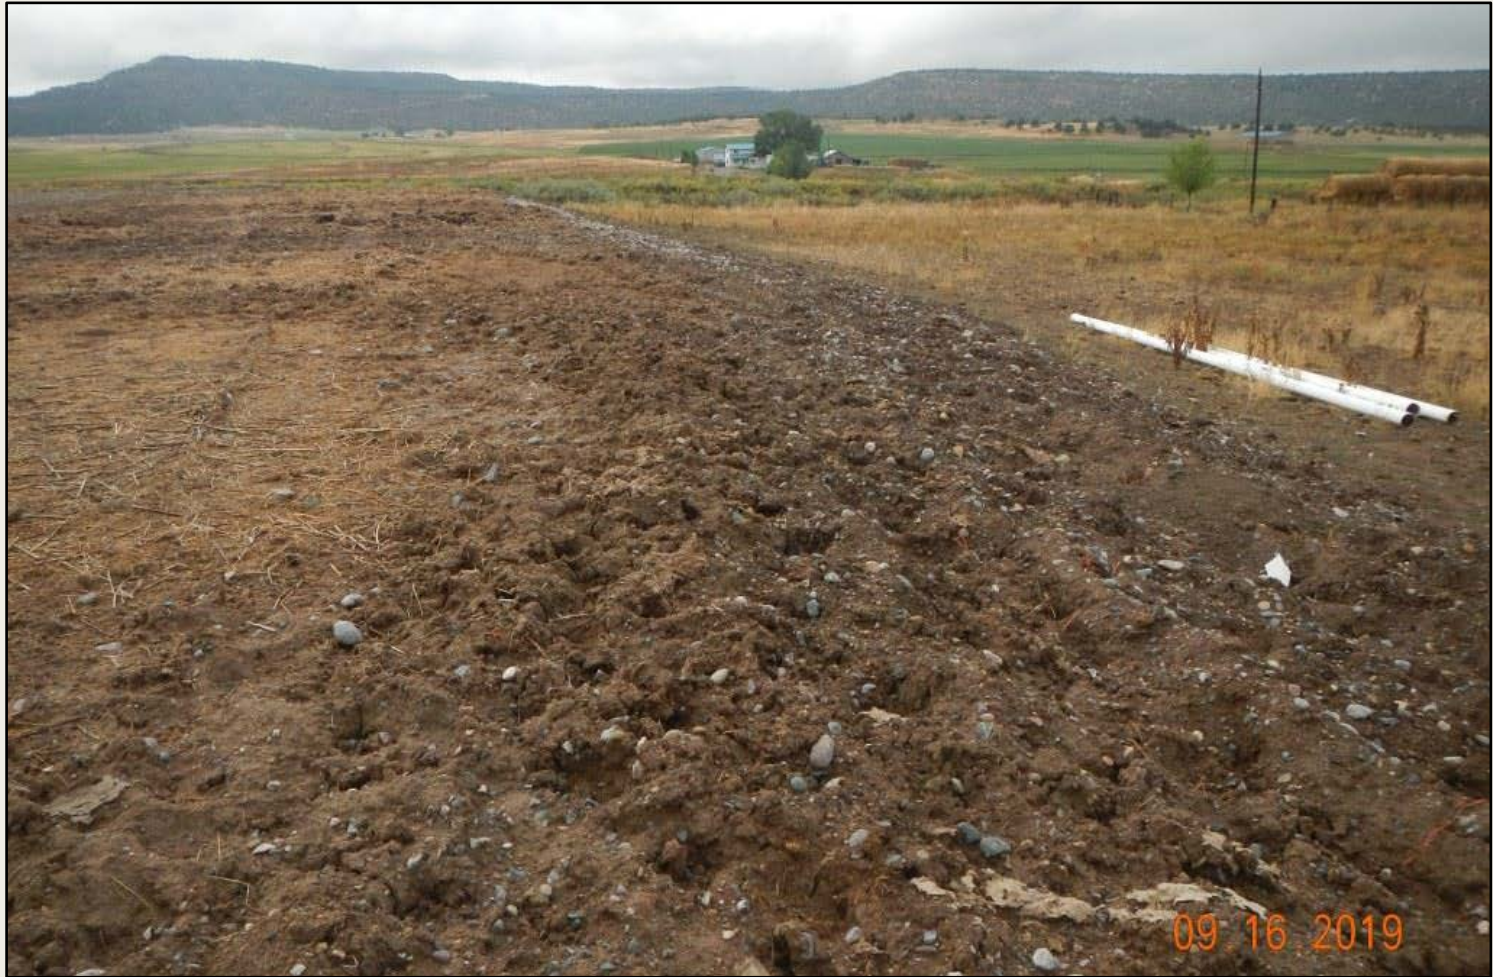
Photo 2. View of the western fill slope facing southward. Little vegetation present here. Revegetation is needed.

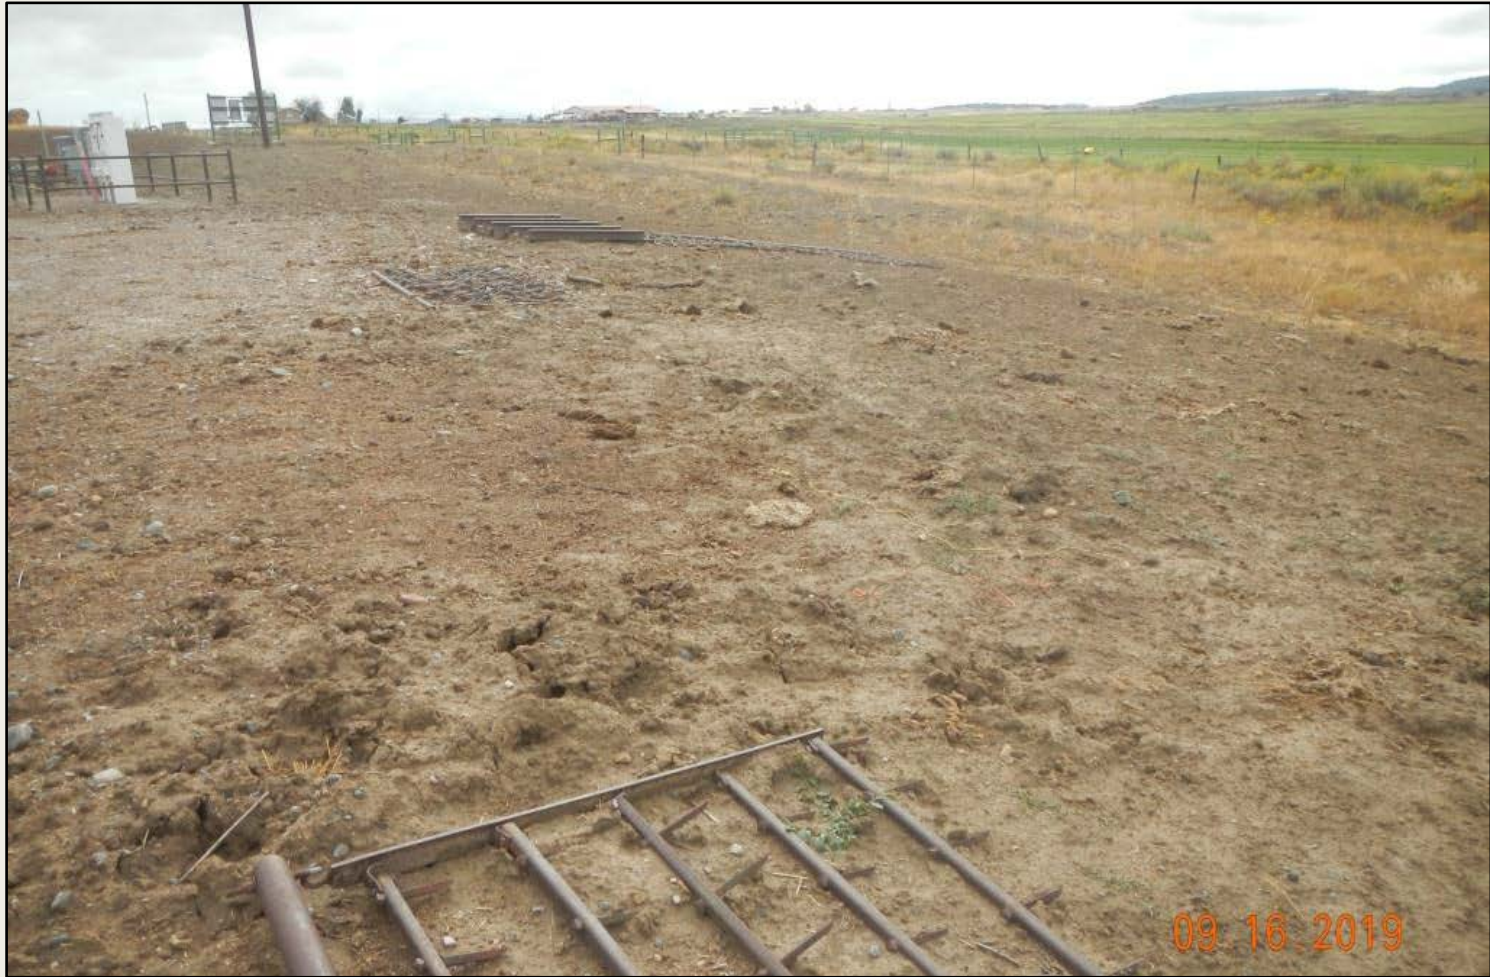
Photo 2. View of the southern project area from the southwestern corner facing eastward.

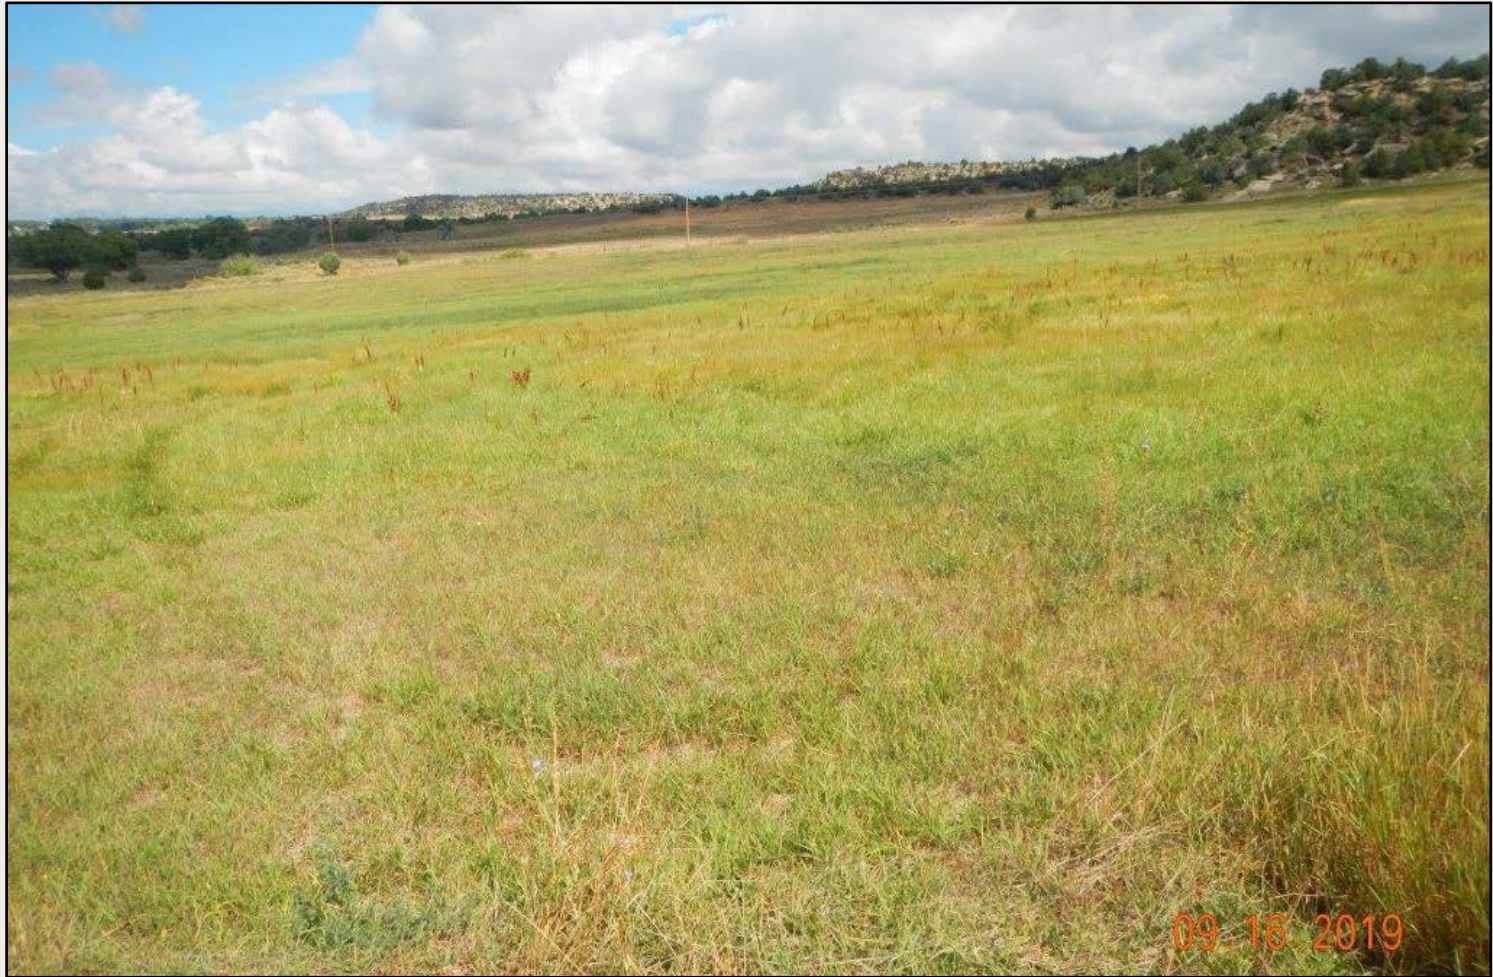
Photo 5. View of reference area vegetation, comprised of open grass field.
