TEP ROCKY MOUNTAIN LLC

SG 34-28FracPad

Location # 334397

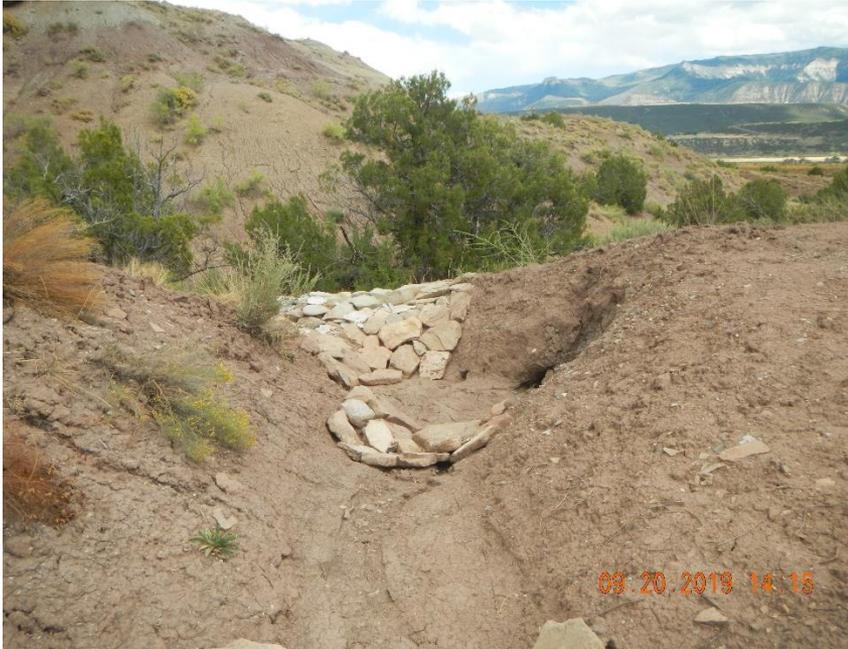
Storm water channel in check dam behind tank battery.

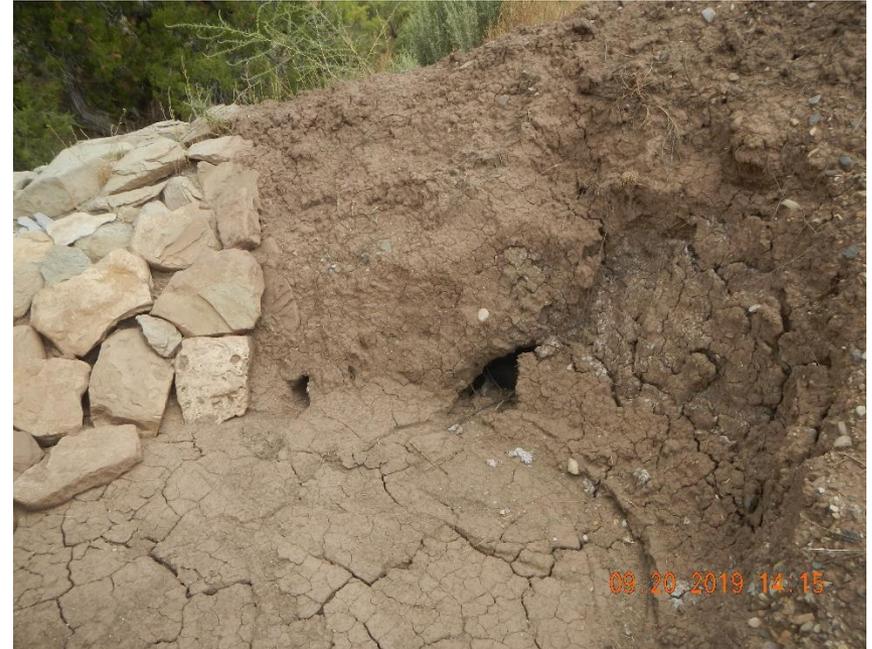
Storm water channel in check dam behind tank battery.

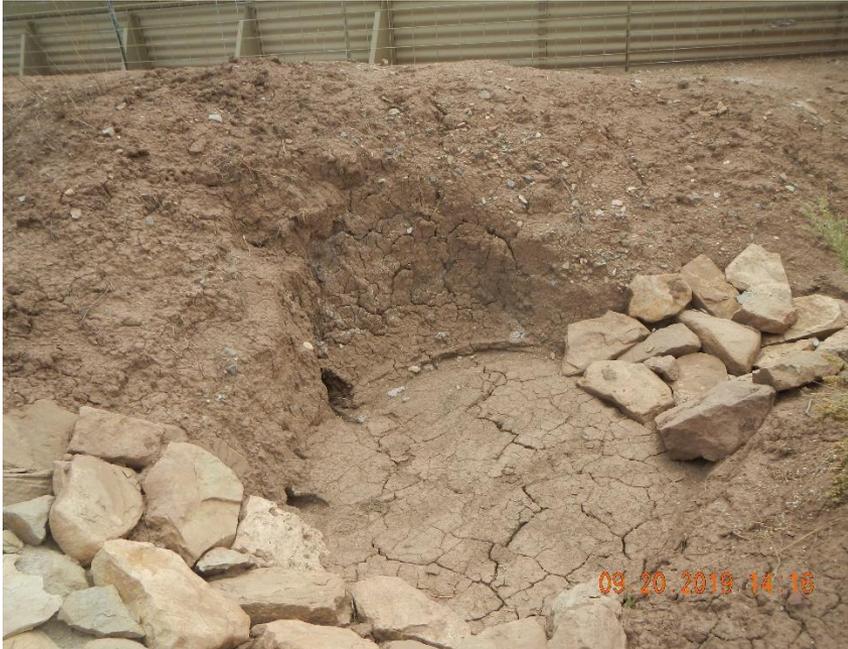
Storm water channel in check dam behind tank battery.

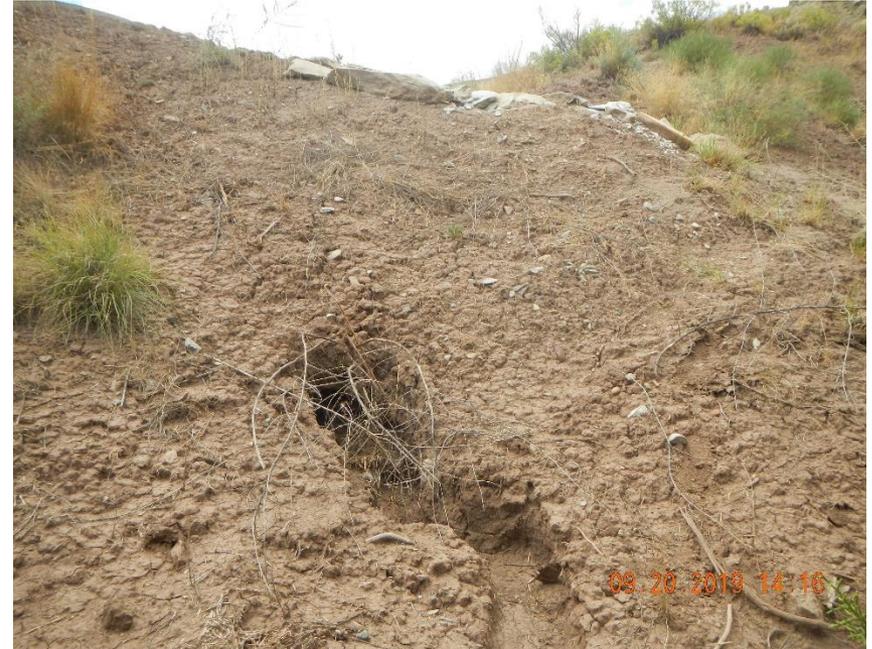
Storm water channel in check dam behind tank battery.

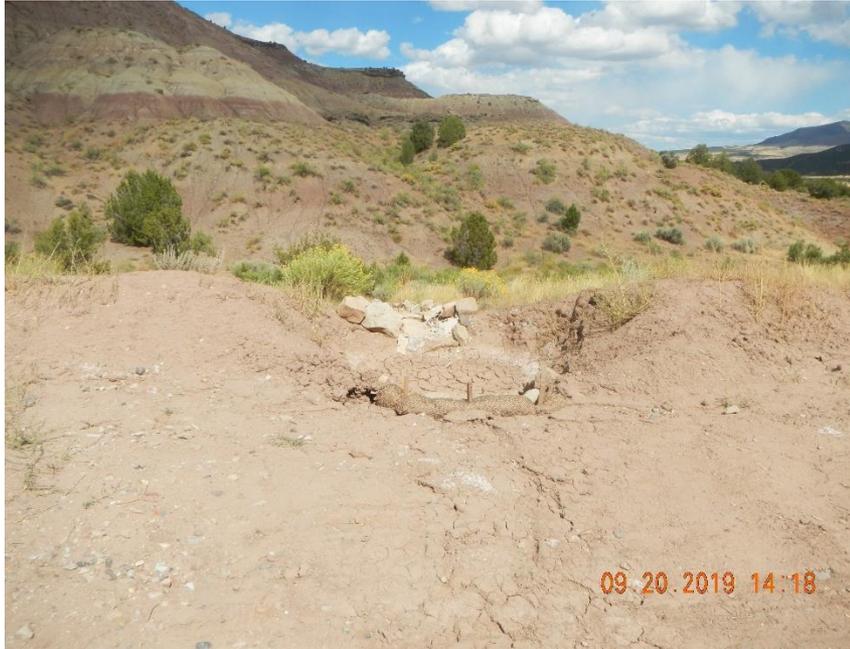
Check dam across from wells has wash damage

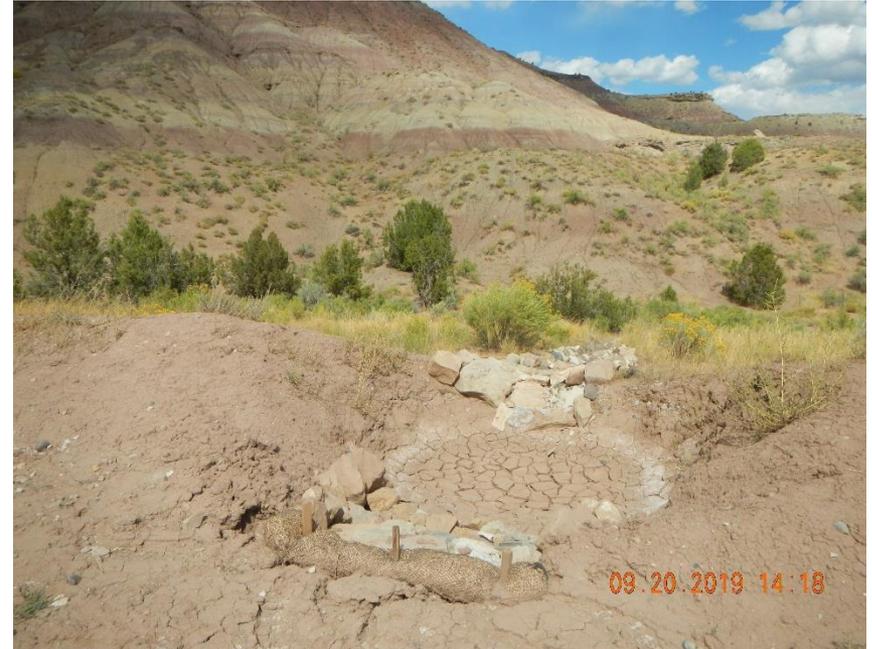
Check dam across from wells has wash damage

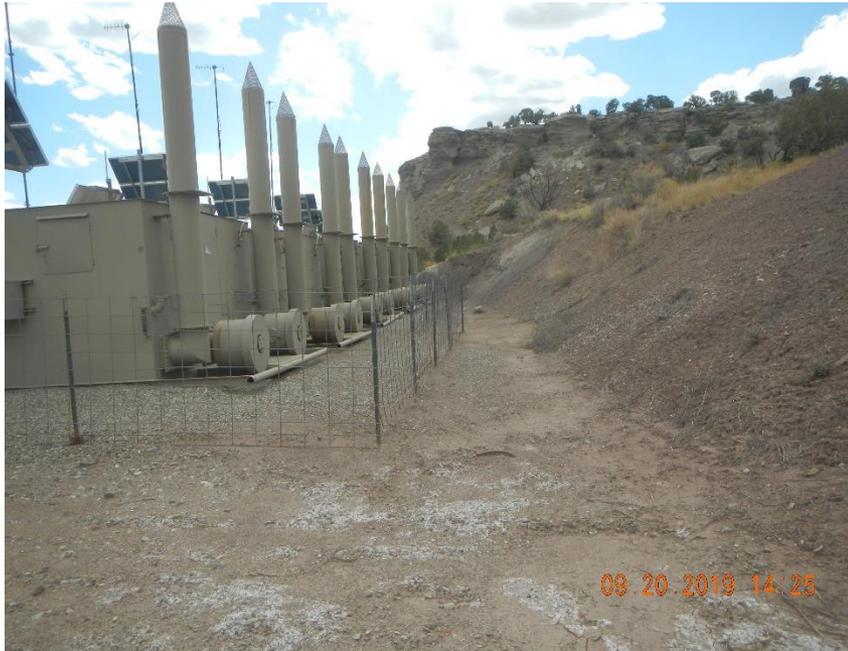
Cut slope behind separators is unstable and sediment build up at base of cut.

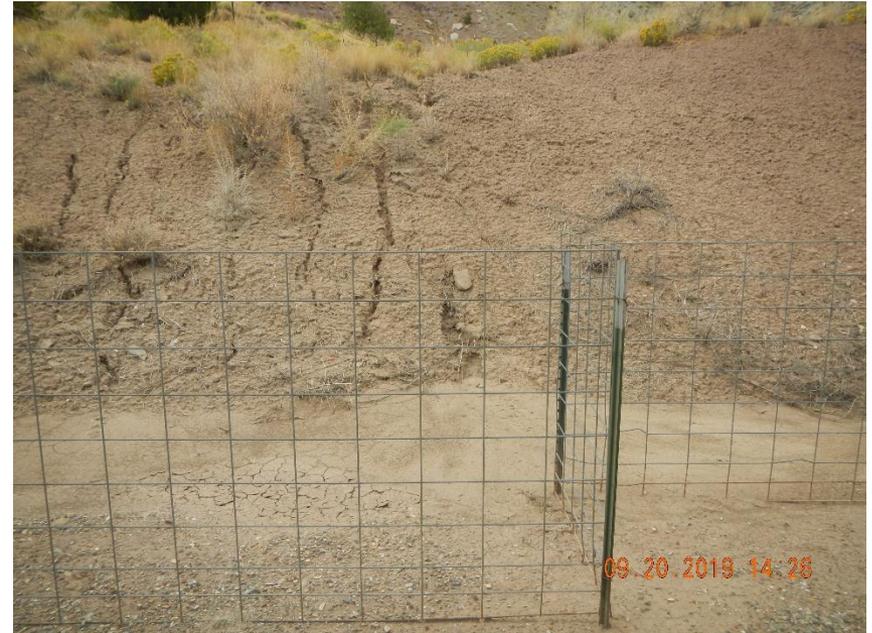
Cut slope behind separators is unstable and sediment build up at base of cut.
