Inspection Photos

09/16/2019

Operator: FOUNDATION ENERGY
MANAGEMENT LLC - 10112

Location ID: 303599
Yuma County, CO

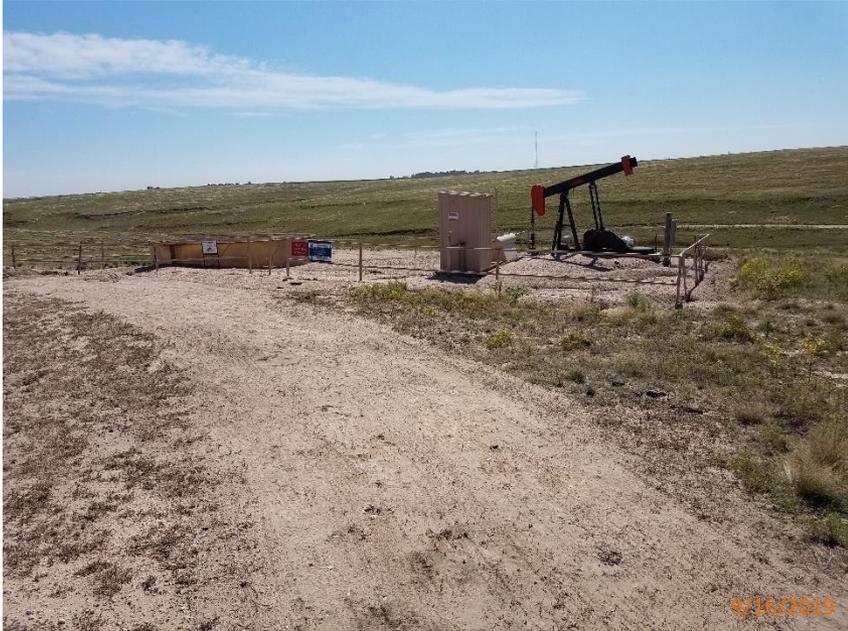
Photo 1: Photo taken from the north of the location, facing south. Photo shows overview of the location.

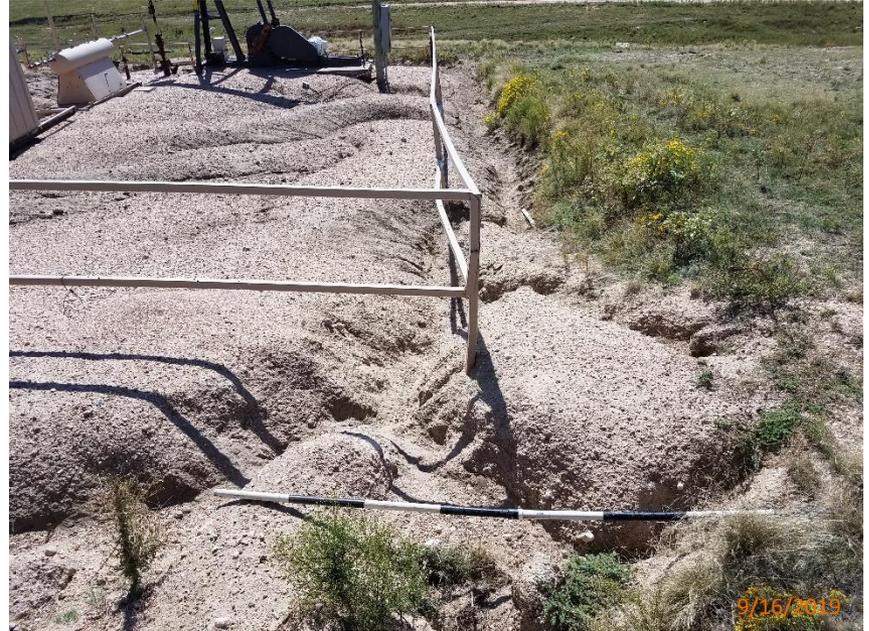
Photo 2: Photo taken from the northwest corner of the location, facing south. Photo shows stormwater erosion degradation. Two meter (6.5 feet) robel pole for reference

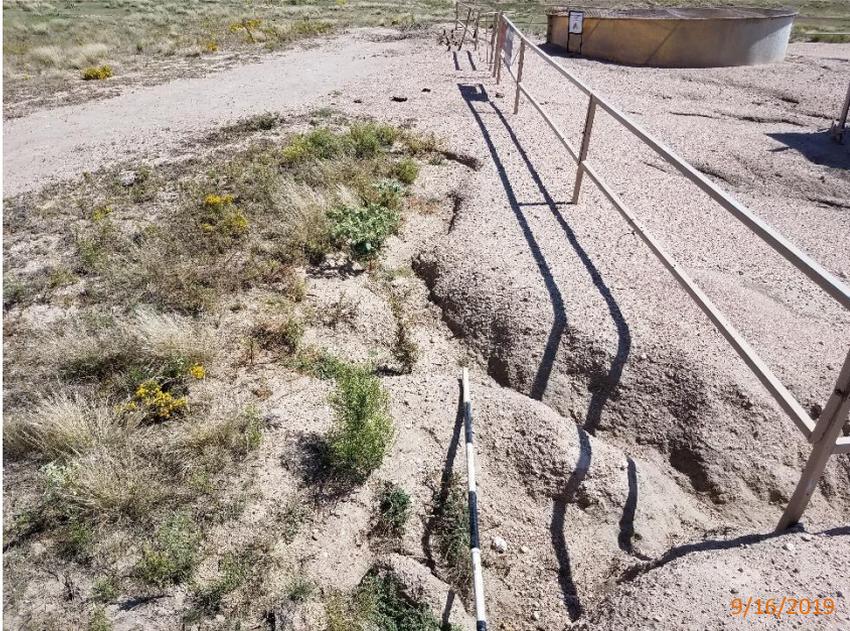
Photo 3: Photo taken from the northwest corner of the location, facing east. See comments under photo 1.

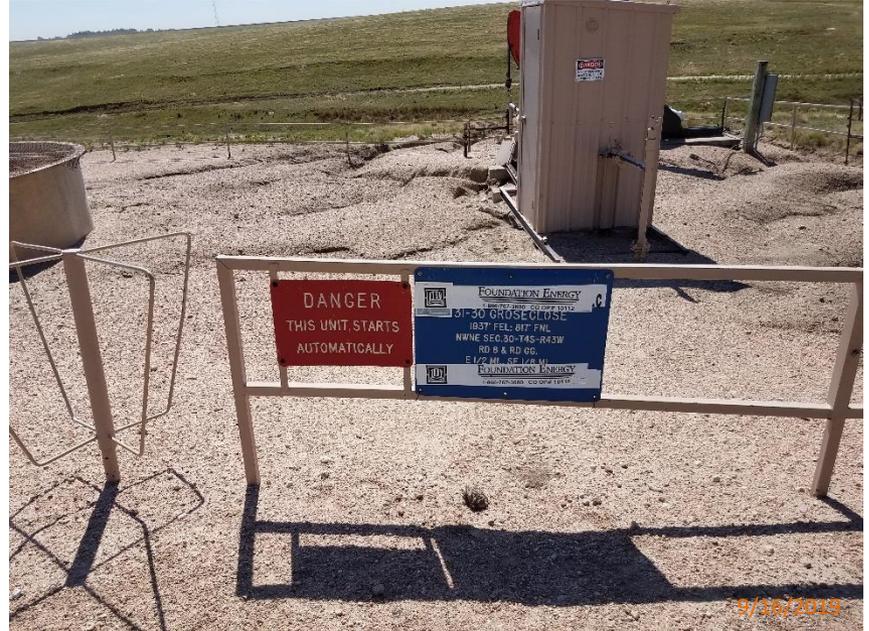
Photo 4: Photo taken from the north end of the location, facing south. Photo of operator signs.

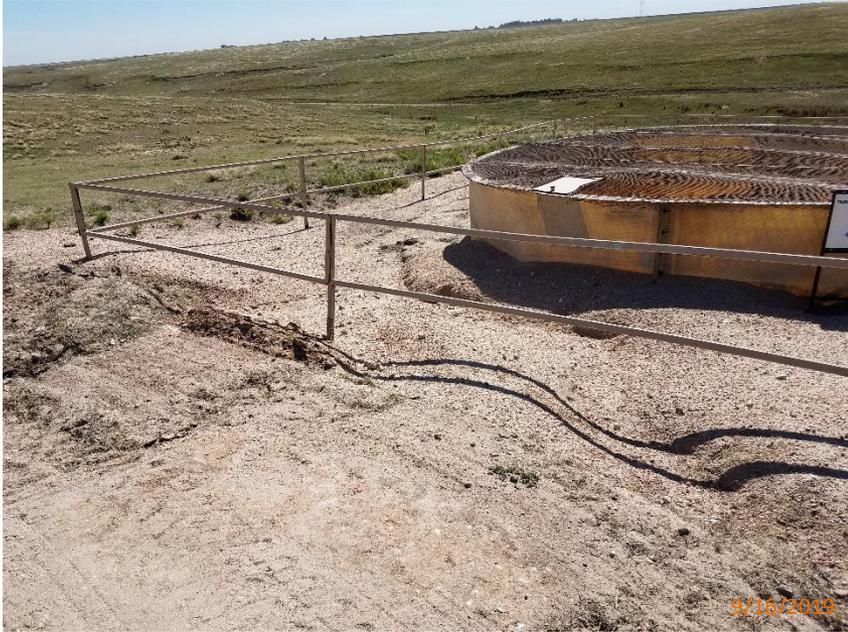
Photo 5: Photo taken from the northeast end of the location, facing southeast. See comments under photo 1.

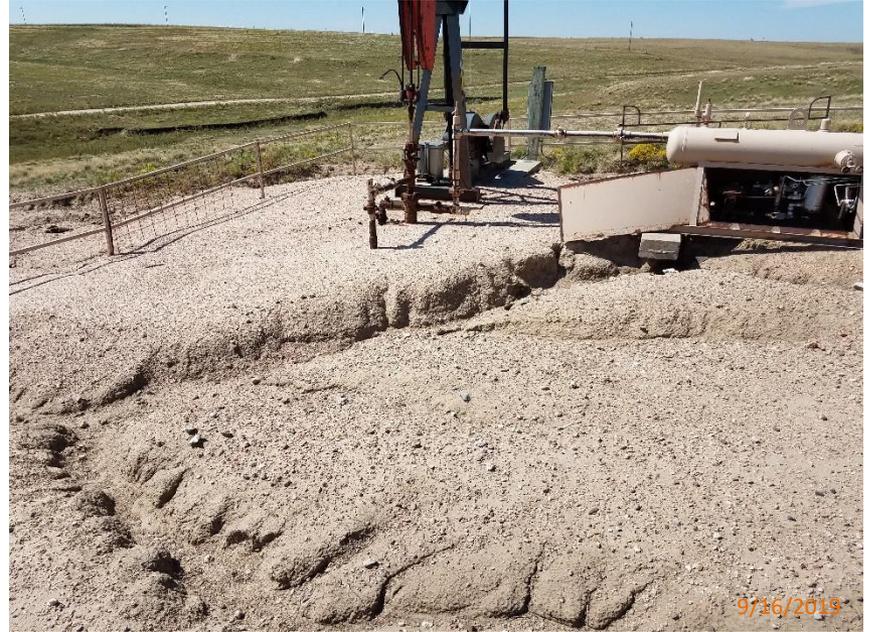
Photo 6: Photo taken from the location, facing west. Photo shows stormwater erosion degradation. Operator has failed to conduct sufficient stormwater management in accordance with 1002.f. Stormwater erosion is compromising the stability of the location.

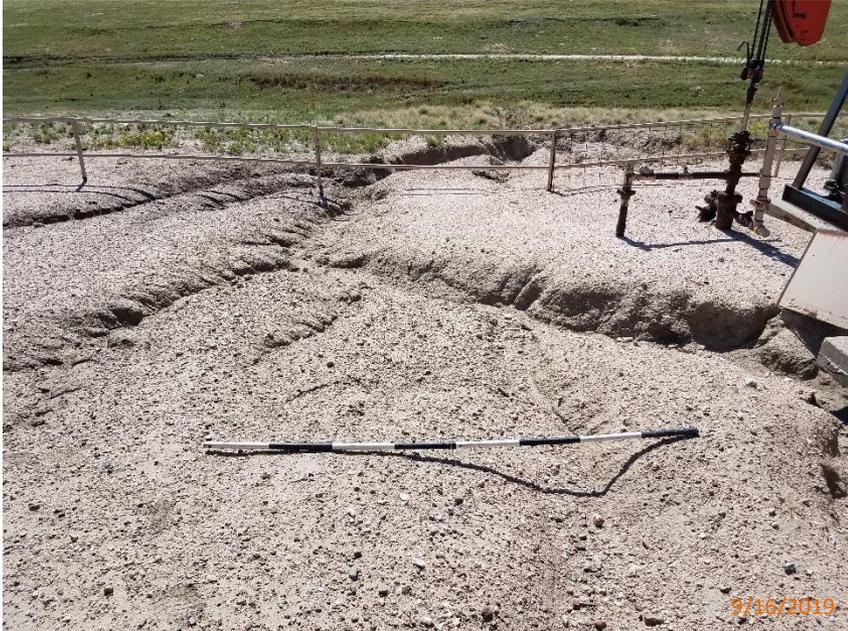
Photo 7: Photo taken from the location, facing south. Photo shows Stormwater erosion degradation is compromising the integrity and stability of the location. Additionally, photo shows stormwater runoff has also caused degradation to the adjacent lands below the location. Two meter (6.5 feet) robel pole for reference

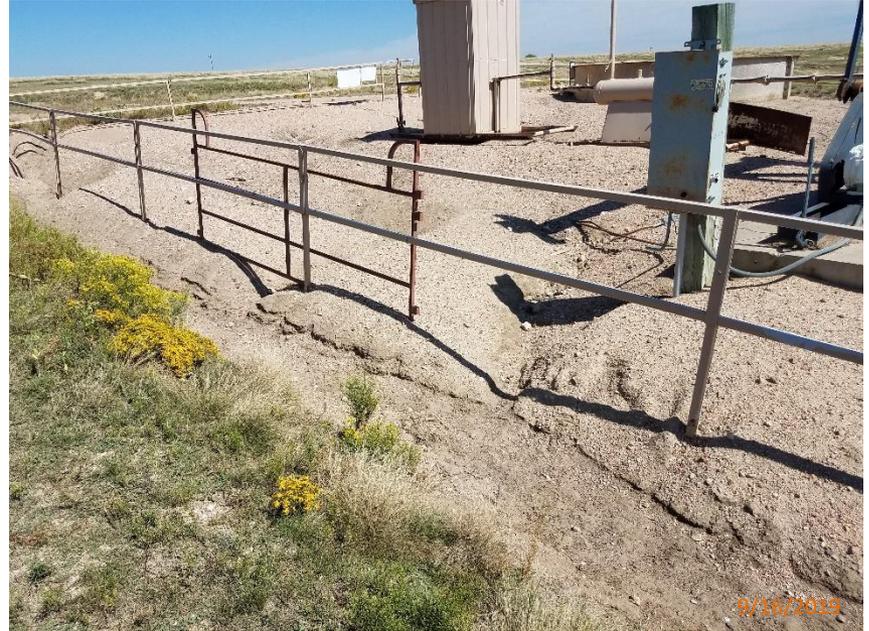
Photo 8: Photo taken from the west end of the location, facing north east. Photo shows stormwater erosion degradation on location. Photo also shows erosion degradation to the adjacent lands due to stormwater runoff from the location.

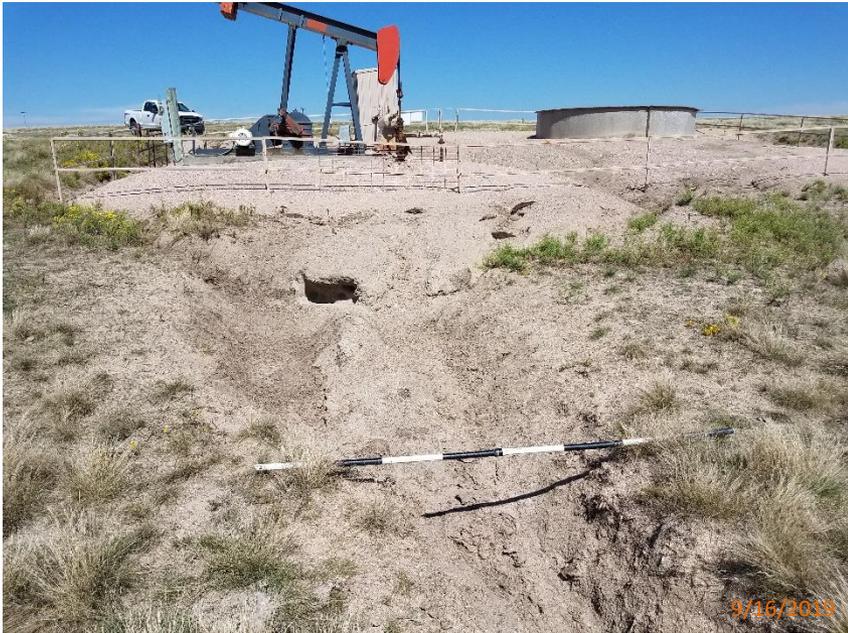
Photo 9: Photo taken from the adjacent lands south of the location, facing north. Photo shows stormwater runoff from the location has caused degradation to the adjacent lands.

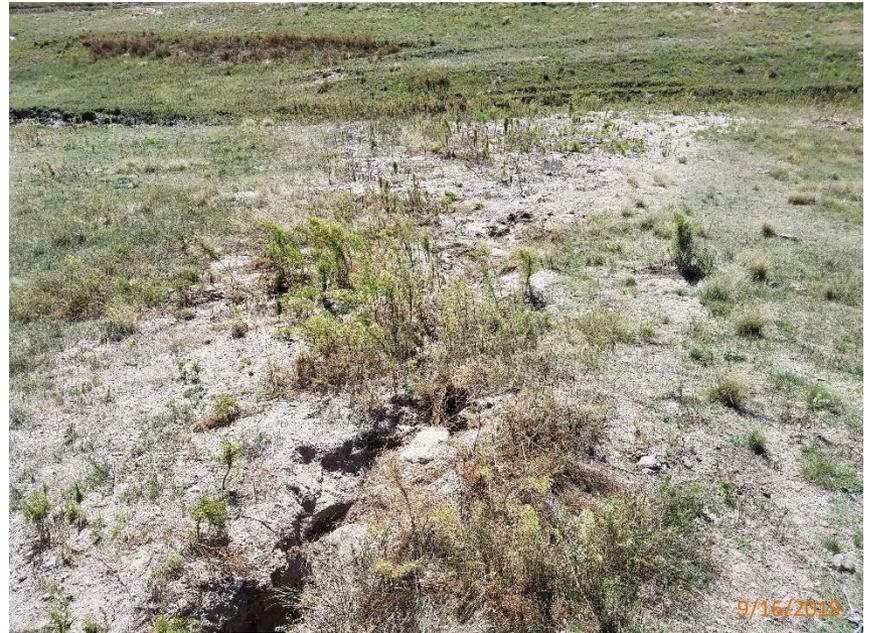
Photo 10: Photo taken from the adjacent lands south of the location, facing south. Photo shows erosion degradation and sediment deposition from stormwater runoff on the adjacent lands.

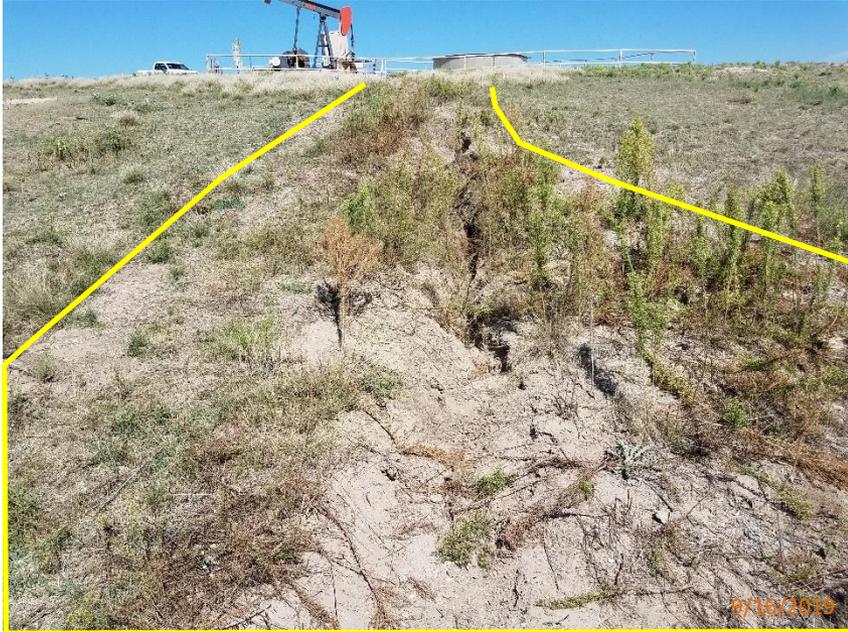
Photo 11: Photo taken from the adjacent lands south of the location, facing north. Photo shows erosion degradation and sediment deposition from stormwater runoff on the adjacent lands.

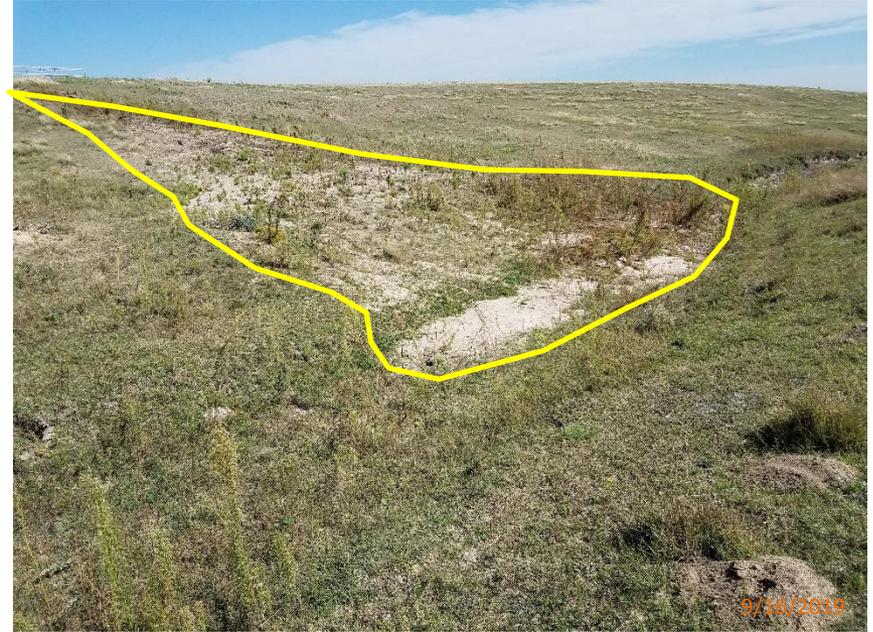
Photo 12: Photo taken from an intermittent drainage south of the location, facing northeast. Photo shows stormwater runoff from the location has caused degradation to the adjacent lands, as well as sediment deposition with an intermittent drainage/stream.

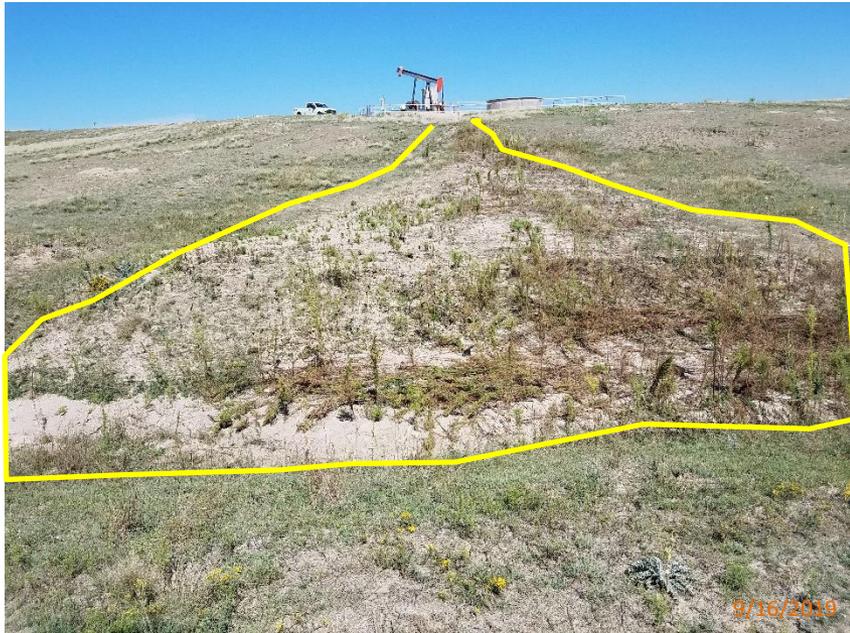
Photo 13: Photo taken from an intermittent drainage south of the location, facing north. See comments under photo 12.

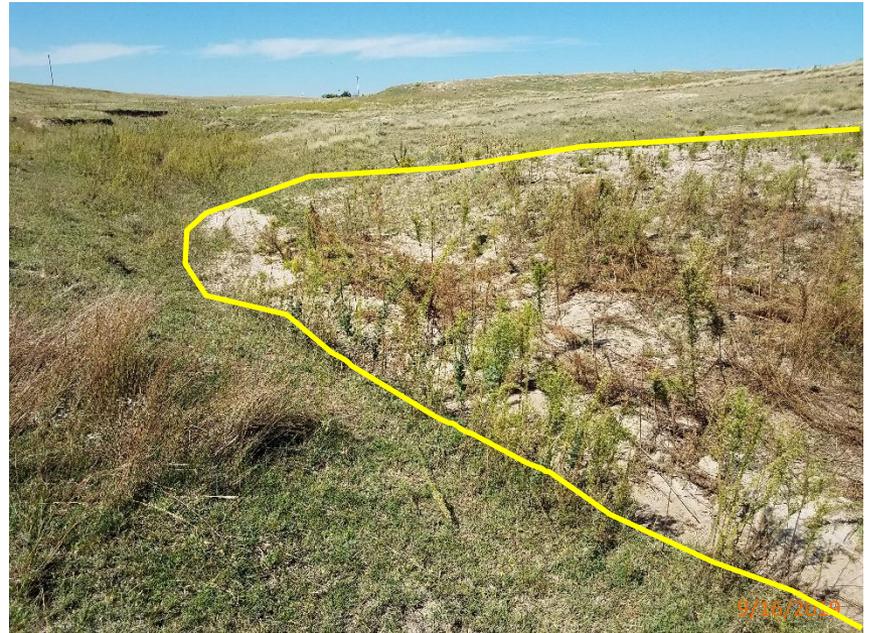
Photo 14: Photo taken from an intermittent drainage south of the location, facing west. See comments under photo 12.

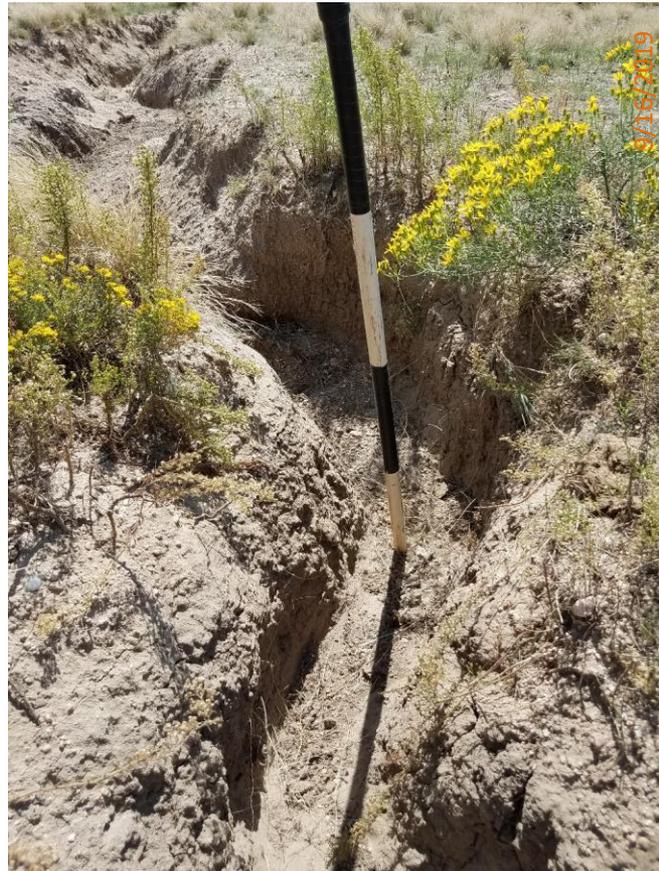
Photo 15: Photo taken from the gully forming to the south of the location. Robel pole for reference. Each white/black marking on pole represent $\frac{1}{4}$ meter (0.8 feet). There are areas of the gully that are 1.5 to 2 feet in depth.

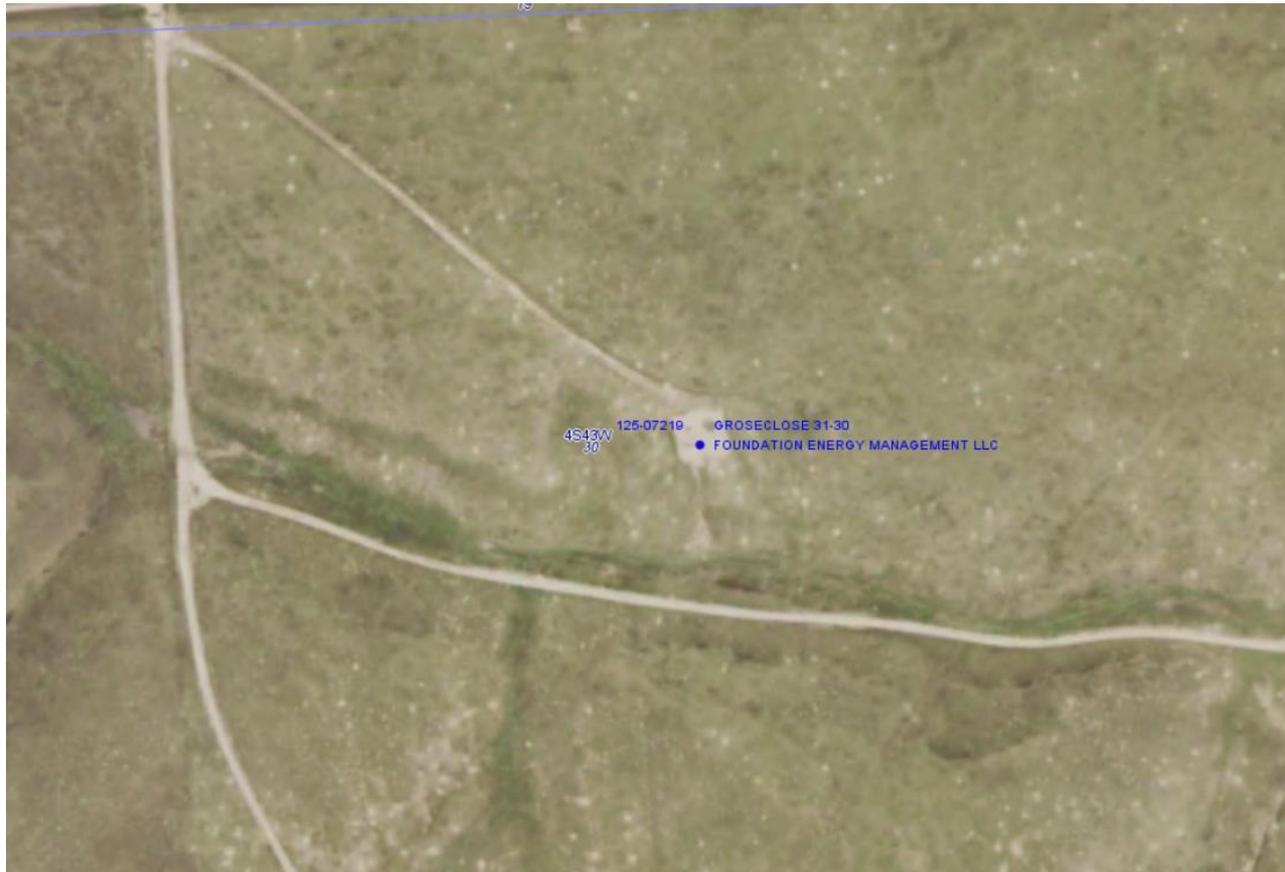
Photo 16: 2017 COGIS aerial imagery of the location.

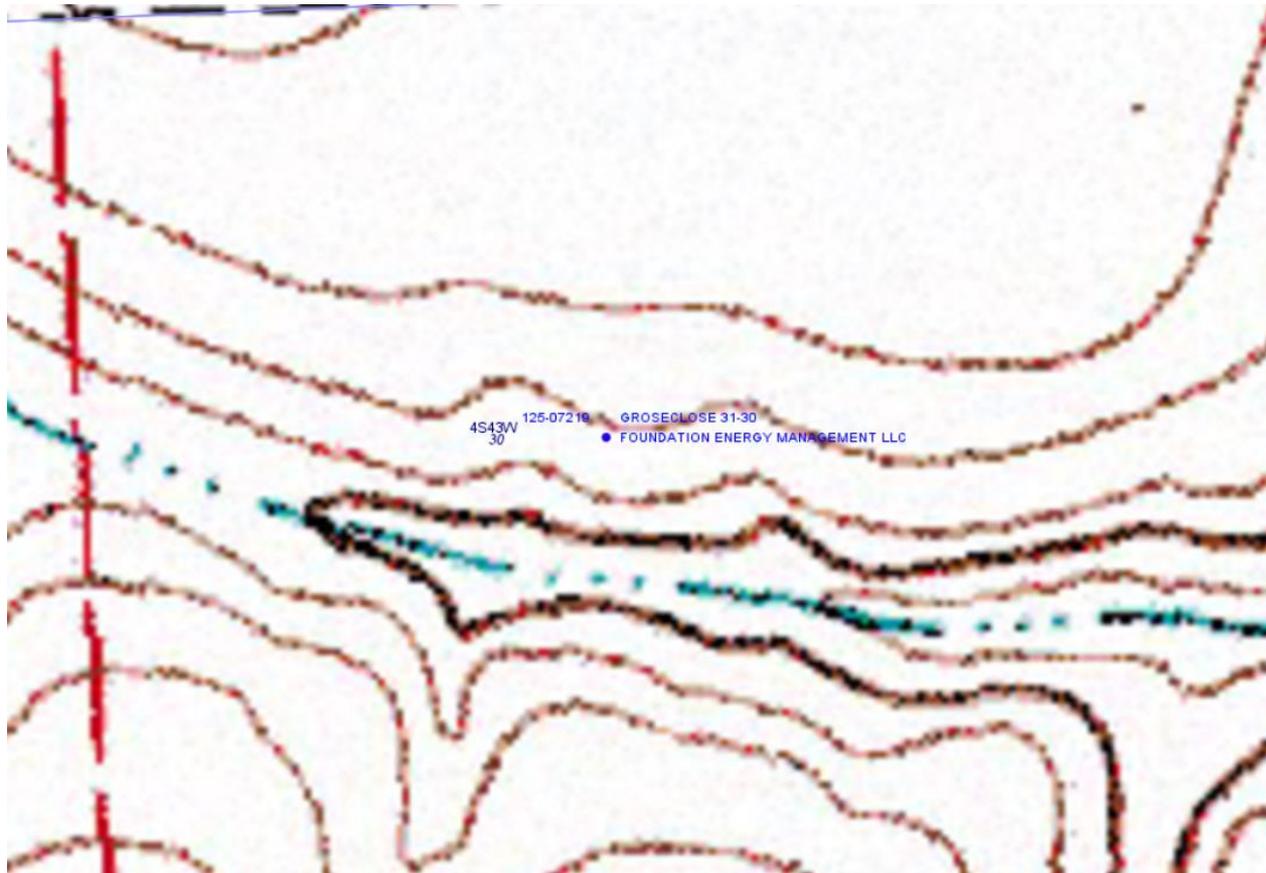
Photo 17: COGIS topographic imagery of the location. Photo shows drainage south of the location is classified as an intermittent stream.
