Inspection Photos
Operator: Hilcorp Energy
Location/API #: 067-09361
Date: 9-16-2019

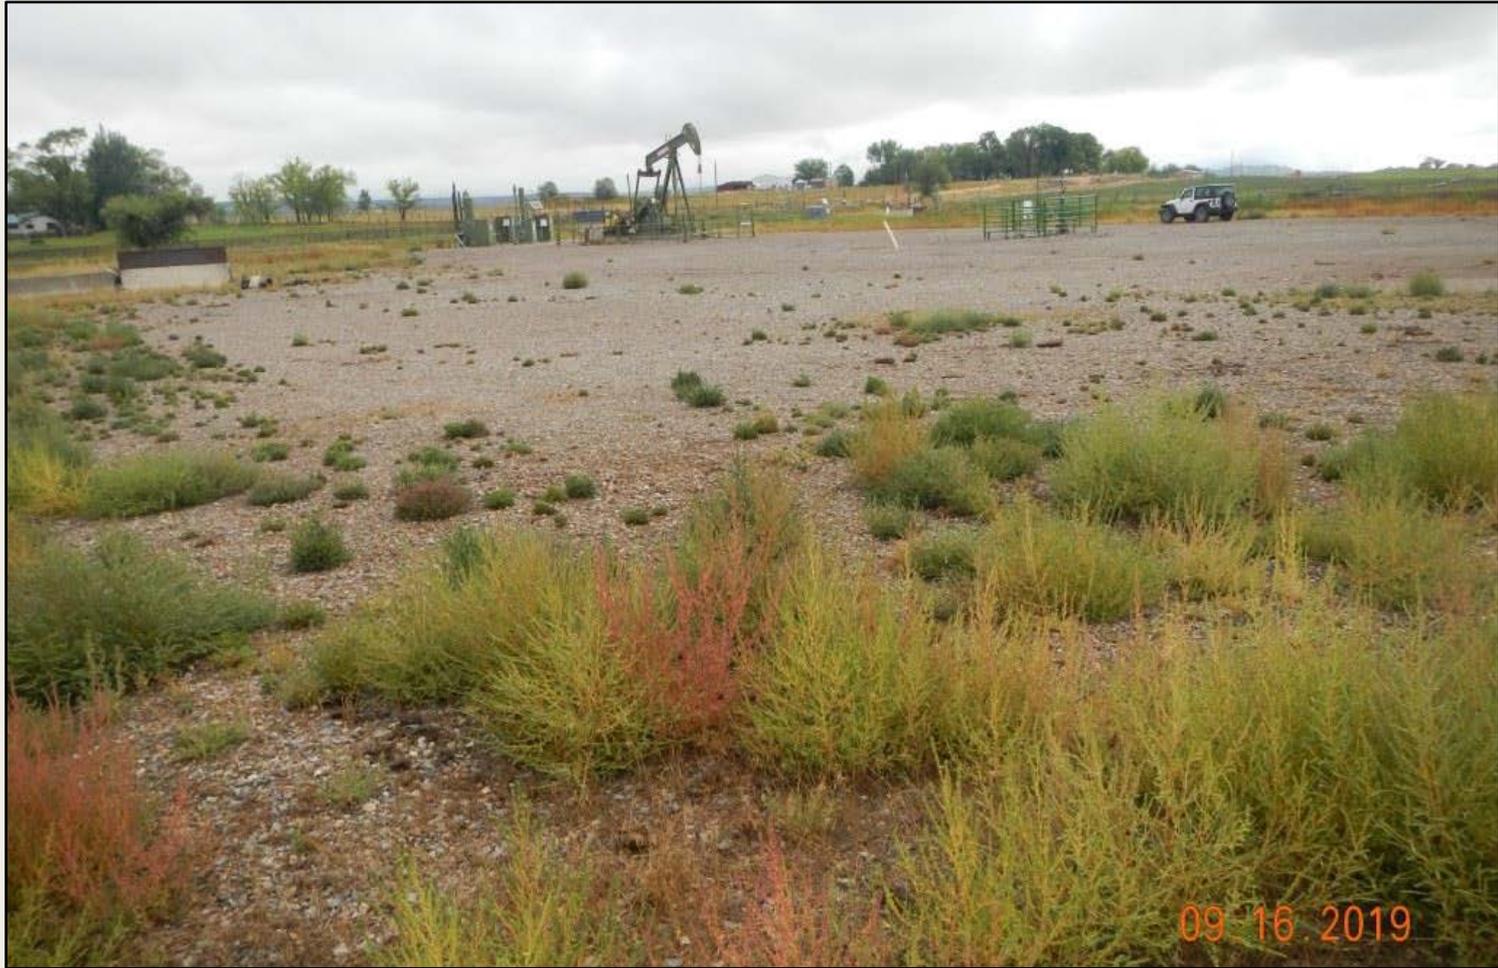
Photo 1. View of the project area from the western corner facing center.

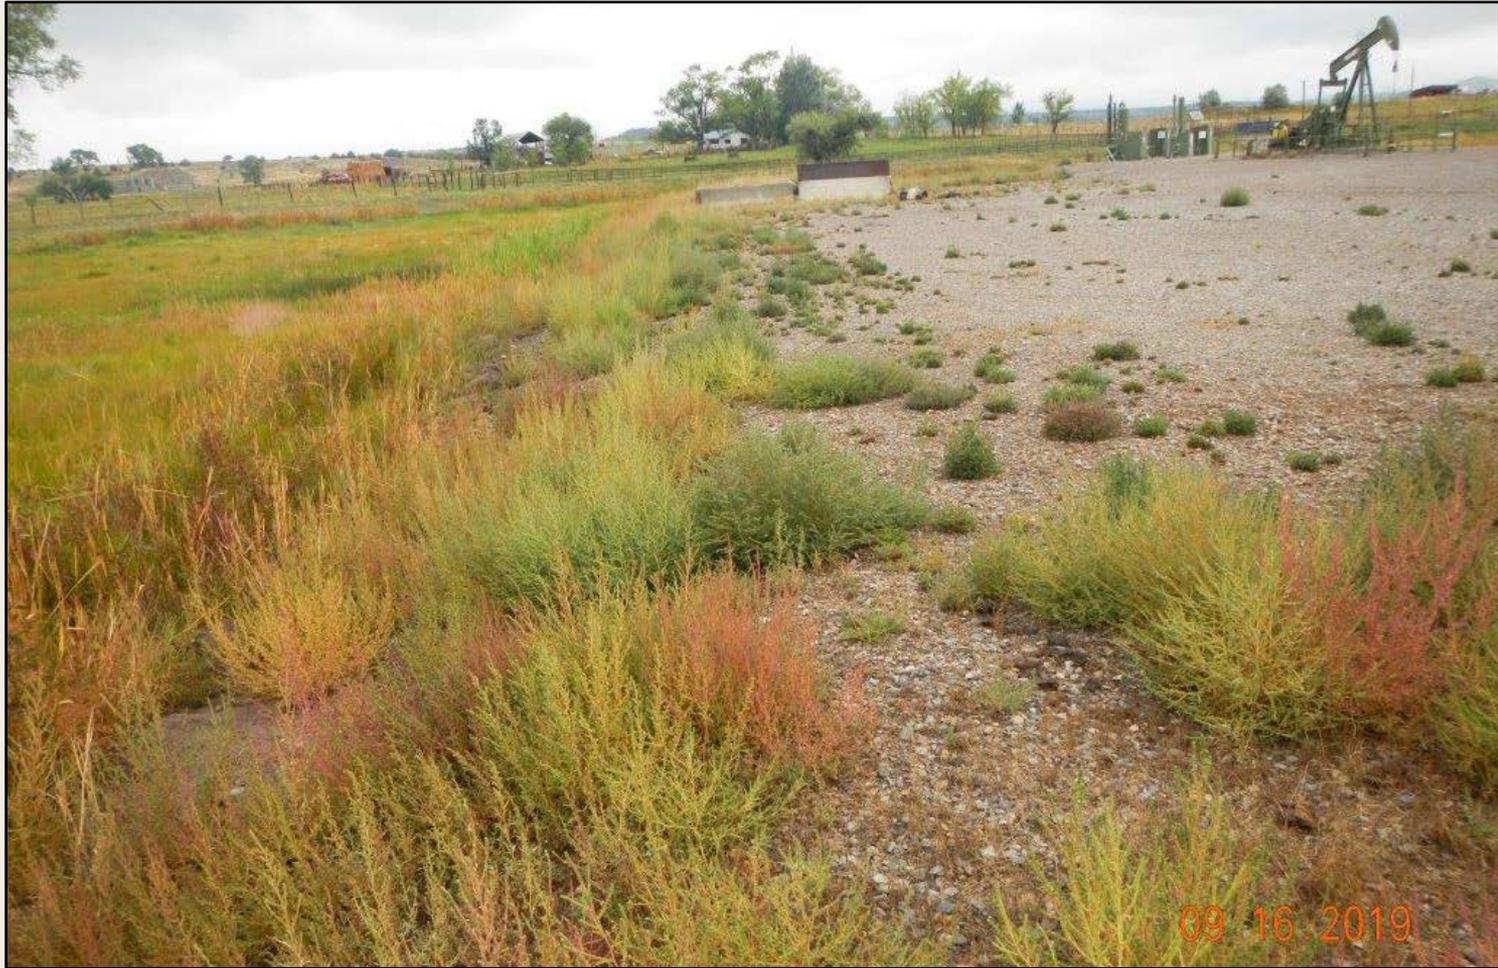
Photo 2. View of the western project area from the western corner facing northeastward. This portion of the well pad needs to be reclaimed.

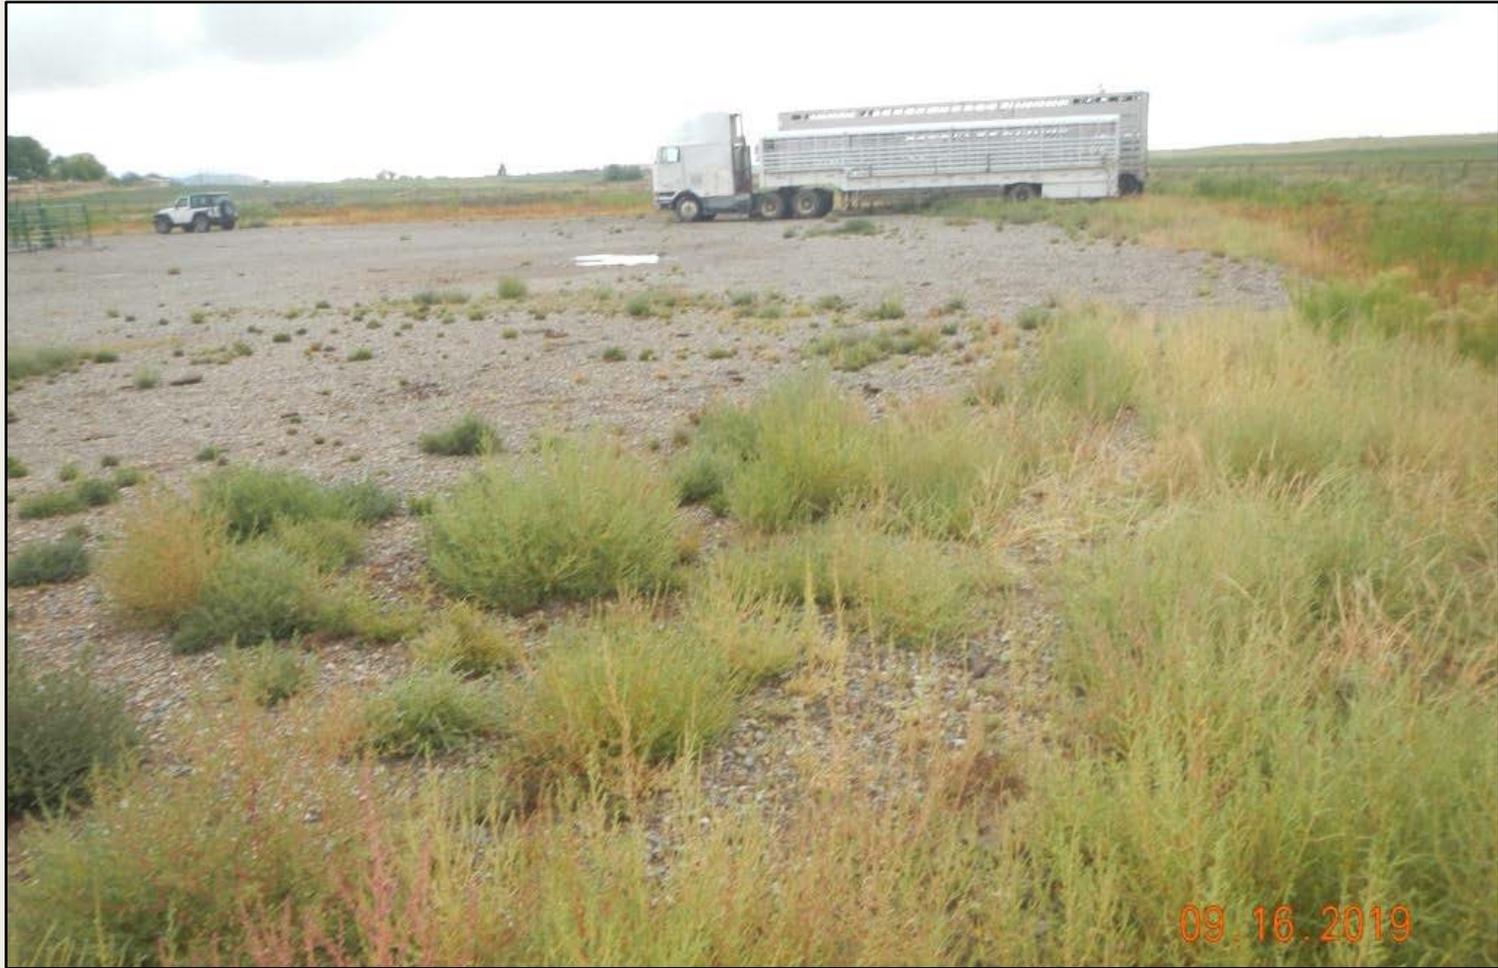
Photo 3. View of the southern project area from the western corner facing southeastward. Truck parked on well pad shows that portions of the southern project area are not needed for production operations and need reclamation.

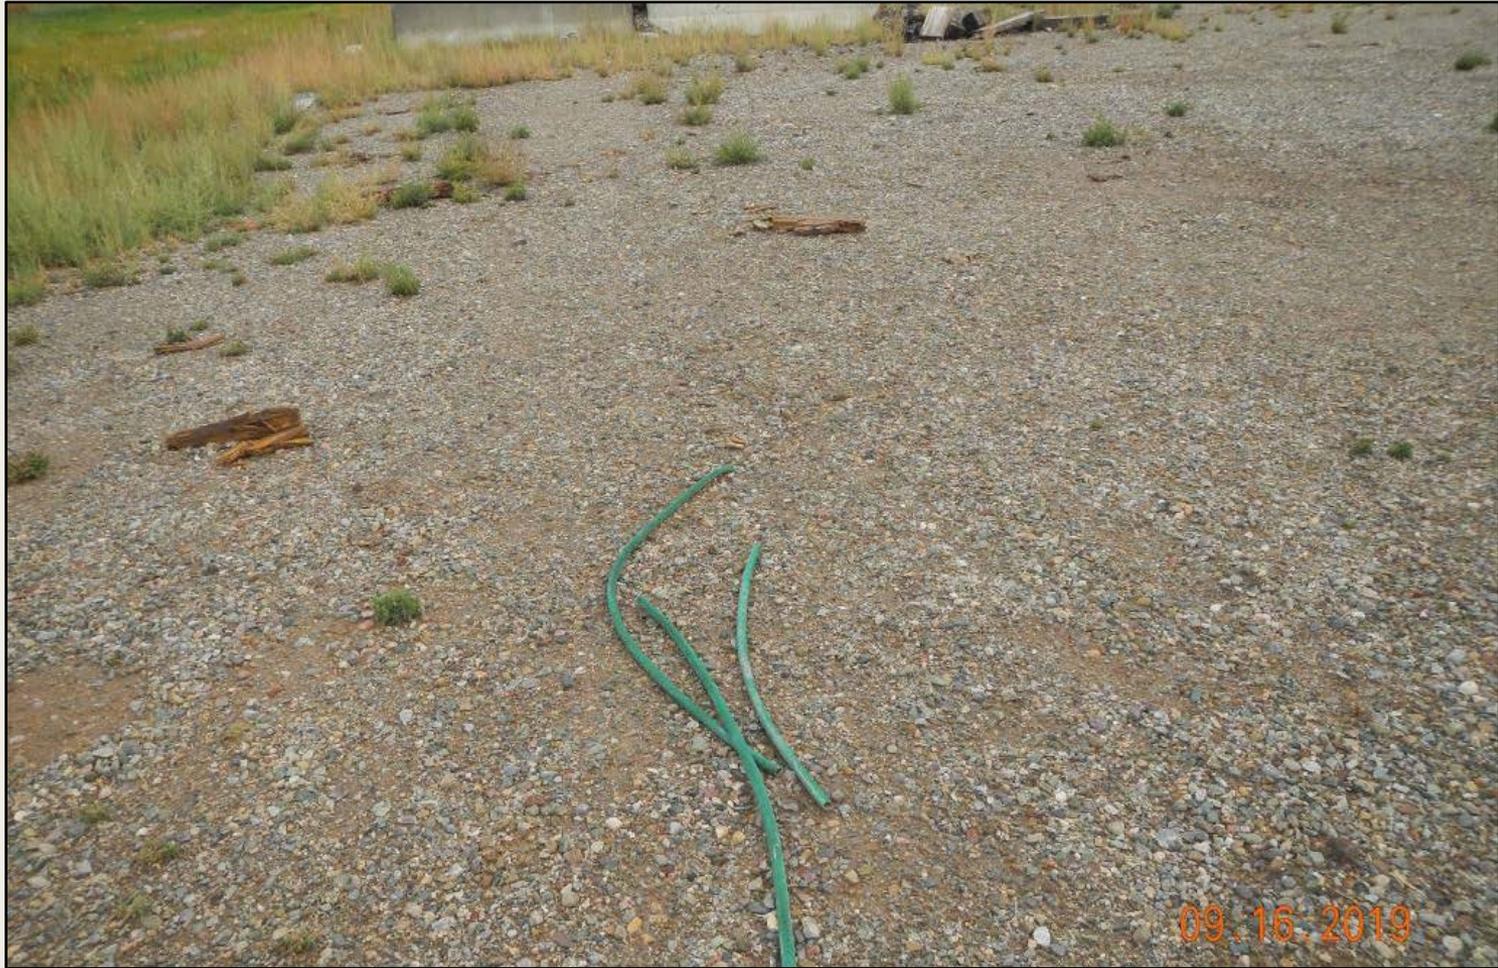
Photo 4. View of hose debris in the western project area.

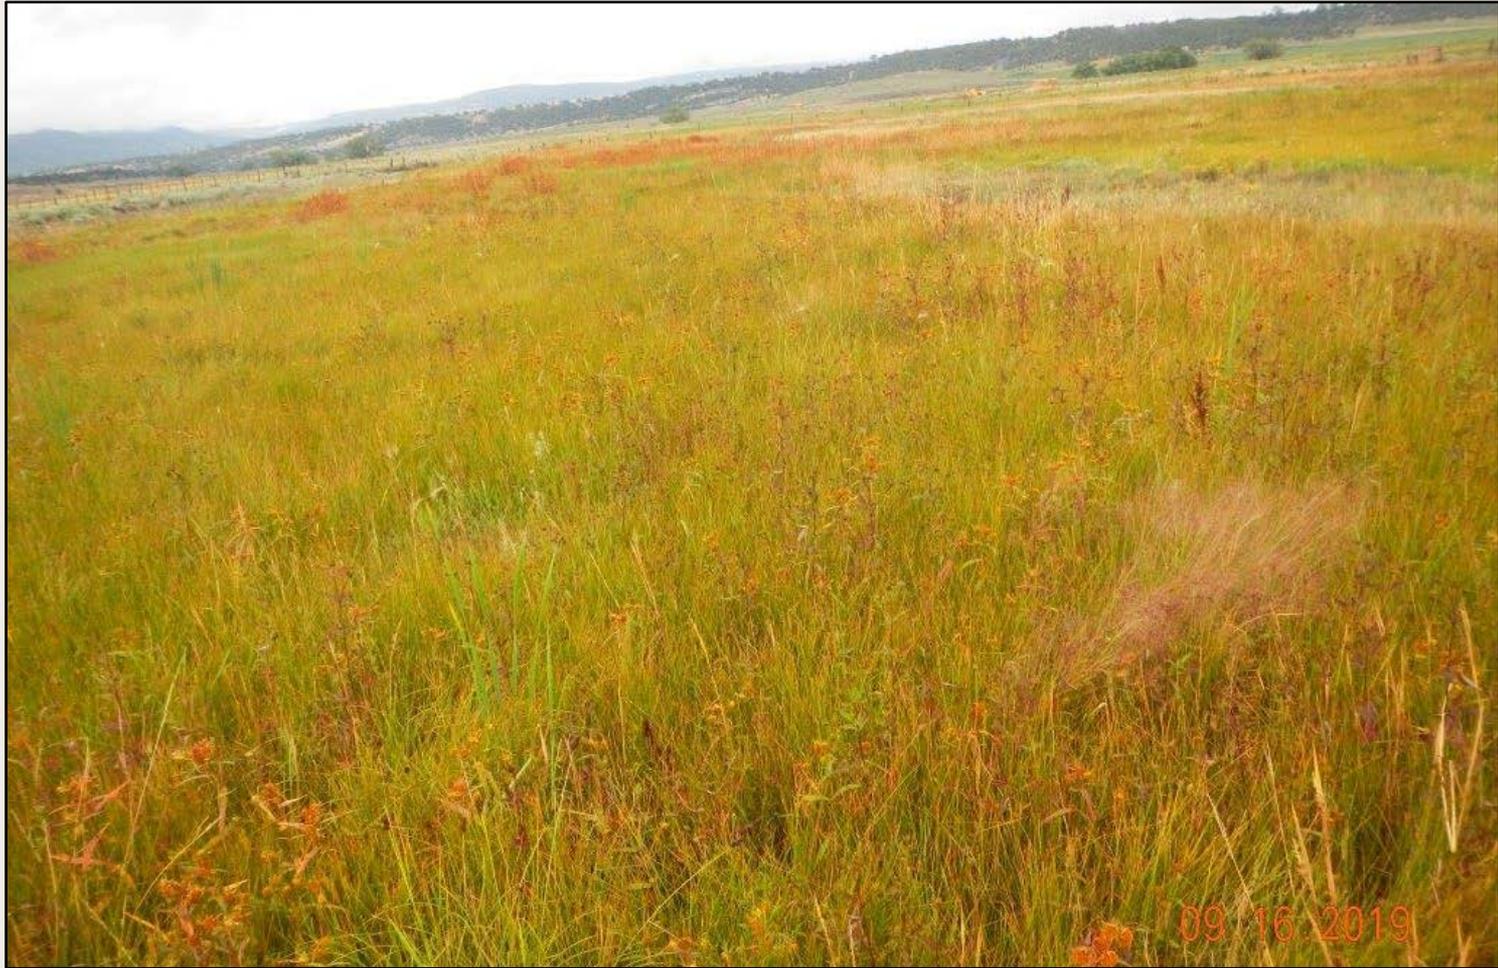
Photo 5. View of reference area vegetation, comprised of open grass field and wetland vegetation.
