Inspection Photos
Operator: Dugan Production
Location/API #: 067-06498
Date: 9-16-2019

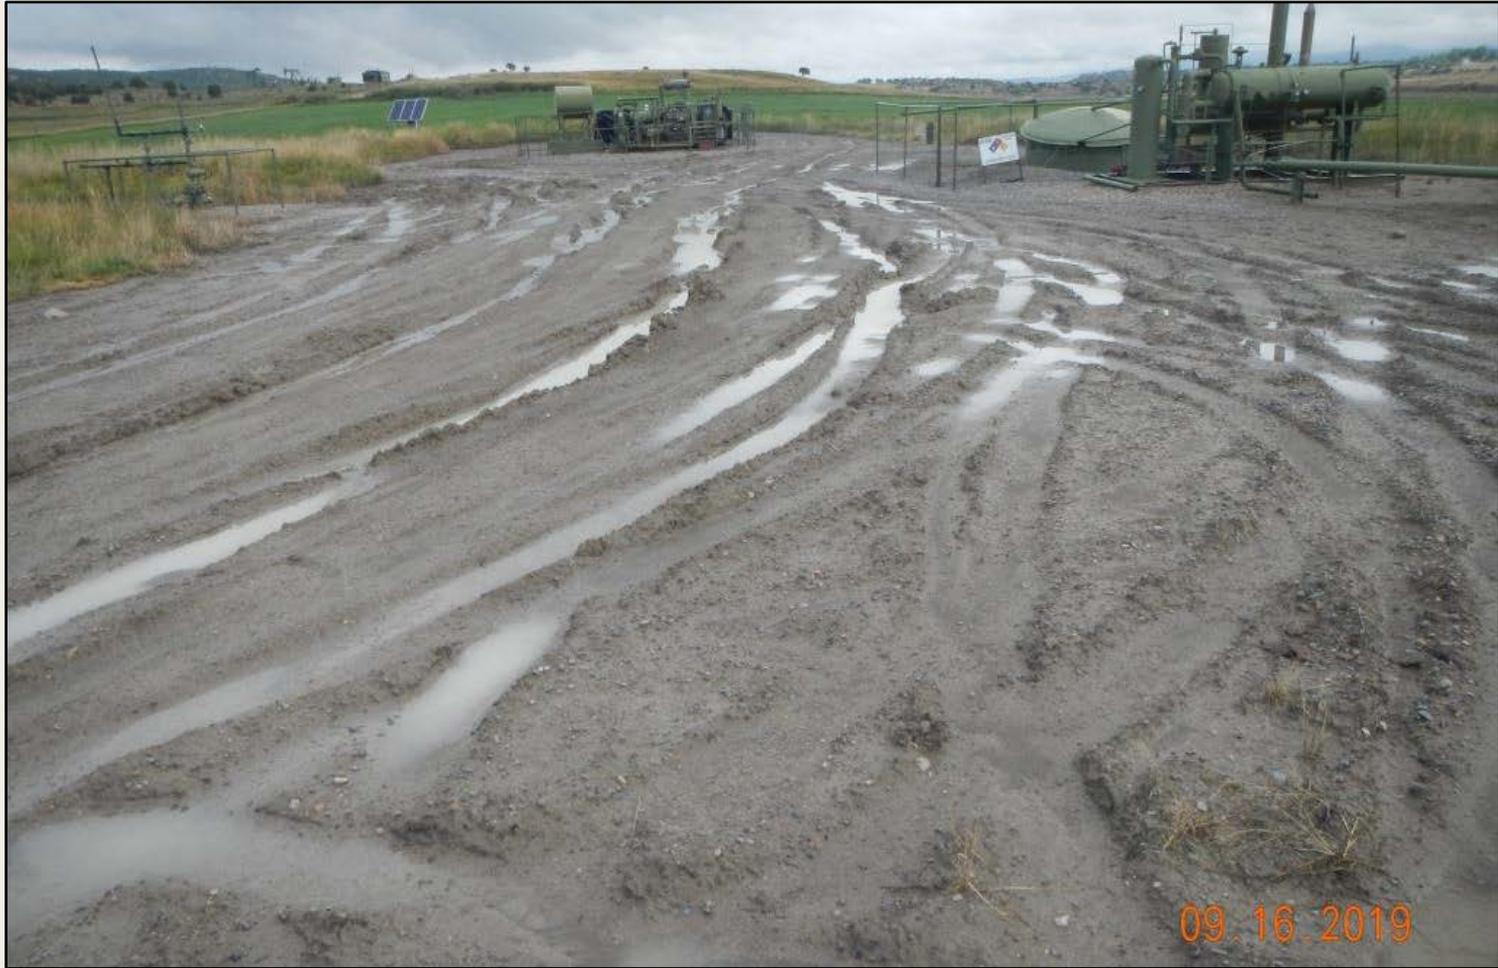
Photo 1. View of the project area from the well pad entrance facing center. Well pad is deeply rutted and water is ponding on working area. Stabilization measures are needed.

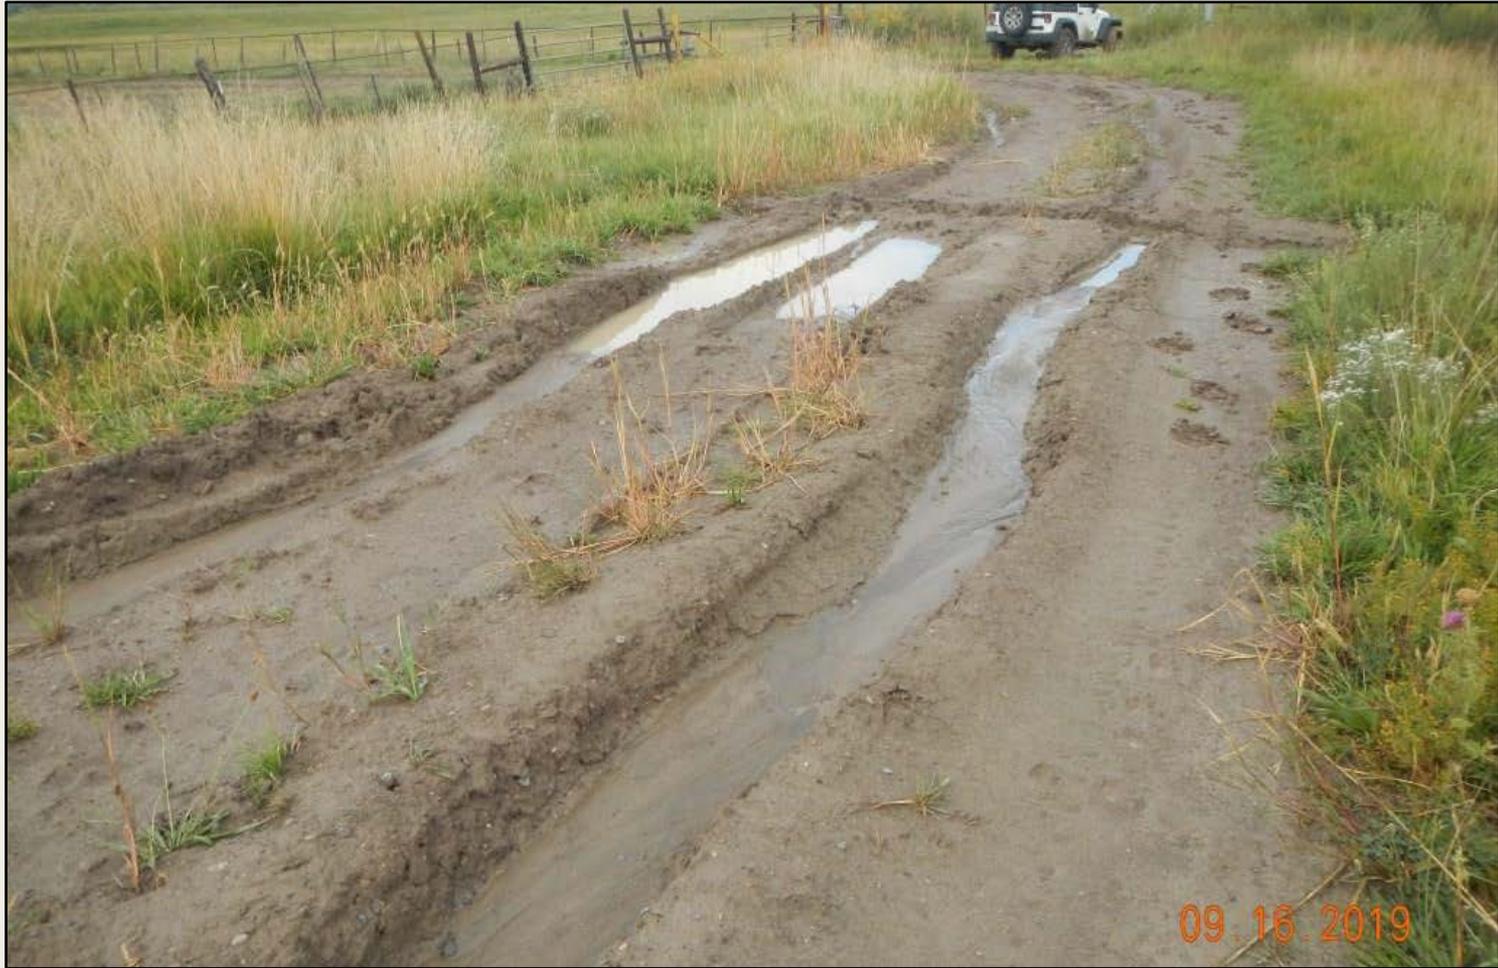
Photo 2. View of rutting up to 12 inches deep on the well pad access road.

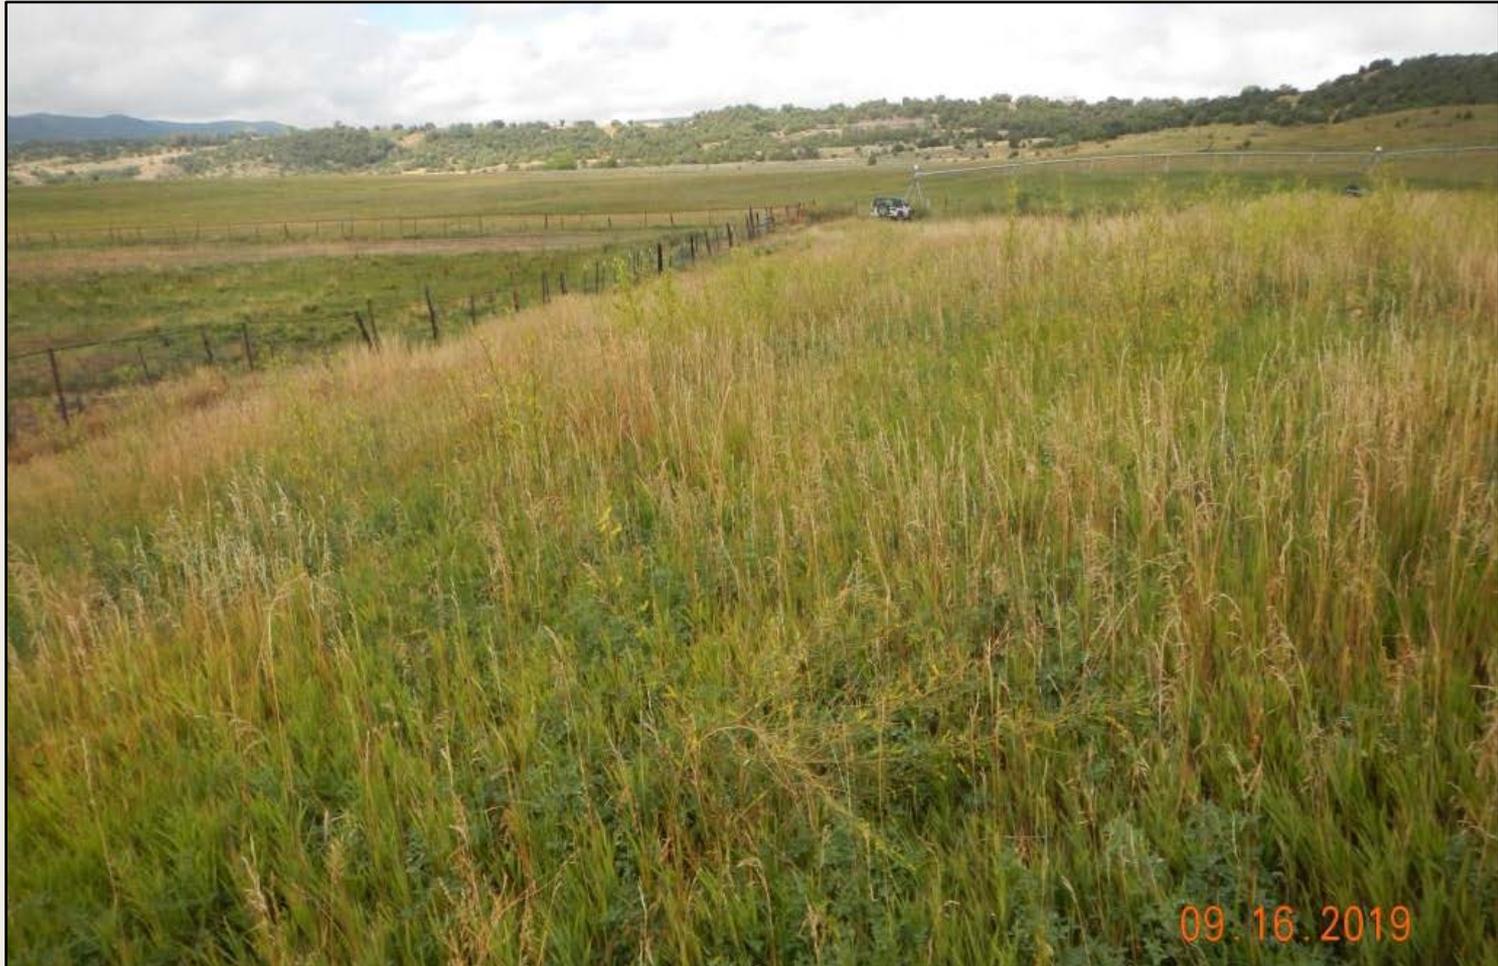
Photo 3. View of the southern project area from the eastern corner facing westward. Vegetation is progressing with perennial grasses such as smooth brome within the interim reclamation areas.

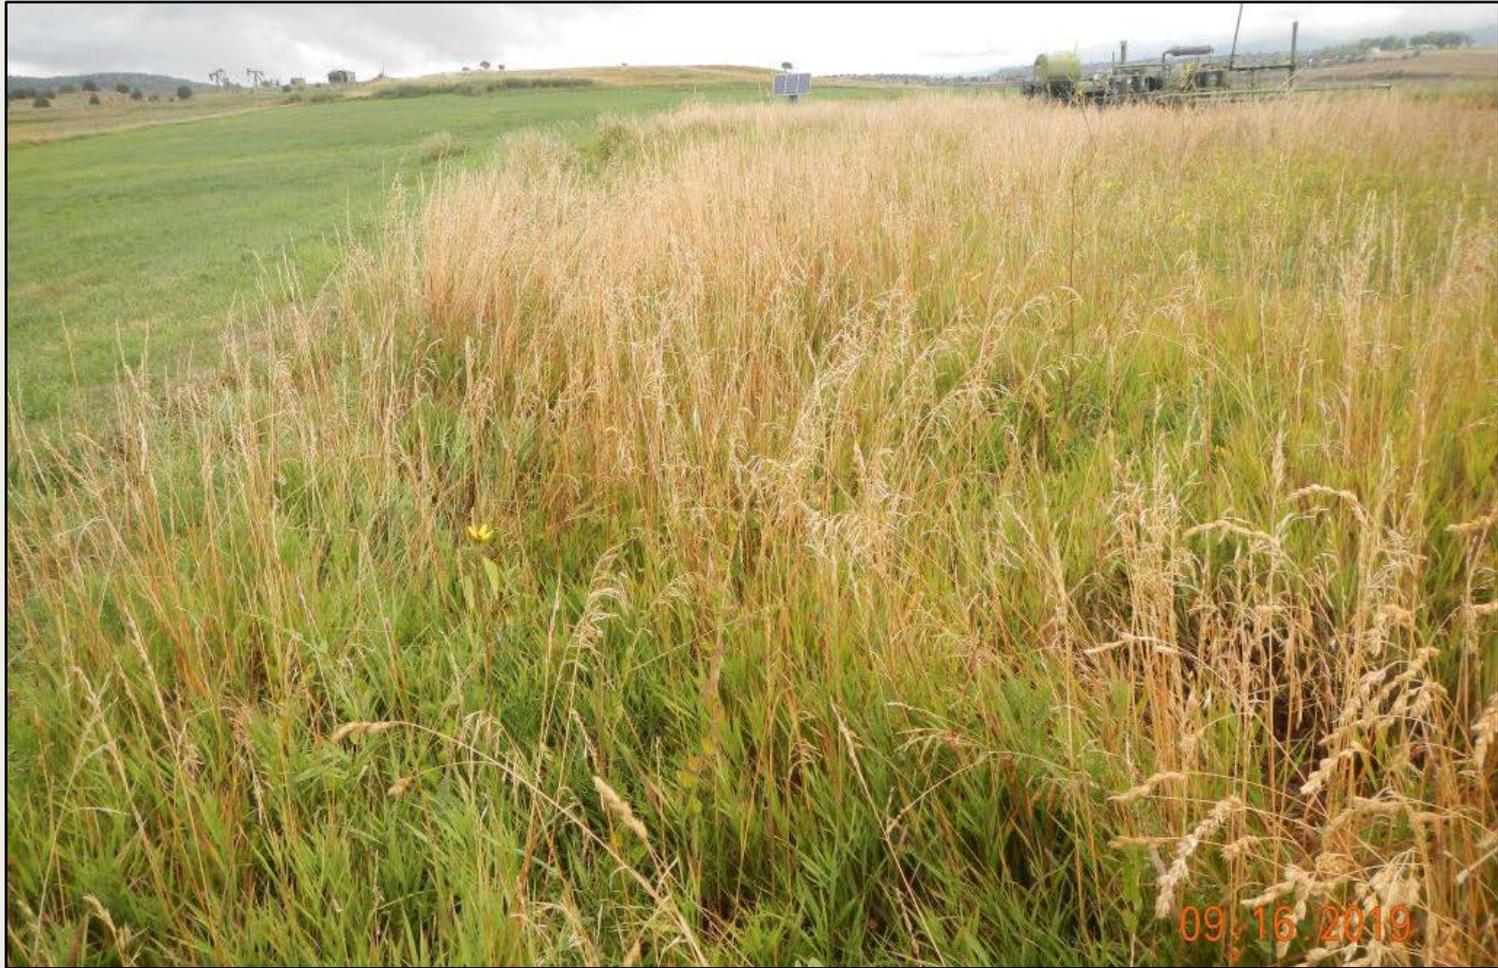
Photo 4. View of the western project area on right, and mowed reference area on left, facing northward. Reference area is comprised of irrigated grass field grasses such as orchard grass and smooth brome.
