Inspection Photos

Operator: Hilcorp Energy
Location/API #: 067-09816
Date: 9-16-2019

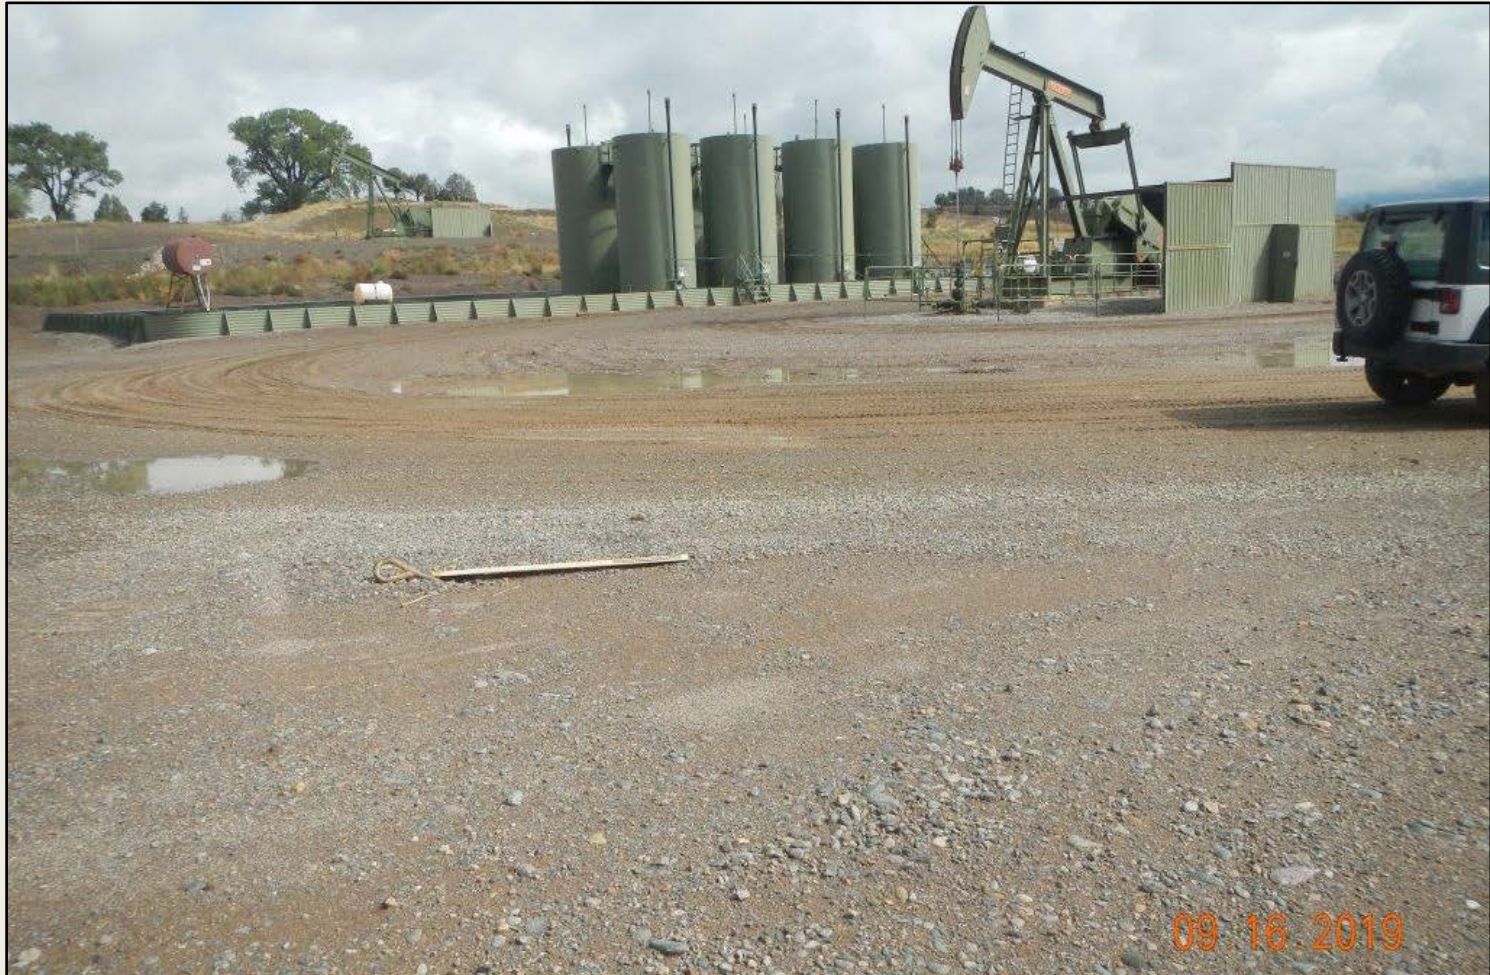
Photo 1. View of the project area from the southwest corner facing center.

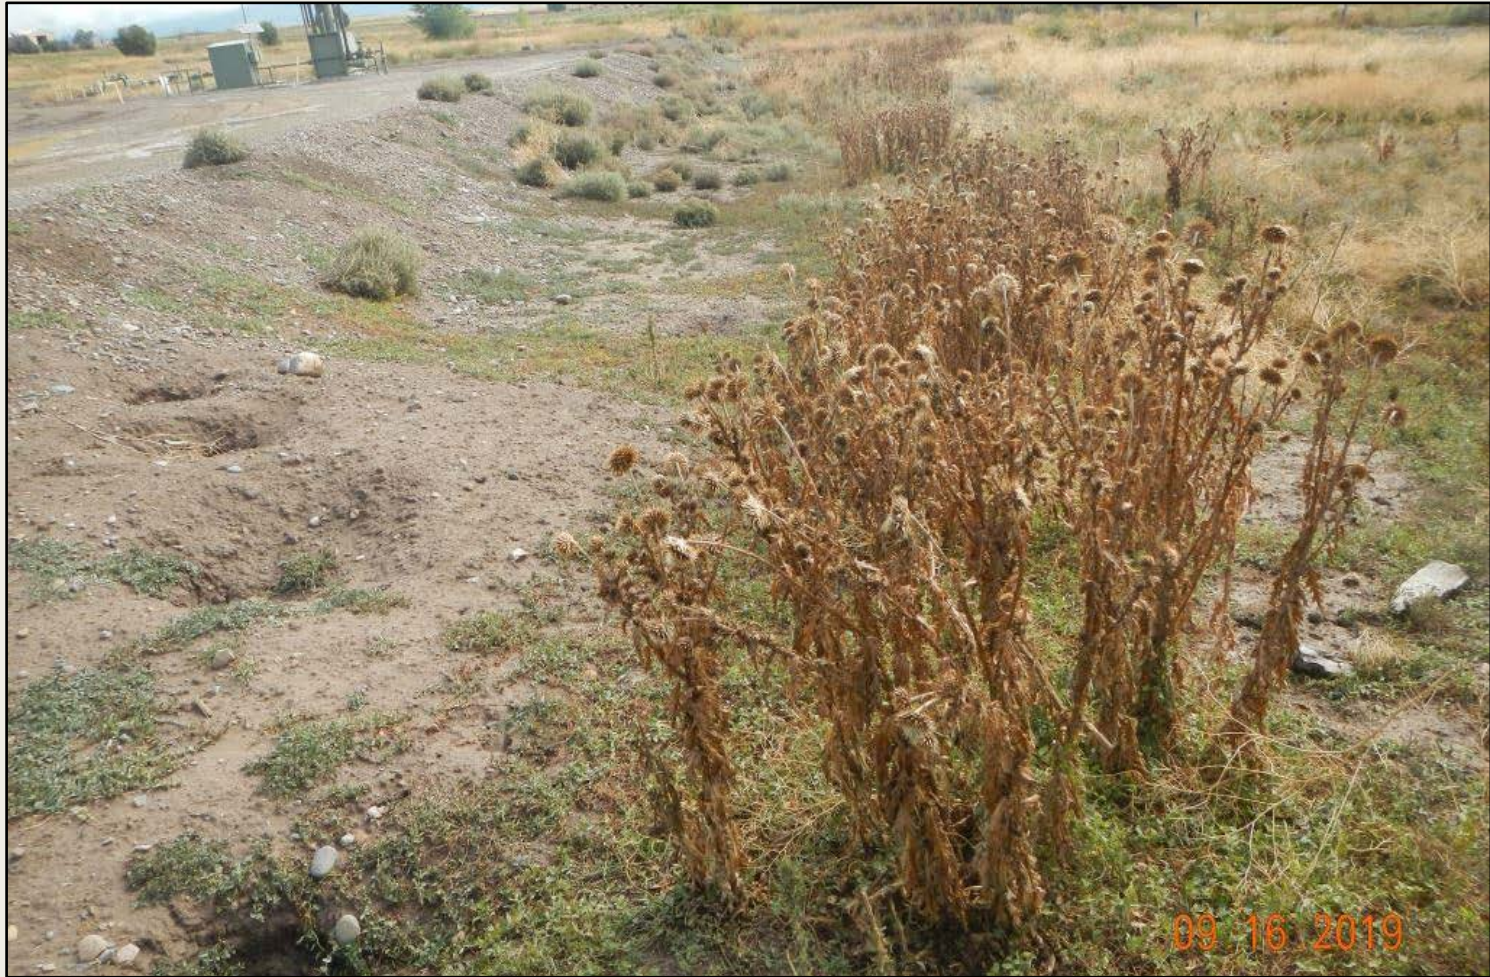
Photo 2. View of the southern fill slope facing eastward. Approximately 1000 musk thistles observed within the outer revegetation areas.

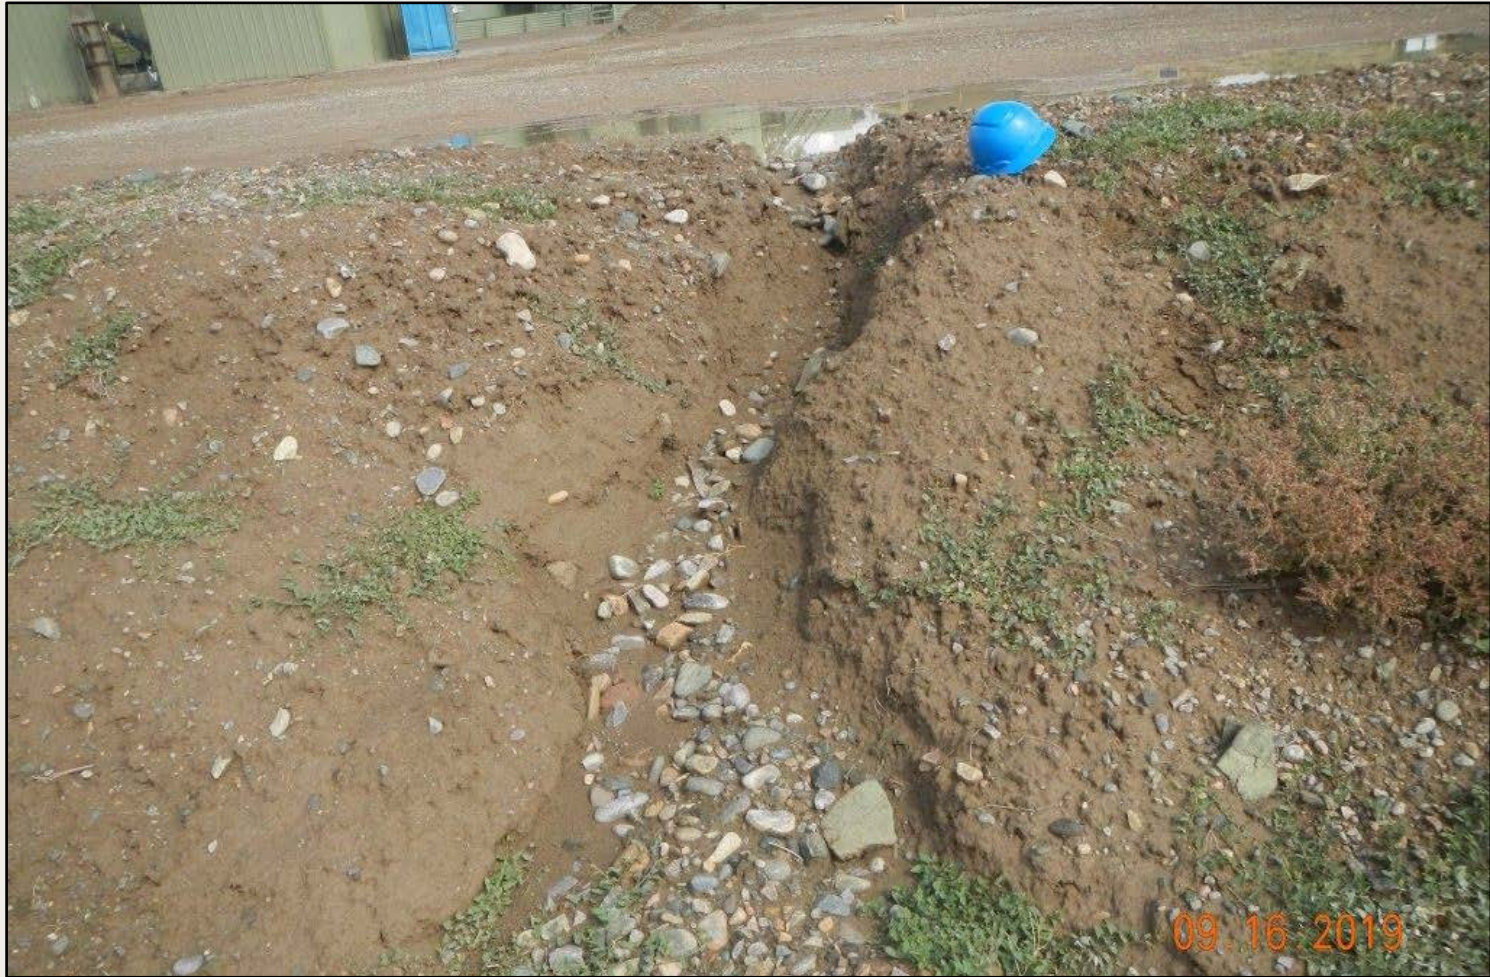
Photo 3. View of erosional channel approximately 2 feet wide and deep within the southern project area.

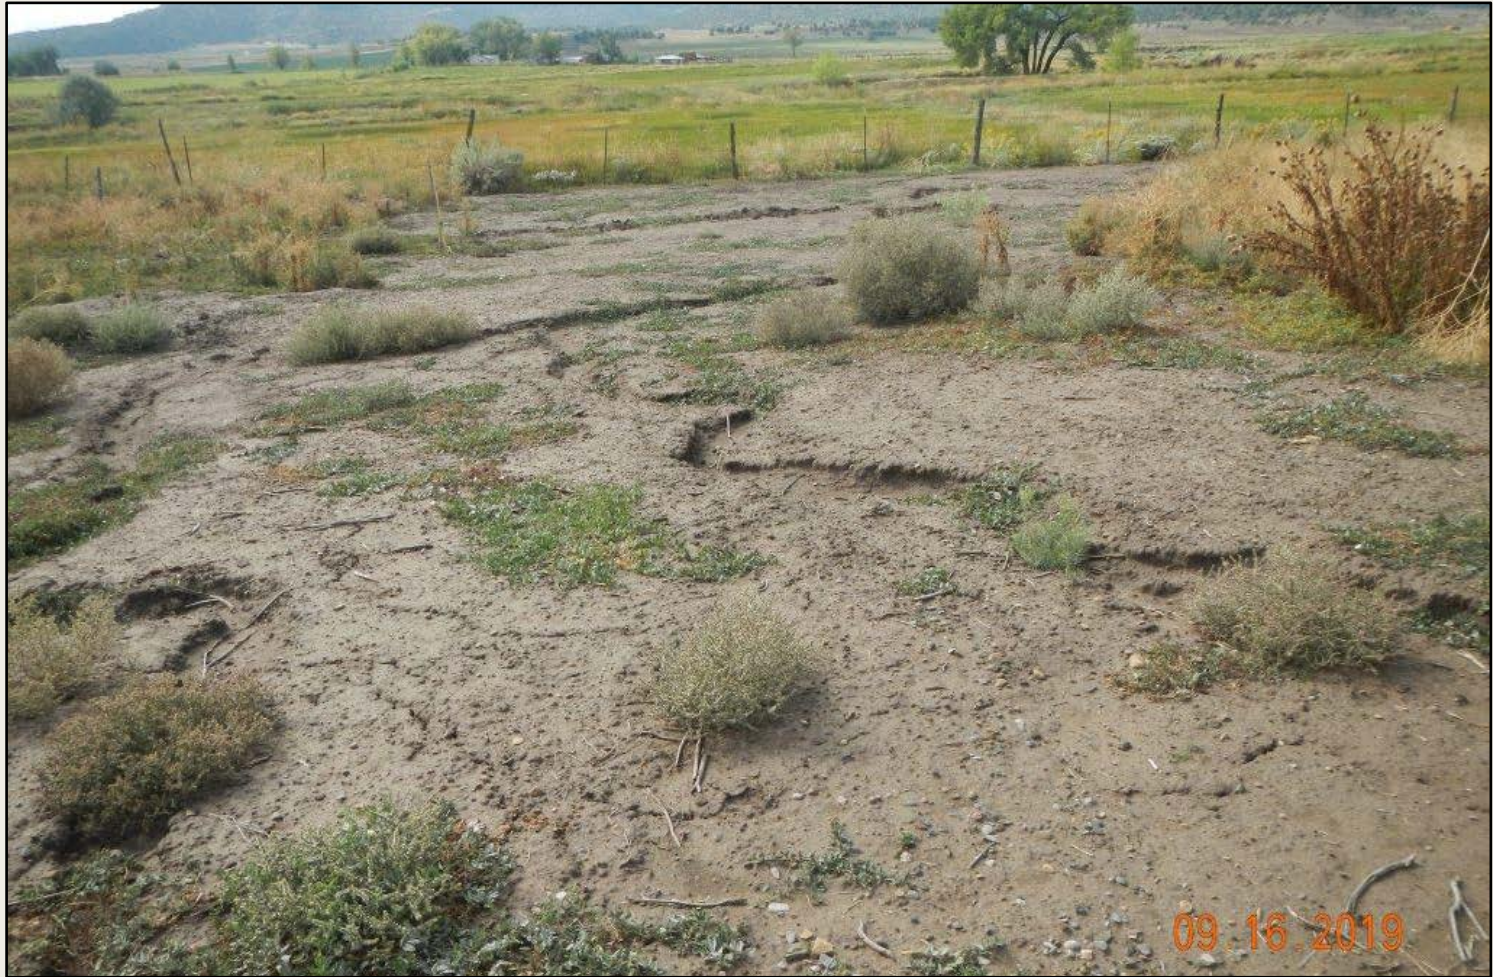
Photo 4. View of extensive (approx. 100 feet long and 50 feet wide) sediment discharge and channeling within the southern project area.

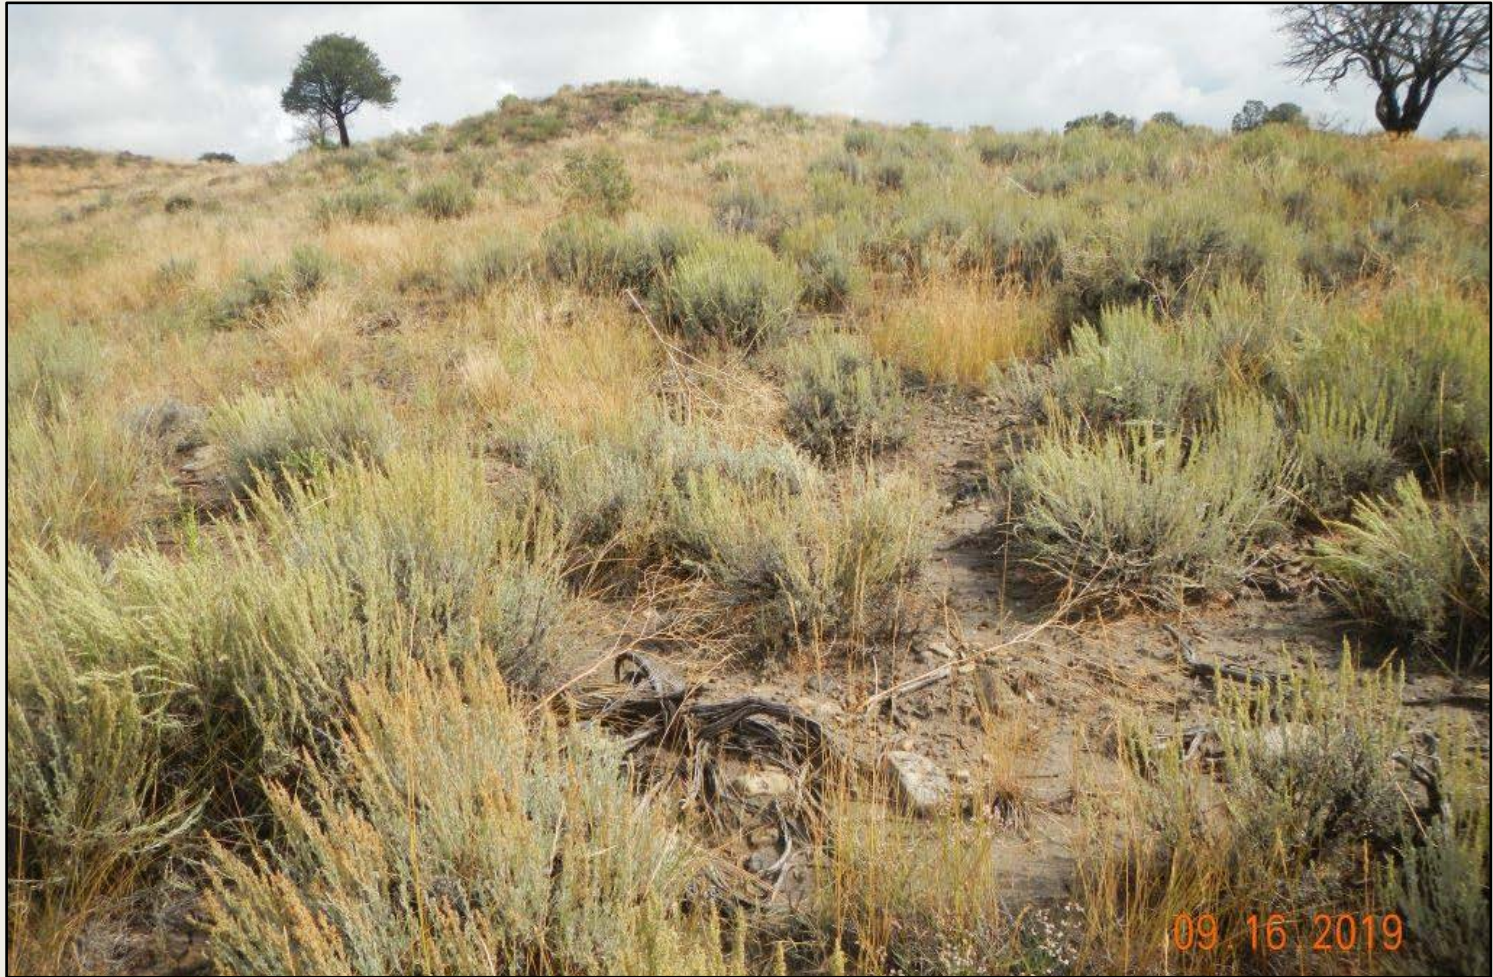
Photo 5. View of reference area vegetation, east of the project area, facing northward.
