Inspection Photos

Operator: BISON OIL & GAS II LLC # 10661

Location ID: 455519

Weld County, CO

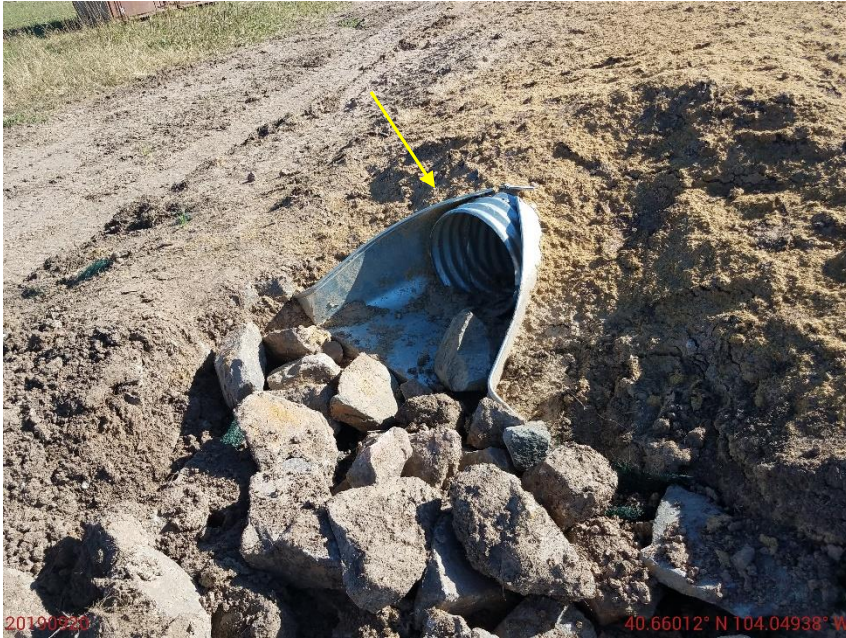
Photo 1: Photo taken from the culvert on the north end of the pad. Photo shows sufficient outlet protection has not been installed above culvert outlet.

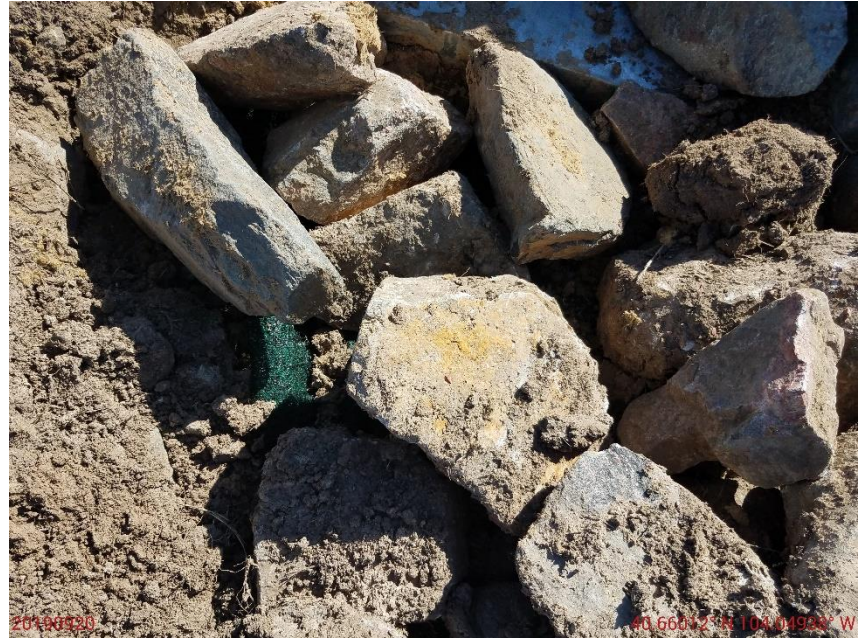
Photo 2: Continued from photo 1. Photo shows geotextile has not been placed under the rip-rap.

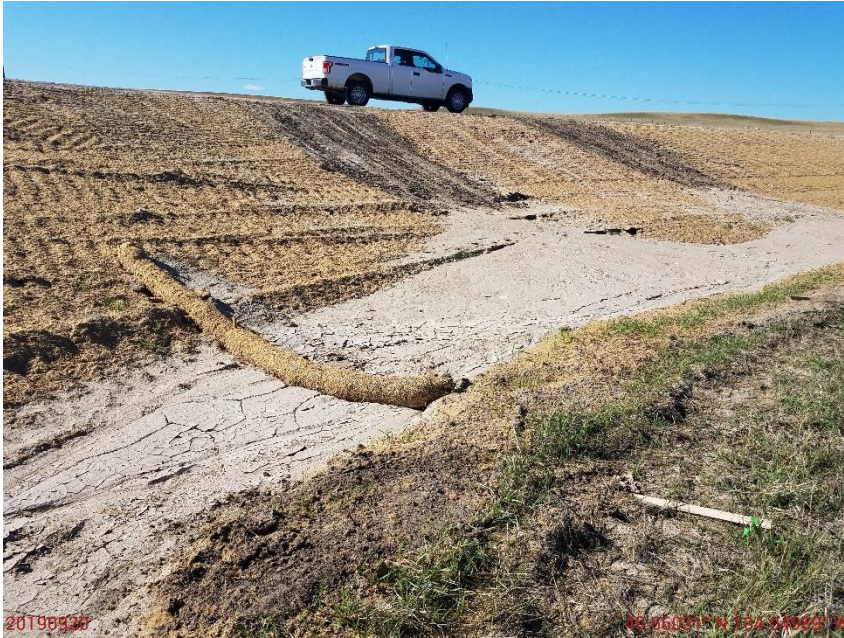
Photo 3: Photo taken from the perimeter stormwater diversion ditch on the south end of the location. Photo shows stormwater appears to have eroded the slopes of the location with sediment deposition within the ditch. Operator appears to have repaired erosion, however, it does not appear as though operator has installed BMPs to stabilize slope, or maintained ditch filled with sediment to ensure proper functioning condition.

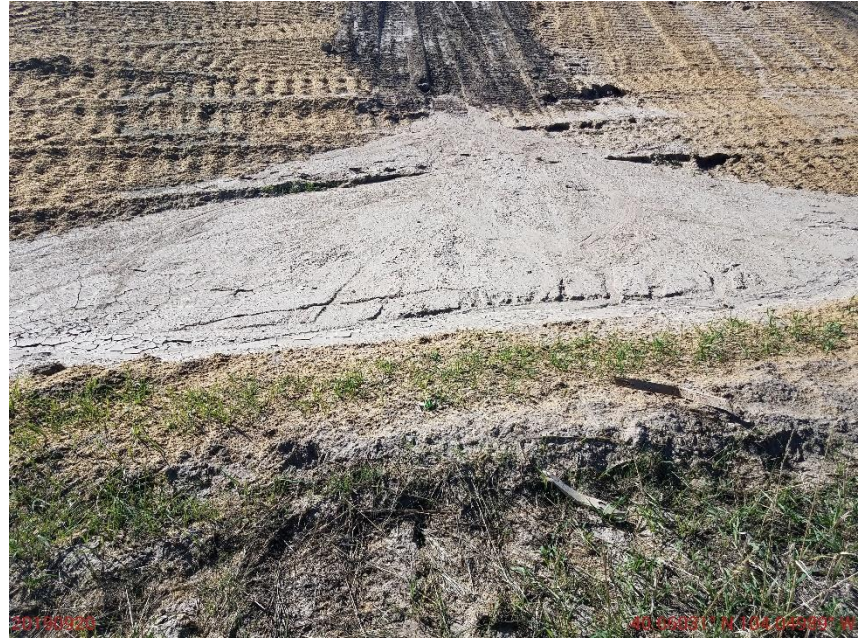
Photo 4: See comments under photo 3.

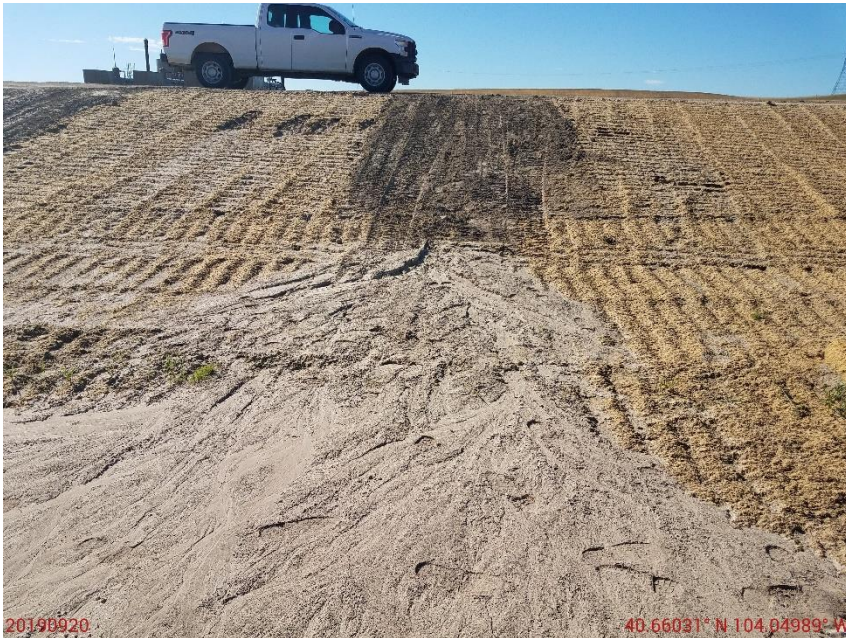
Photo 5: See comments under photo 3.

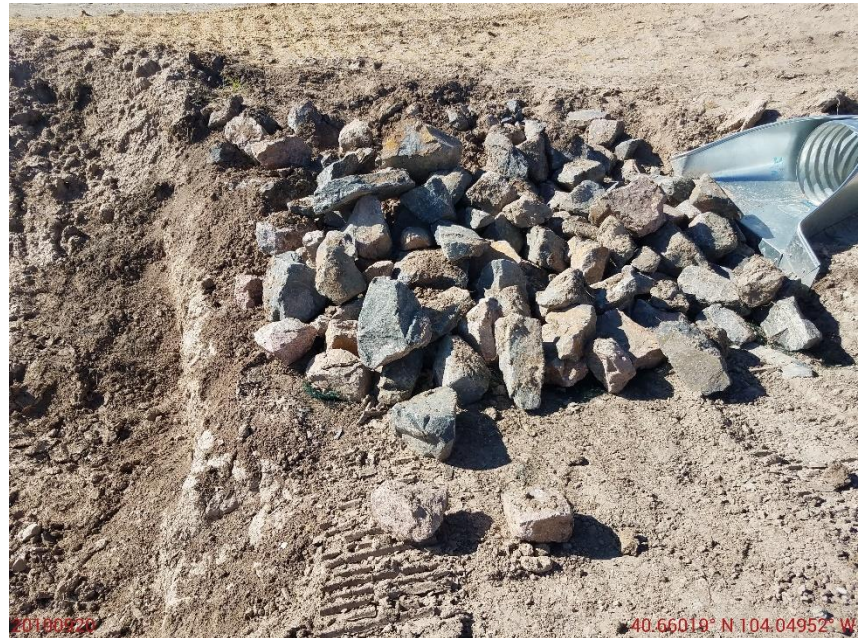
Photo 6: Photo taken from the sediment trap inlet on the south end of the location. Operator has placed geotextile under the rip-rap. Inlet has been constructed with a horizontal grade/cut without sufficient inlet/slope protections. This is not good engineering practices.

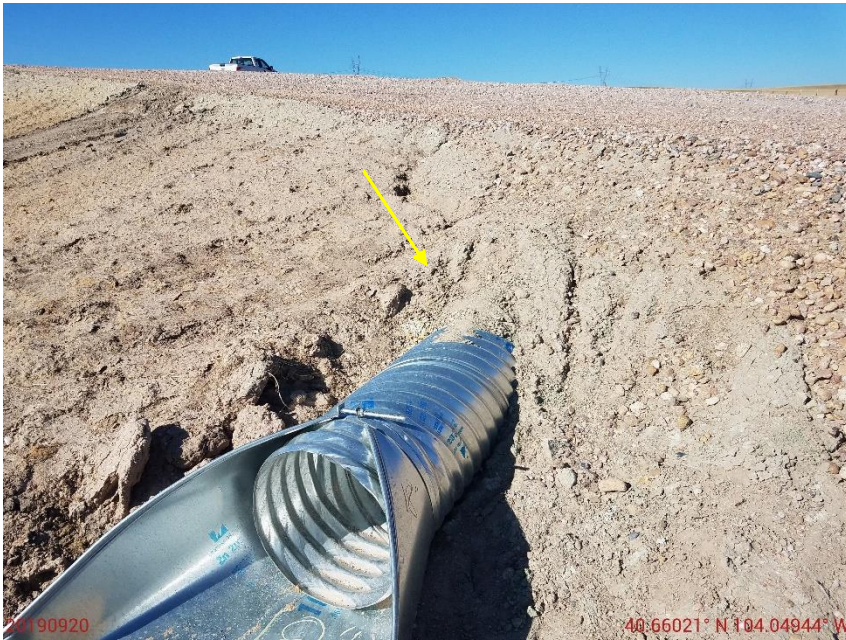
Photo 7: Photo taken from the culvert on the north end of the pad. Photo shows sufficient outlet protection has not been installed above culvert outlet. Erosion degradation around culvert evident.

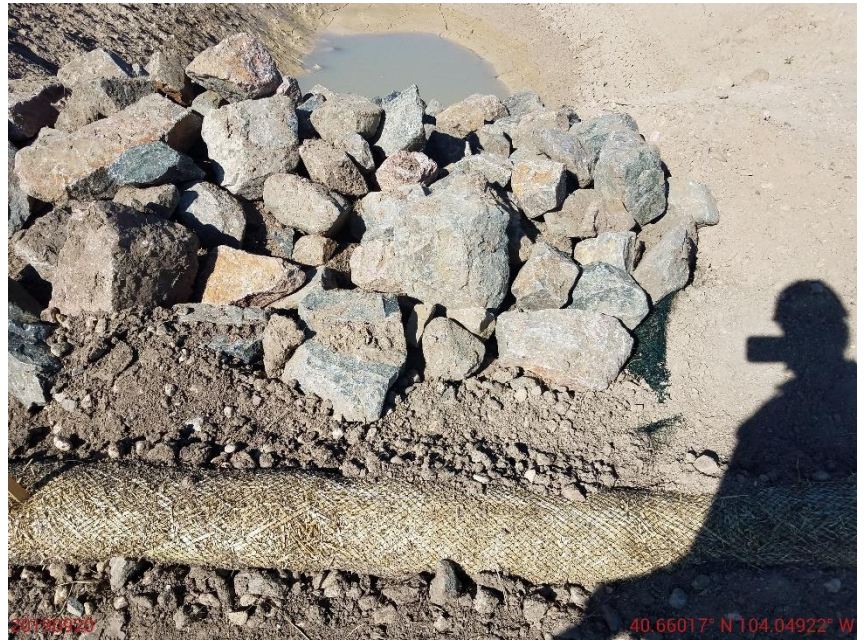
Photo 8: Photo taken from the outlet of the sediment trap on the north end of the location. Photo shows geotextile has been placed beneath the rip-rap of the outlet. Operator appears to have only used a single-type large aggregate within outlet

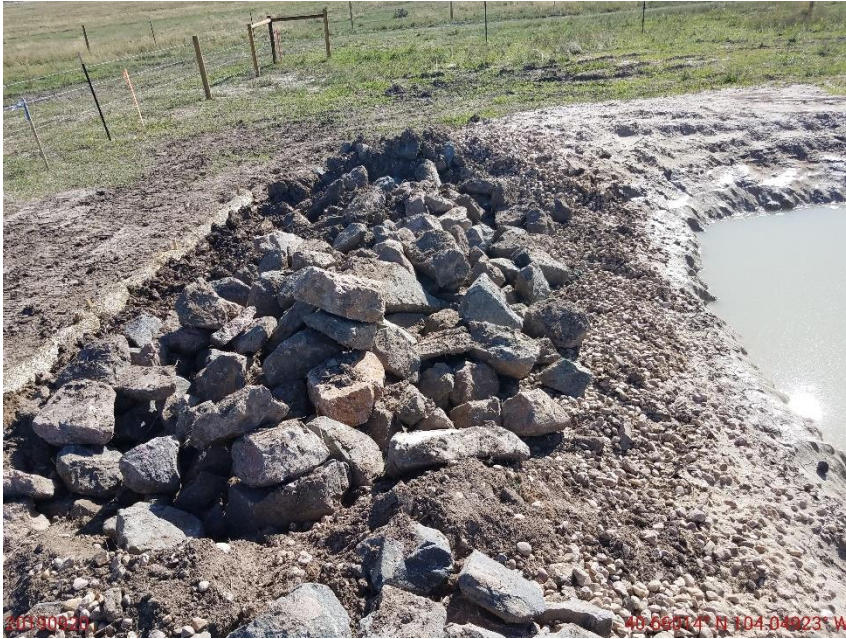
Photo 9: Photo of outlet at the sediment trap on the northeast end of the location. Operator appears to have installed outlet with a combination of sufficient, and appropriately sized (large/small) aggregate with a geotextile lining; Outlet appears to have been installed in accordance with good engineering practices.

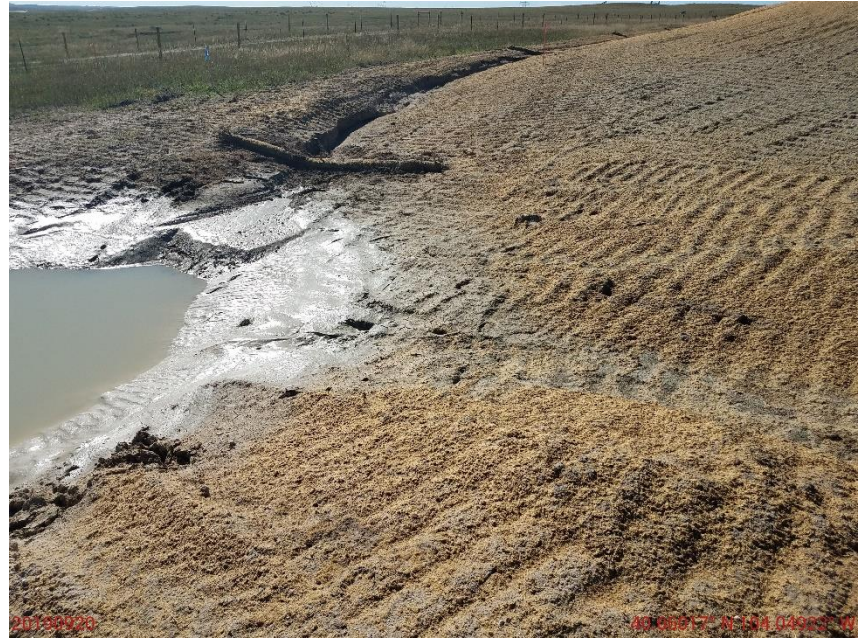
Photo 10: Photo of inlet at the sediment trap on the northeast end of the location, facing southeast. Photo shows BMP has not been constructed in accordance with good engineering practices and is missing sufficient inlet protections. Erosion degradation evident at inlet and diversion ditch. Additionally, operator appears to have installed a wattle at the inlet without repairing ditch.

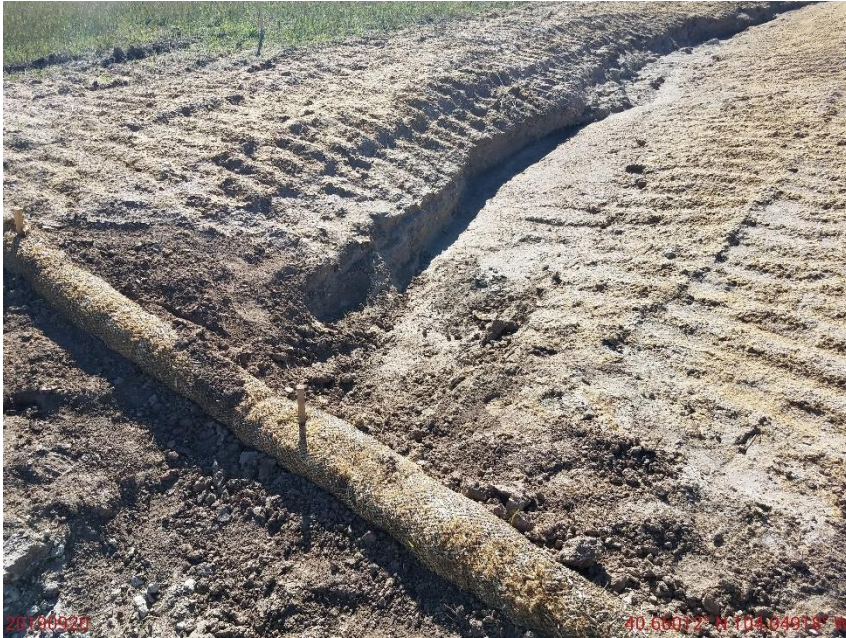
Photo 11: Continued from photo 10.

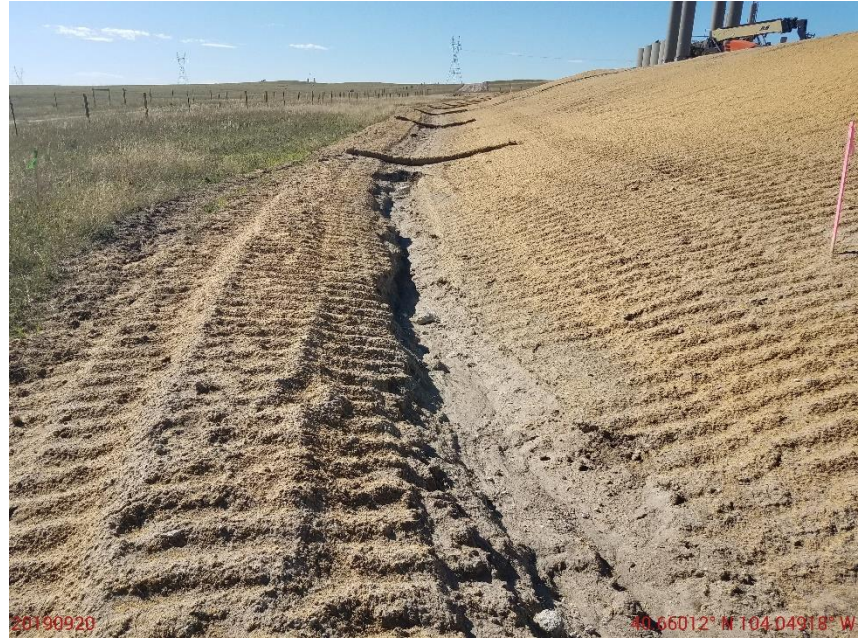
Photo 12: Continued from photo 10.

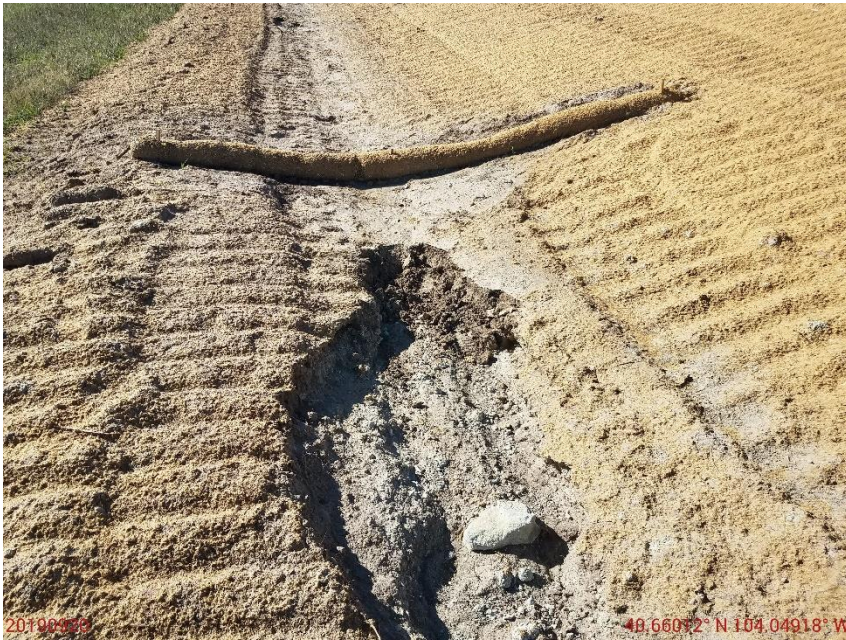
Photo 13: Continued from photo 10.

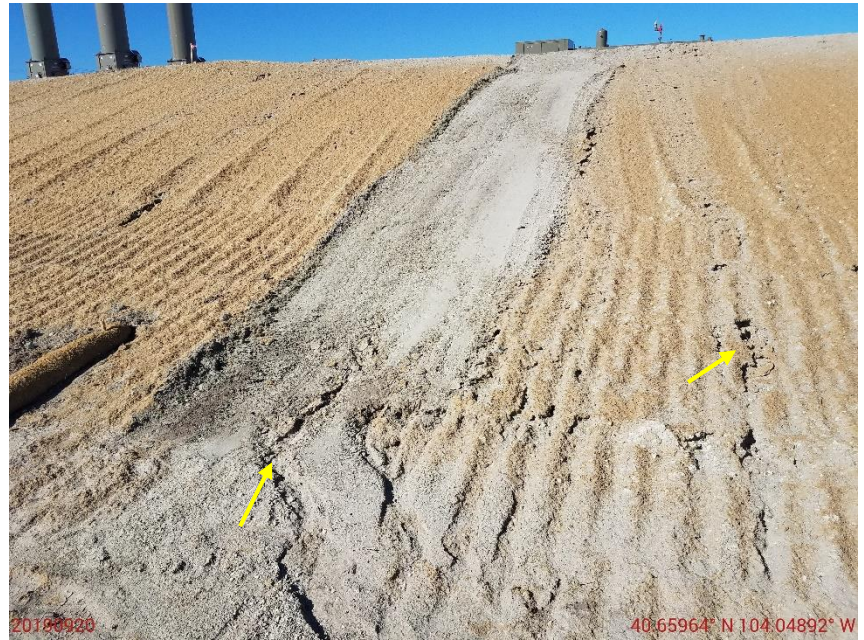
Photo 14: : Photo taken from the slopes on the east end of the location. Photo shows stormwater appears to have eroded the slopes of the location. Operator appears to have repaired erosion, however, it does not appear as though operator has installed BMPs to stabilize slope. Photo also shows areas where operator tracked slope along the contour of the slopes, rather than up and down. As a result, rill erosion has formed on areas of the slopes (arrow)

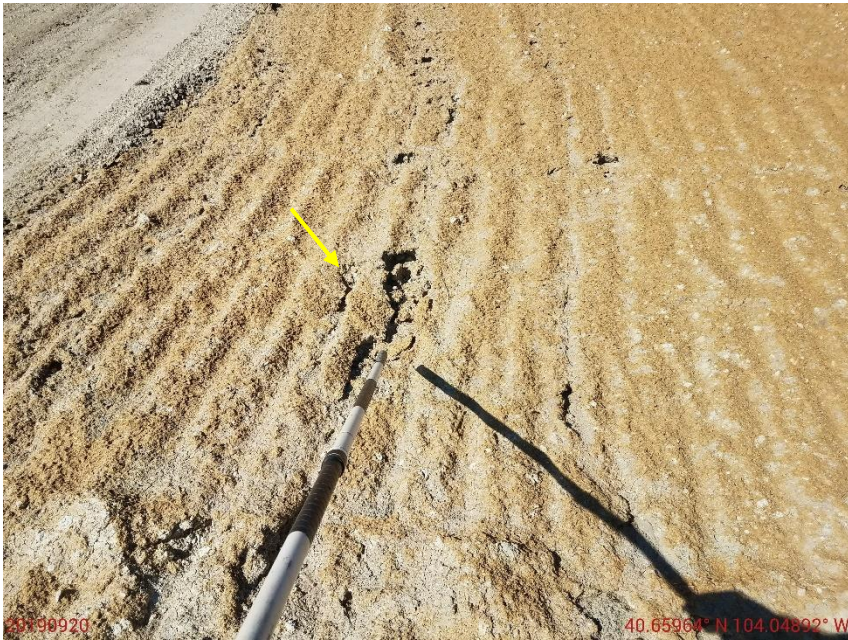
Photo 15: Continued from photo 14. Photo shows areas where operator tracked slope along the contour of the slopes, rather than up and down. As a result, rill erosion has formed on areas of the slopes

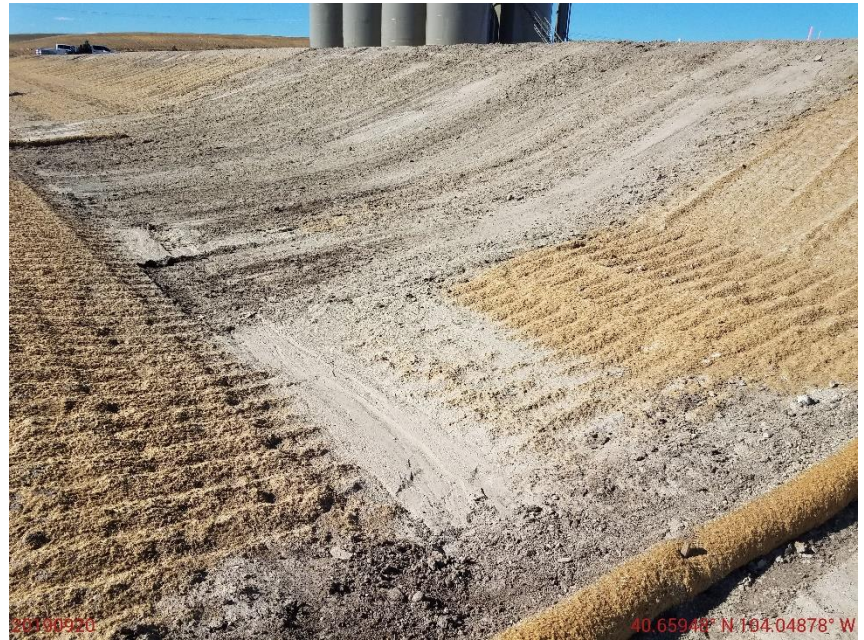
Photo 16: See comments under photo 14.

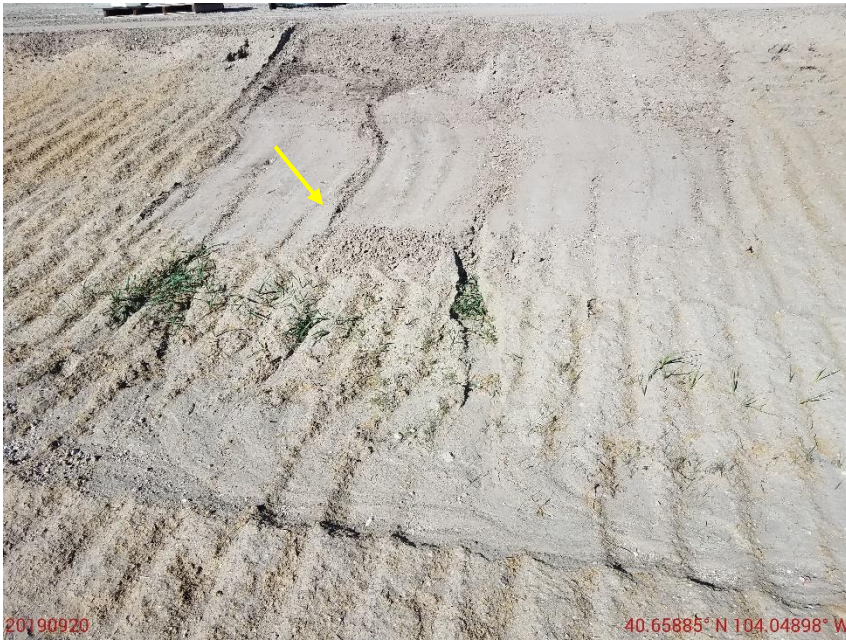
Photo 17: See comments under photo 15.

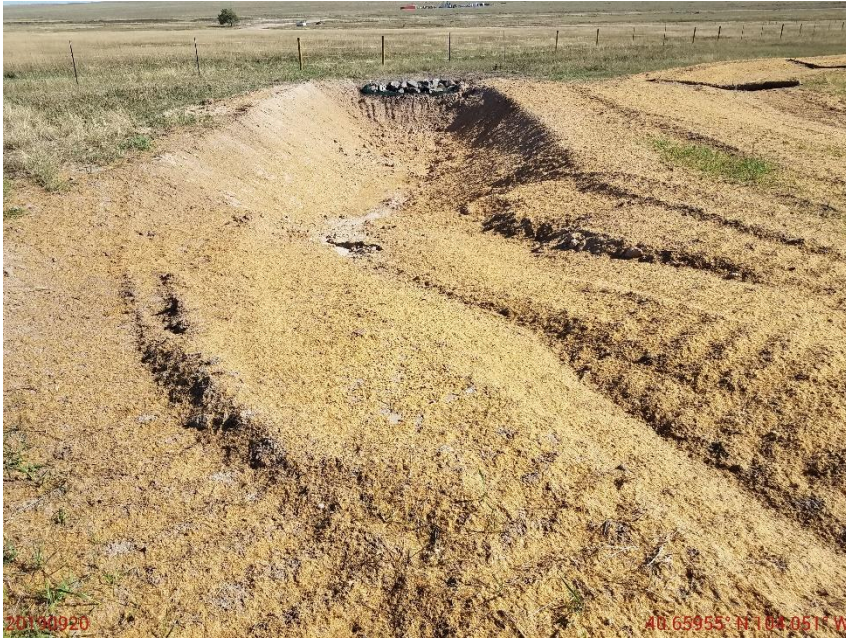
Photo 19: Photo taken from the sediment trap on the northwest corner of the location. Photo shows BMP has not been constructed in accordance with good engineering practices with sufficient inlet/outlet and slope protection. Photo shows erosion degradation evident at inlet.

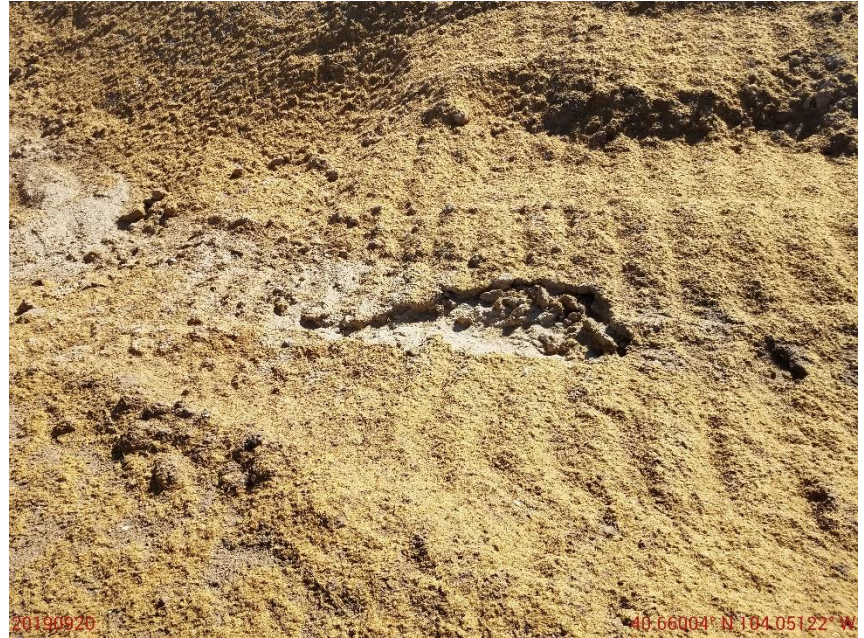
Photo 20: See comments under photo 19.

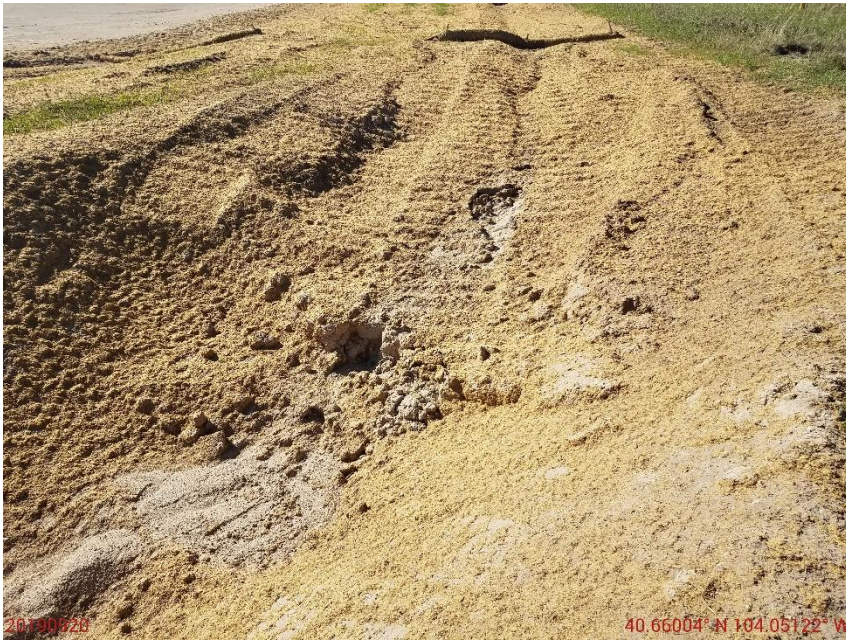
Photo 21: See comments under photo 19.

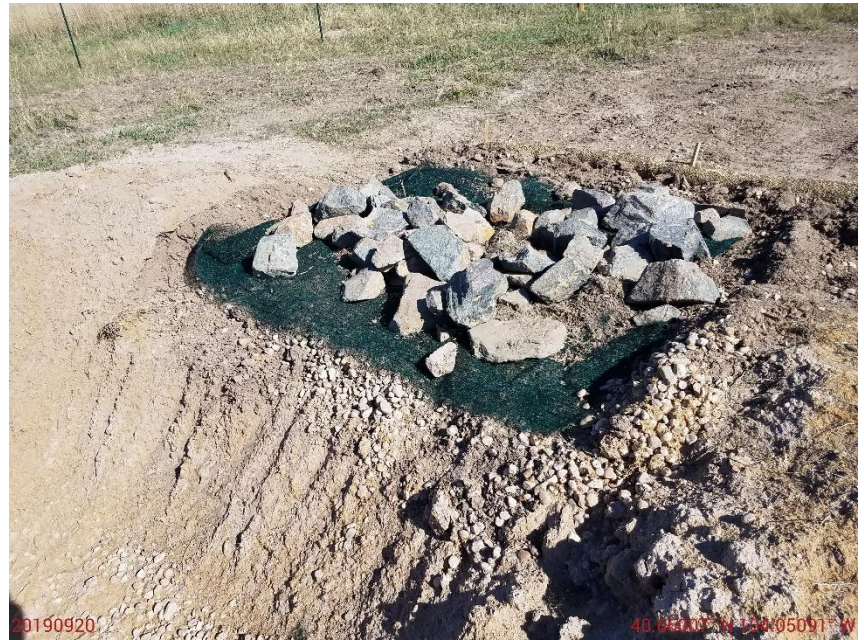
Photo 22: See comments under photo 19.

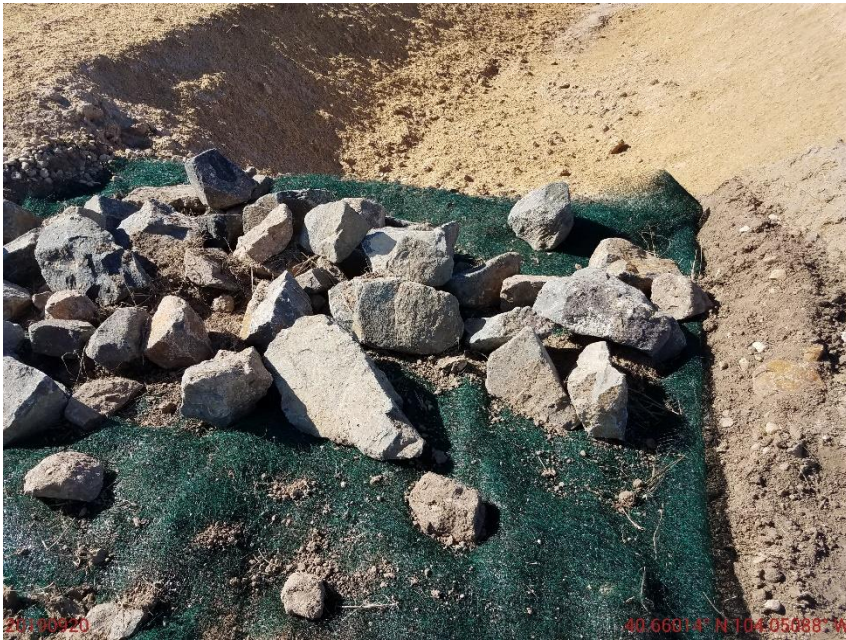
Photo 23: Continued from photo 22. Photo shows outlet has not been constructed in accordance with good engineering practices.

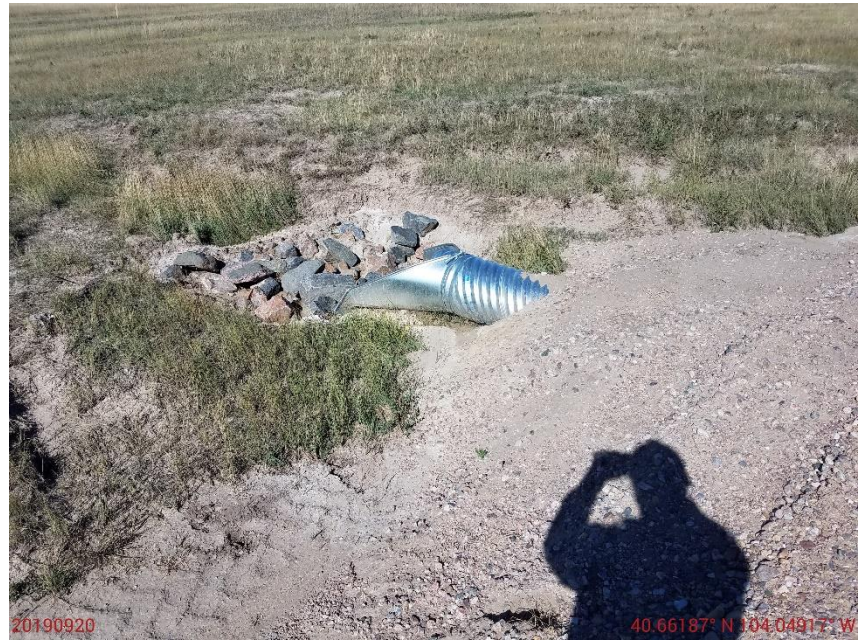
Photo 24: Photo taken from the culvert on the access road north of the pad. Photo shows sufficient outlet protection has not been installed above culvert outlet. Erosion degradation around culvert evident.

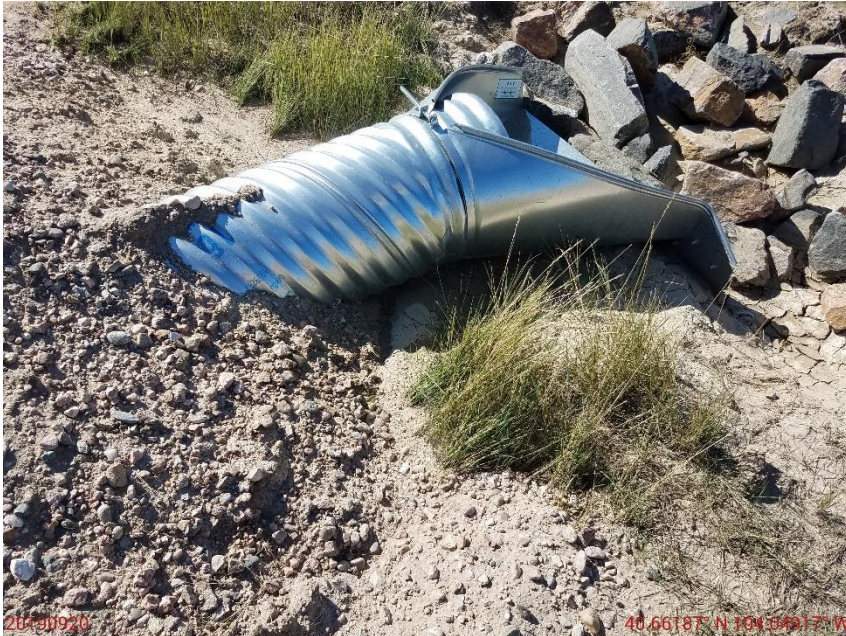
Photo 25: Photo taken from the culvert on the access road north of the pad. Photo shows sufficient outlet protection has not been installed above culvert outlet. Erosion degradation around culvert evident.

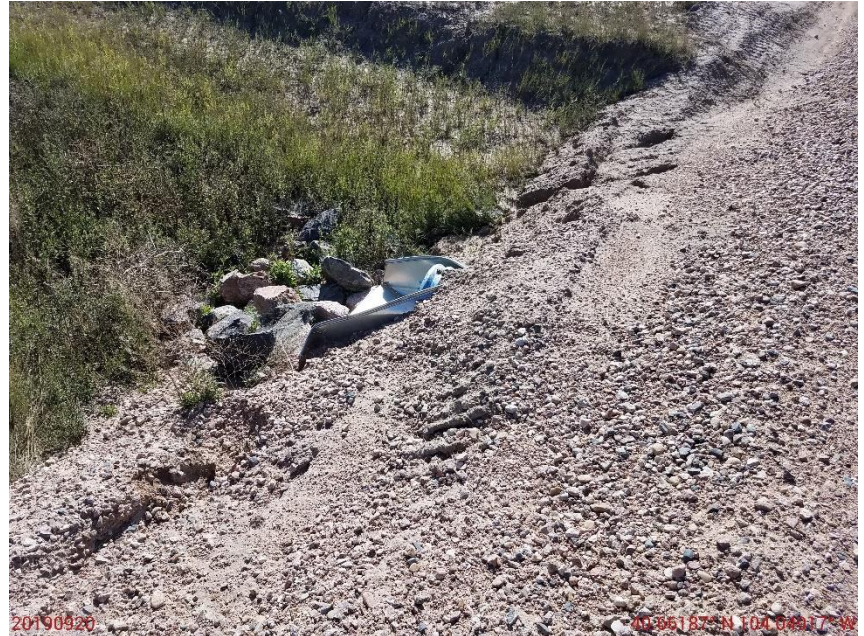
Photo 26: See comments under photo 25.

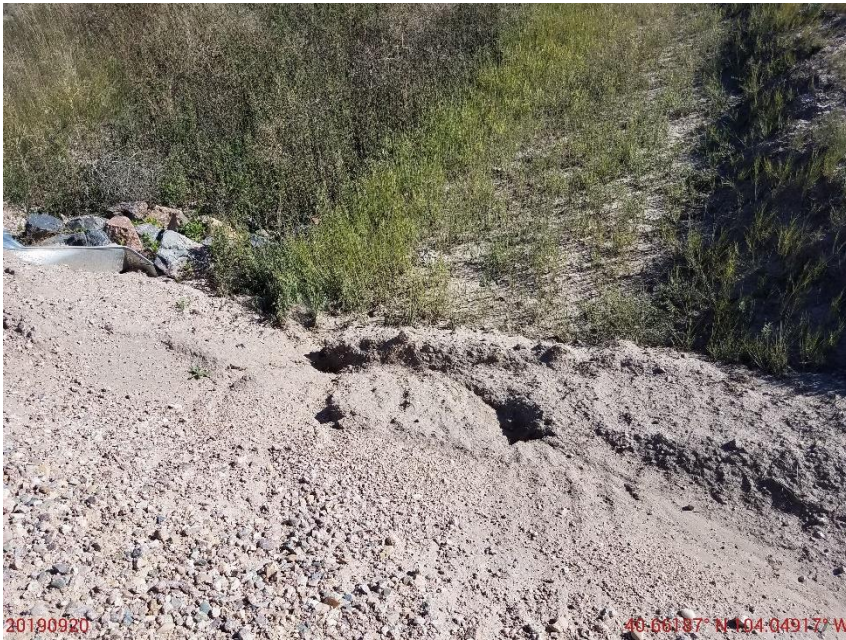
Photo 27: See comments under photo 25.

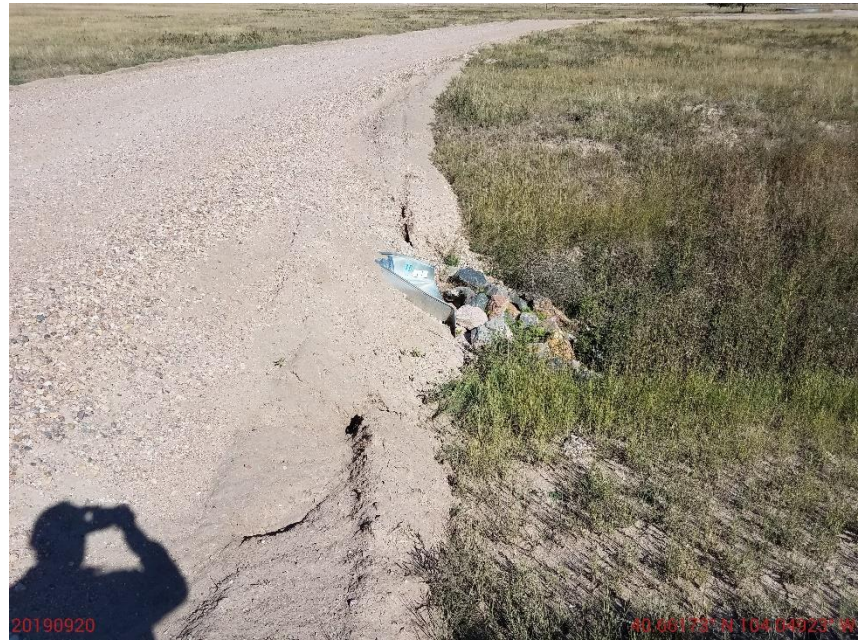
Photo 28: See comments under photo 25.
