Inspection Photos

09/20/2019

Operator: BISON OIL & GAS II LLC # 10661

Location ID: 454591

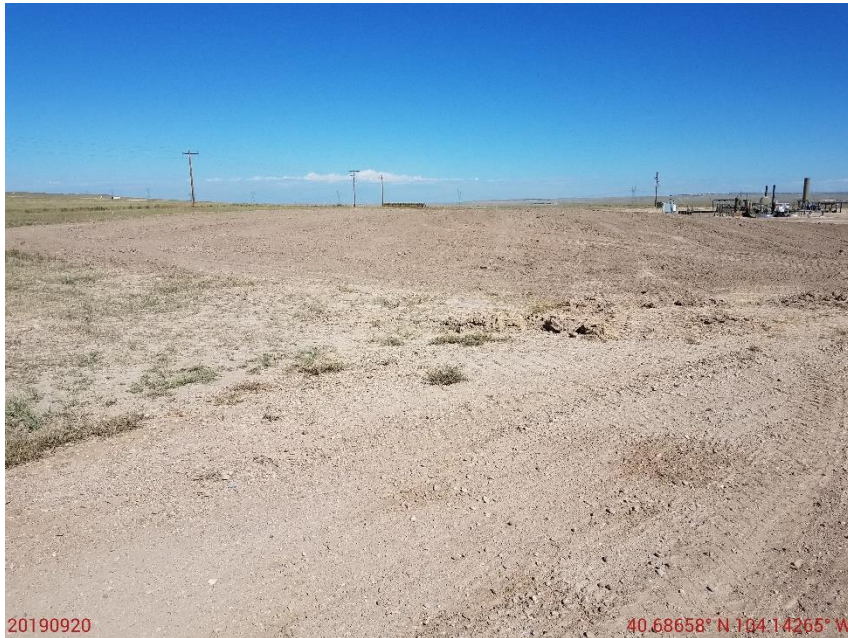
Photo 1: Photo taken from the south end of the location, facing north. Photos 1-3 provide an overview of the location from north, northeast to east. Photos show operator appears to be conducting interim reclamation.

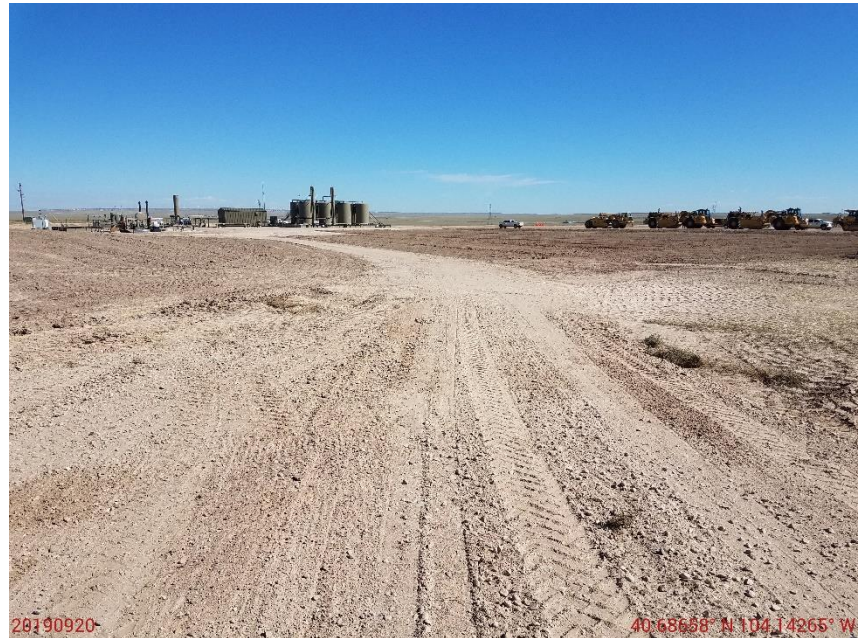
Photo 2: See comments under photo 1.

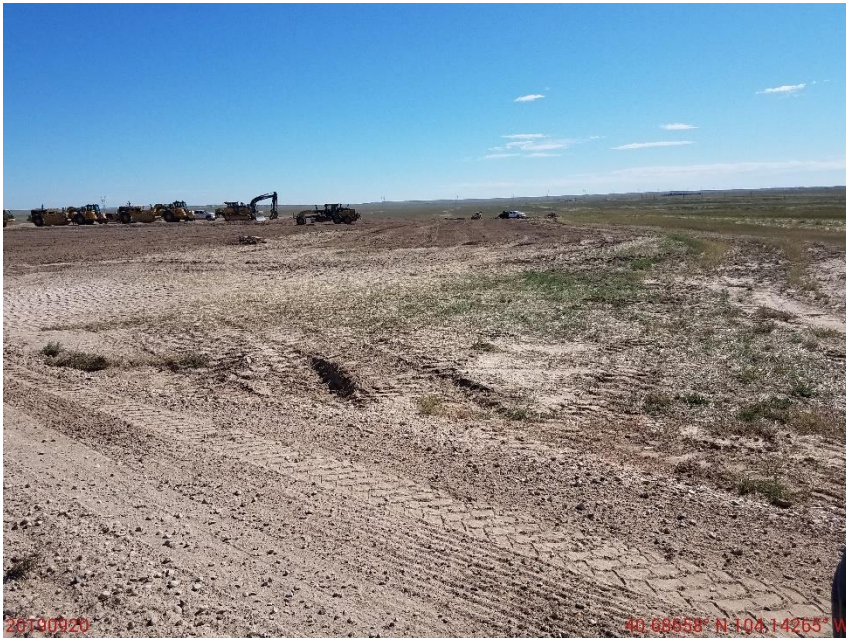
Photo 3: See comments under photo 1.

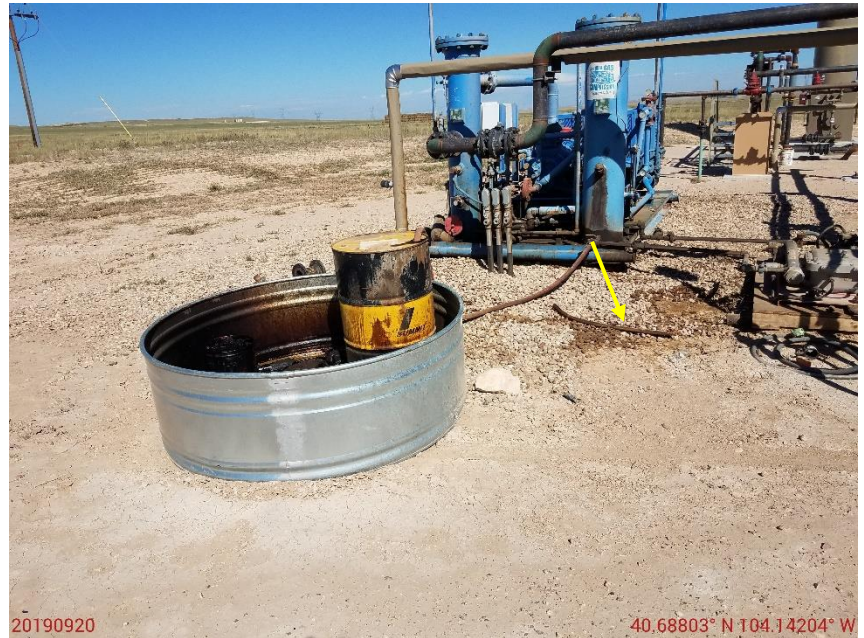
Photo 4: Photo taken from the north end of the location. Photo shows containers have been placed in secondary containment. Photo also shows stained soils observed in previous inspections have not been sufficiently cleaned/treated and/or removed.

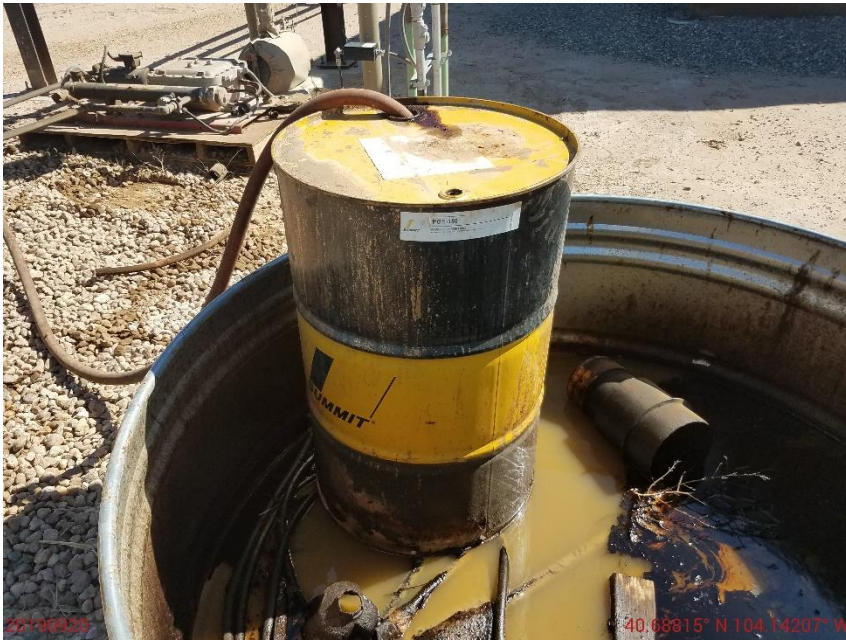
Photo 5: Previous inspections documented insufficient, or illegible labeling on tanks identifying contents. Photo shows labeling remains insufficient.

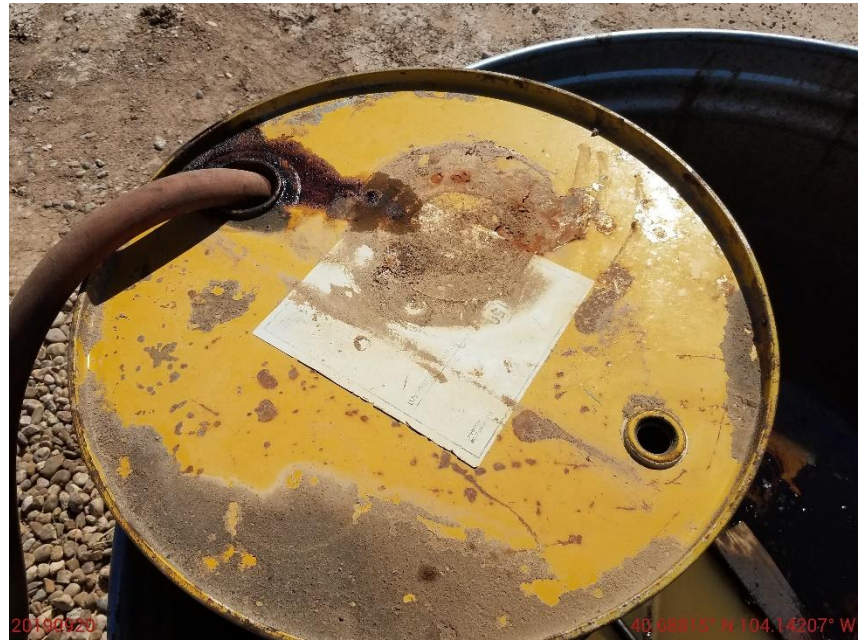
Photo 6: See comments under photo 5.

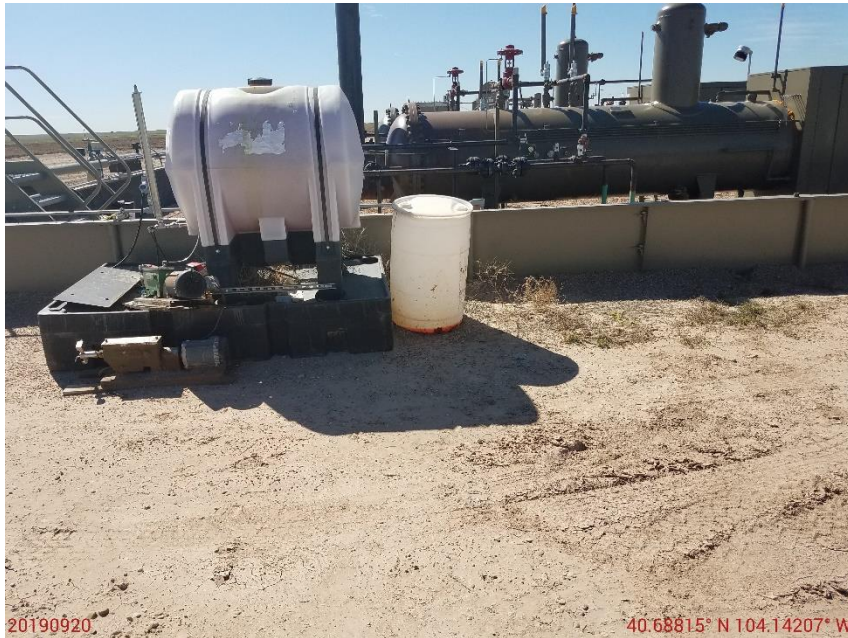
Photo 7: Photo taken from the north end of the location. Photo shows container previously identified has not been placed in secondary containment. Photo also shows required labeling identifying contents remains missing.

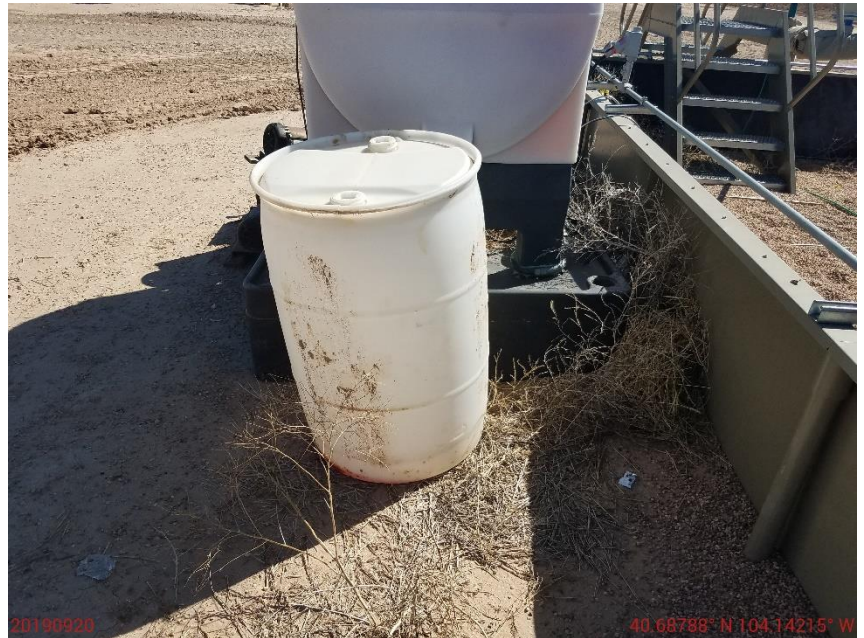
Photo 8: Continued from photo 7

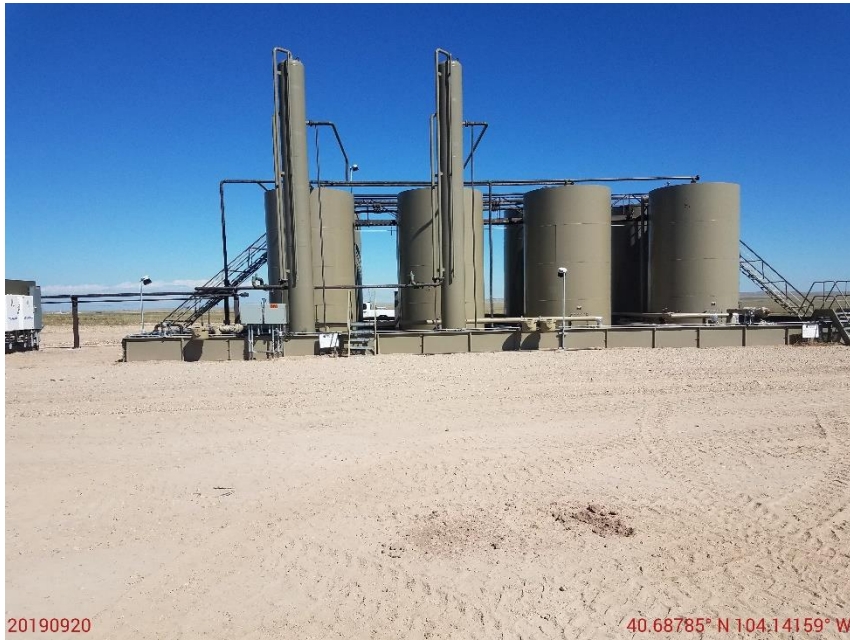
Photo 9: Photo shows required labeling on tanks remains missing.

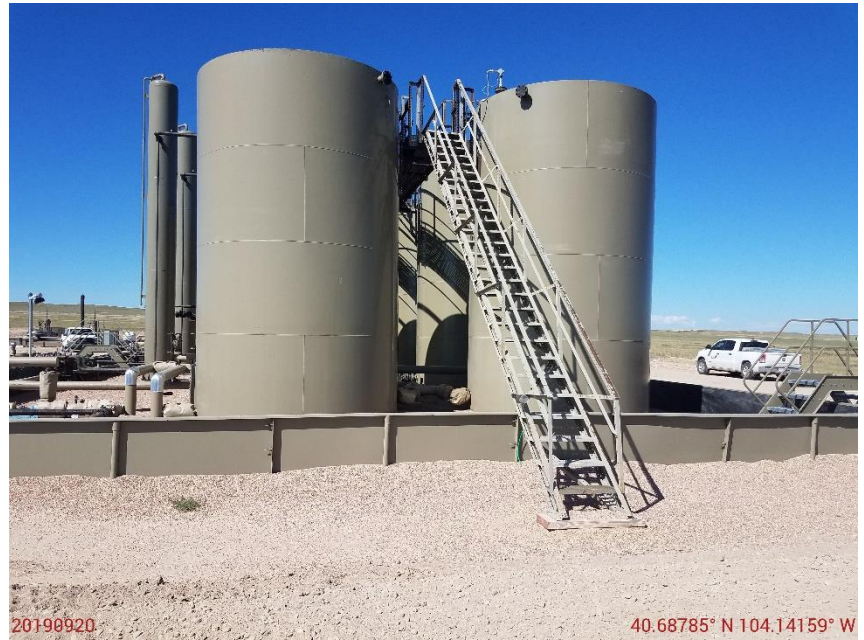
Photo 10: See comments under photo 9.

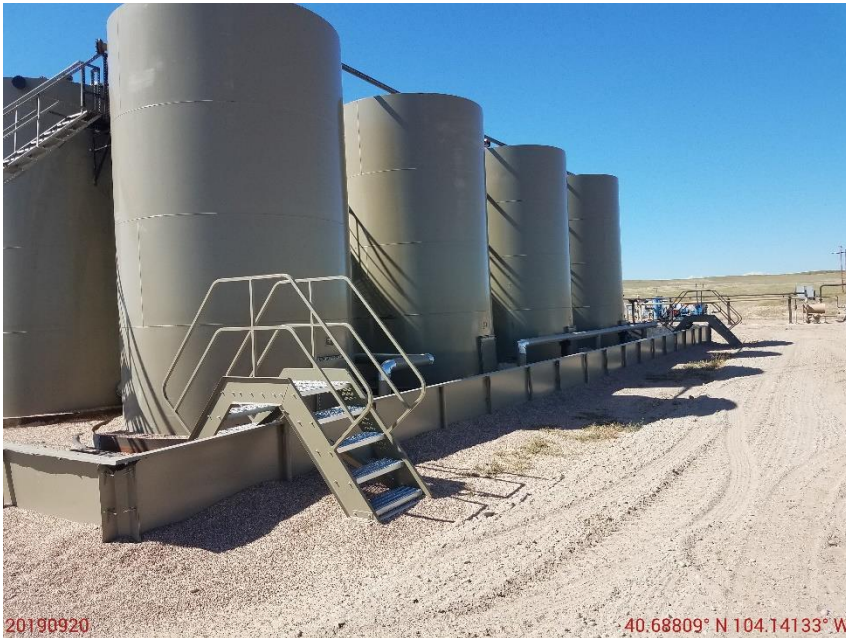
Photo 11: See comments under photo 9..

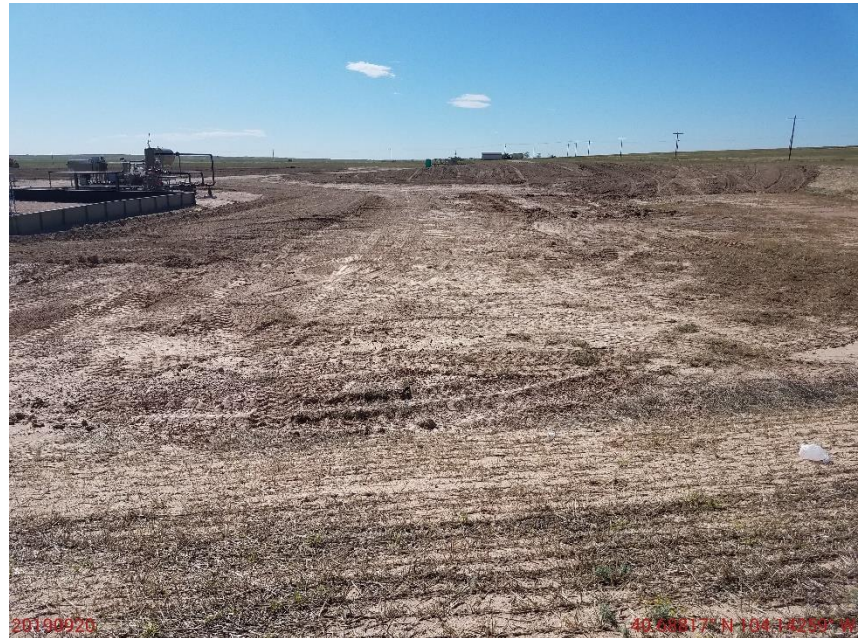
Photo 12: Photo taken from the northwest corner of the location, facing south. Photos show operator appears to be conducted interim reclamation.

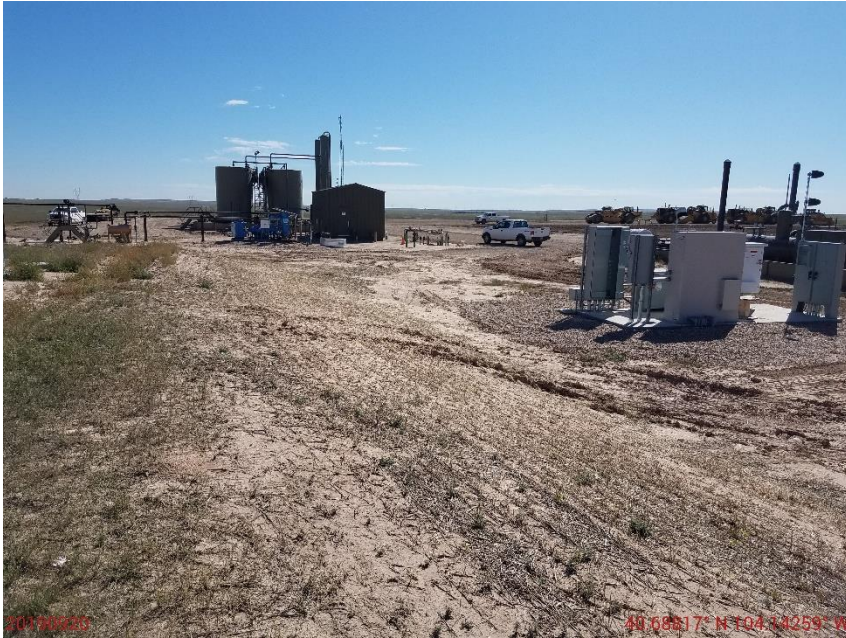
Photo 13: Photo taken from the northwest corner of the location, facing southeast. Photos show operator appears to be conducted interim reclamation.

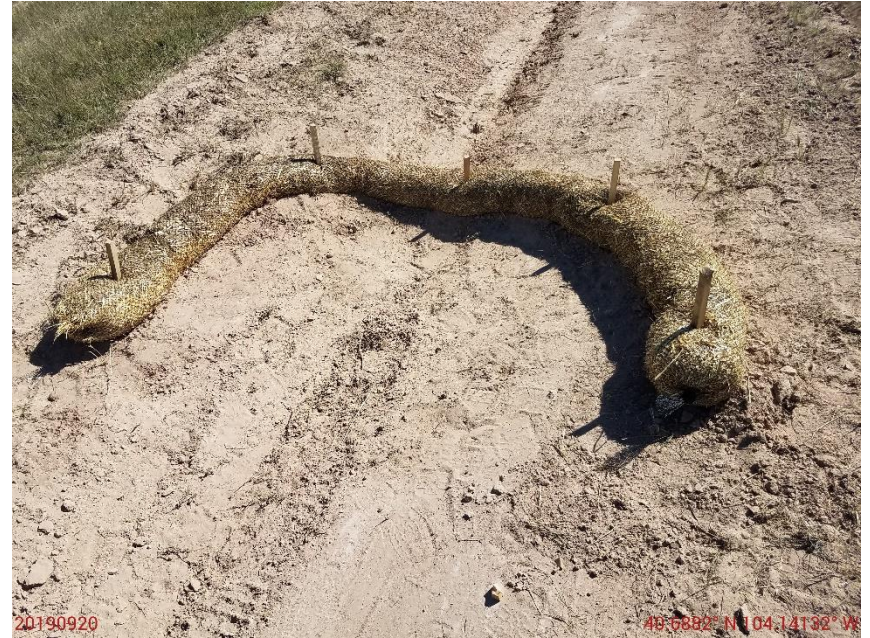
Photo 14: Photo of wattles within ditch. BMP appears to have been installed in accordance with good engineering practices.

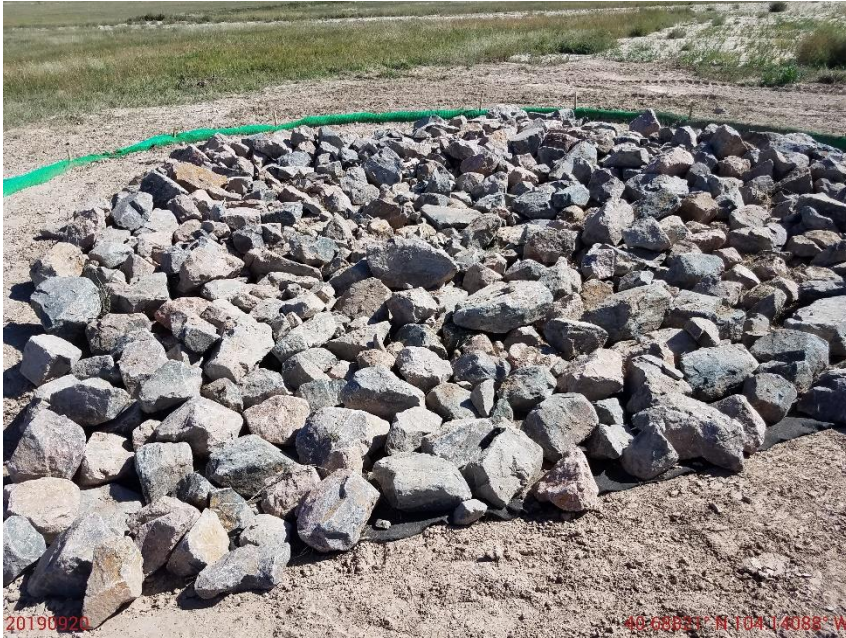
Photo 15: Photo taken from the northeast end of the location. Photo shows operator appears to have installed a sediment trap. BMP appears to be sufficient and proper functioning condition to meet the site's conditions post interim reclamation.

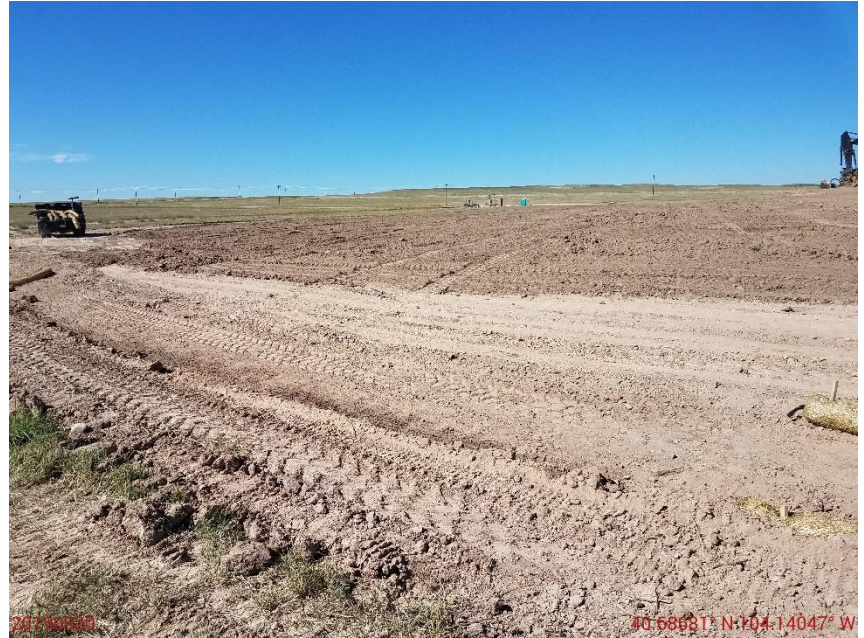
Photo 16: Photo taken from the east end of the location facing west. Photos show operator appears to be conducted interim reclamation.

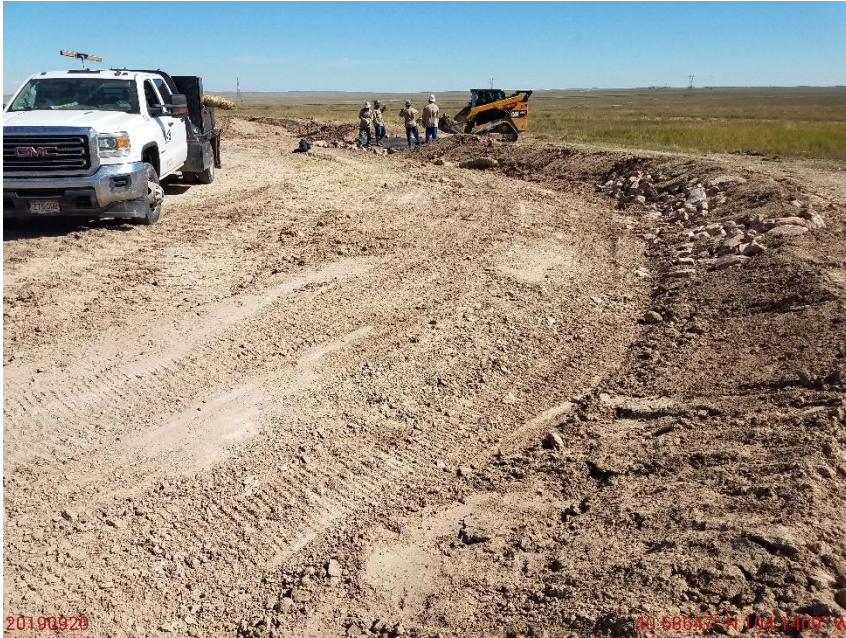
Photo 17: Photo taken from the southeast end of the location. Photo shows contractor on site installing stormwater BMPs.

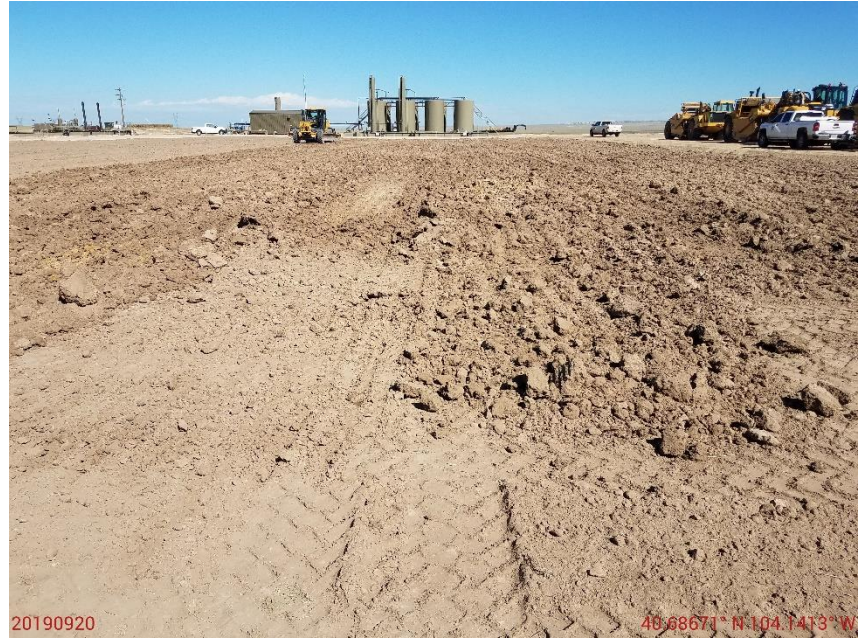
Photo 18: Photo taken from the south end of the location, facing north. Photo shows compaction alleviation in process. Rule 1003.c requires locations to be cross-ripped to a minimum depth of 18 inches. Photo shows location has only been ripped once in one direction. Contractor on site stated that the location was not planned to be cross-ripped in accordance with 1003.c.

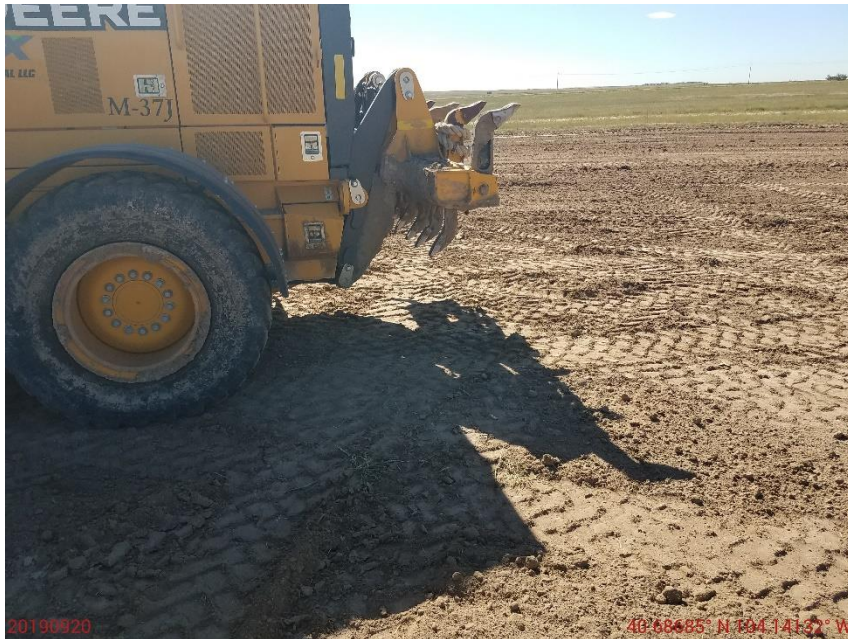
Photo 19: Photo shows ripper teeth used to conduct compaction alleviation. Photo shows used to conduct compaction alleviation are not sufficient in size to rip to a minimum depth of eighteen (18) inches in accordance with 1003.c.

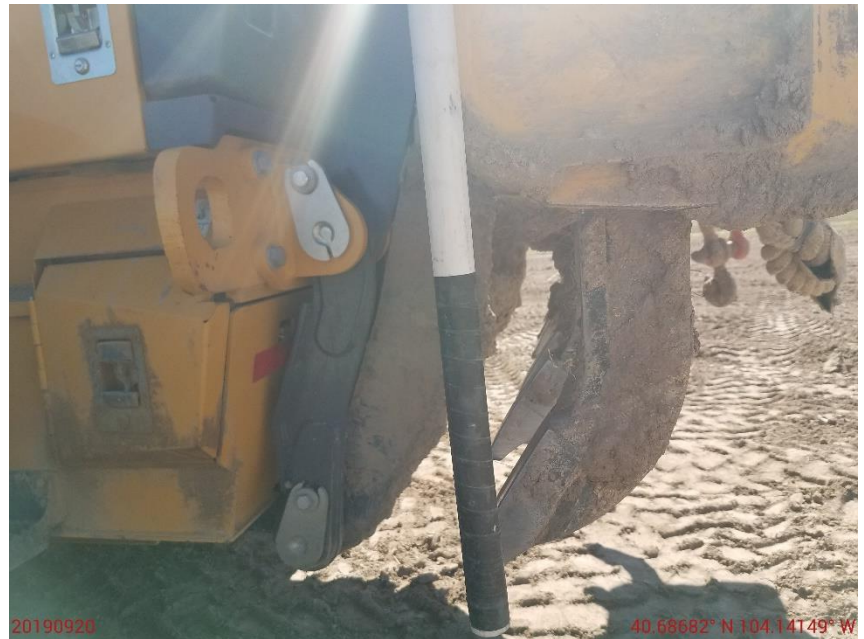
Photo 20: Continued from photo 19. Photo shows teeth used to conduct compaction alleviation was approximately 1 foot in length.
