Stormwater Inspection Report

| Operator: | Laramie Energy, LLC |
| Project: | Horseshoe Canyon Project Area |
| Location: | Mesa 18-10E Pad |

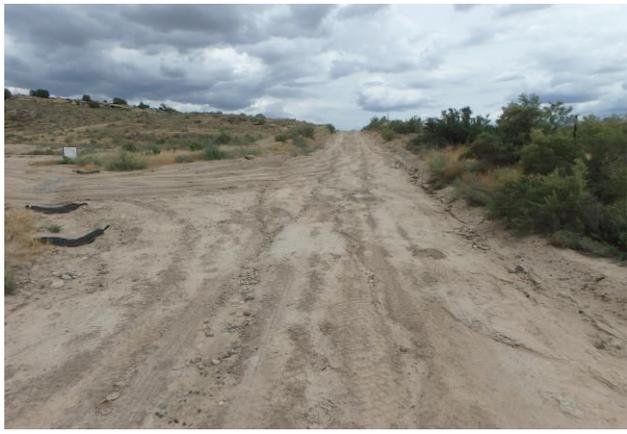
Photo 1

Erosion on Unaffiliated Access Road

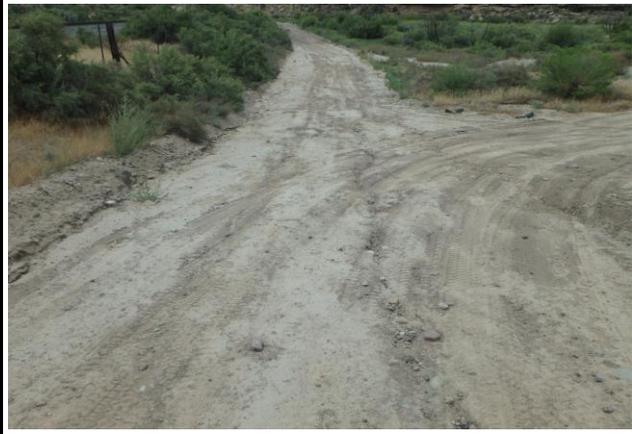
Photo 2

Erosion on Unaffiliated Access Road
