**Inspection Photos**  
**Location Name: DYER-66N64W /2NENW**  
**Location #: 302248**

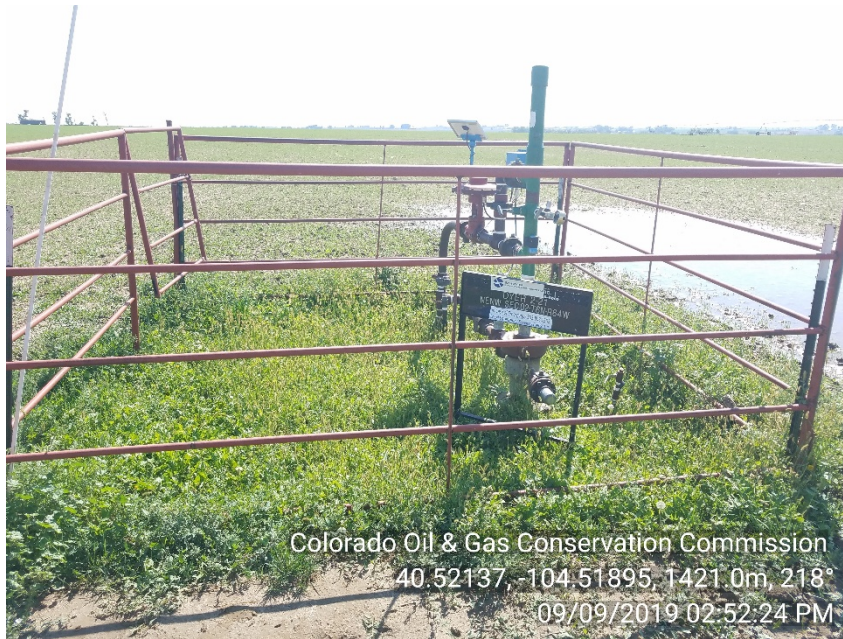
**Photo #1**  
**Dyer 2-21 (05-123-28012) Wellsite**  
**Shut-In | SI**  
*prior insp.*

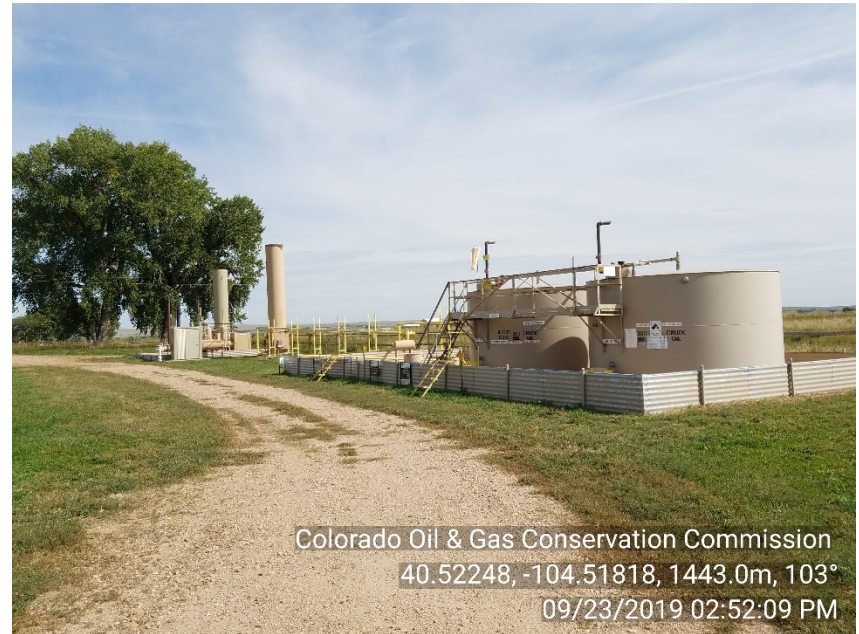
**Photo #2**  
**Dyer 2-21, 2-24, 2-25 Battery**  
**Shut-down | Inactive**

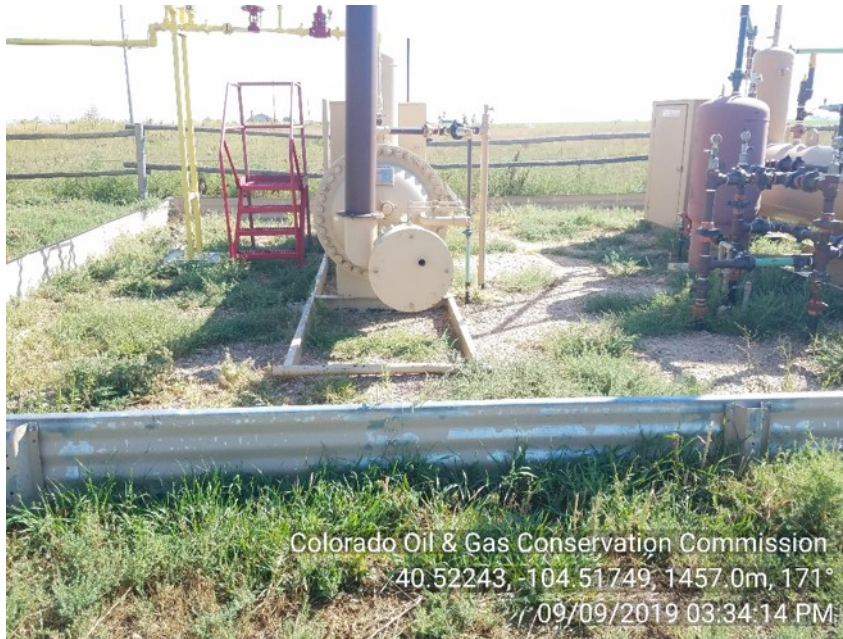
**Photo #3**  
**Dyer 2-21, 2-24, 2-25 Separators**  
**Shut-down | Inactive**  
**Weeds**  
*prior insp.*

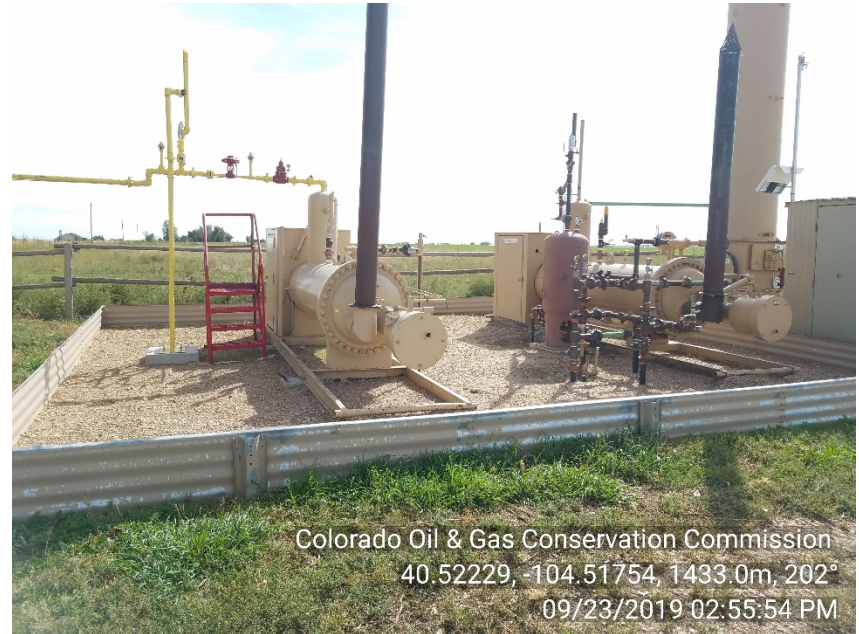
**Photo #4**  
**Dyer 2-21, 2-24, 2-25 Separators**  
**Shut-down | Inactive**  
**Weeds appear mitigated**
