Inspection Photos

API: 05-071-09062

Operator: ARP PRODUCTION COMPANY

Inspection Date: 9/23/2019

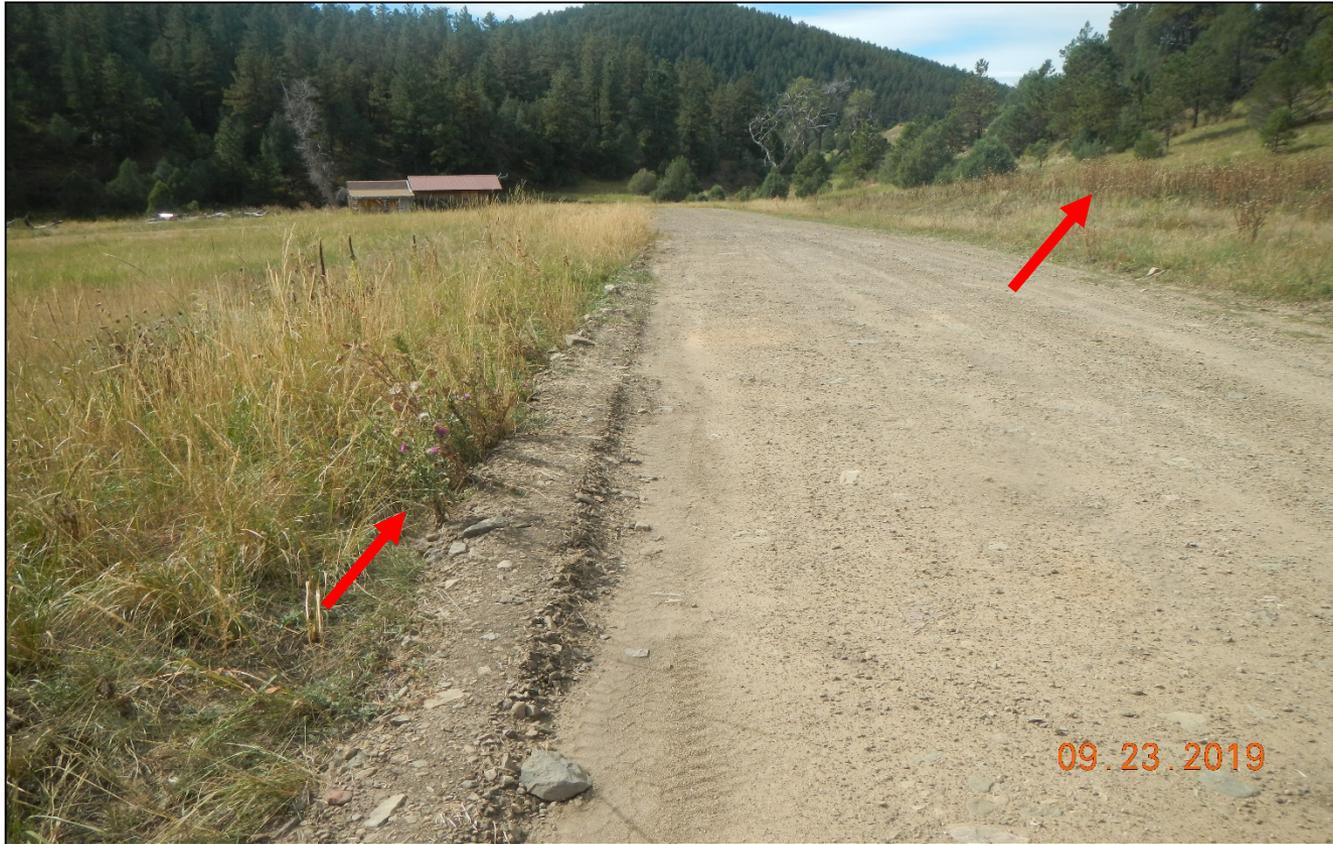
Photo 1. There is List B noxious weeds growing along the main & access road to the location. (Musk thistle shown in photo) There were a few weeds wilting but most were not treated. Corrective action was not completed since previous inspection.

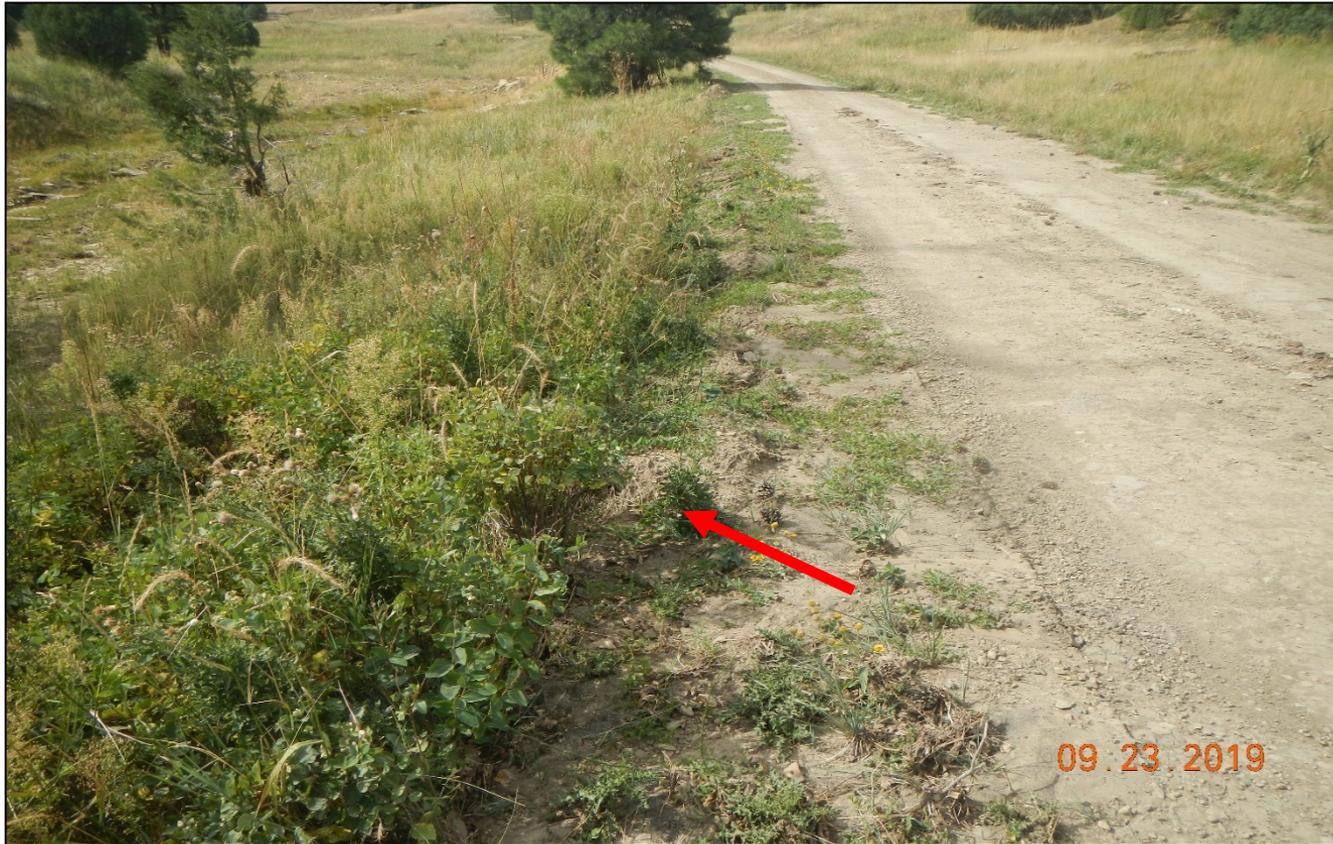
Photo 2. There is List B noxious weeds growing along the main & access road to the location. (Canada thistle shown in photo) Corrective action was not completed since previous inspection.

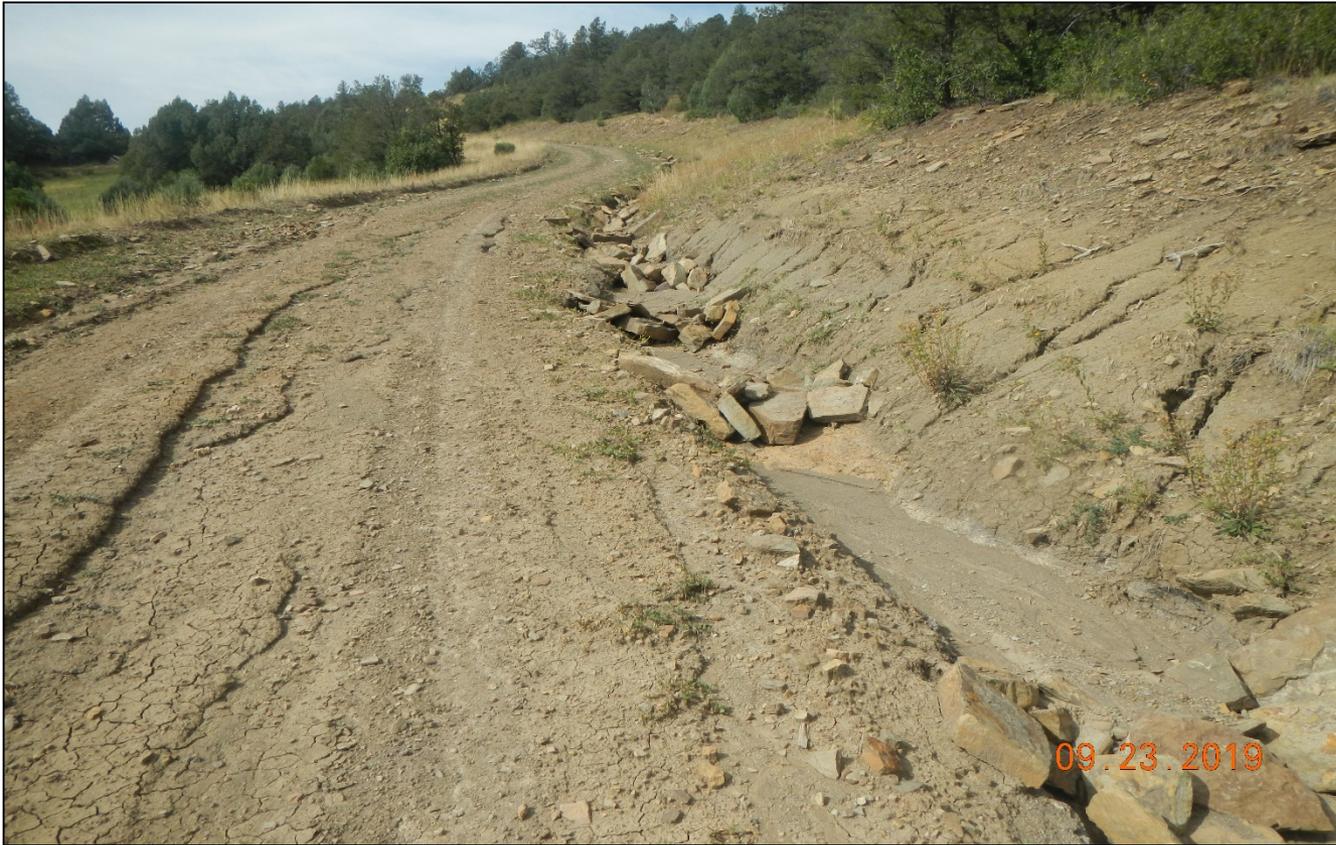
Photo 3. Sediment has filled into the check dams. Erosion is occurring down and along the side of the road. Corrective action was not properly completed since previous inspection.

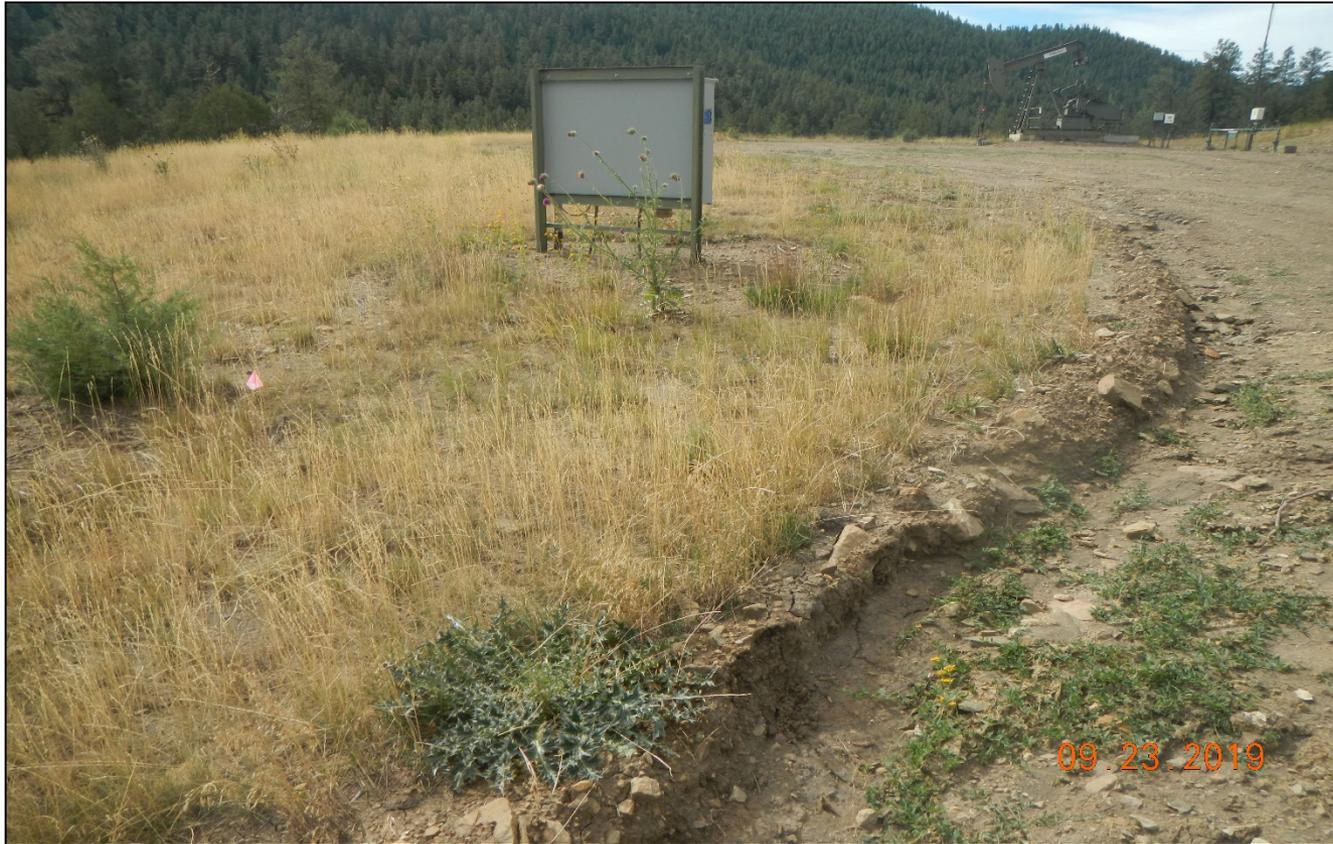
Photo 4. Facing southwest toward the location. There are numerous noxious weeds at the location. Corrective action was not completed since previous inspection.

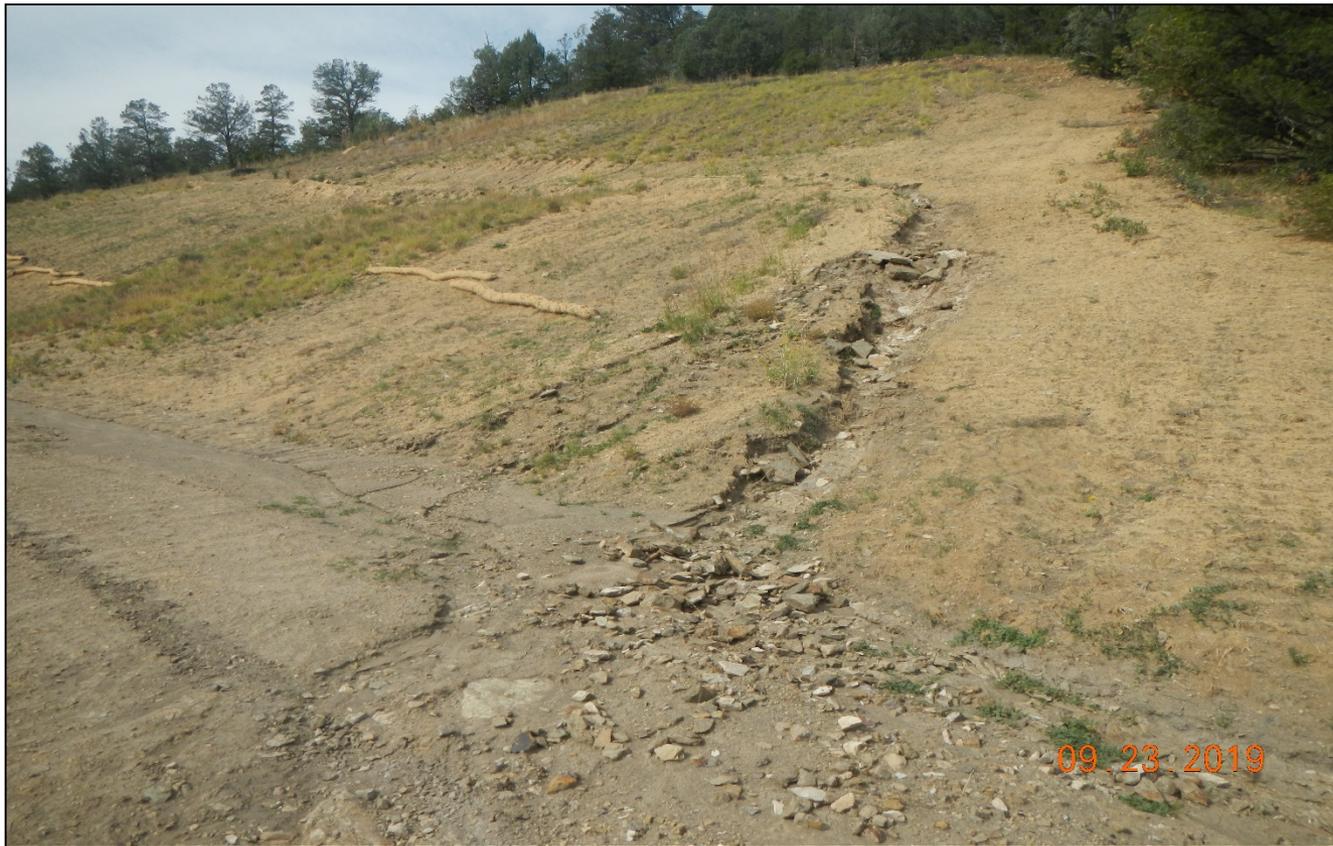
Photo 5. Erosion is occurring down the cut slope from the diversion ditch.

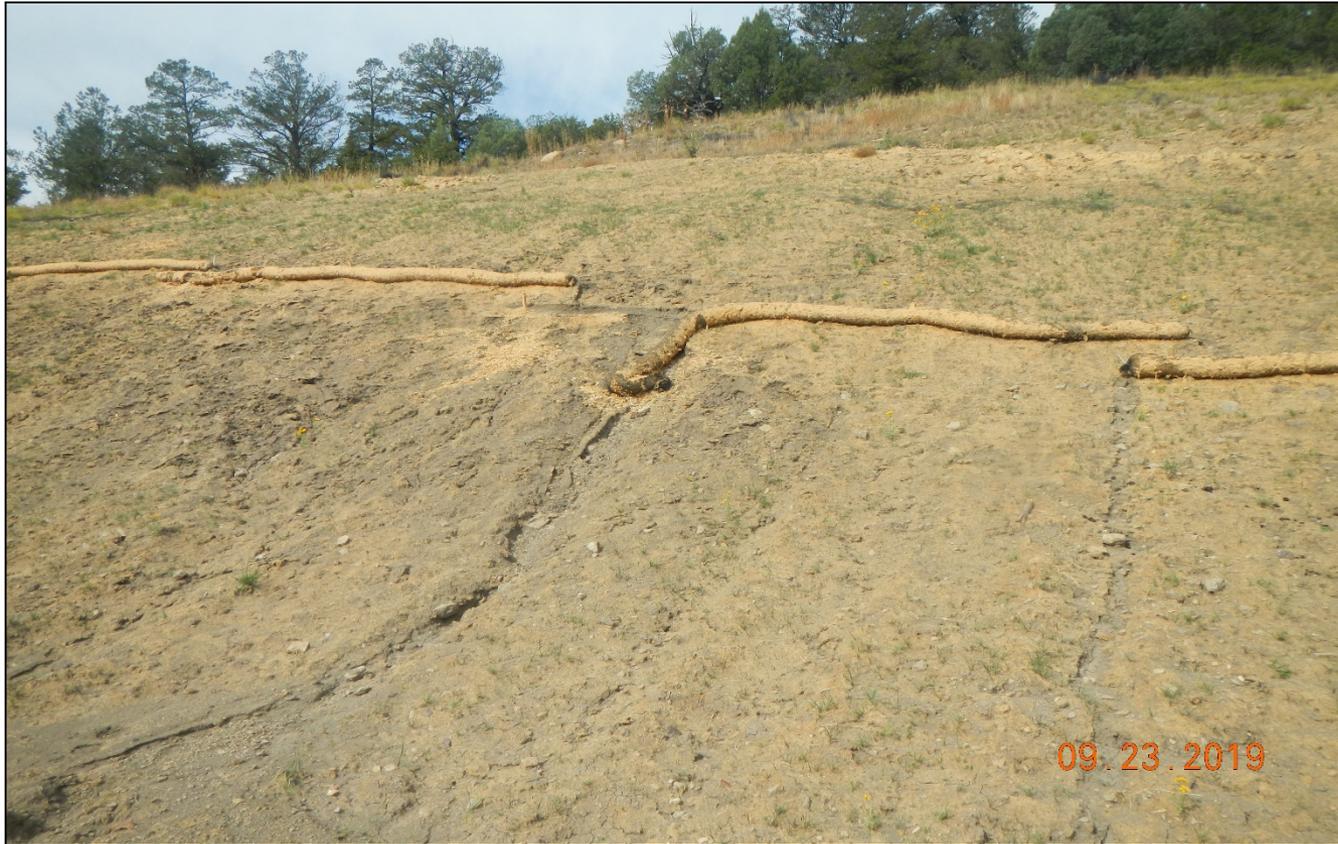
Photo 6. Wattles are displaced along the cut slope.

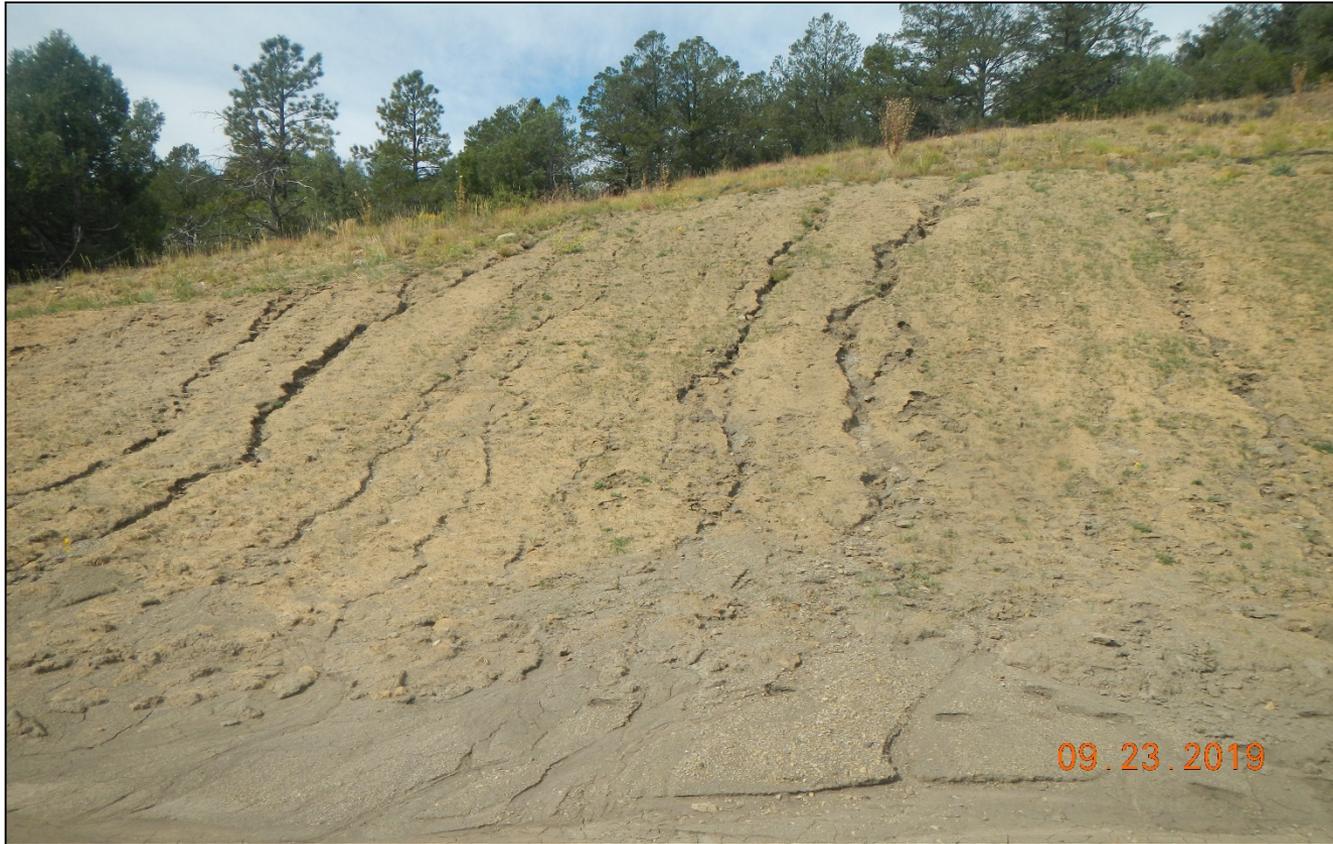
Photo 7. There are erosion channels developing along the cut slope which need to be repaired.

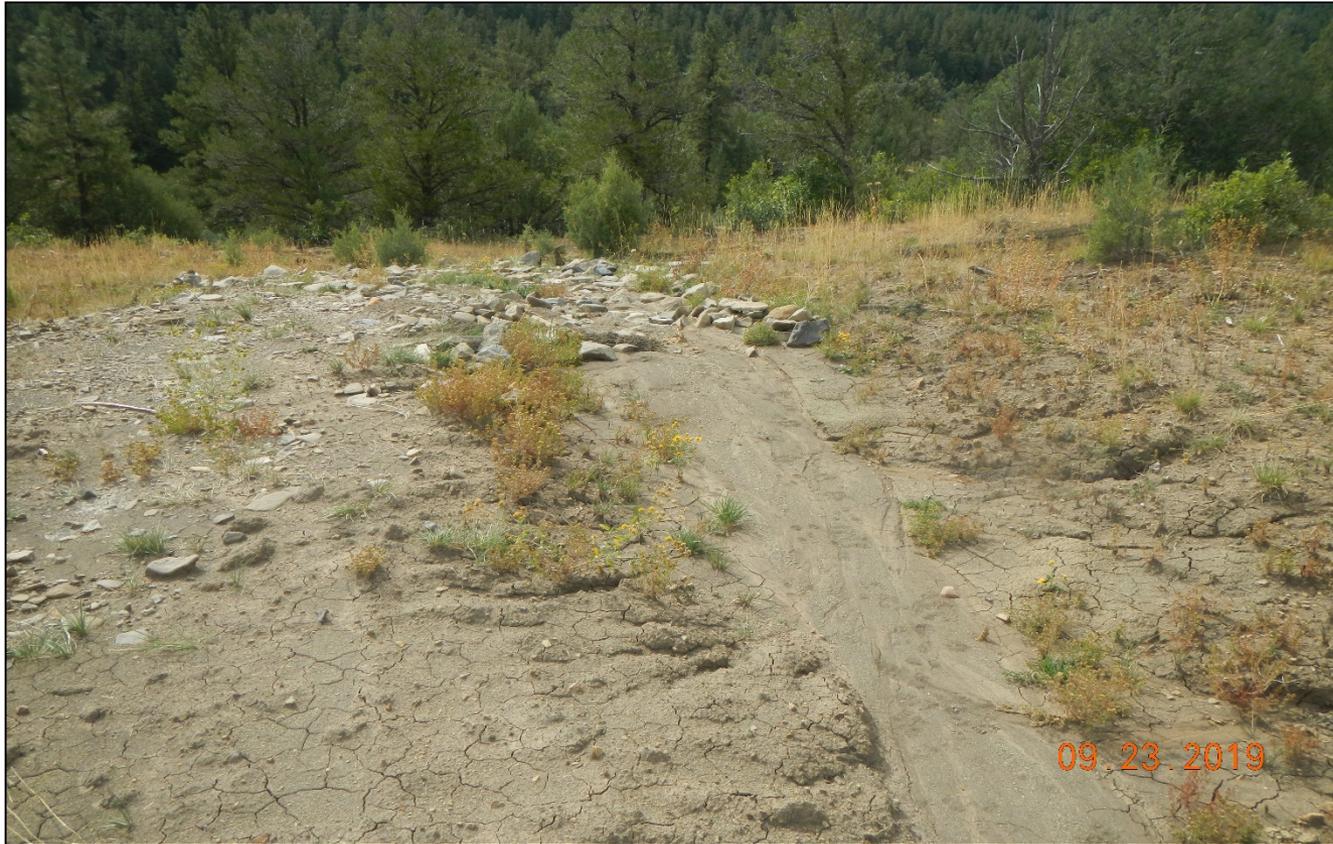
Photo 8. Rock rip/rap was installed at the end of the diversion ditch however, sediment has already filled in the diversion ditch from erosion of the cut slope. Corrective action was not completed since previous inspection.

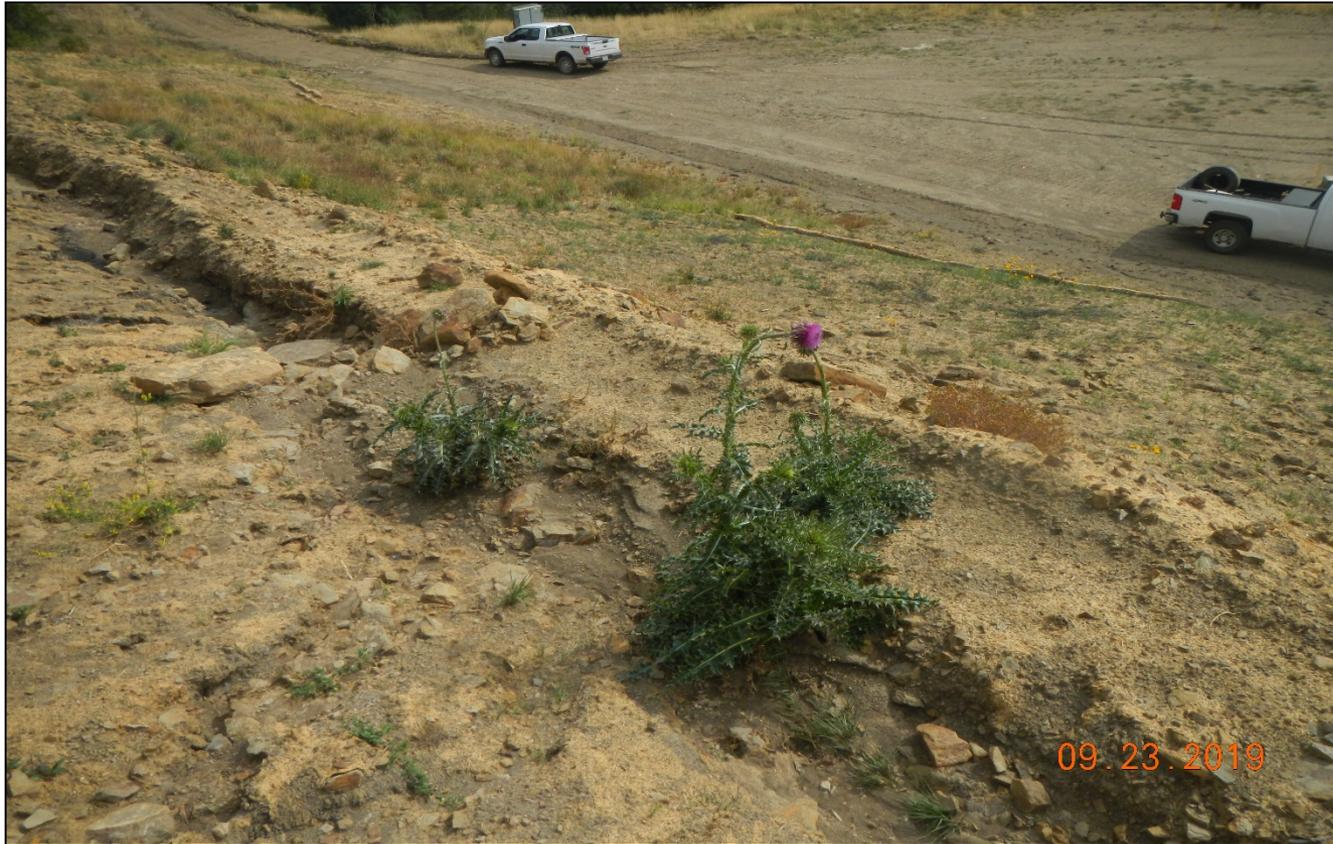
Photo 9. There are noxious weeds (Musk thistle) growing at the top of the cut slope. Corrective action was not completed since previous inspection.

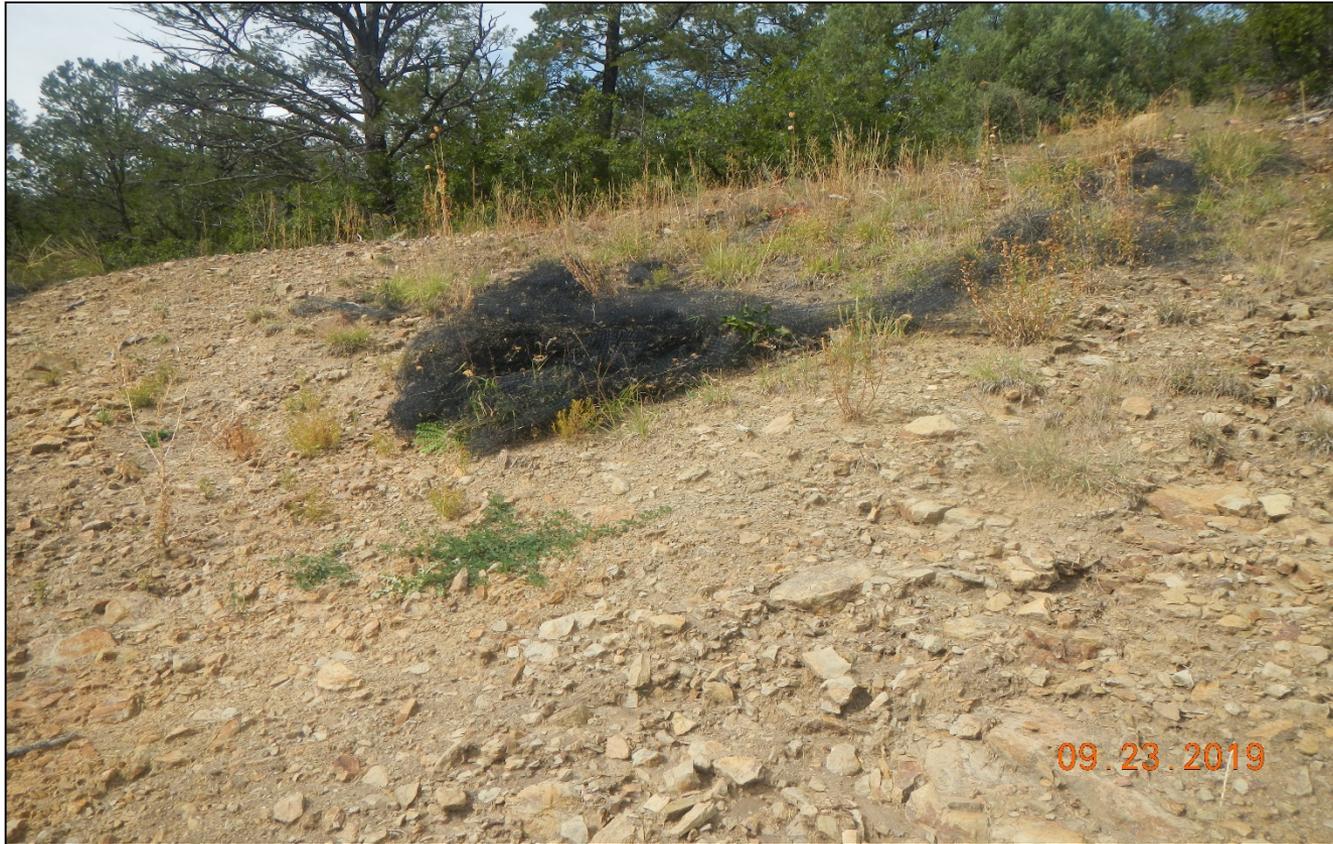
Photo 10. There is plastic netting that remains in a pile at the top of the cut slope. This is debris that must be removed.
