Inspection Photos

API: 05-071-07915

Operator: ARP PRODUCTION COMPANY
WAPITI OPERATING LLC

Inspection Date: 9/23/2019

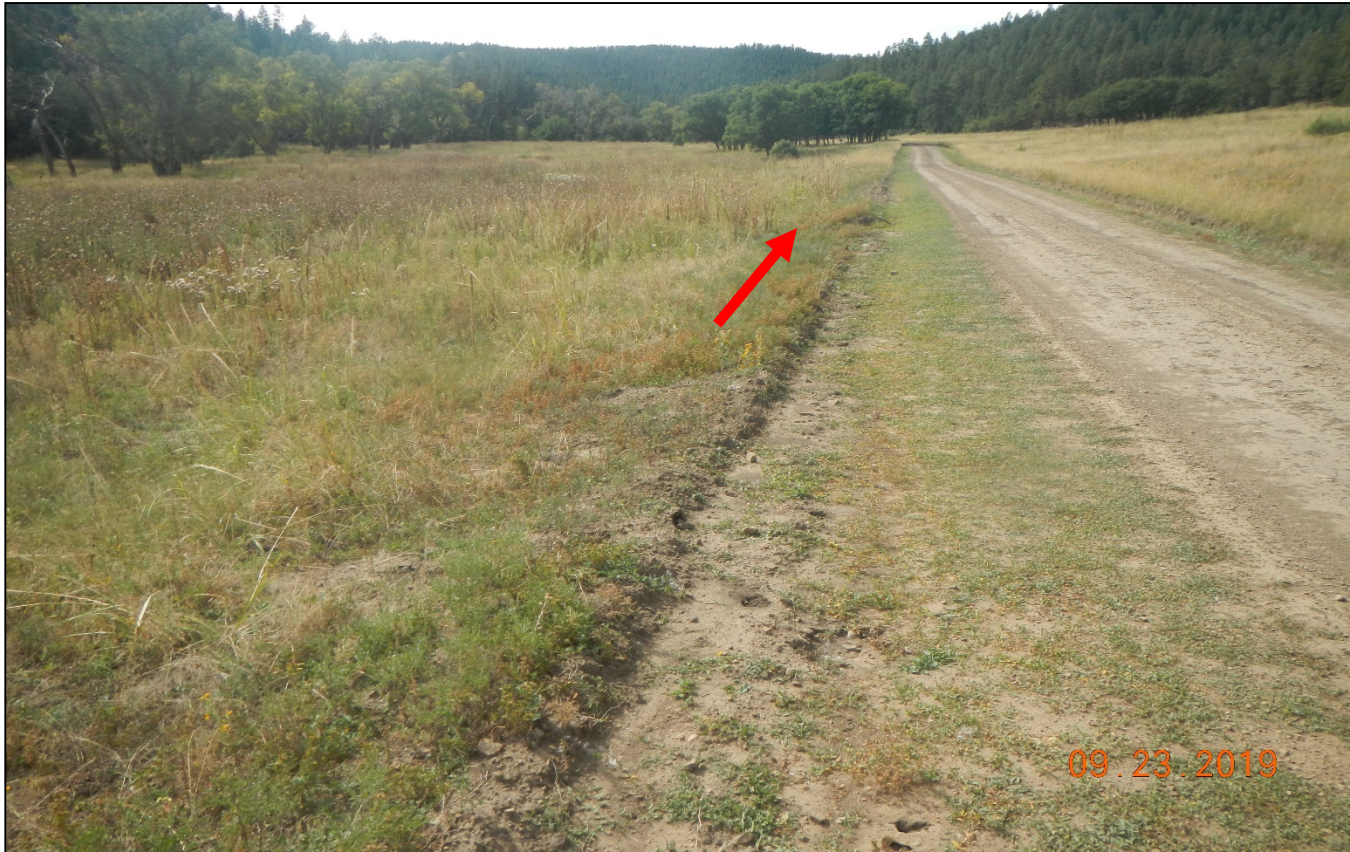
Photo 1. There are noxious weeds along the main road which have not been controlled. (Musk thistle)

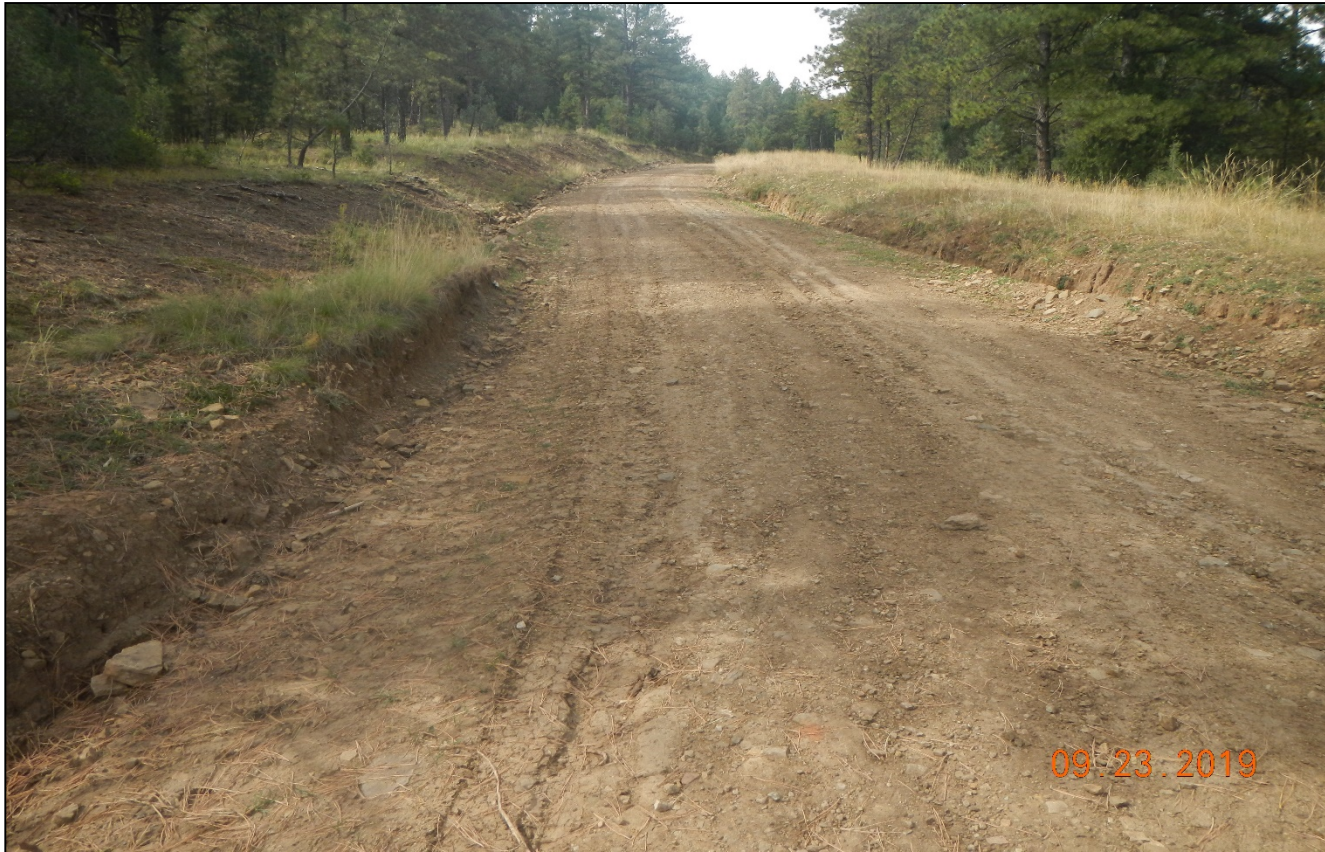
Photo 1. The road has been graded to allow stormwater to drain off the road.

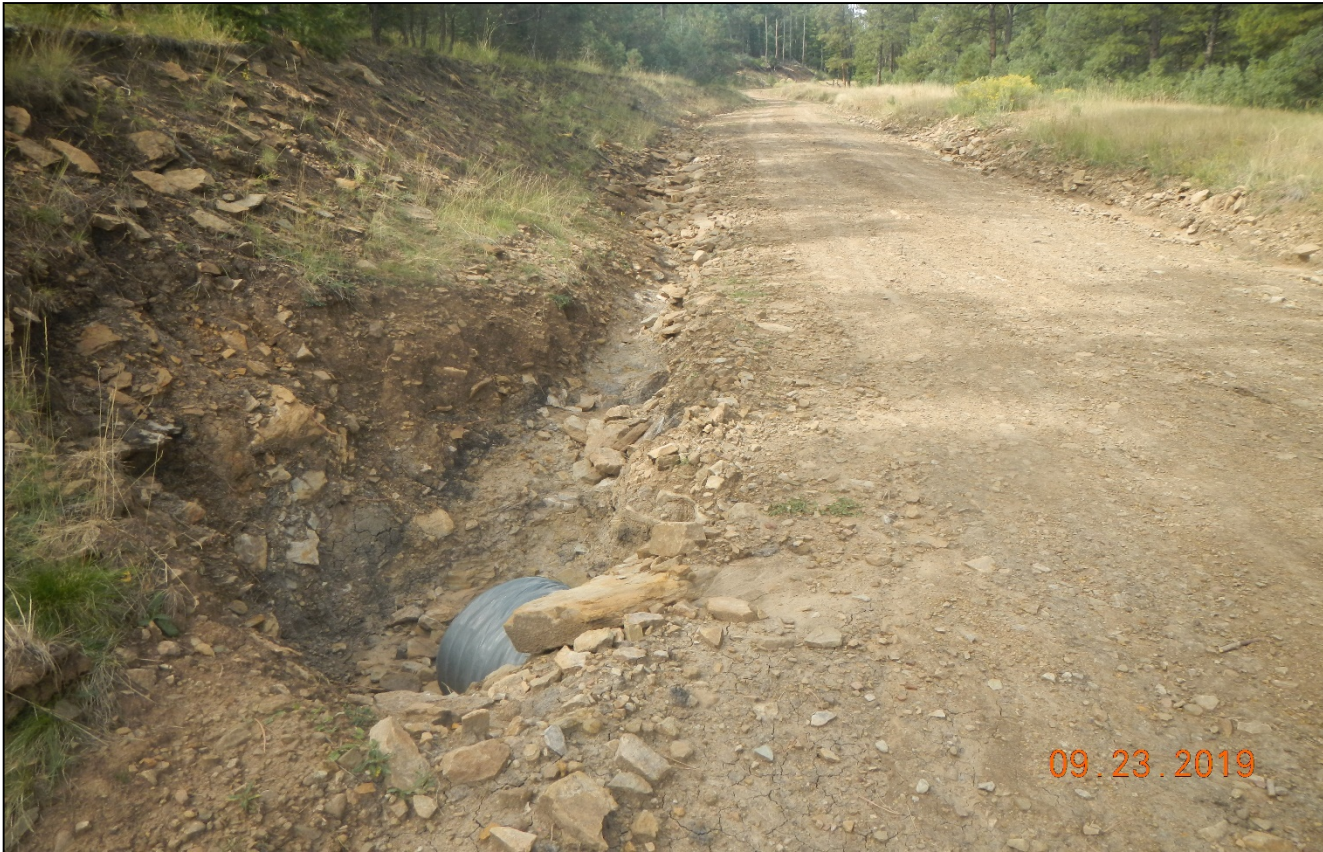
Photo 3. Culvert has been maintained.

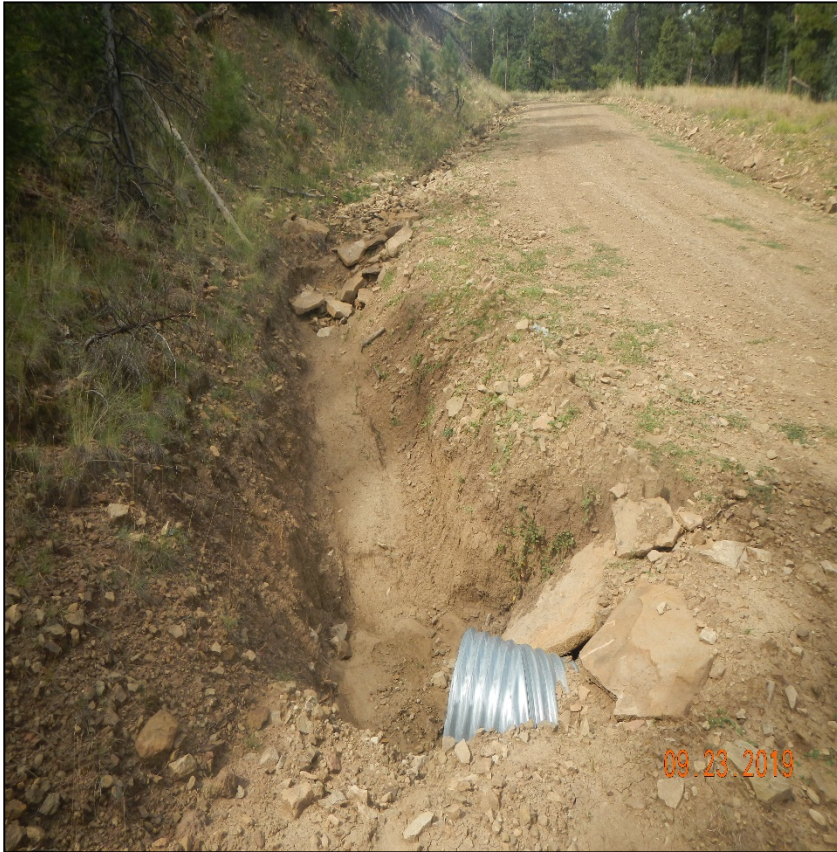
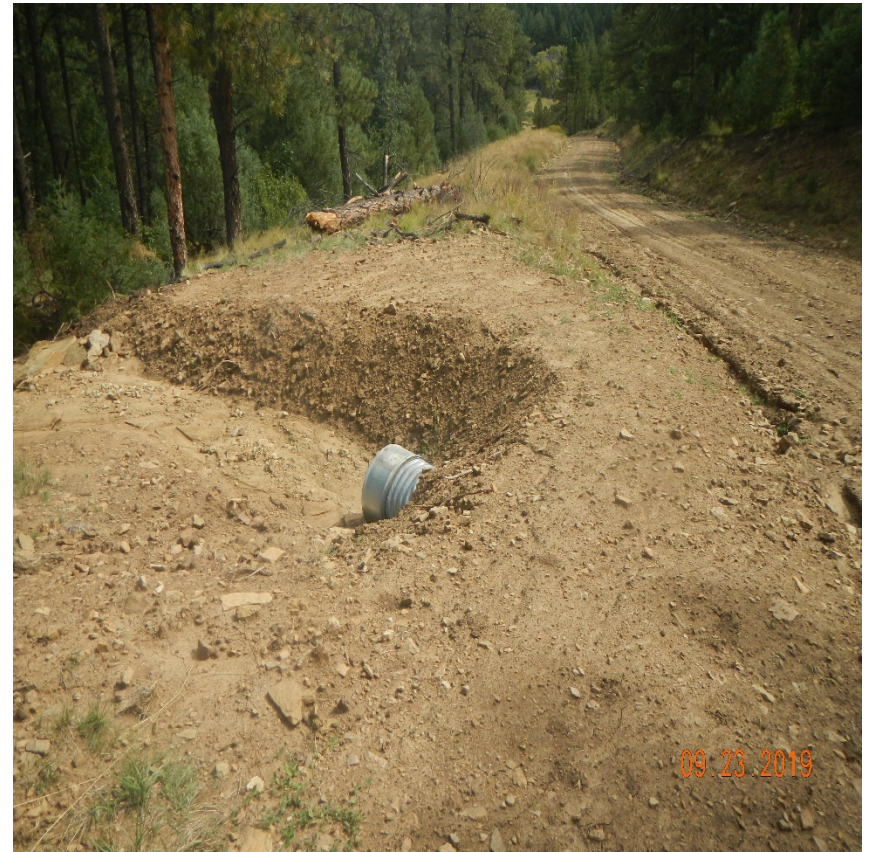
Photo 4. It appears a new culvert was installed at this point in the road. There is no outlet protection which is shown in the right photo. Disturbance area must be reclaimed.

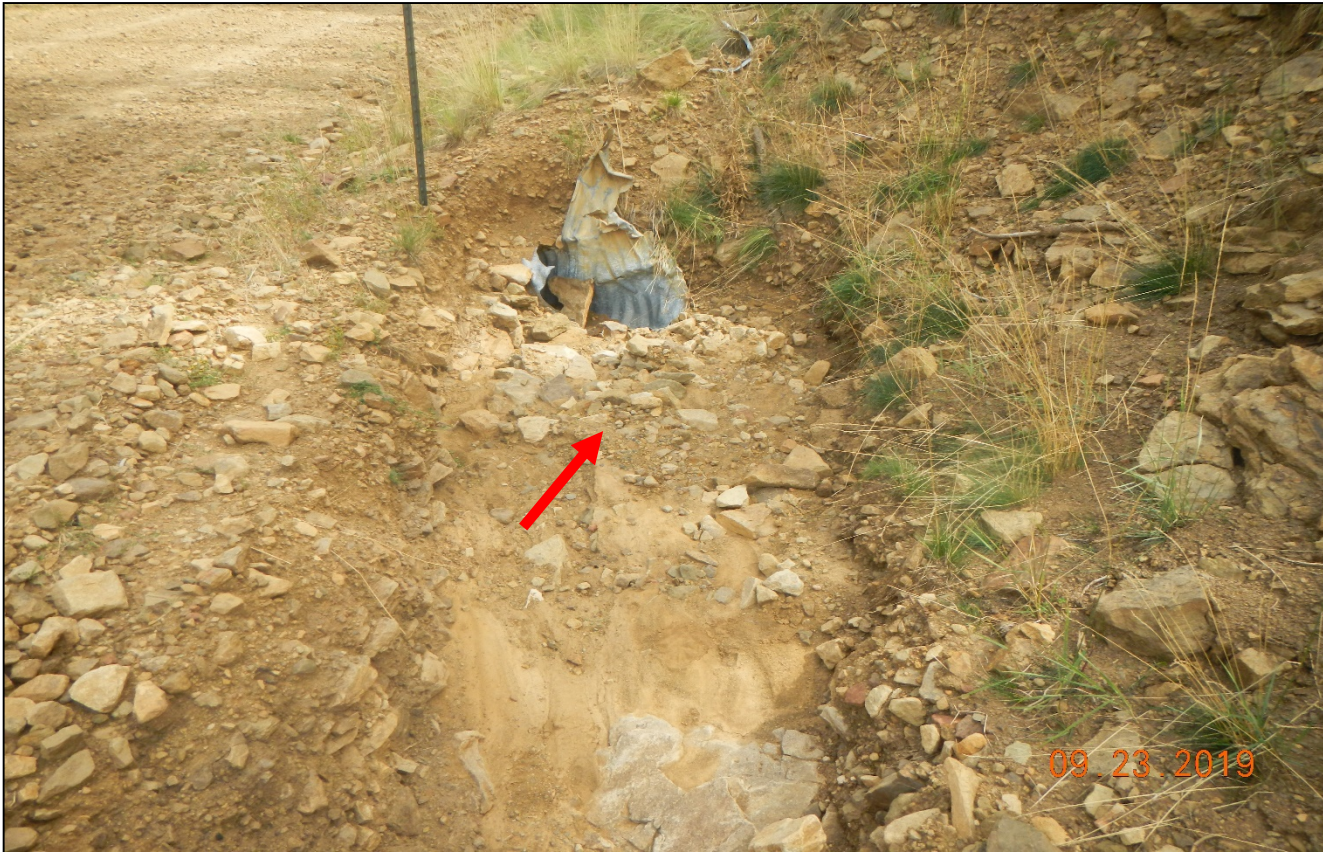
Photo 5. This culvert is partially filled in with sediment and damaged.

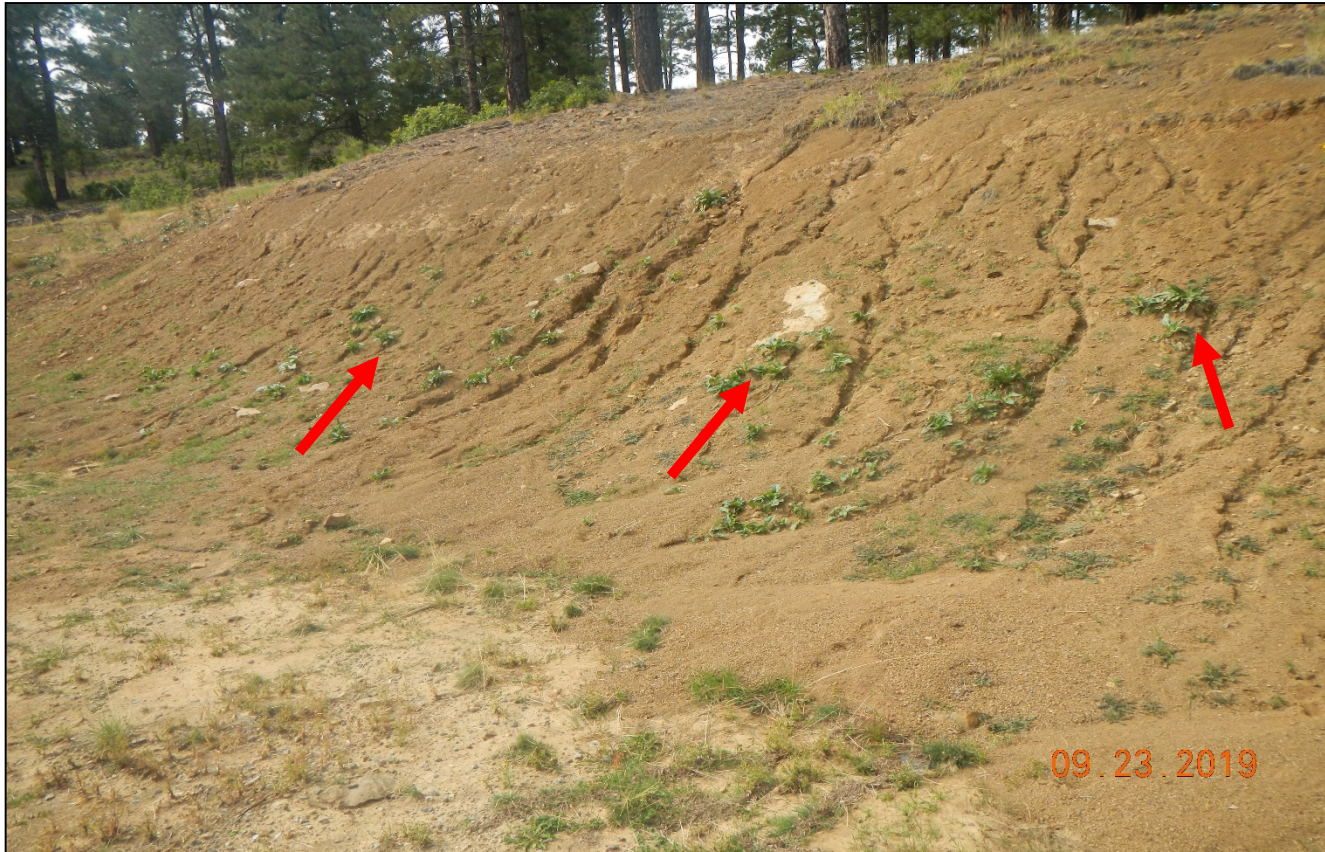
Photo 7. Facing toward the cut slope. Red arrow points to List B noxious weeds. The cut slope is not stabilized. Corrective action was not completed since previous inspection.

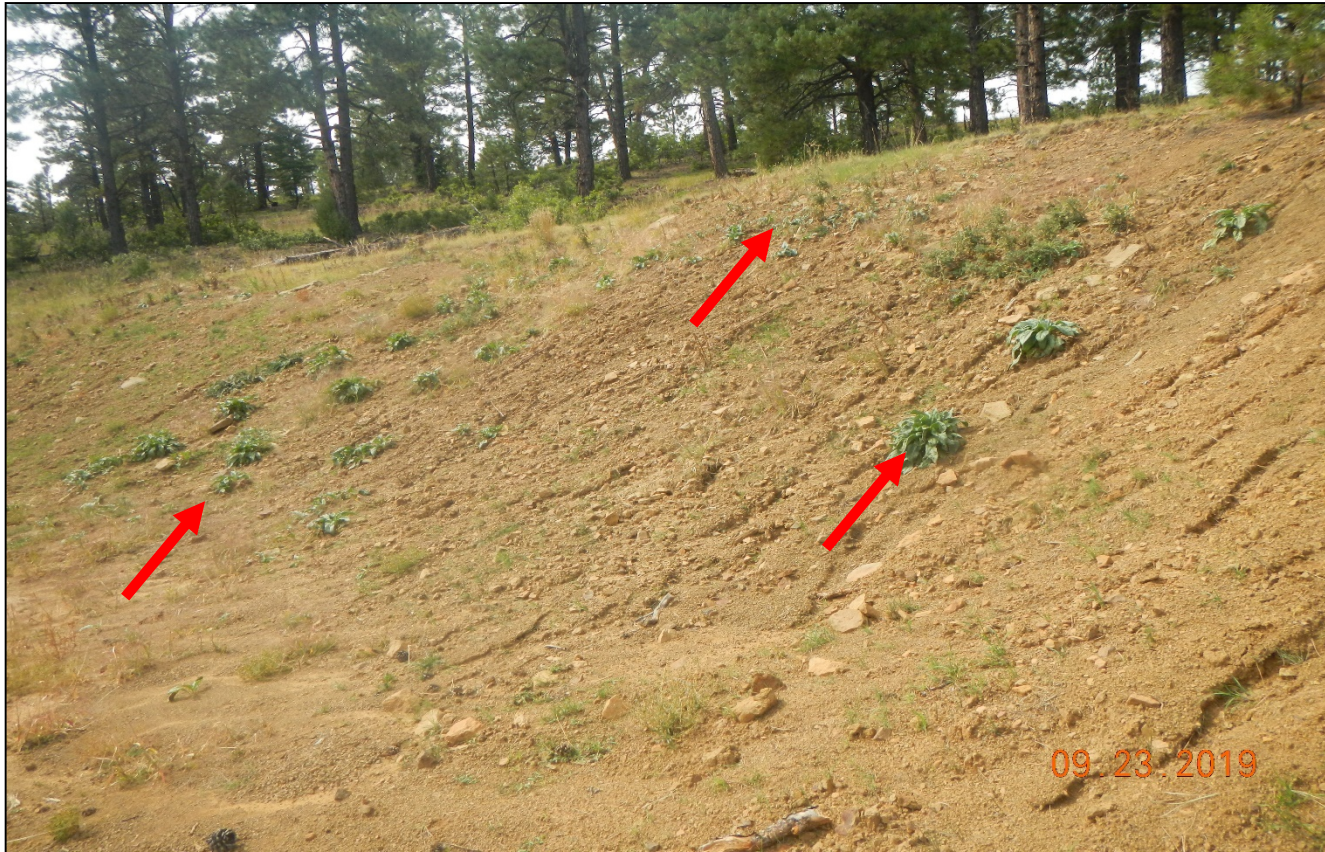
Photo 8. Facing toward the southwest cut slope. Red arrow points to List B noxious weeds. The cut slope is not stabilized. Corrective action was not completed since previous inspection.
