Inspection Photos

API: 05-071-09051

Operator: ARP PRODUCTION COMPANY
WAPITI OPERATING LLC

Inspection Date: 9/23/2019

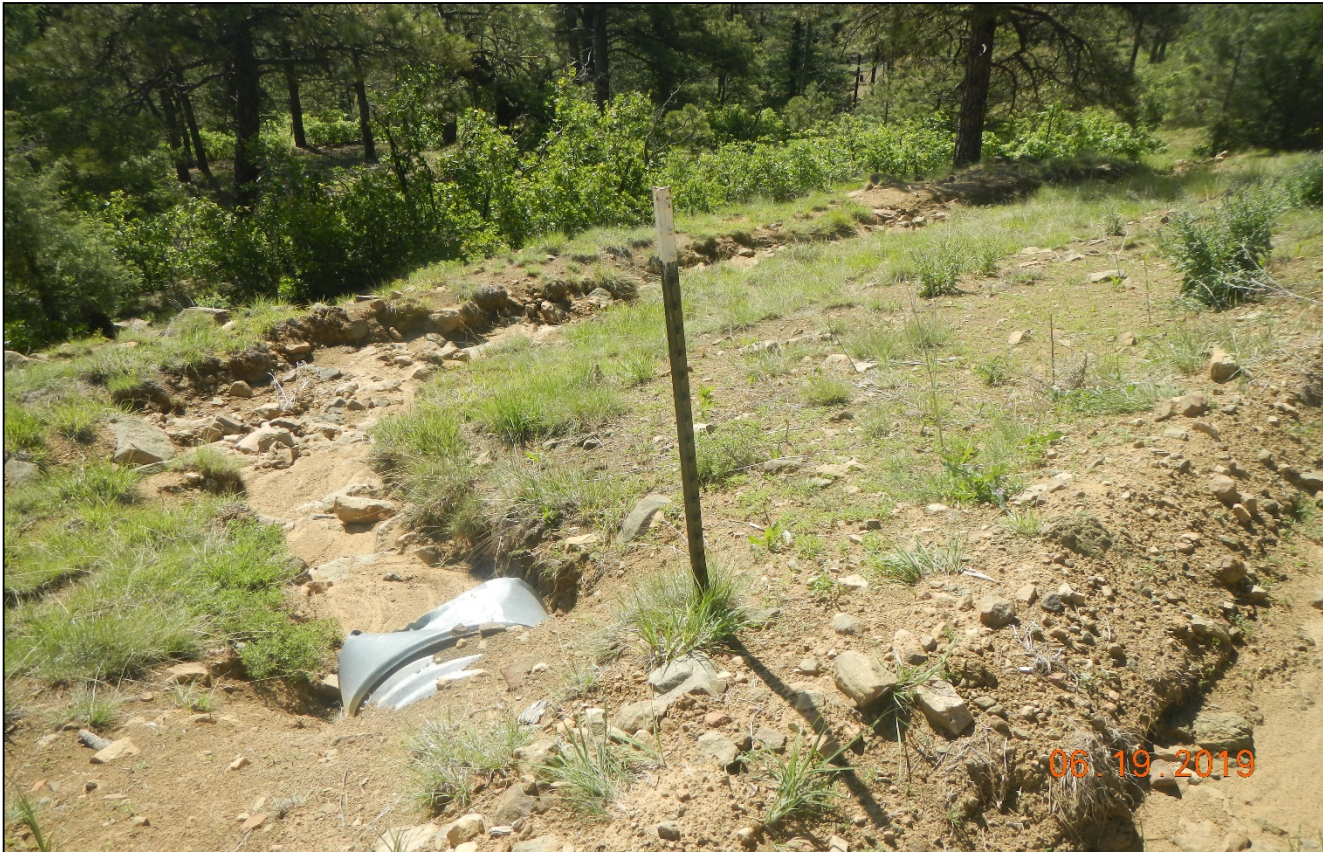
Photo 1. The outlet culvert at the location has no BMP's to prevent erosion. This photo was from previous inspection and was not inspected.

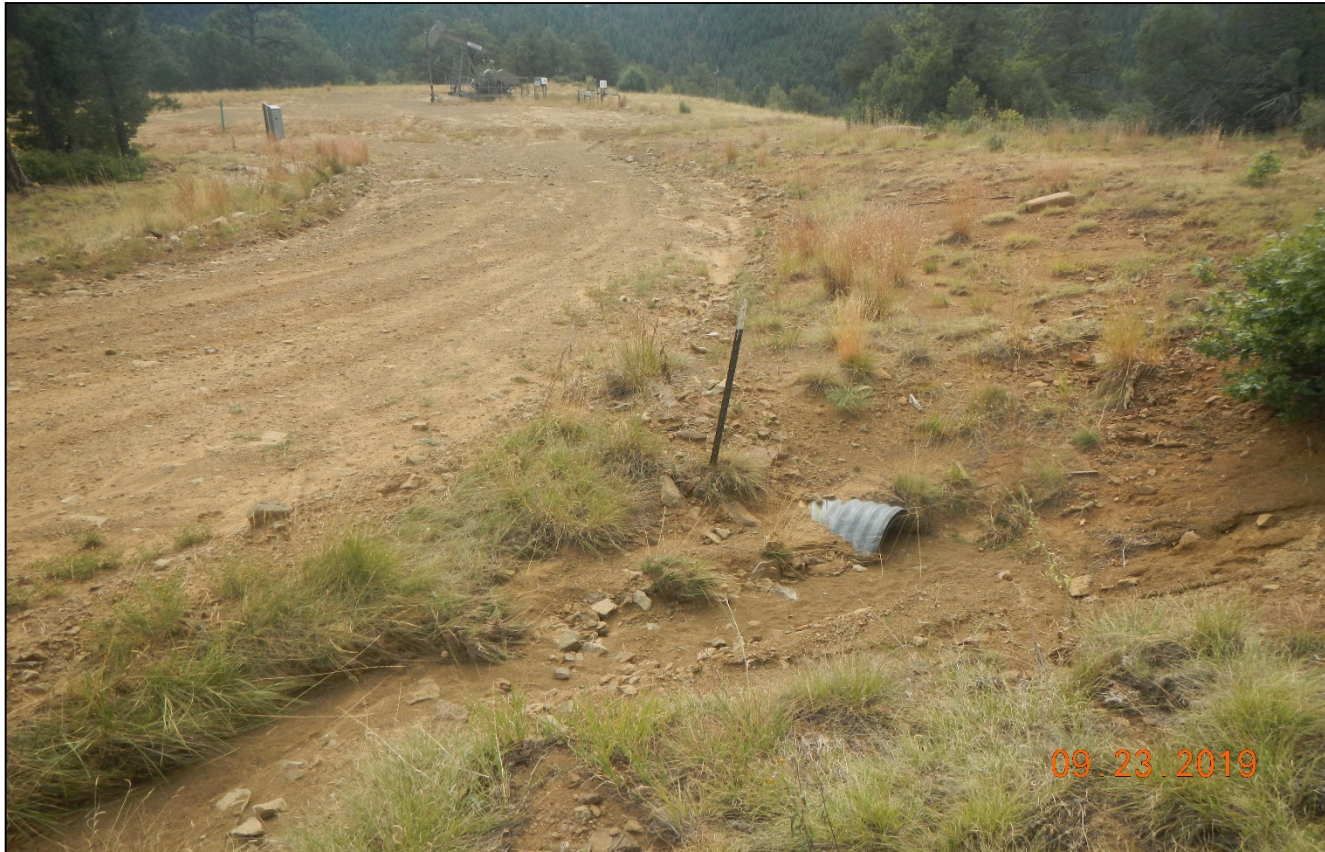
Photo 1. The inlet culvert near the location is partially filled in with sediment.

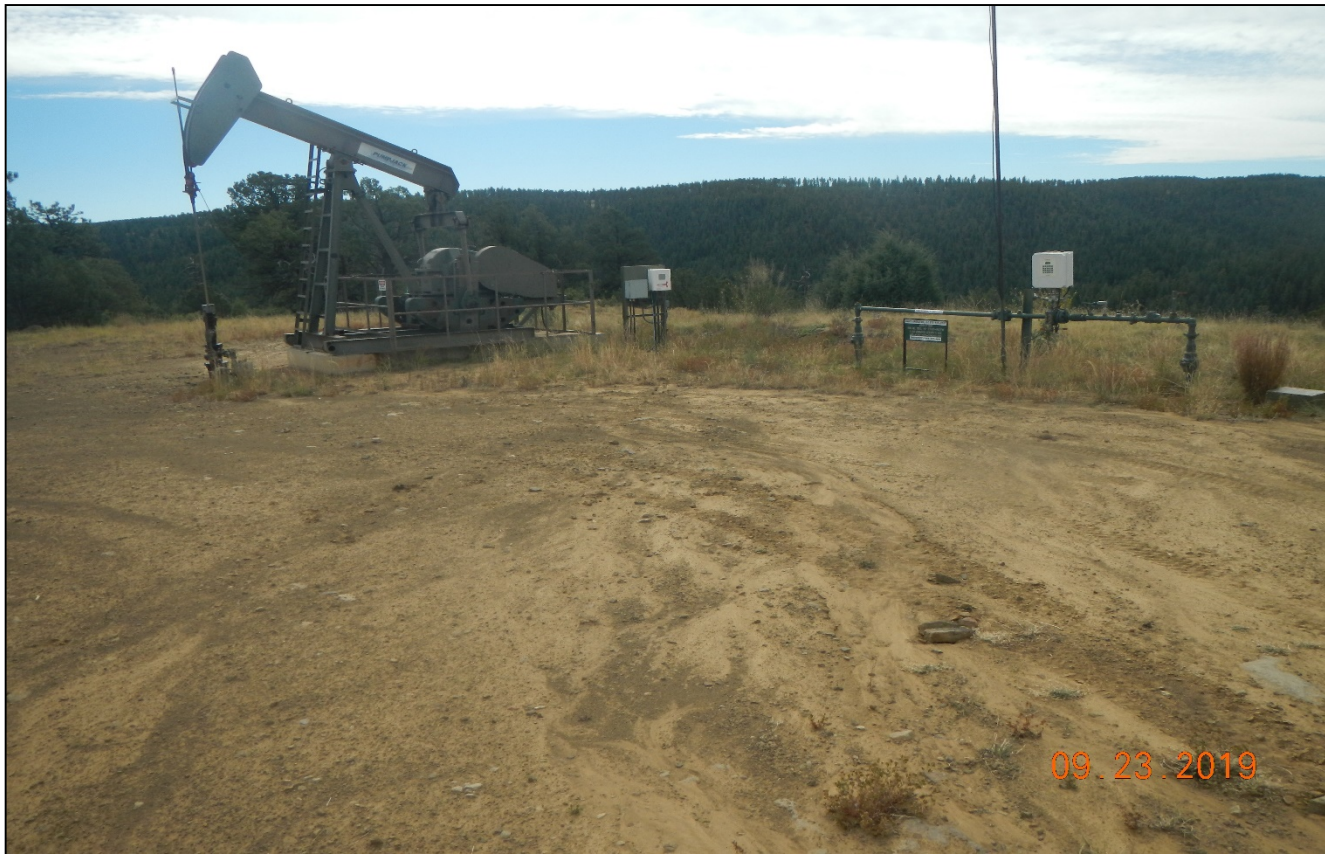
Photo 3. Facing toward the pumpjack.

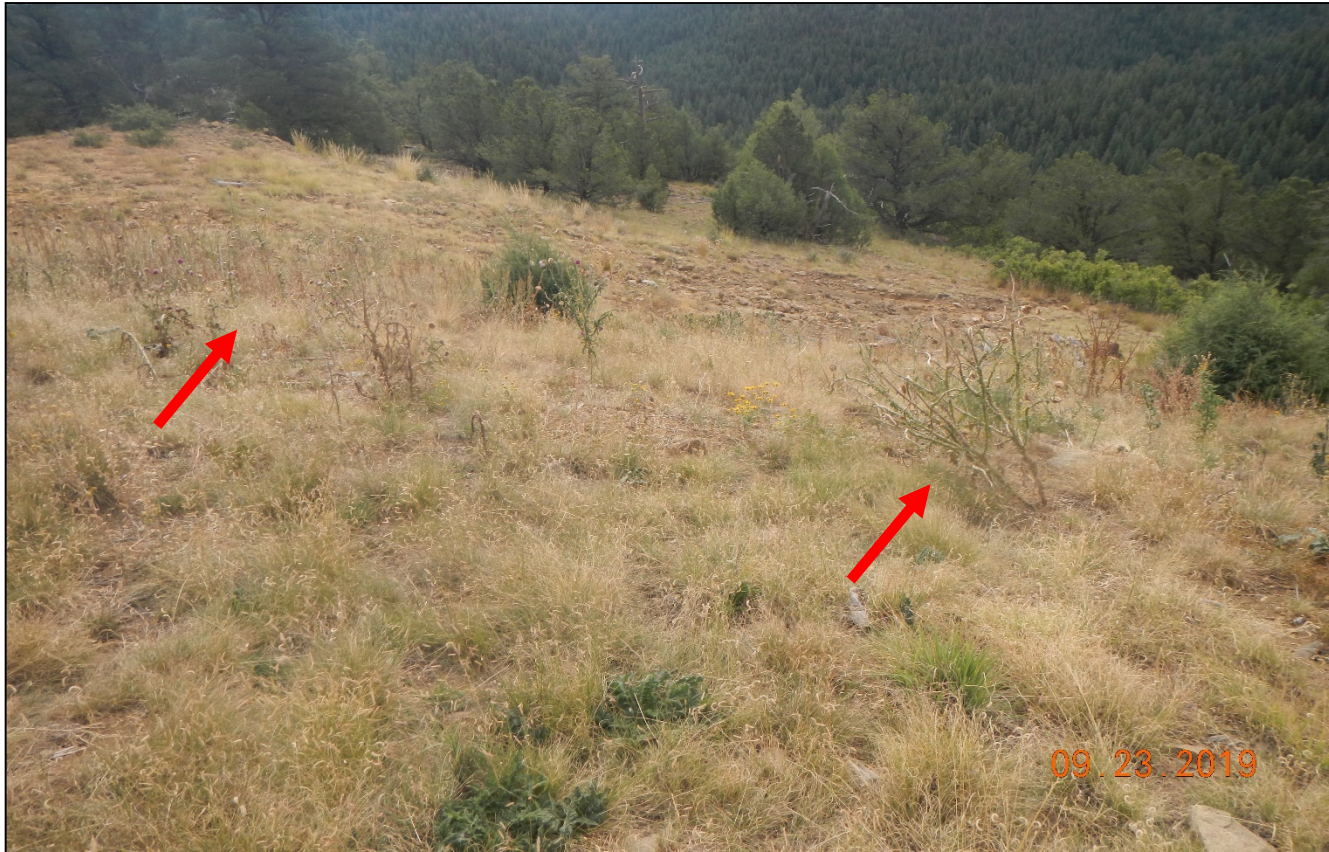
Photo 4. There are List B noxious weeds along the south side of the location. Corrective action was not completed since previous inspection.
