Inspection Photos

API: 05-071-06867

Operator: ARP PRODUCTION COMPANY
WAPITI OPERATING LLC

Inspection Date: 9/23/2019

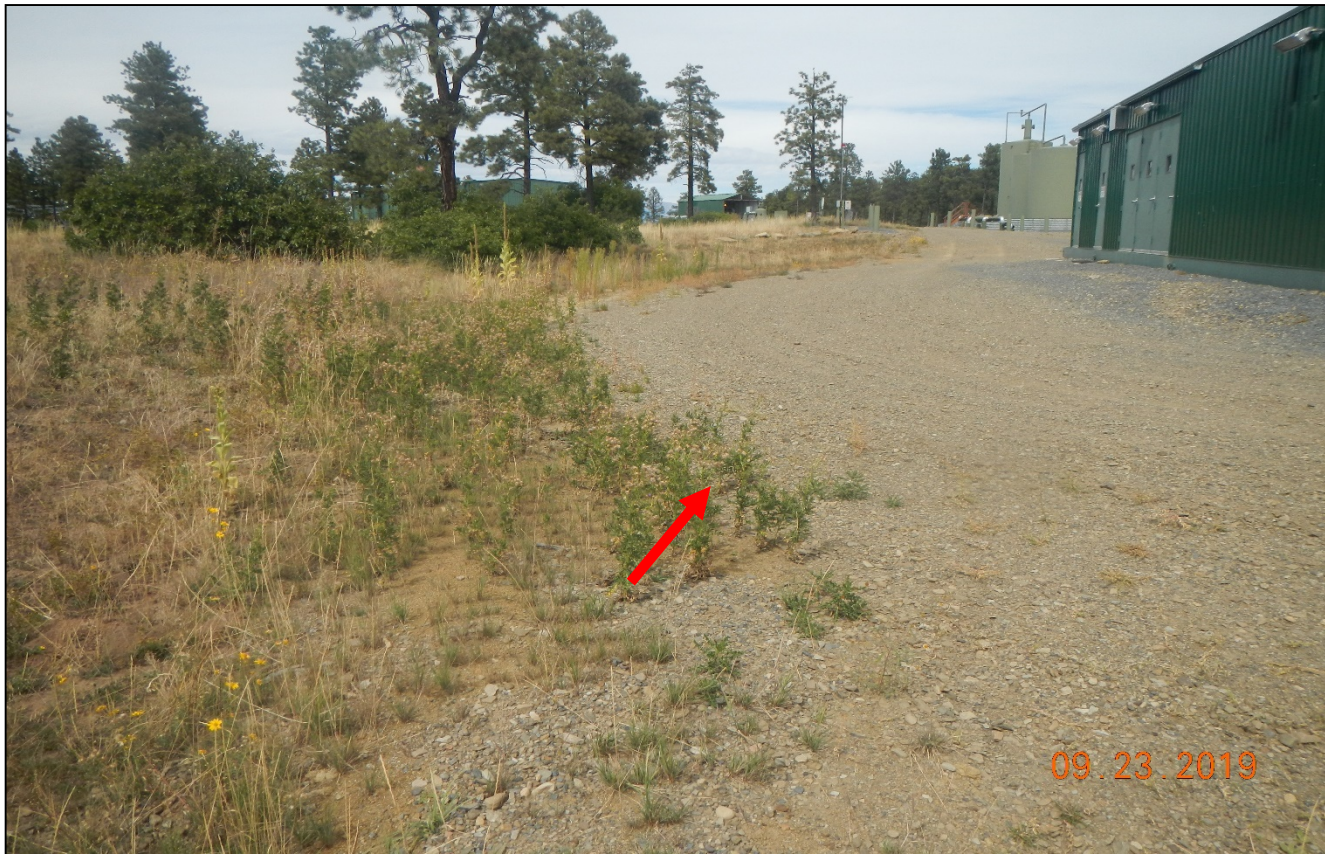
Photo 1. There is List B noxious weeds growing along the access road near the building near the location. (Canada thistle shown in photo)

Corrective action was not performed since previous inspection.

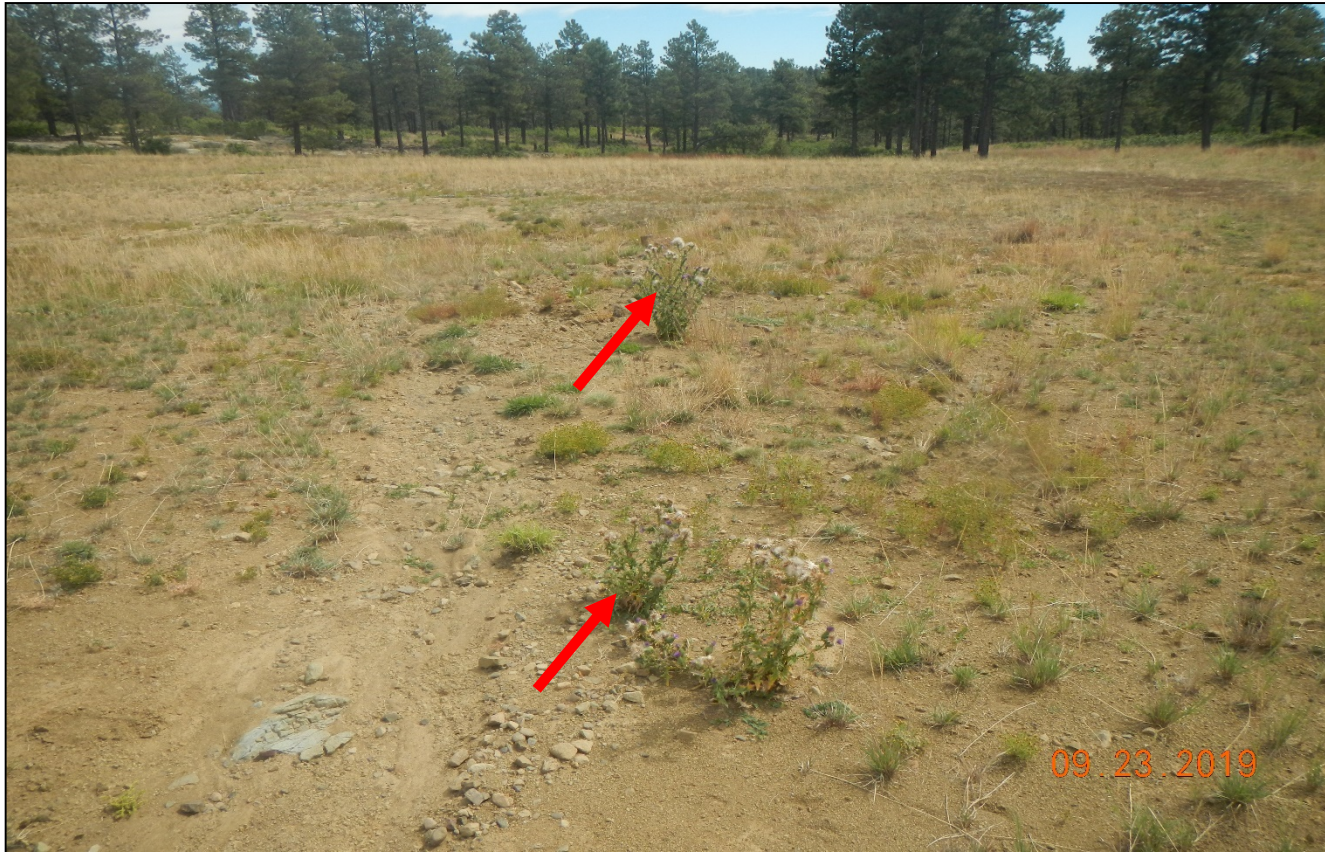
Photo 2. Facing toward the location. Vegetation has not established throughout the location. There are Lis B noxious weeds at the location. (Photo shows Bull thistle)

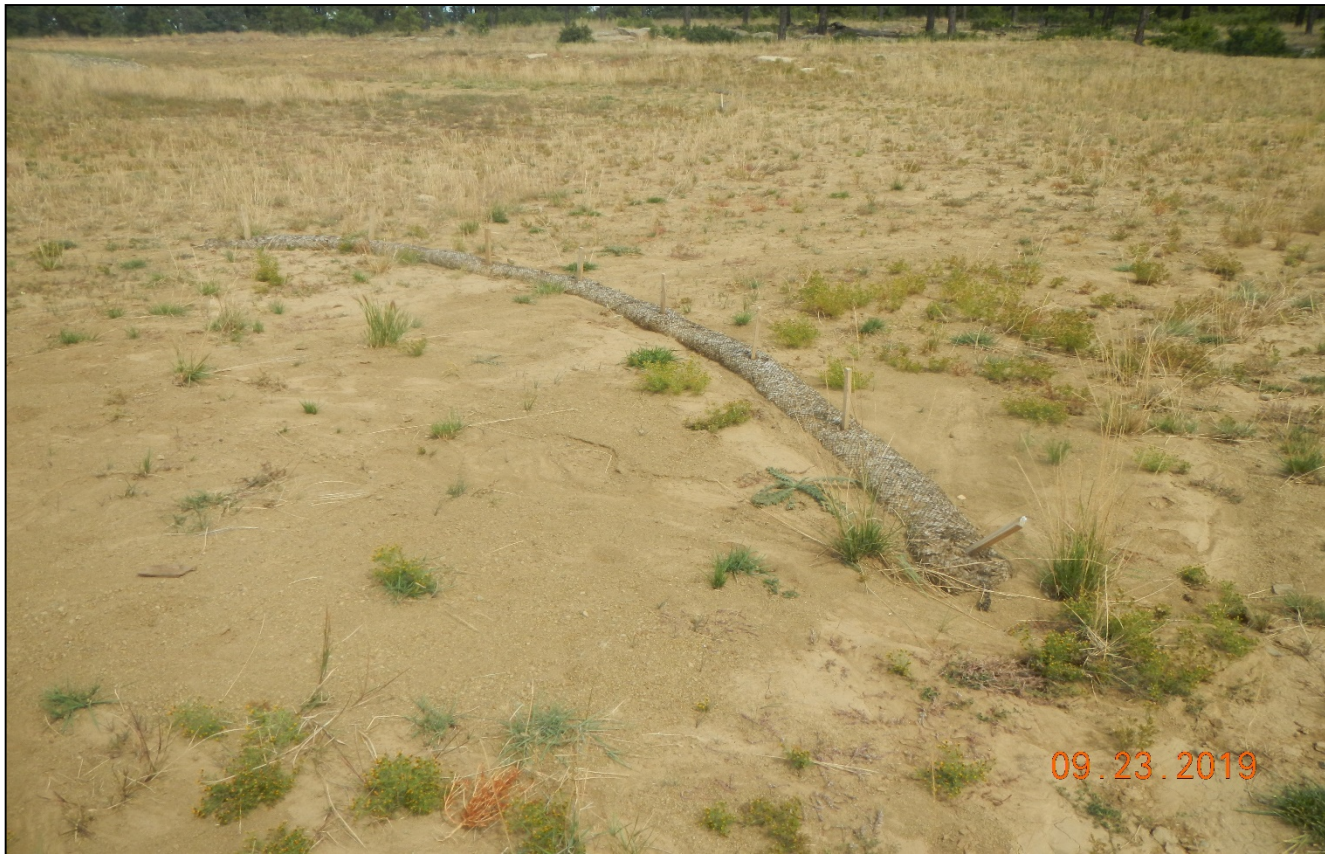
Photo 3. Sediment has filled into the wattles.

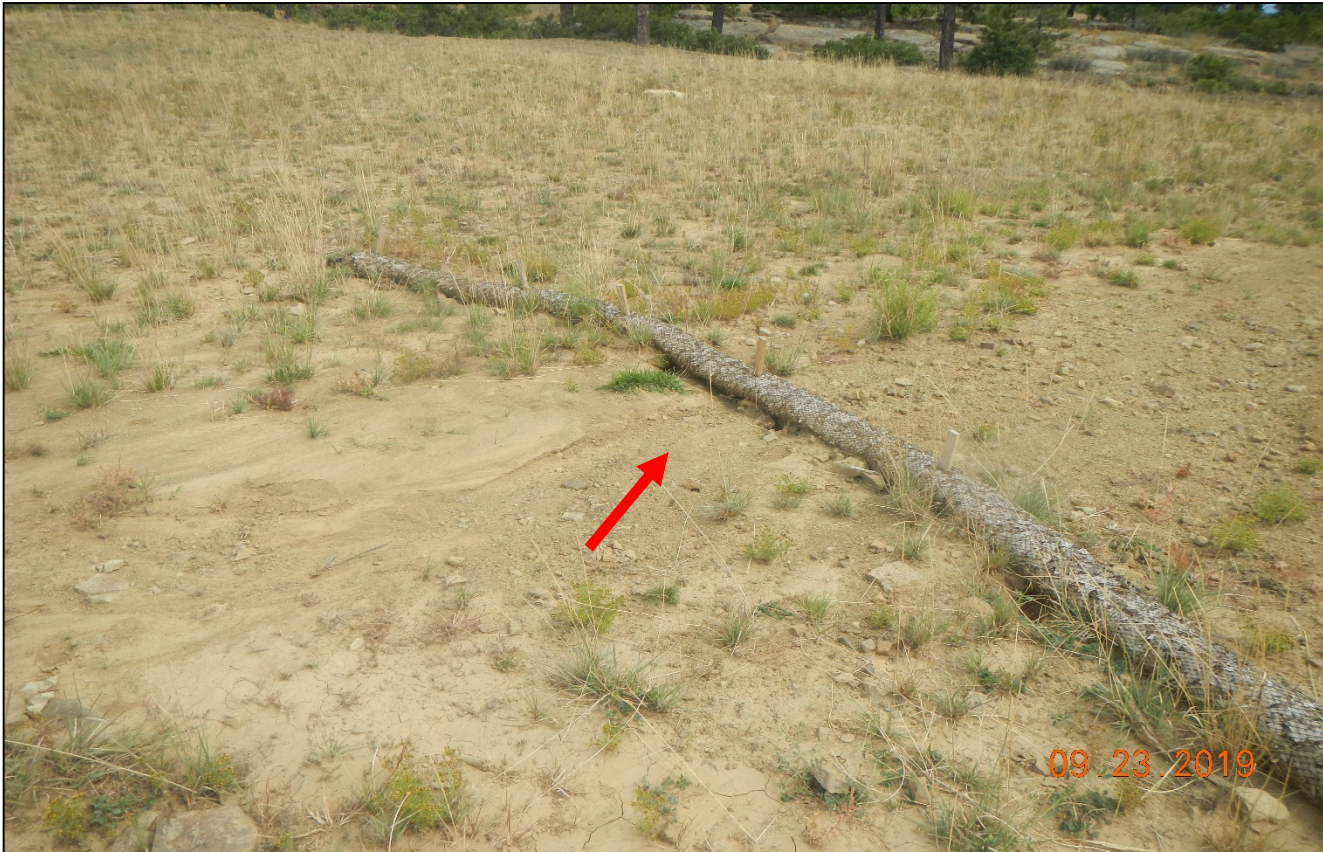
Photo 4. There are sign stormwater is flowing underneath the wattle. Wattles were not properly trenched into the ground. Corrective action was not completed since previous inspection.
