Inspection Photos  
Location Name: Newlander Pit  
Location ID 114274

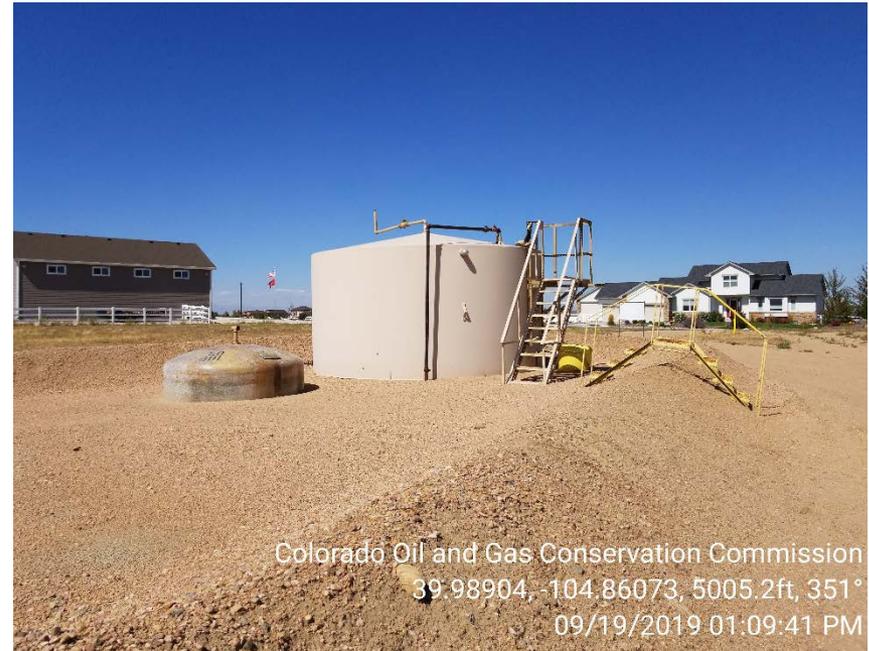
Photo 2 – Location photo; fiberglass partially buried produced water tank on site

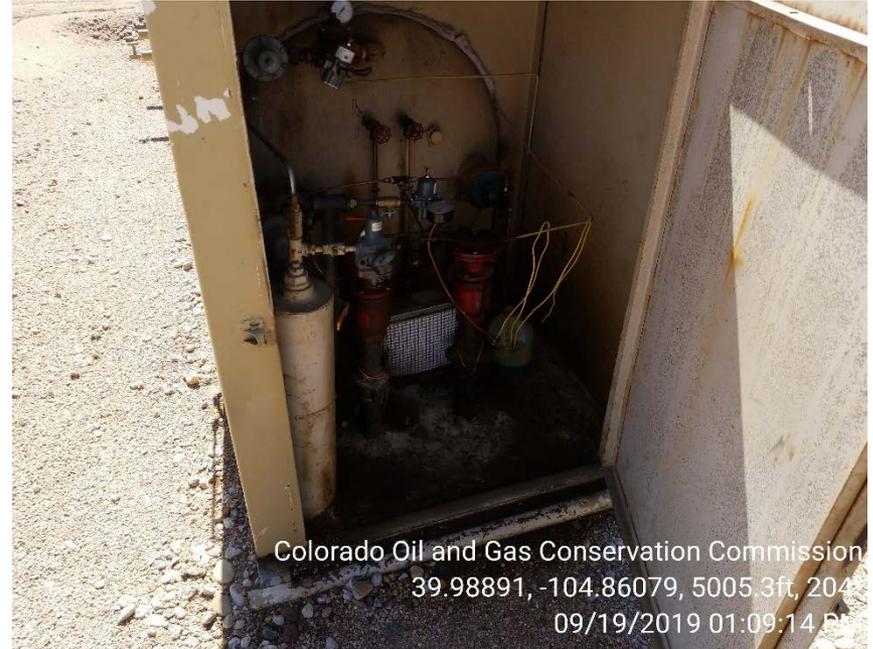
**Photo 4 – Stained soil at separator**

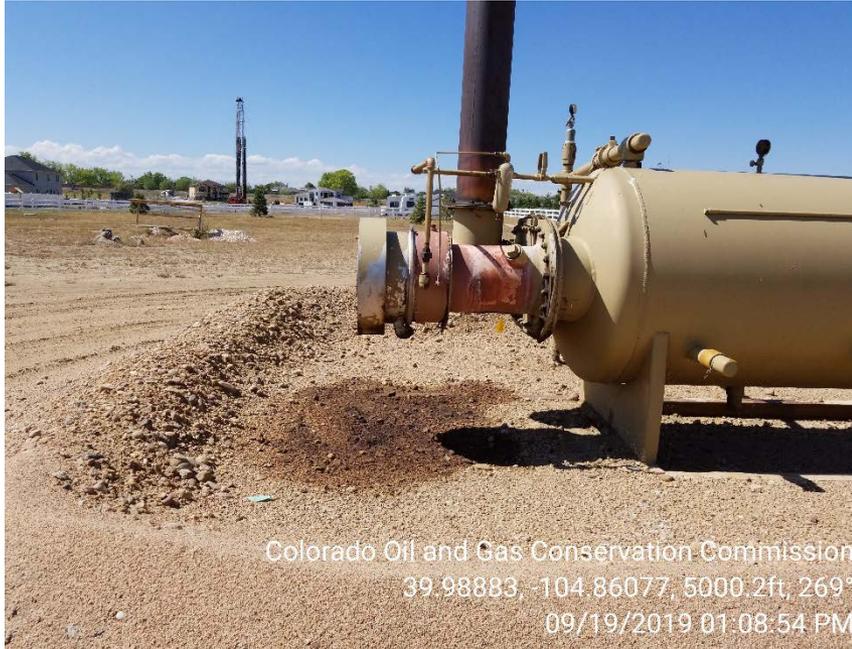
**Photo 5 – Stained soil under fire tube**
