Inspection Photos
Location Name: Ocoma 31-27
Facility ID: 250003

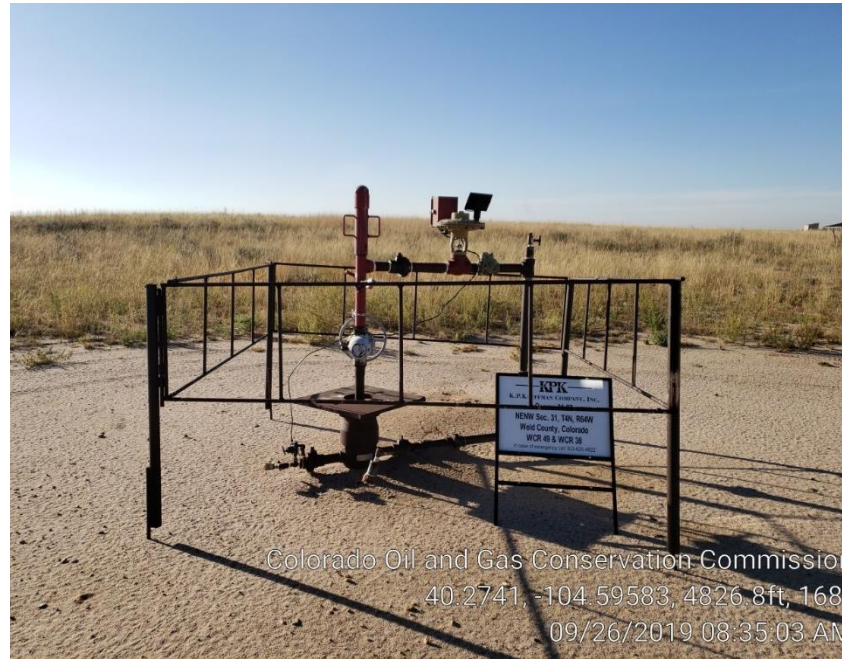
Photo # 1 Wellhead & Sign

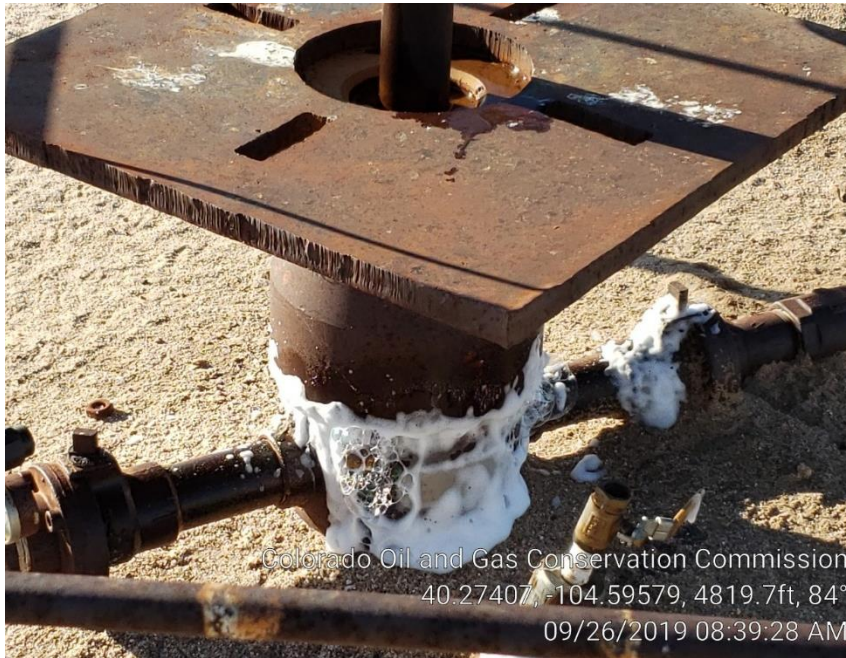
Photo #2 Active leak at the casing collar

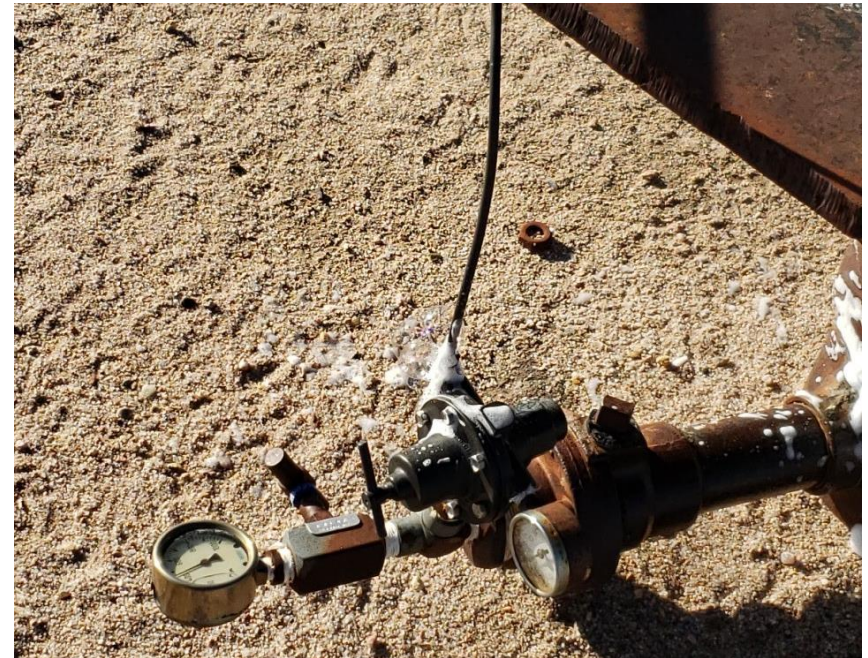
Photo #3 Active leak at the Meco regulator stainless fitting.
