Inspection Photos
Operator: Hilcorp Energy
Location/API #: 067-09839
Date: 9-16-2019

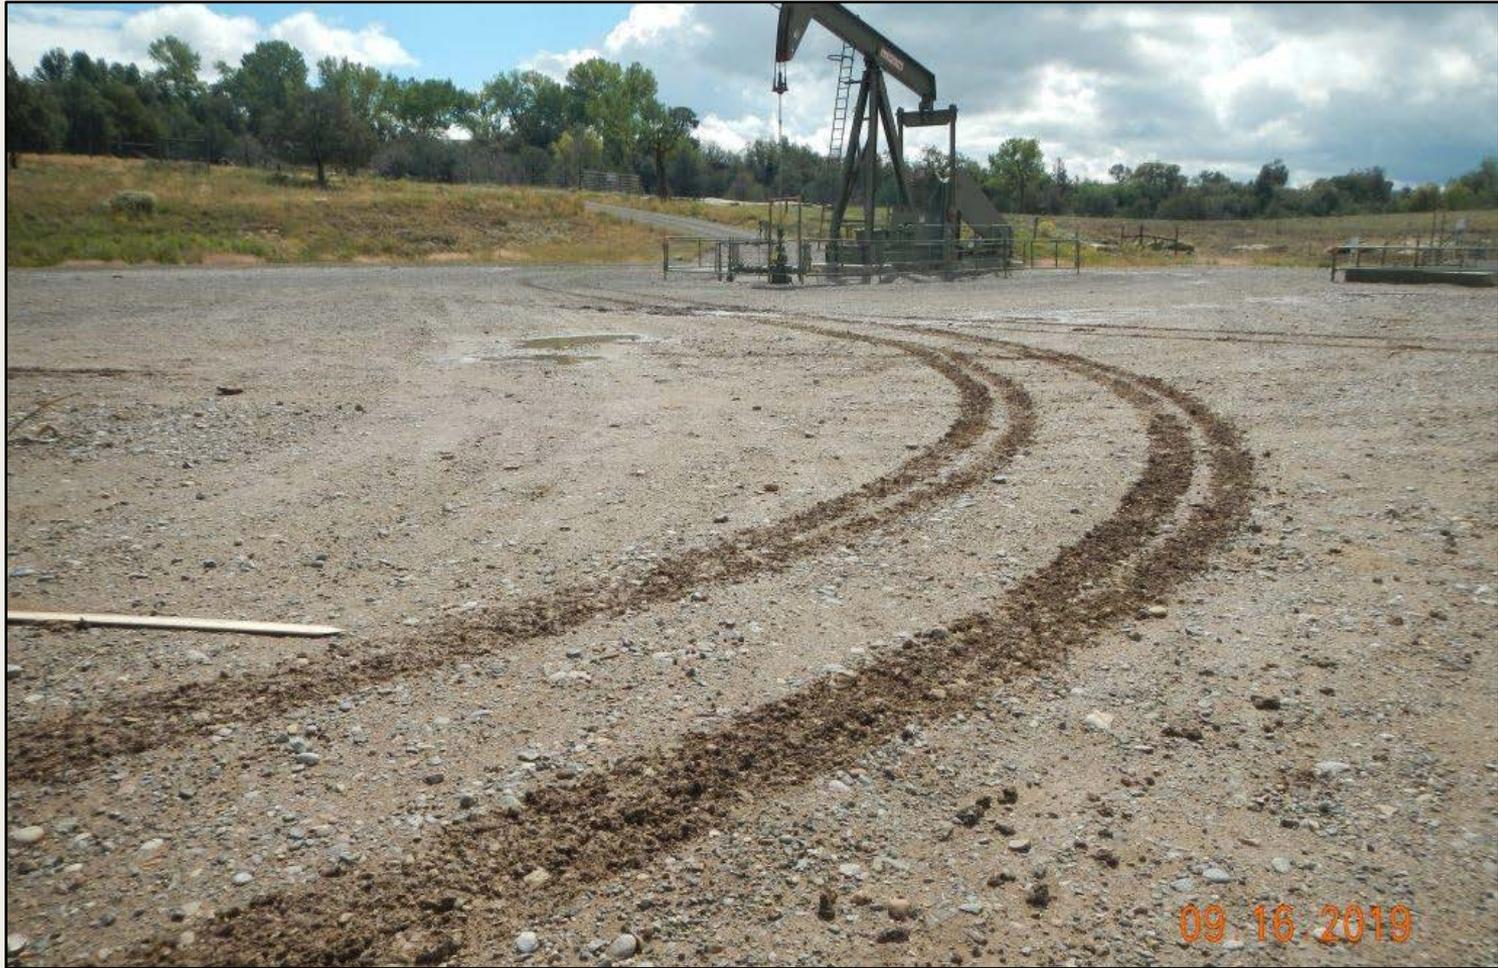
Photo 1. View of the project area from the northwestern corner facing center.

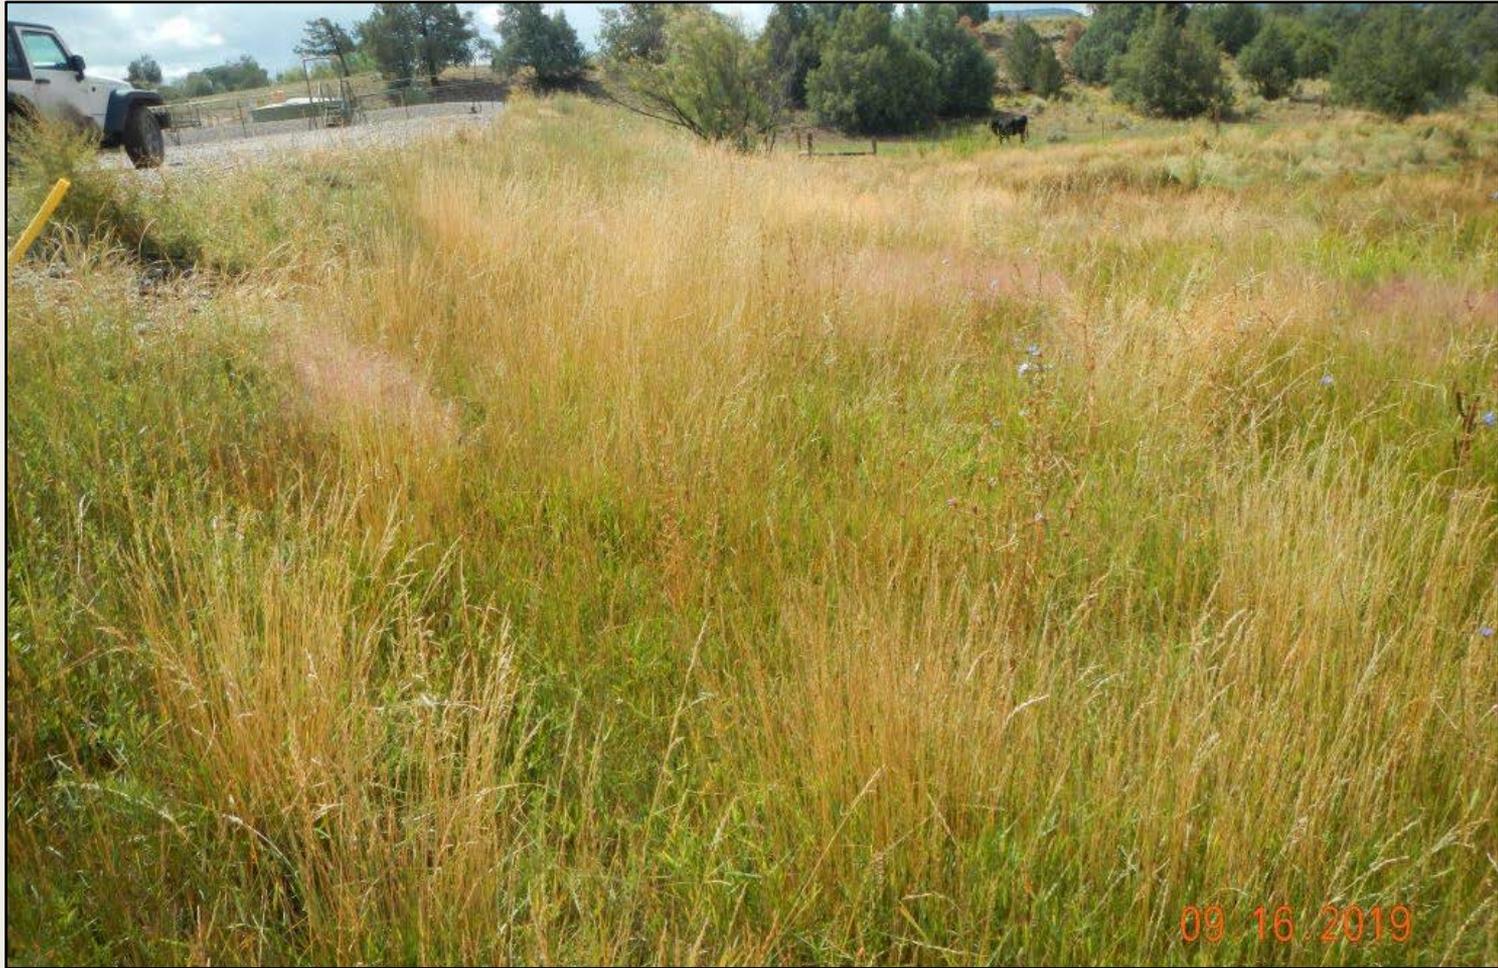
Photo 2. View of the western fill slope facing southward. Revegetation is progressing with grasses such as smooth brome and western wheatgrass.

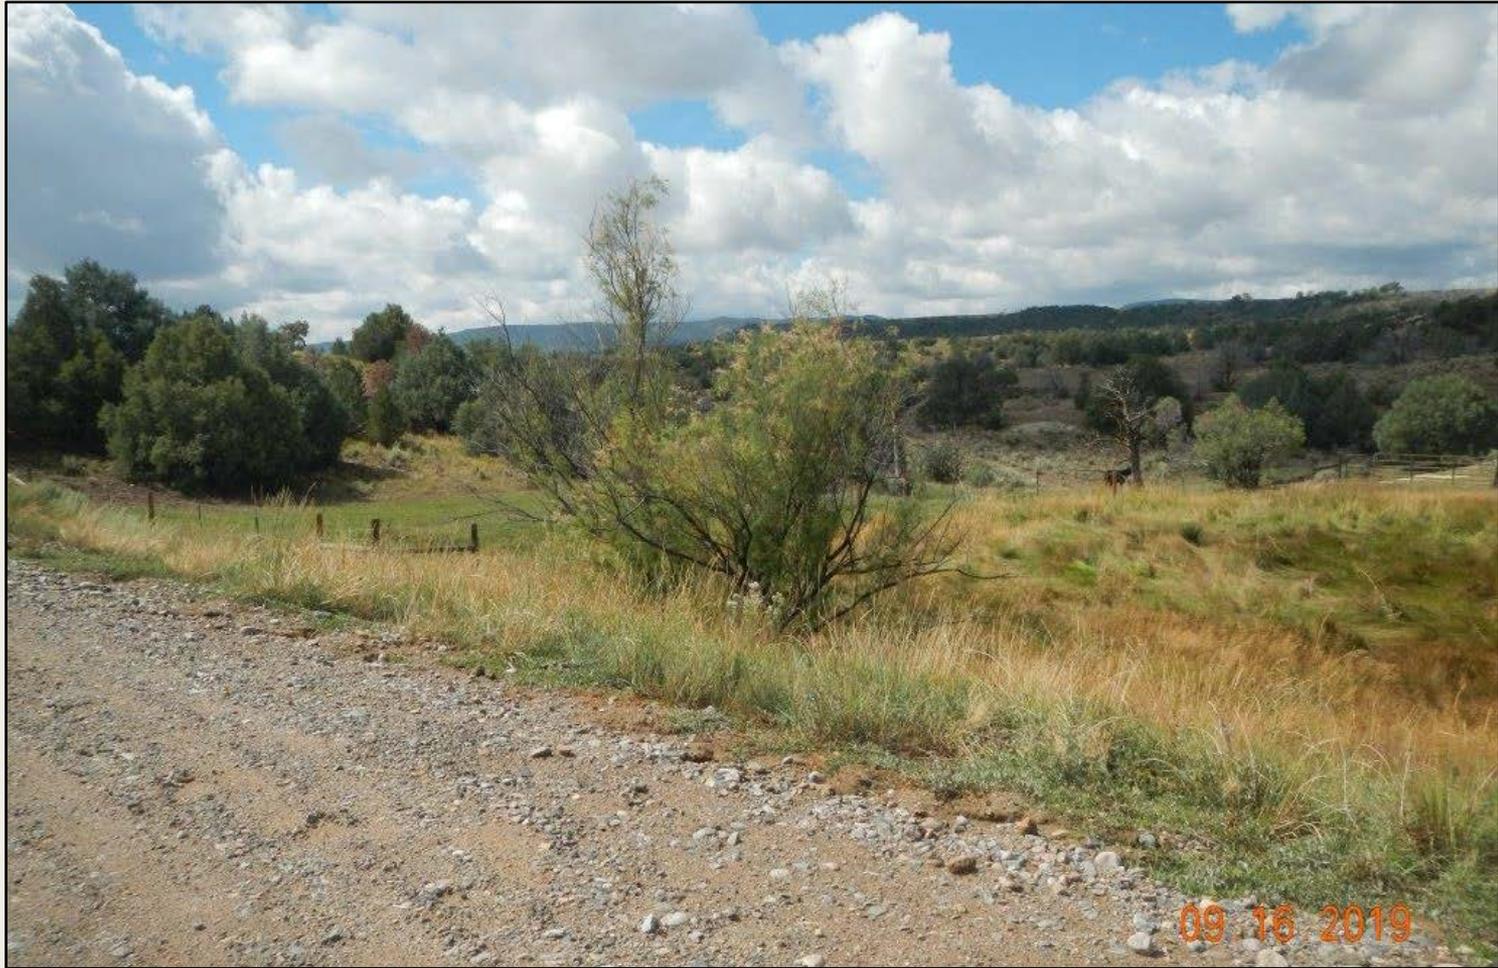
Photo 3. View of salt cedar tree within the western fill slope, needs to be controlled.

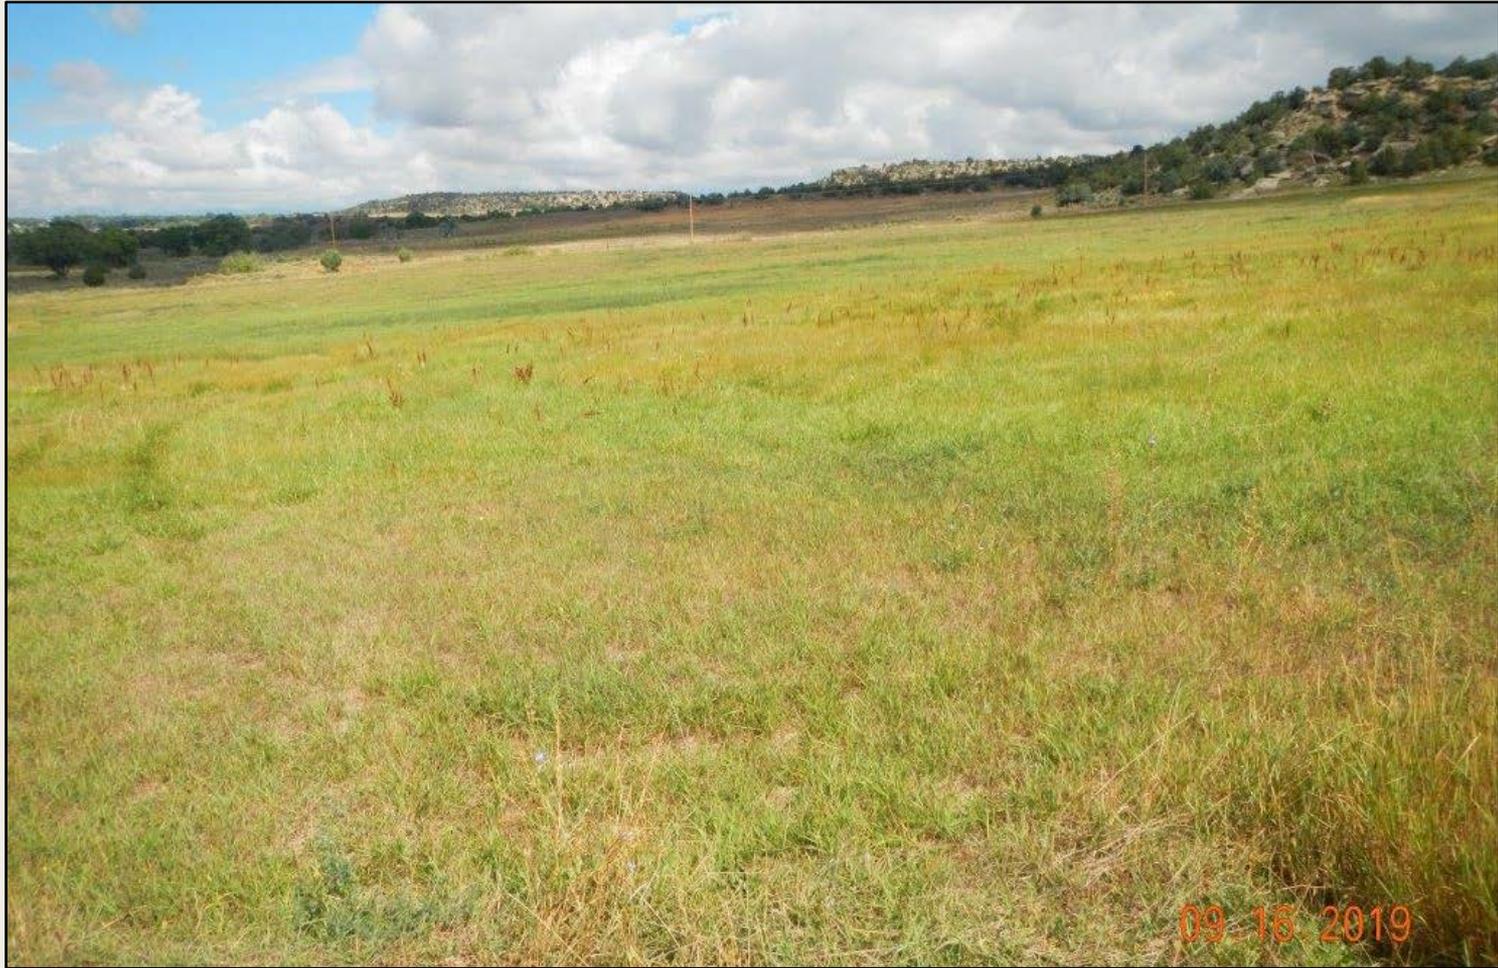
Photo 4. View of reference area vegetation, north of the project area, facing northward. Comprised of irrigated grass fields such as smooth brome and wheat grasses.
