Inspection Photos

Operator: Hilcorp Energy
Location/API #: 067-06933
Date: 9-16-2019

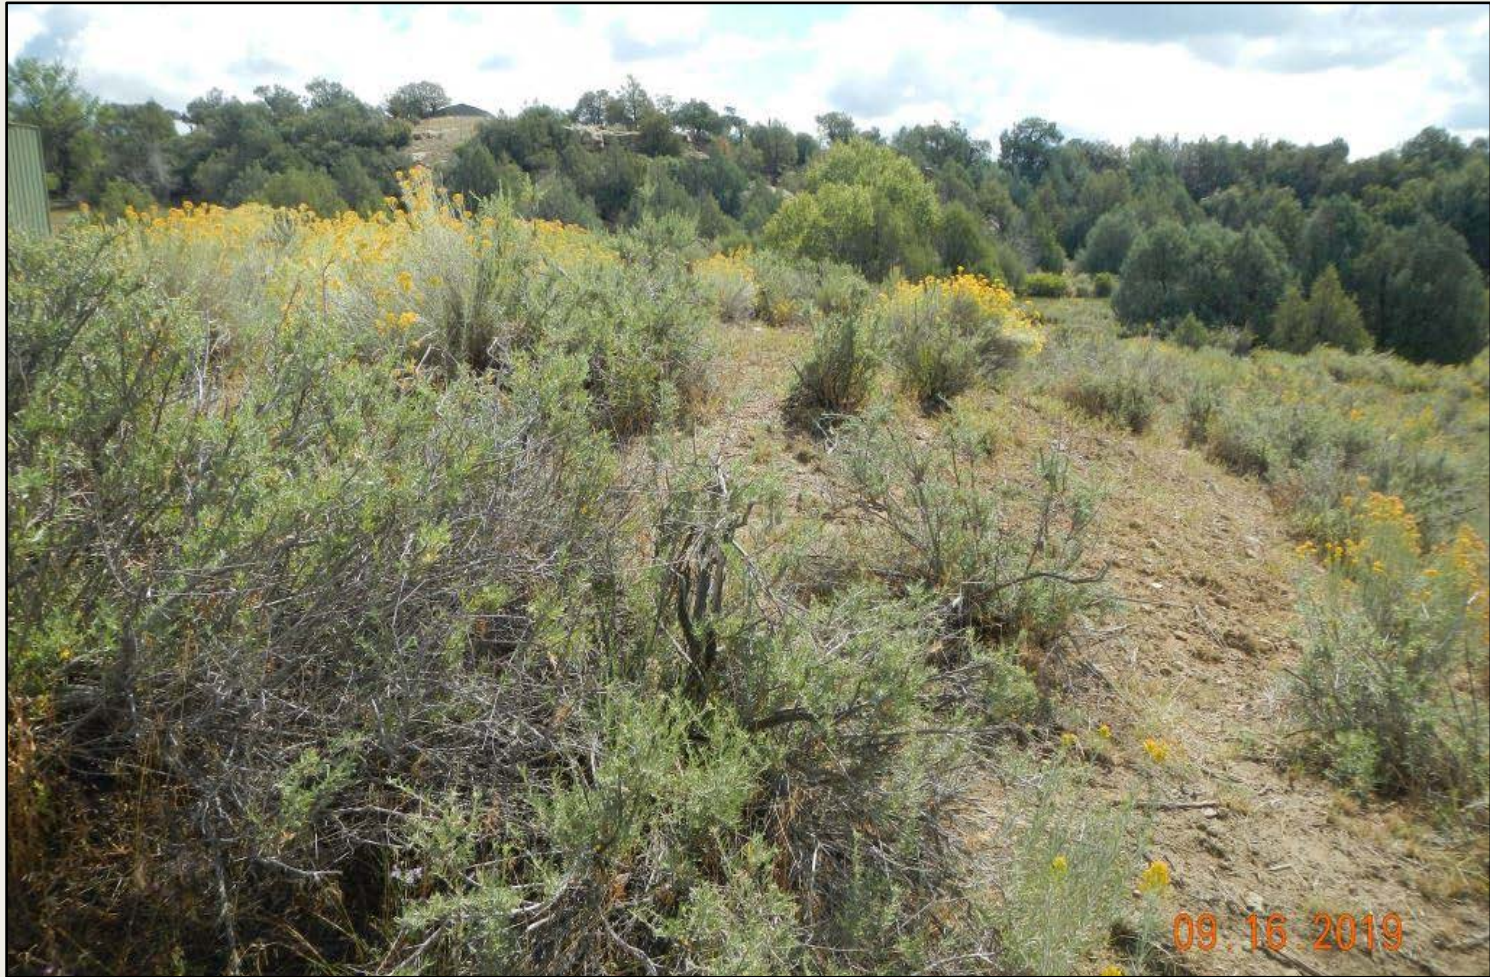
Photo 1. View of the southern fill slope from the southwestern edge facing eastward. Revegetation is comprised of tall shrubs such as rubber rabbitbrush and fourwing salt bush, with grazed herbaceous understory.

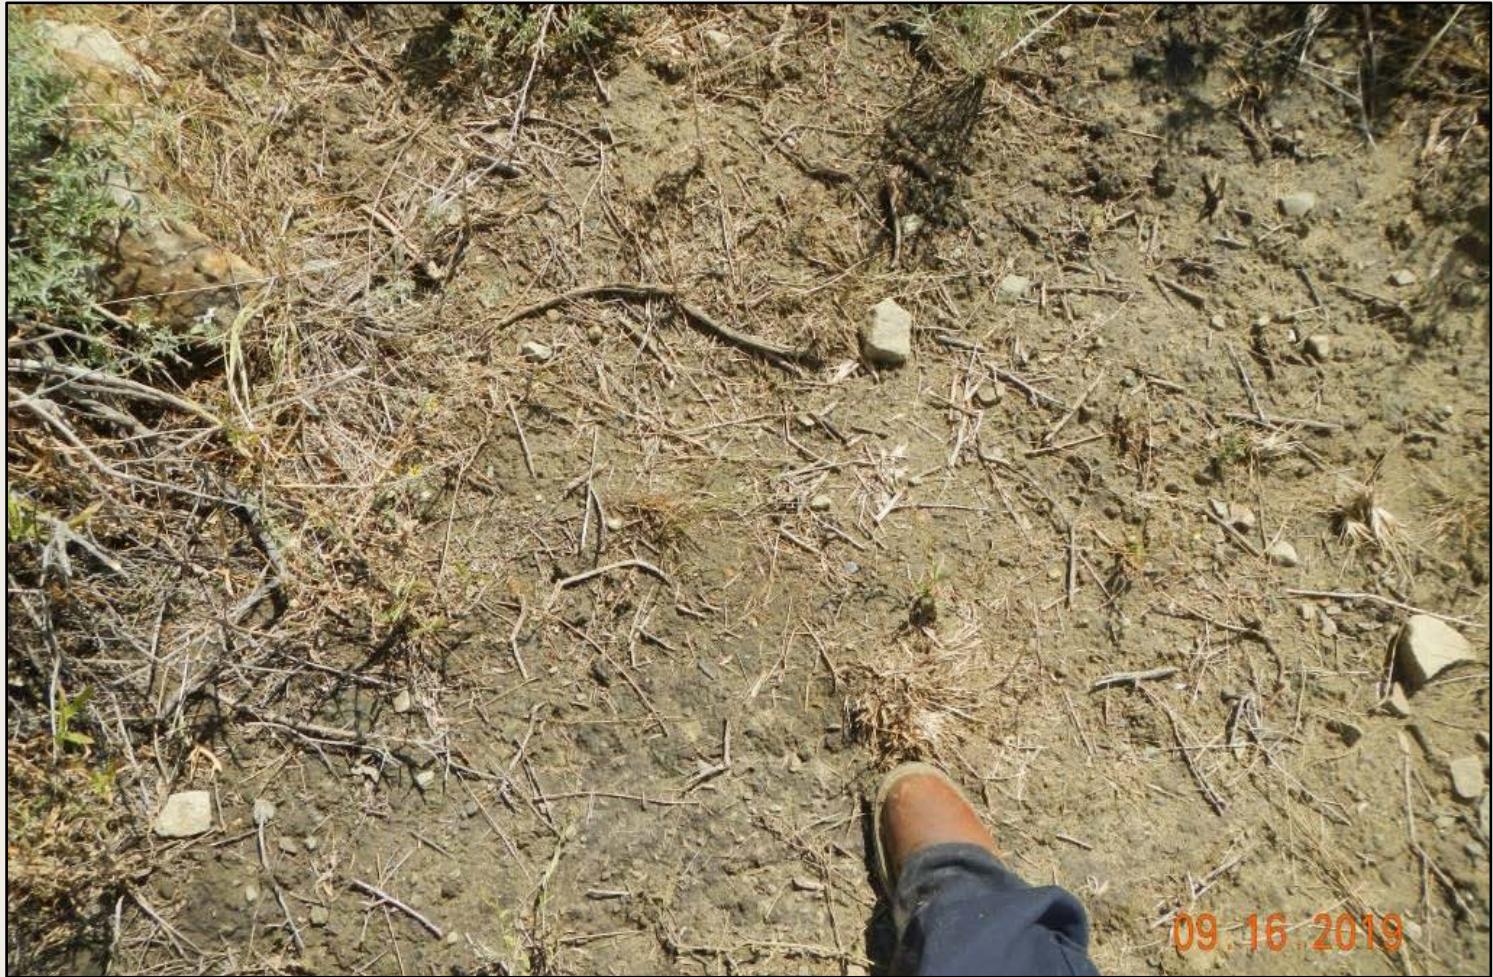
Photo 2. View of grazed vegetation within the southern project area.

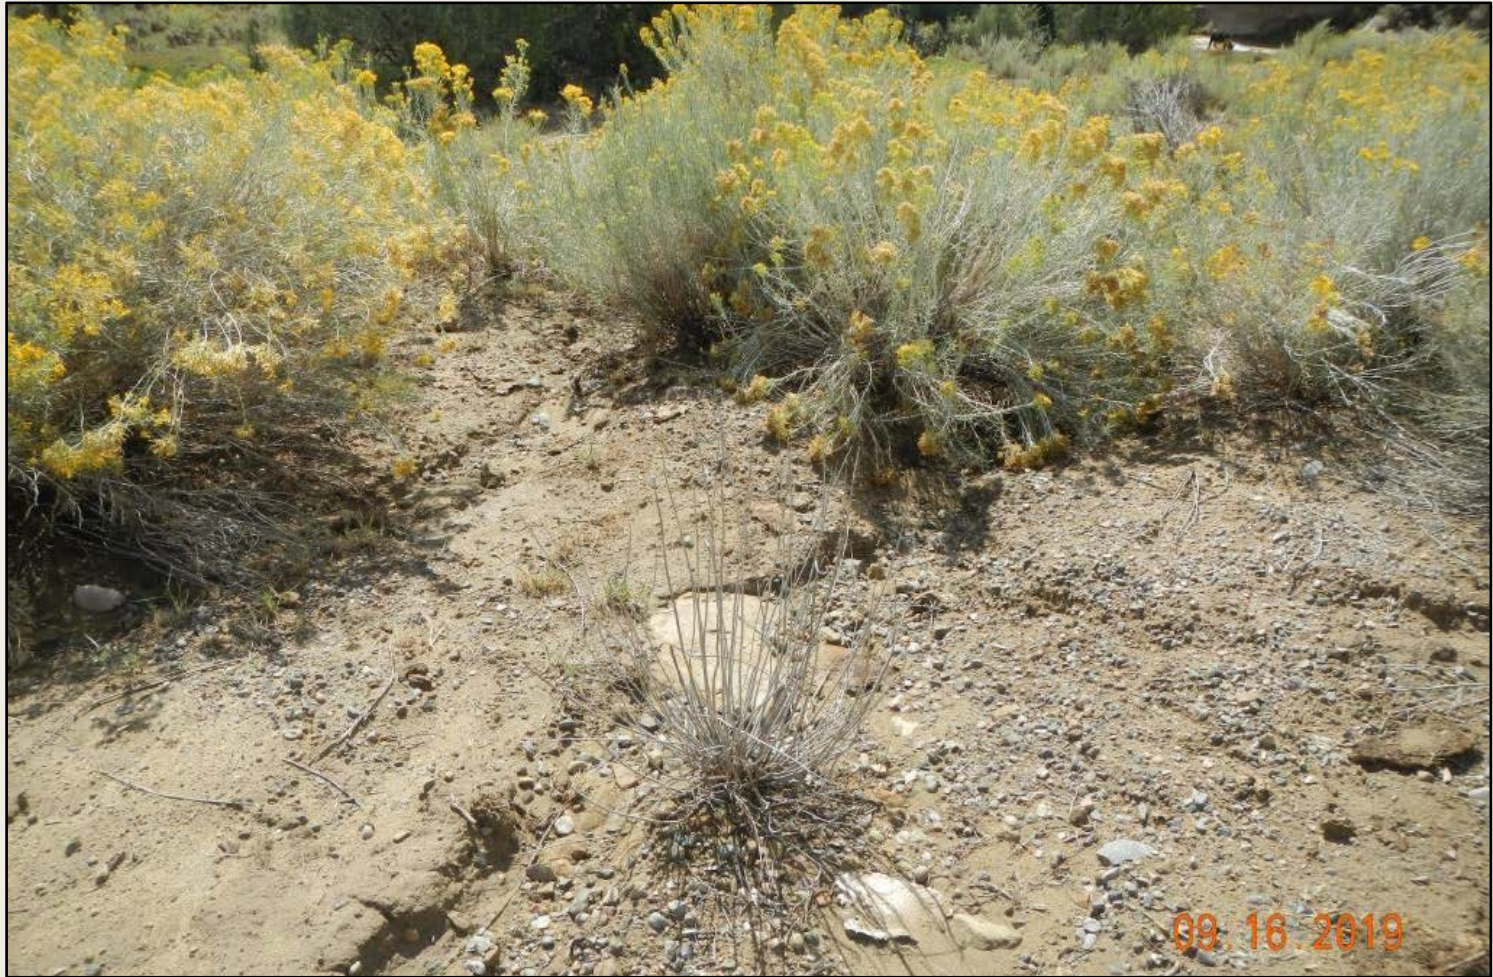
Photo 3. View erosional channeling, approximately 10 inches wide and 6 inches deep within the southern project area.

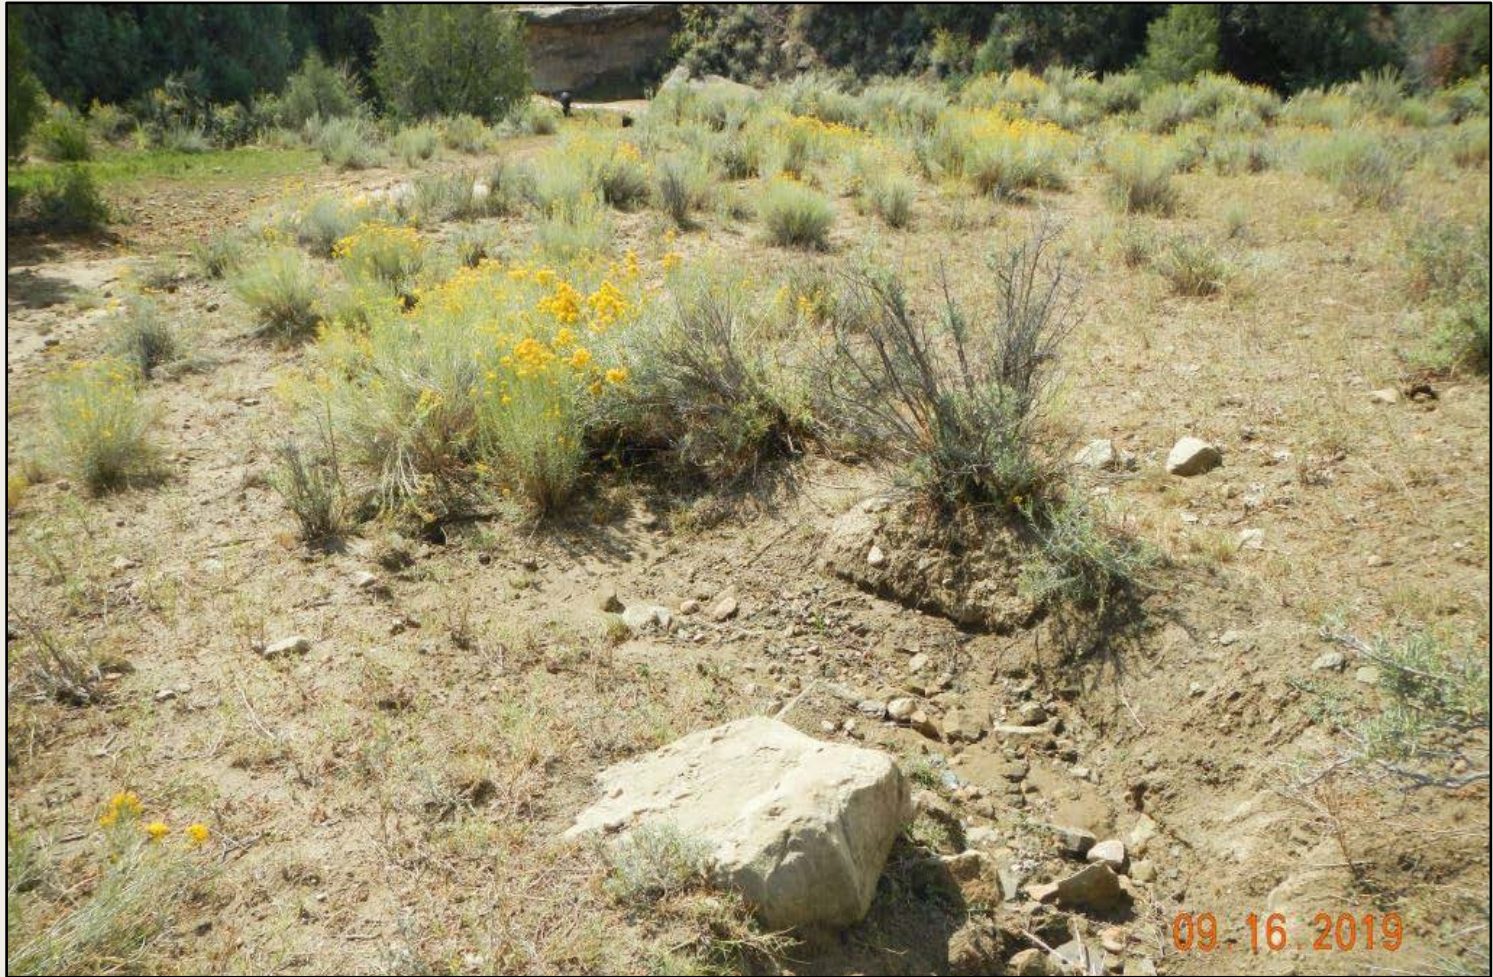
Photo 4. View of erosional channel, approximately 2 feet wide and deep, within the southern project area.

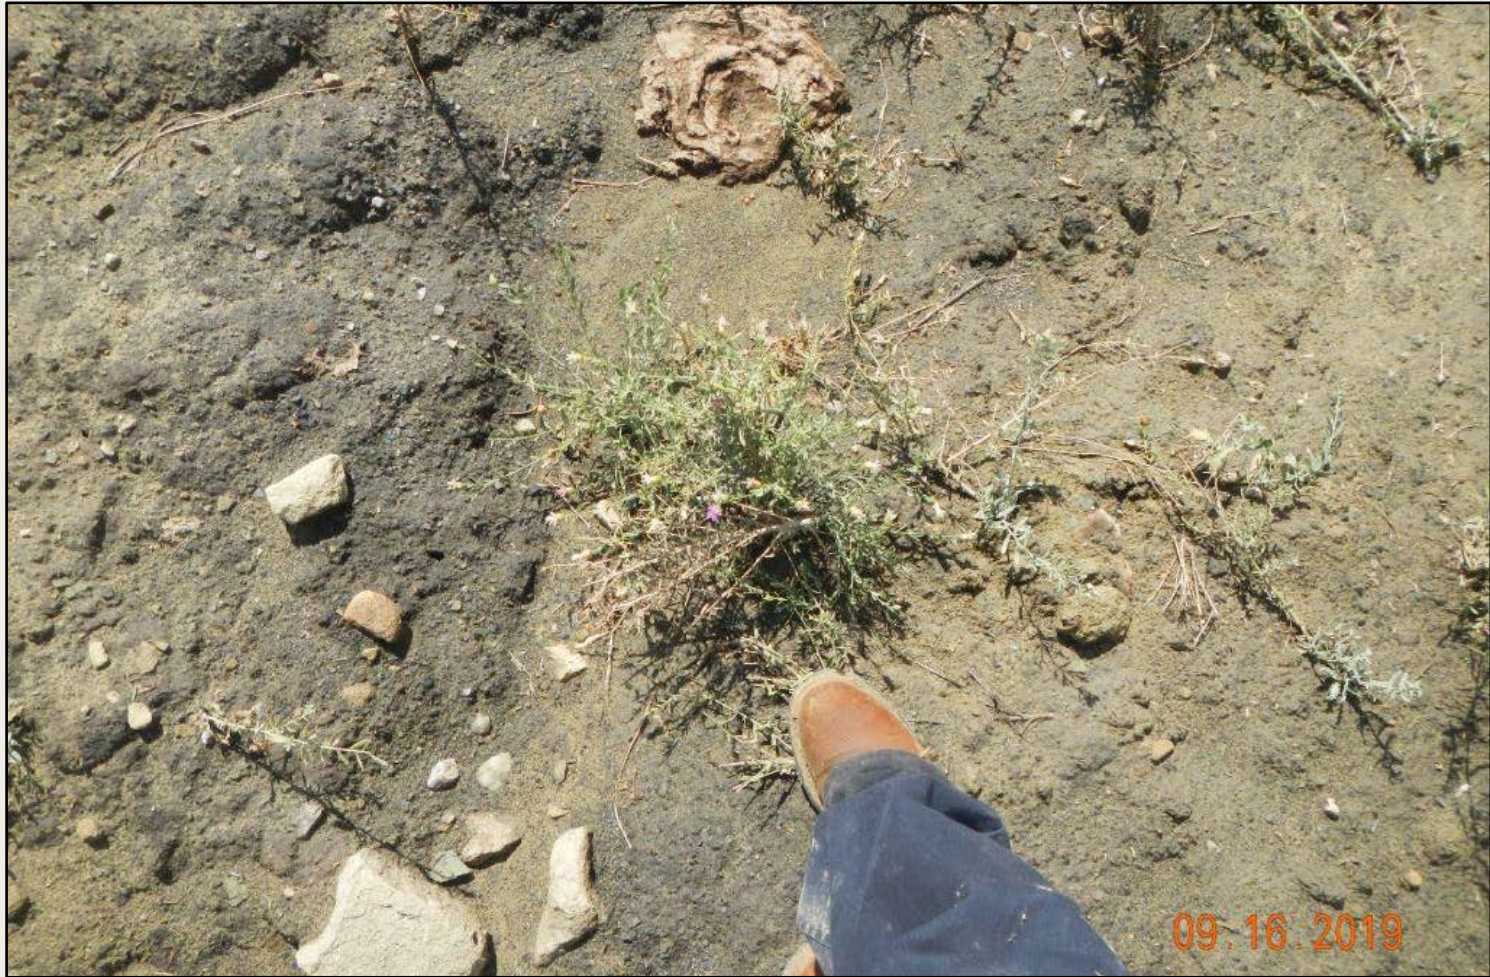
Photo 5. View of Russian knapweed and erosional channeling within the southern project area.

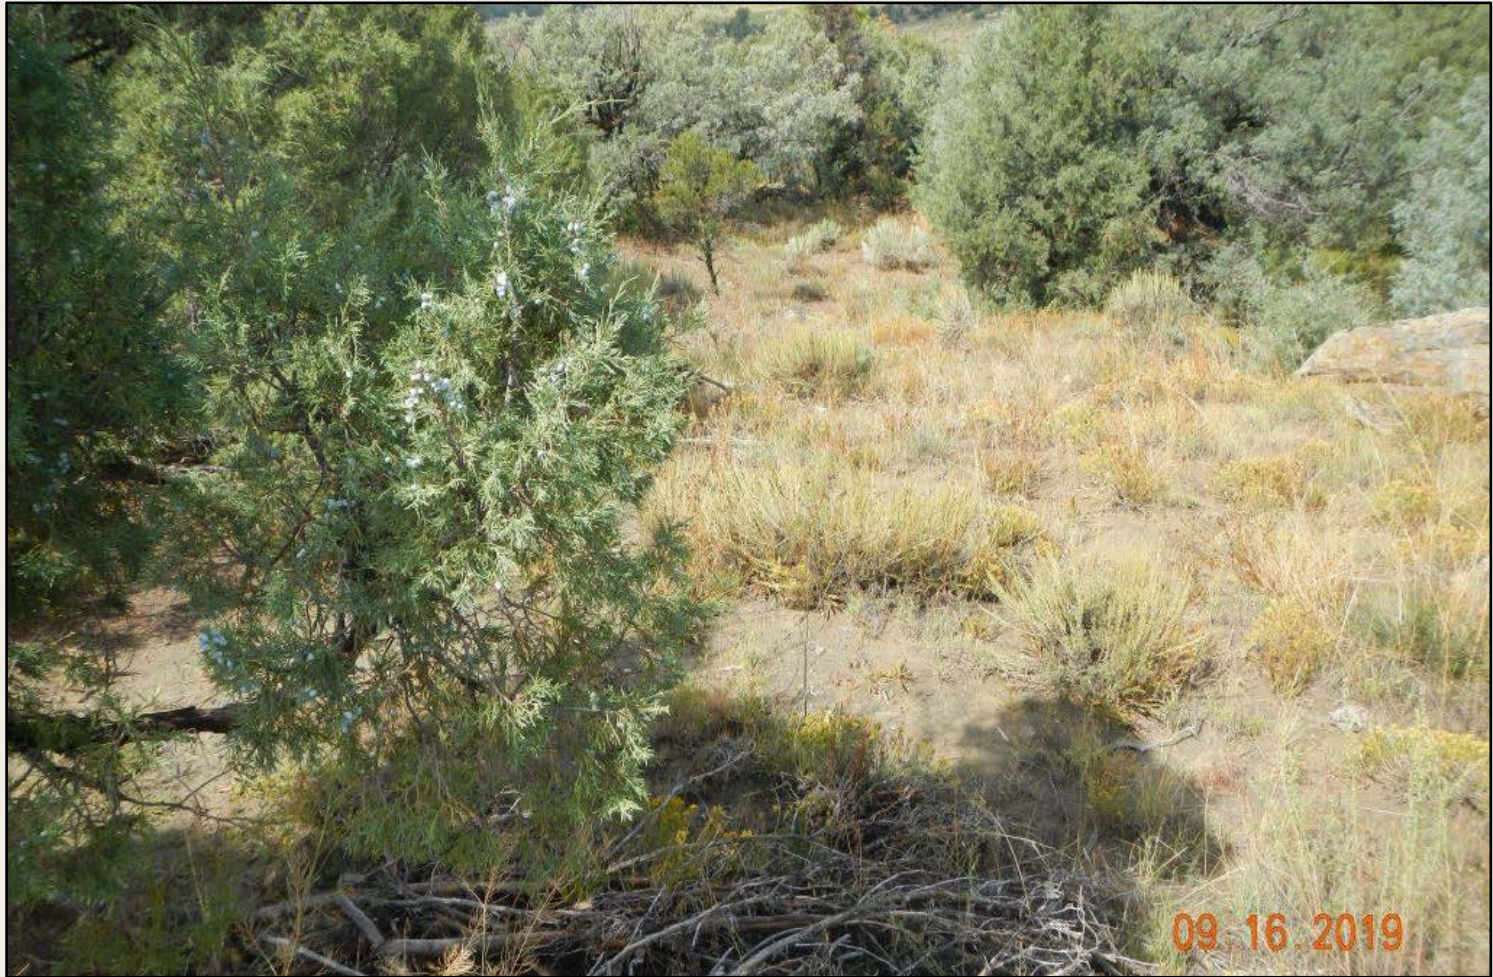
Photo 6. View of reference area vegetation, north of the project area, facing westward. Comprised of open pinyon juniper woodland, with native shrubby/herbaceous understory.
