**Inspection Photos**  
**Operator: Hilcorp Energy**  
**Location/API #: 067-09838**  
**Date: 9-16-2019**

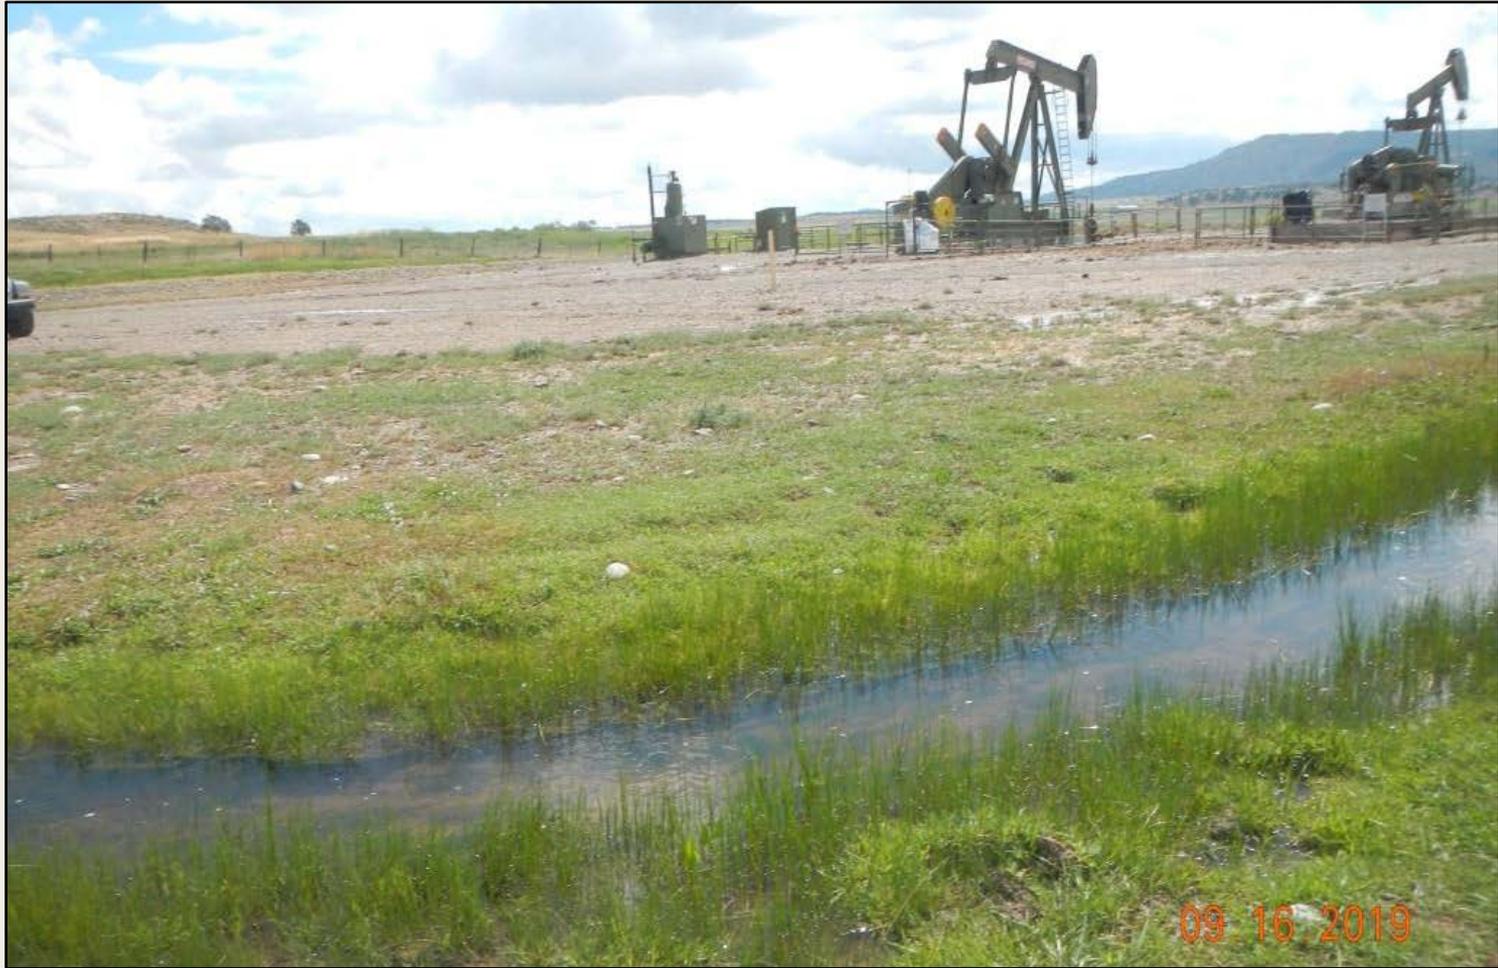
Photo 1. View of the project area from the northwestern corner facing center.

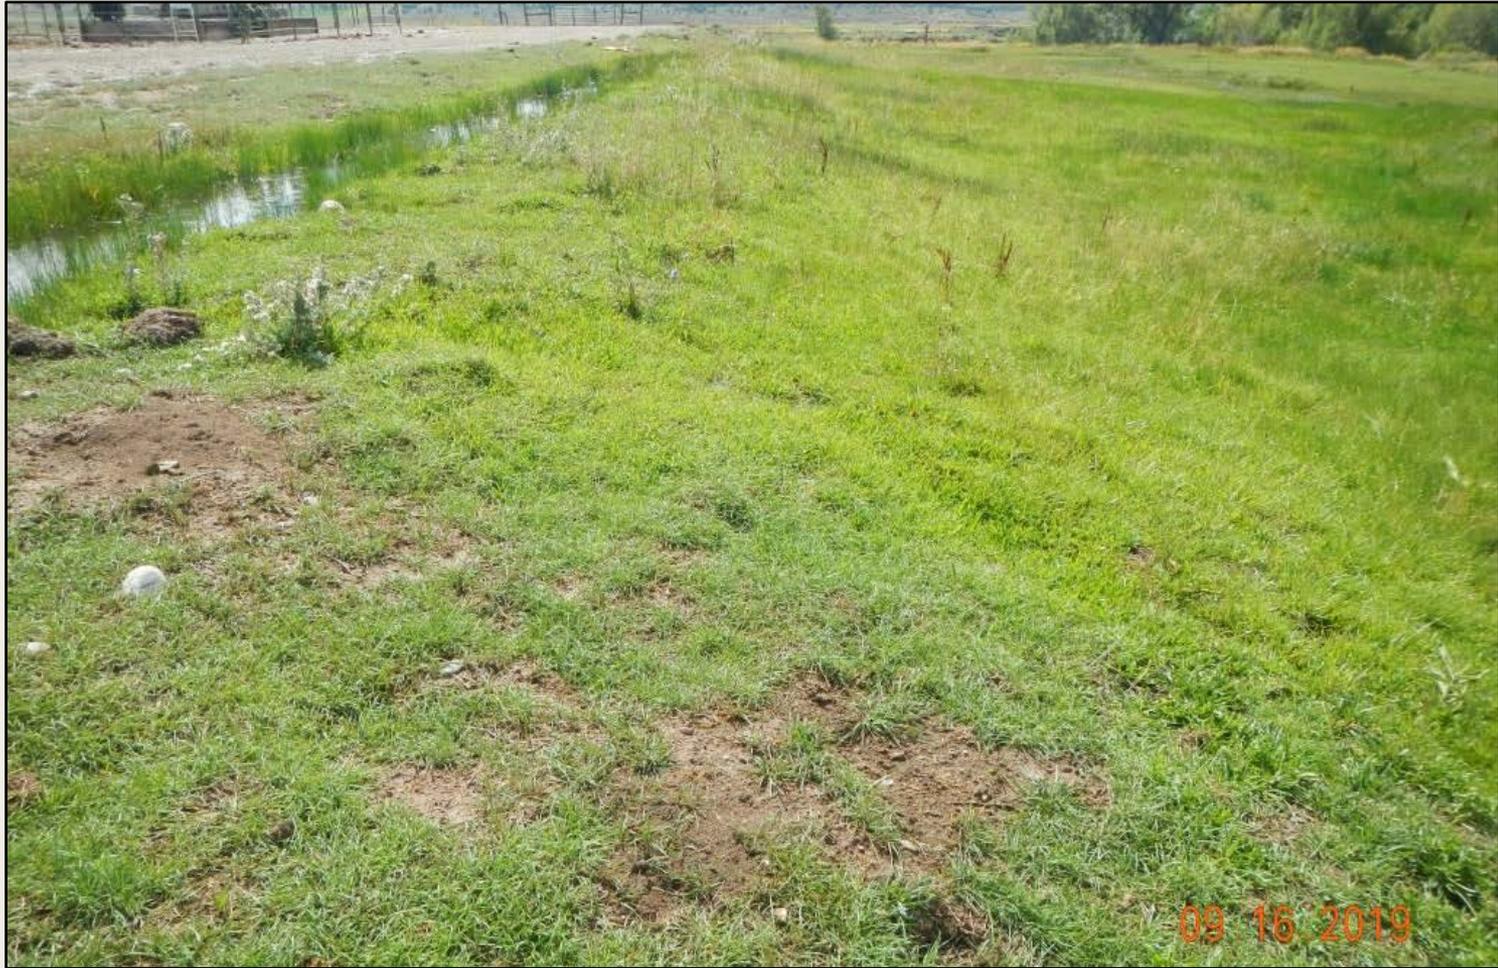
Photo 2. View of the western fill slope facing southward. Revegetation is approximately continuous with surrounding irrigated grass field.

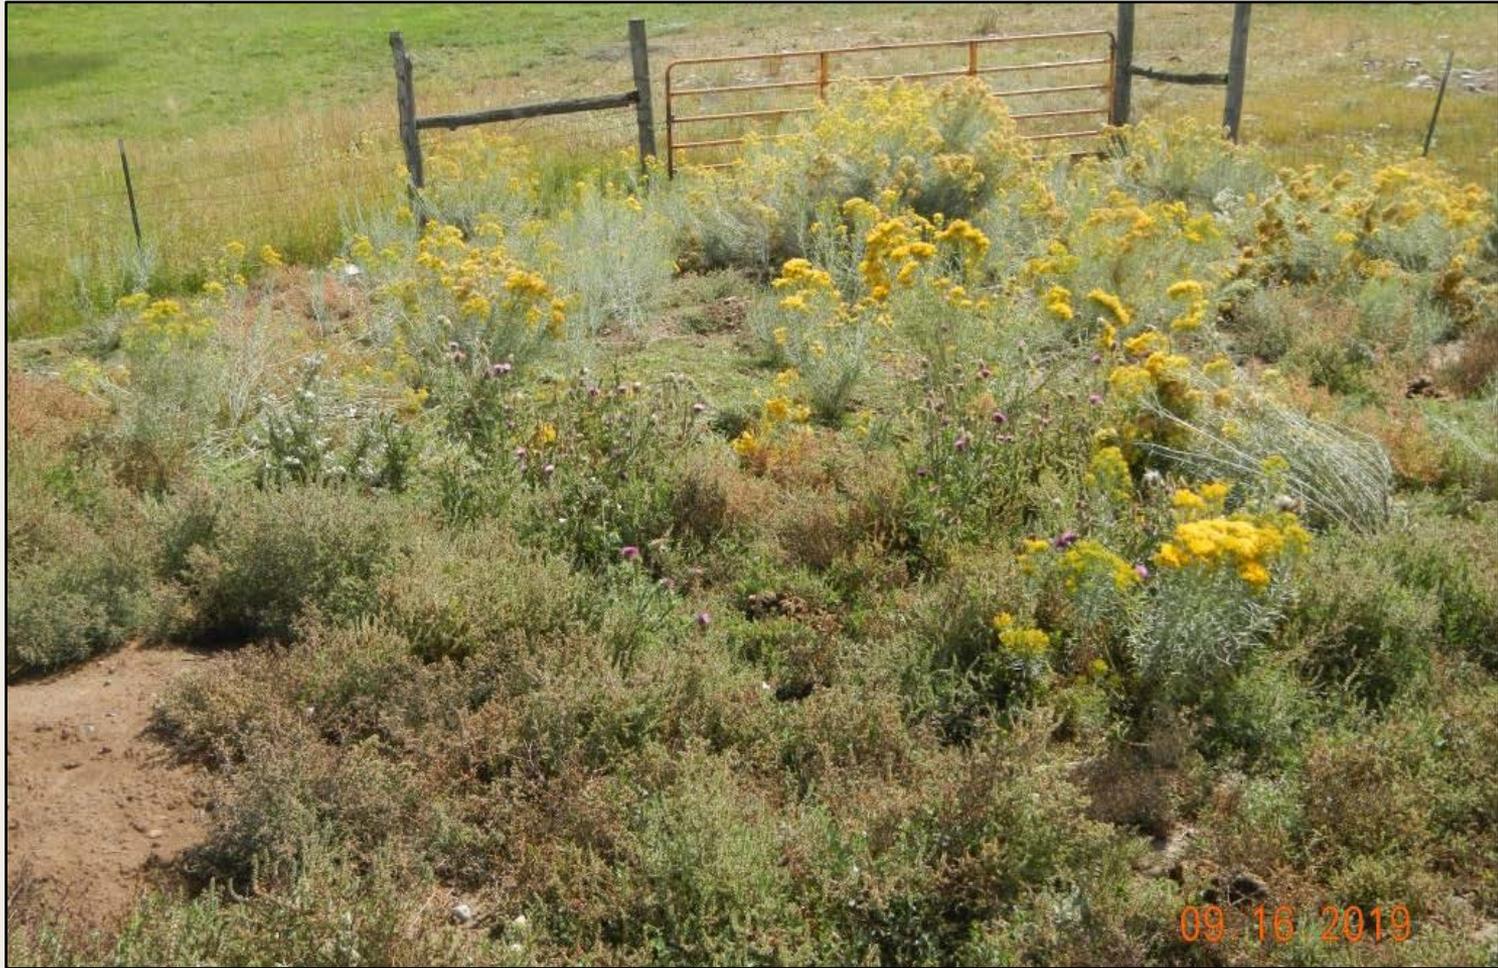
Photo 3. View Russian thistle and musk thistles within the southeastern project area.

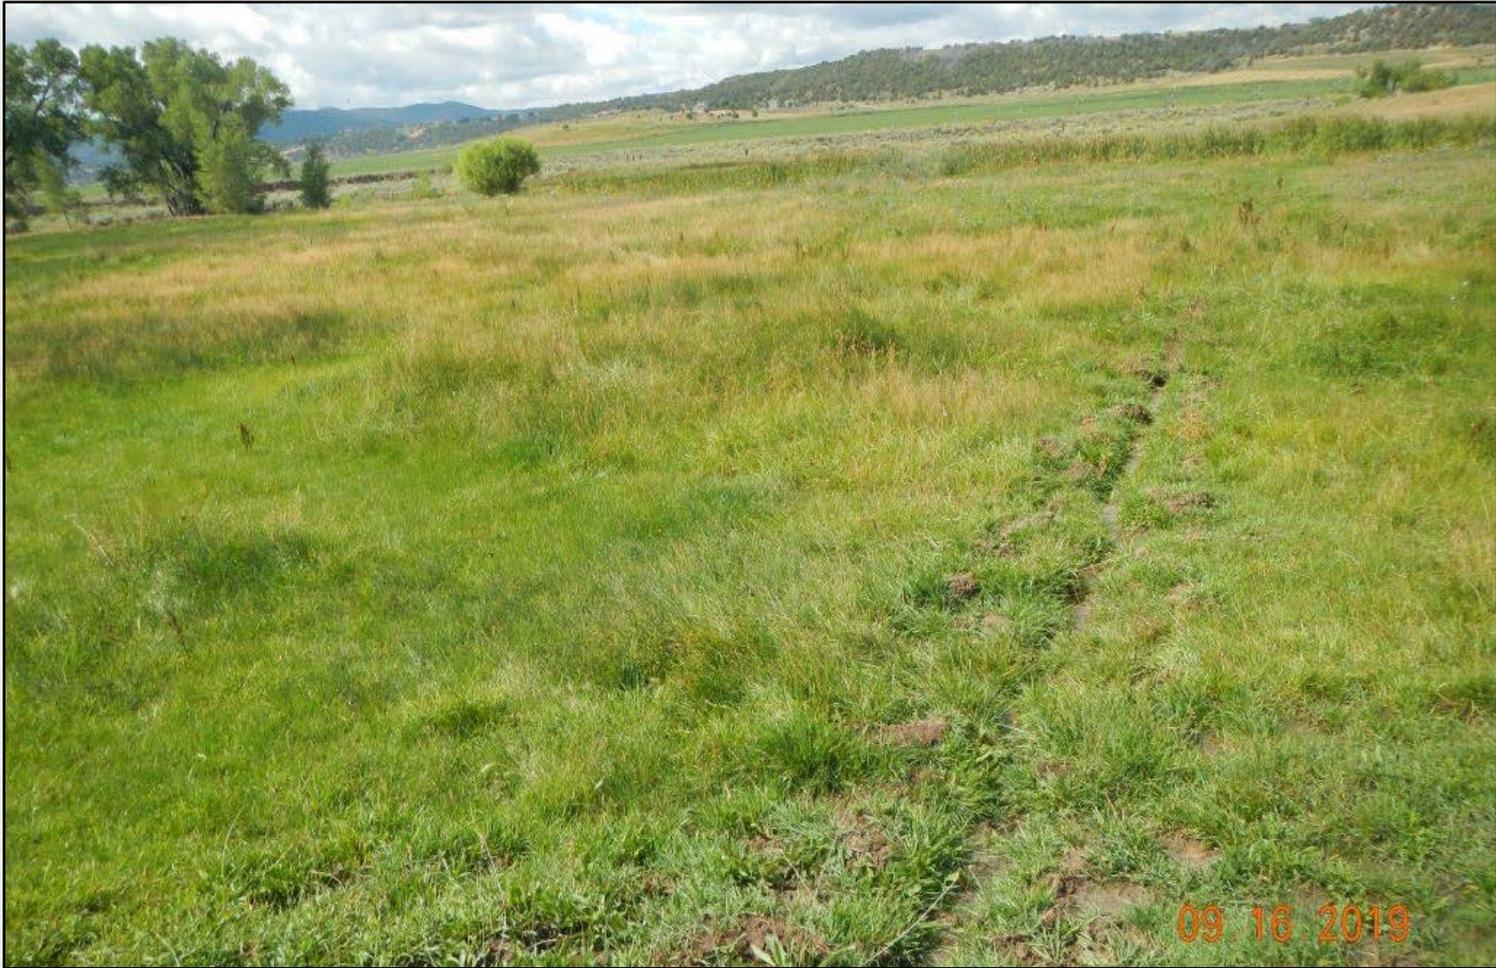
Photo 4. View of reference area vegetation, west of the project area, comprised of irrigated grass field, grasses mowed and not in identifiable condition.
