Inspection Photos

Operator: Hilcorp Energy
Location/API #: 067-06266
Date: 9-11-2019

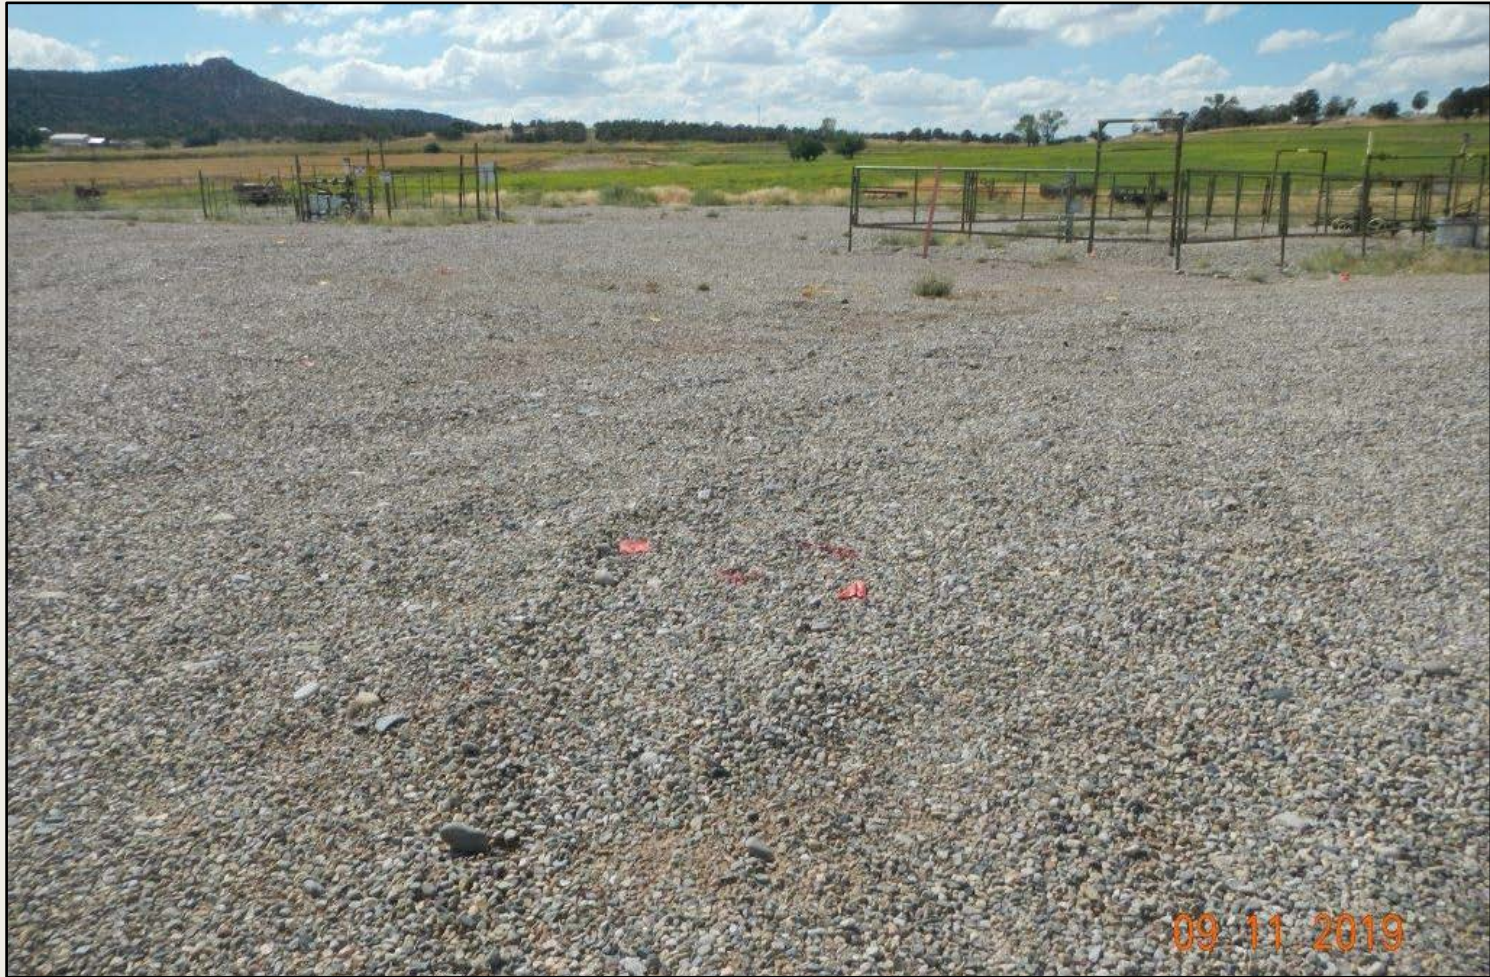
Photo 1. View of the project area from the southern corner facing center.

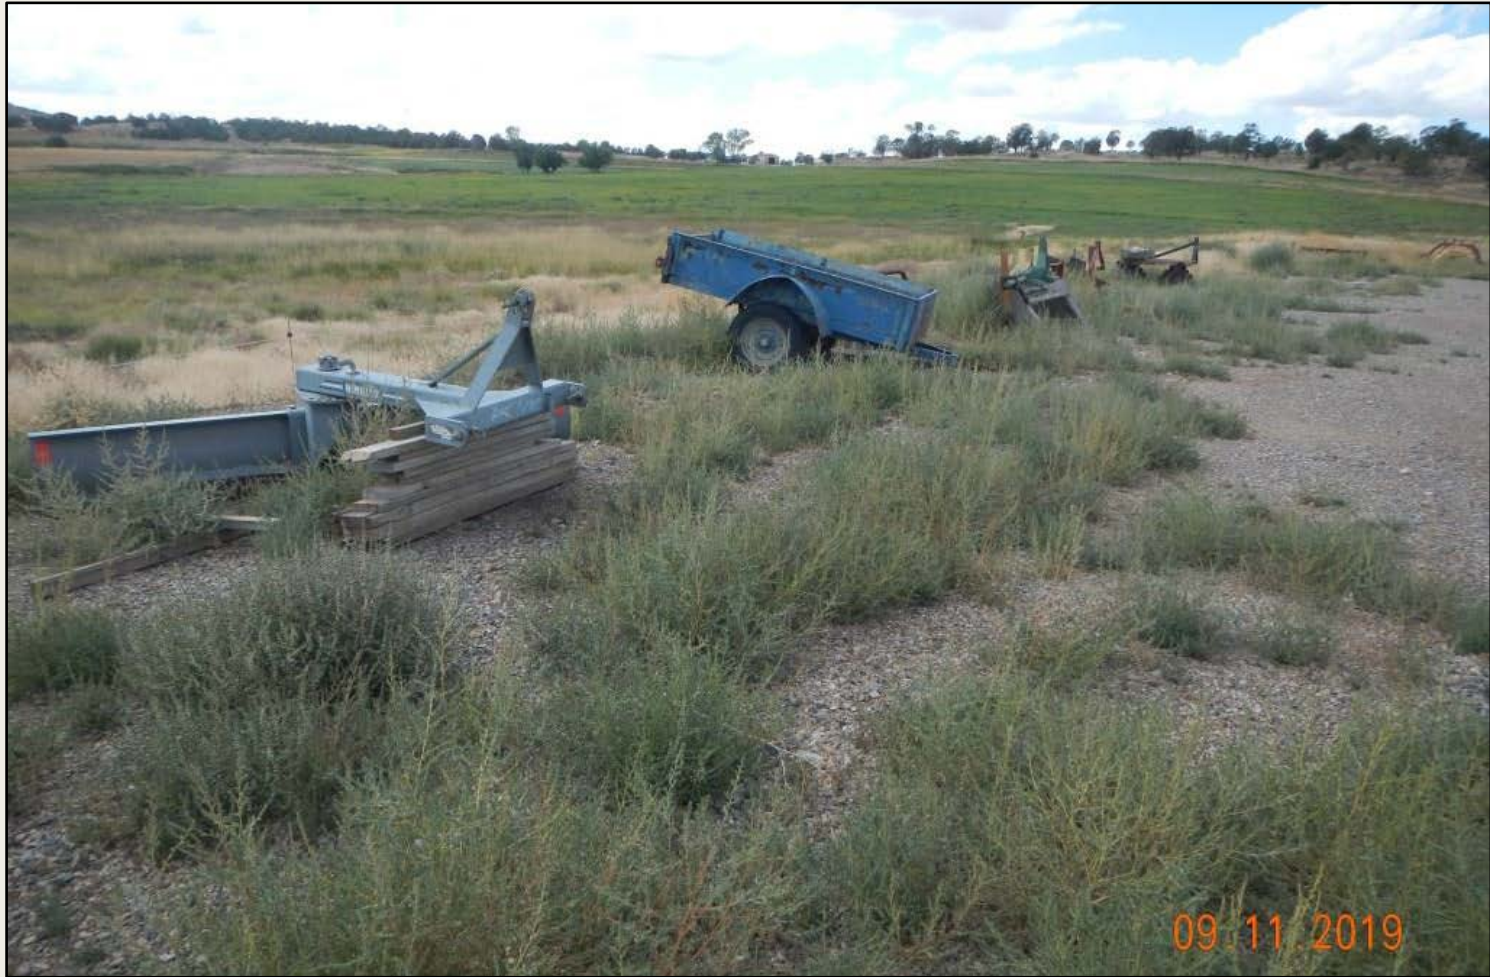
Photo 2. View of what appears to be surface owner equipment stored on the western portion of the well pad.

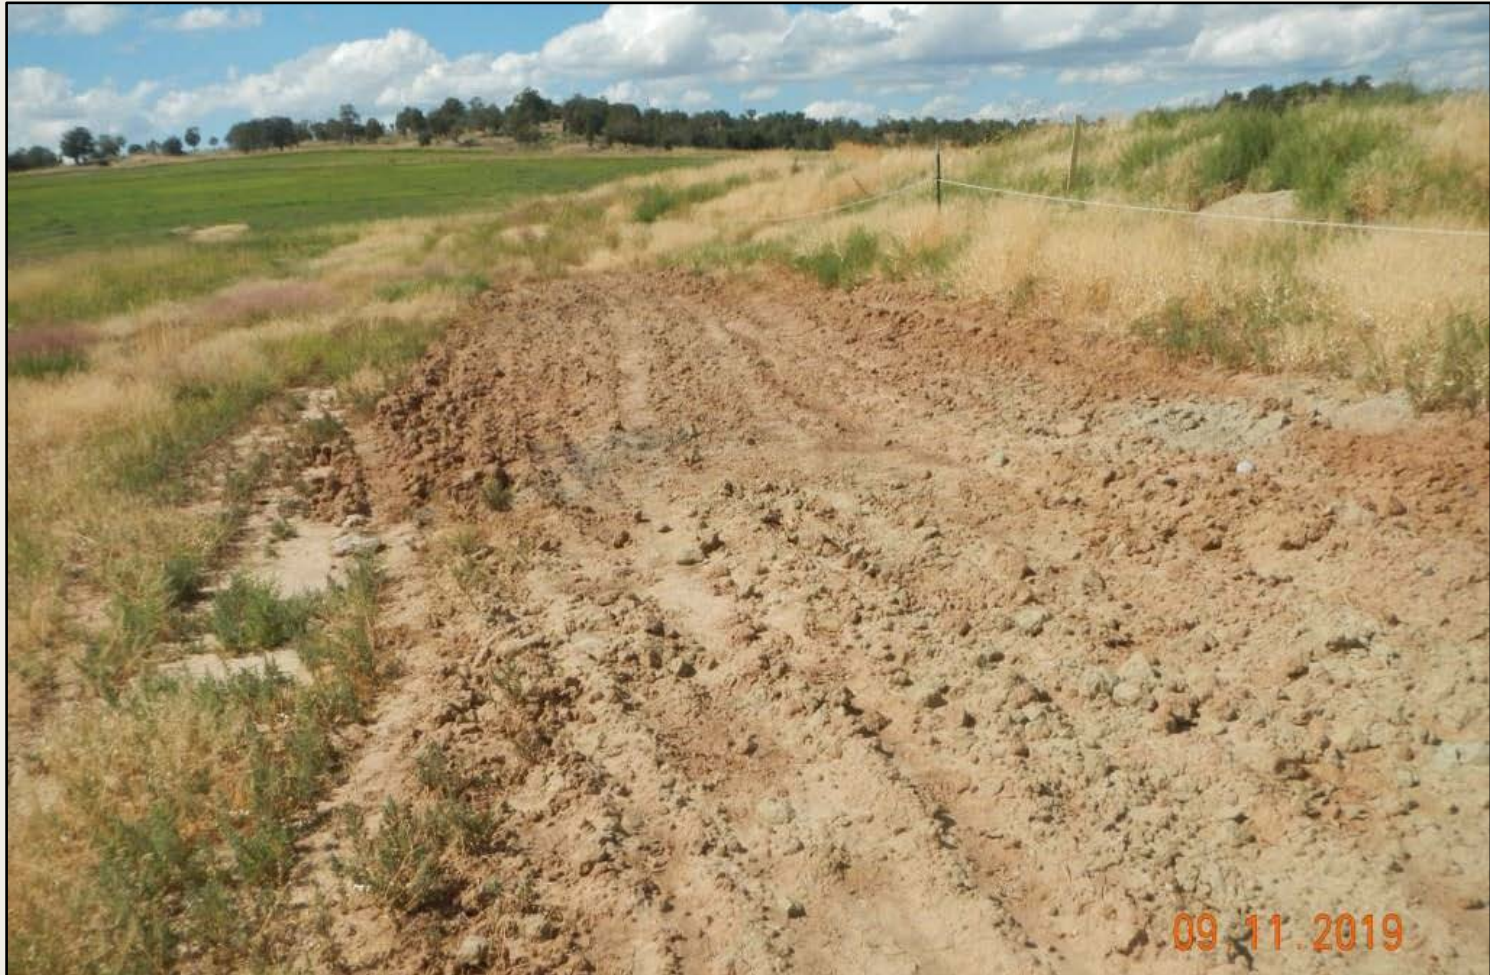
Photo 3. View of remediation area within the western project area facing northwestward. Area needs revegetation.

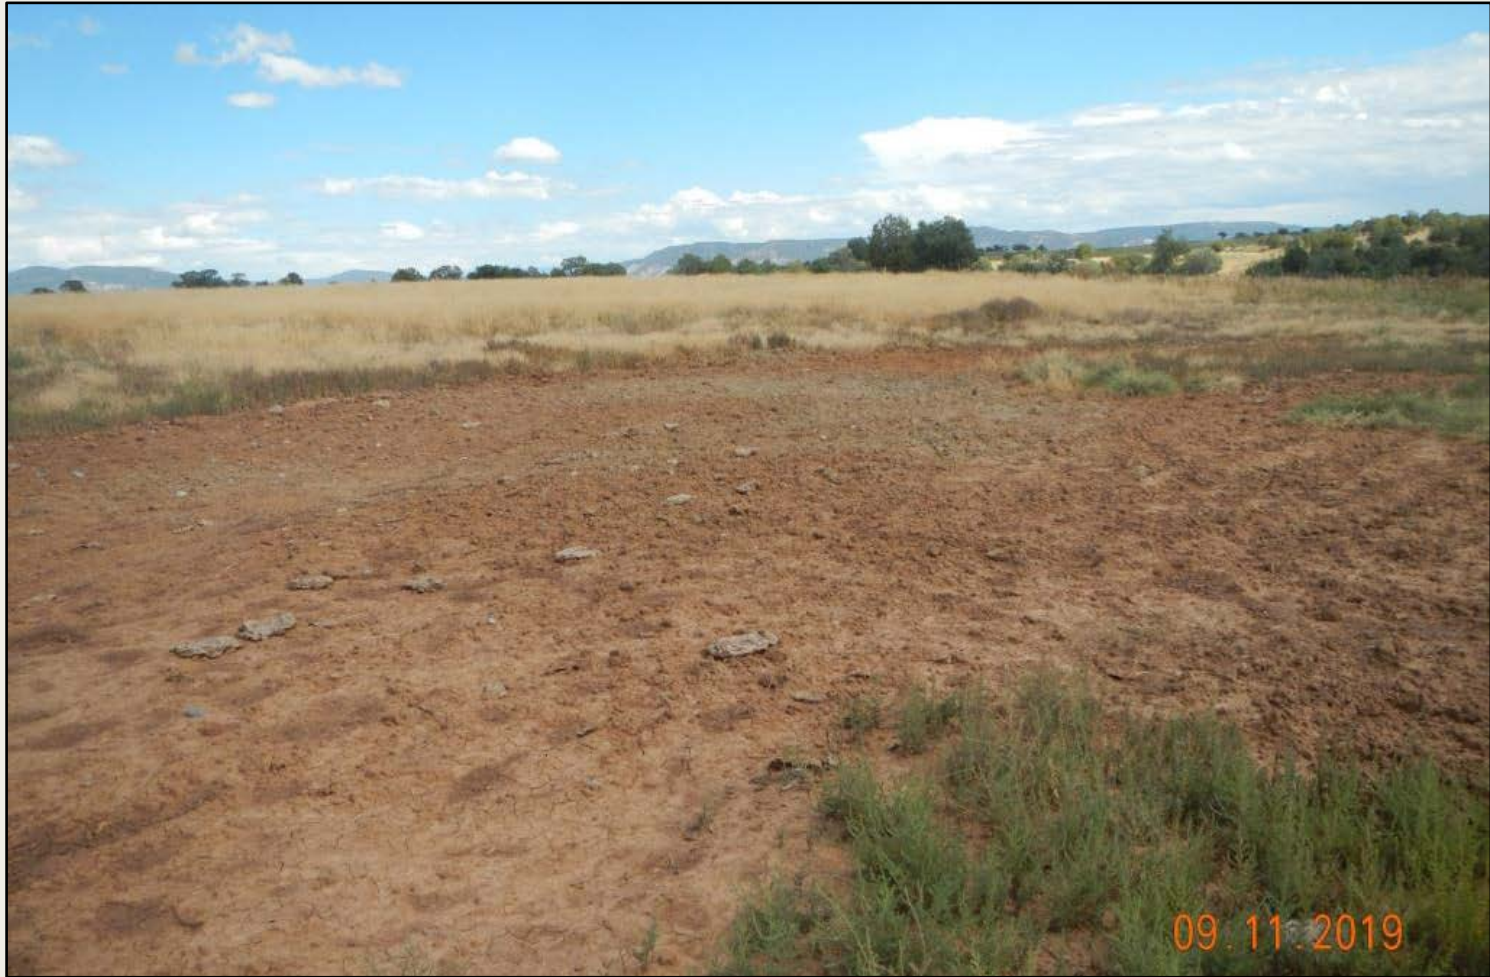
Photo 4. View of remediation area within the southwestern project area facing southward. Area needs revegetation.

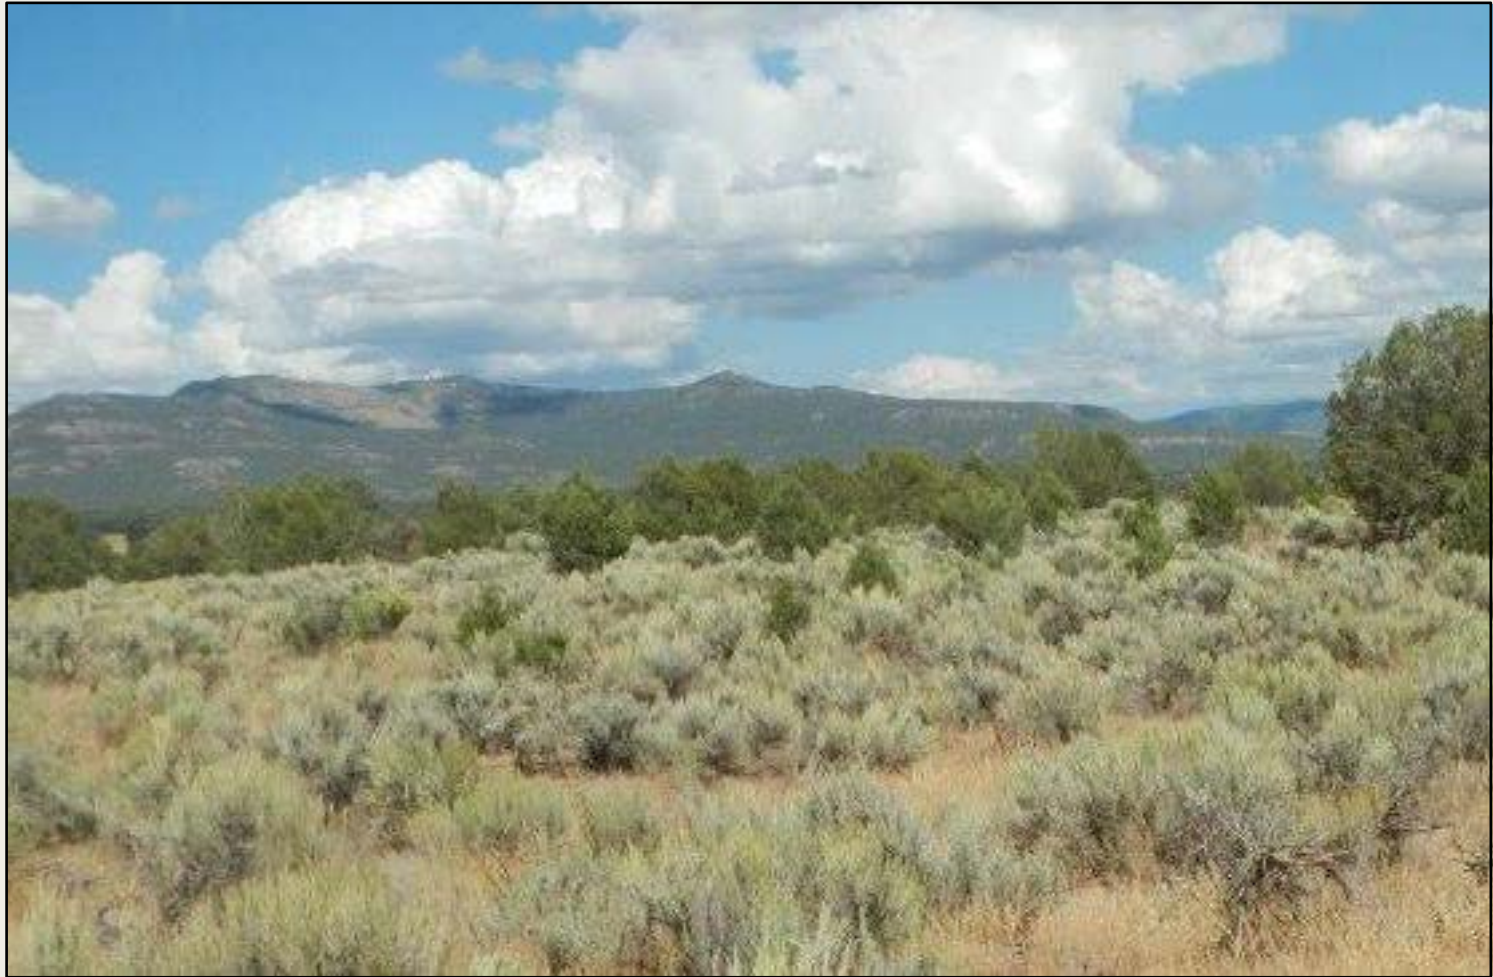
Photo 6. View of reference area vegetation east of the project area, largely comprised of sagebrush shrubland and open juniper woodland.
