Inspection Photos
Operator: BP America
Location/API #: 067-07590
Date: 9-11-2019

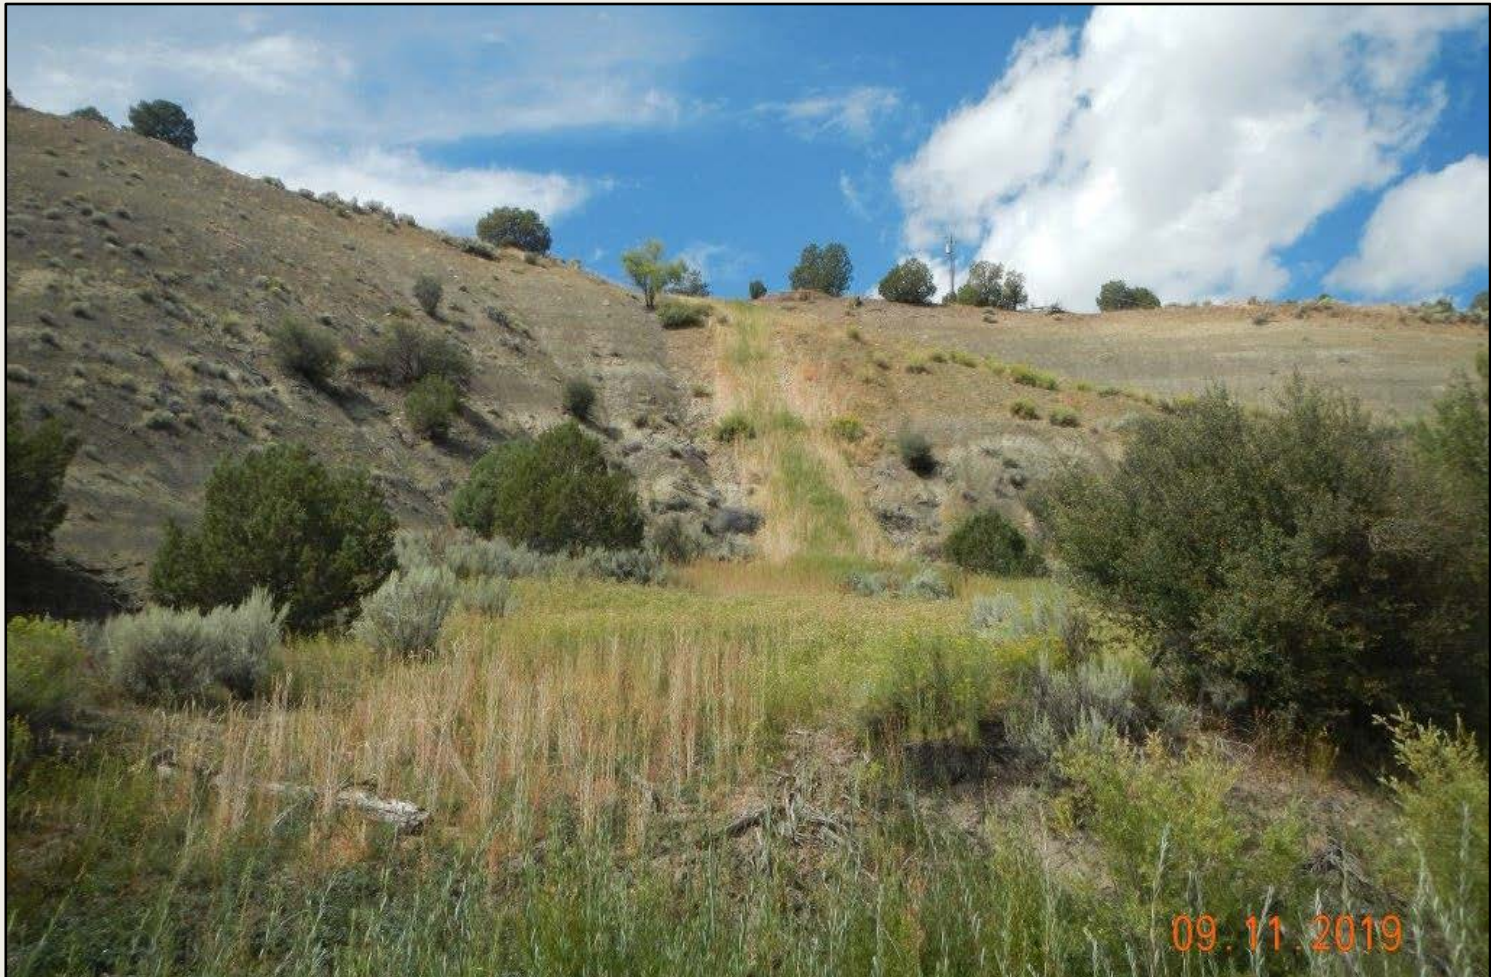
Photo 1. View of the release area facing upslope. Vegetation is largely comprised of annual covercrop wheat (brown) and kochia (green).

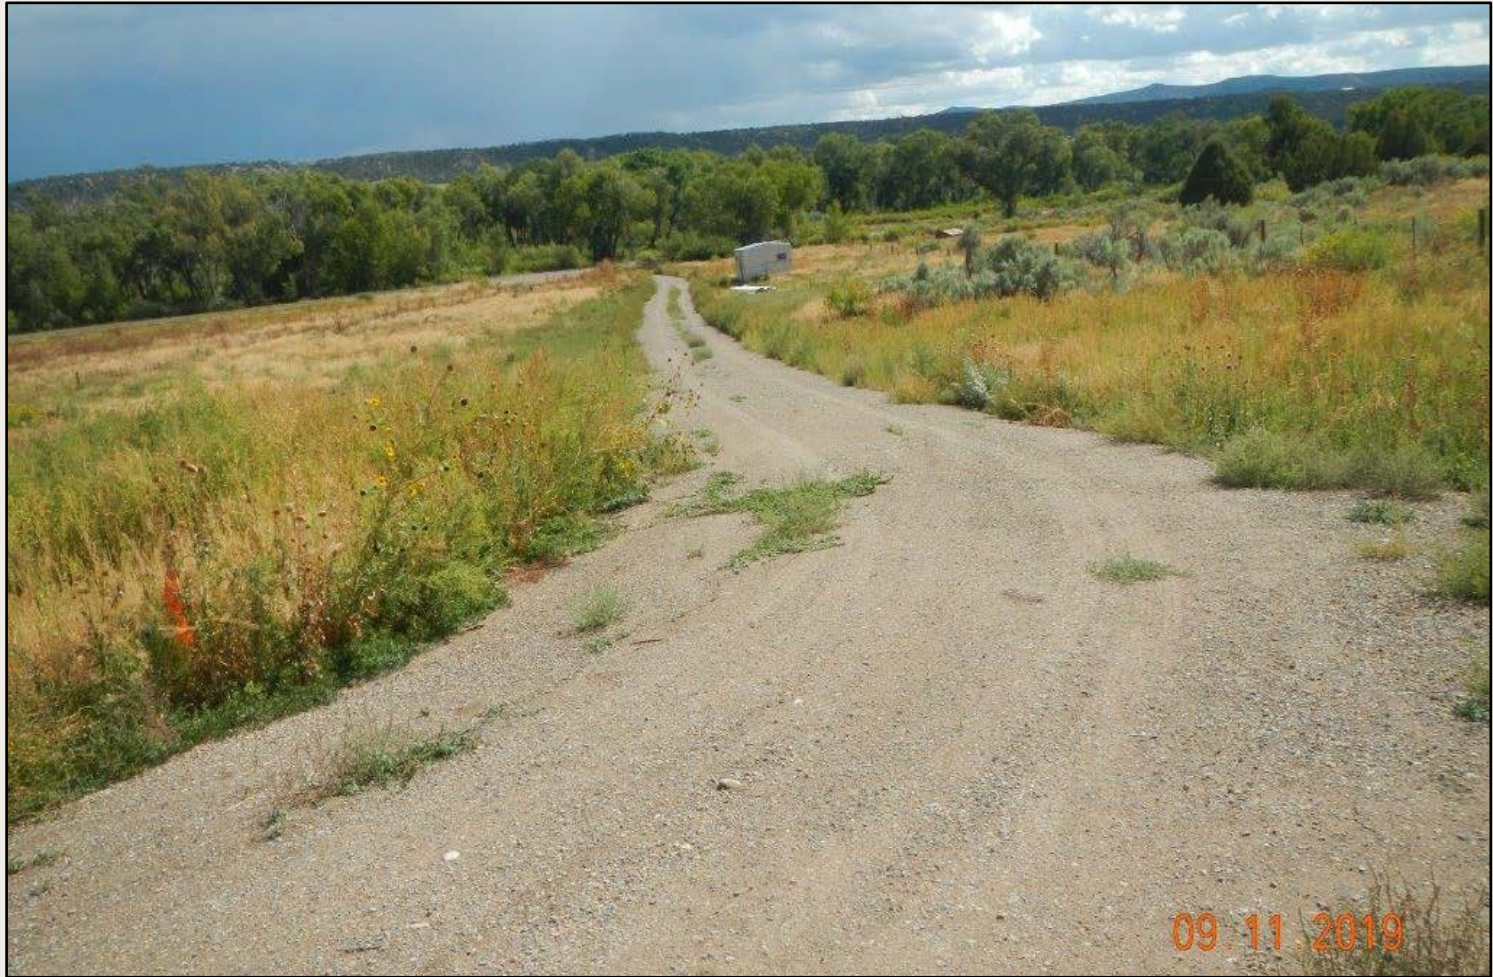
Photo 2. View of road created to remediate the release, needs to be reclaimed.

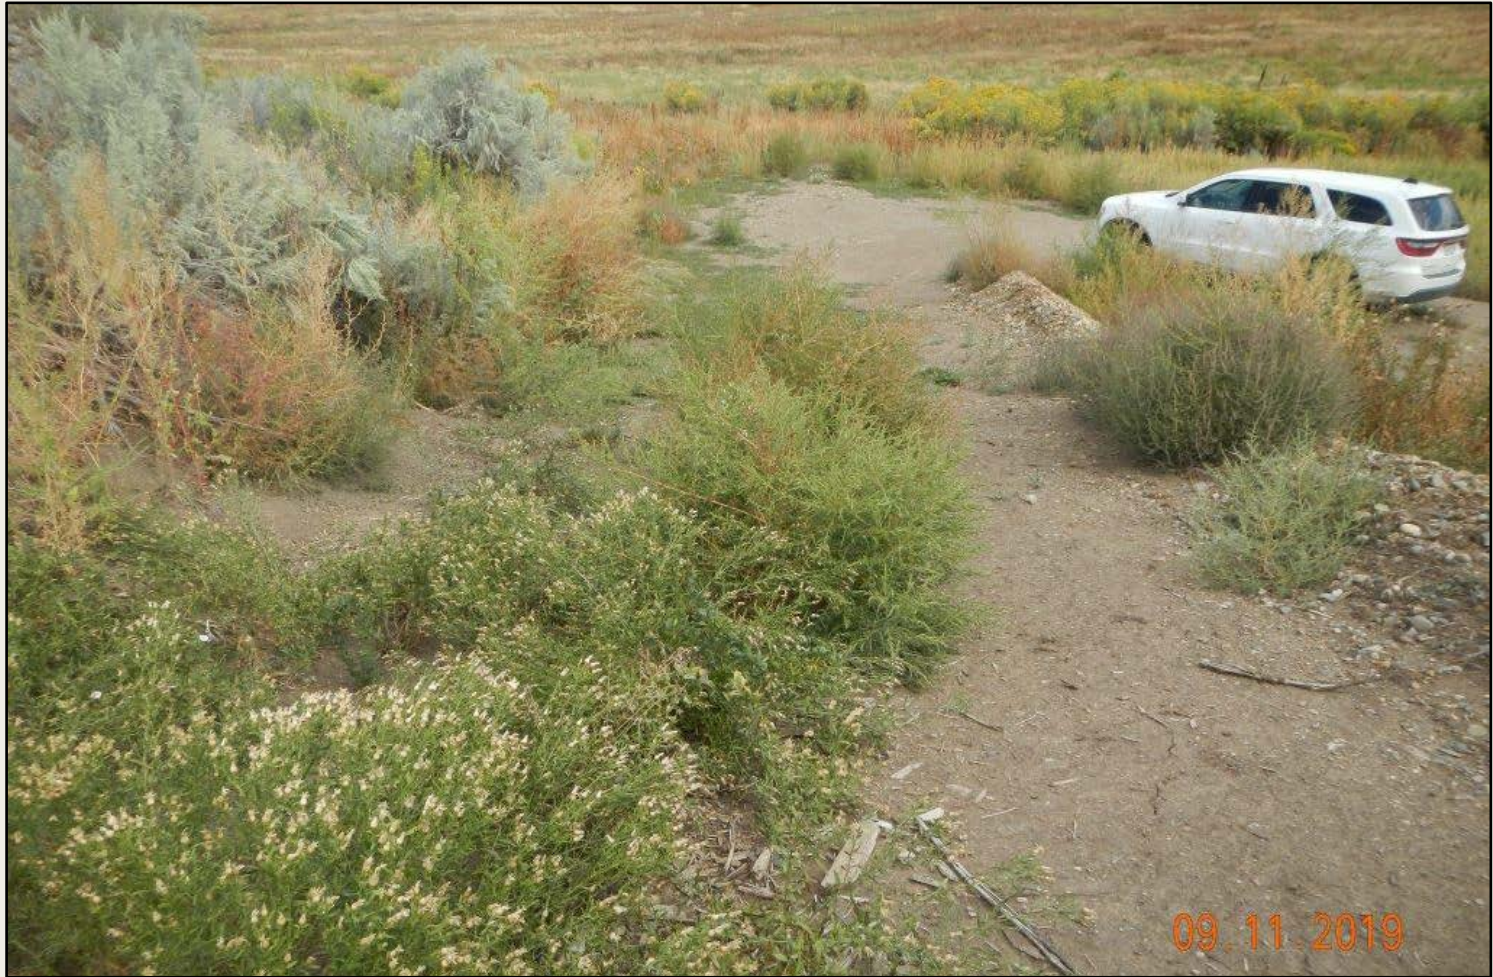
Photo 3. View of Russian knapweed at bottom of slope to access point for release, needs to be controlled.

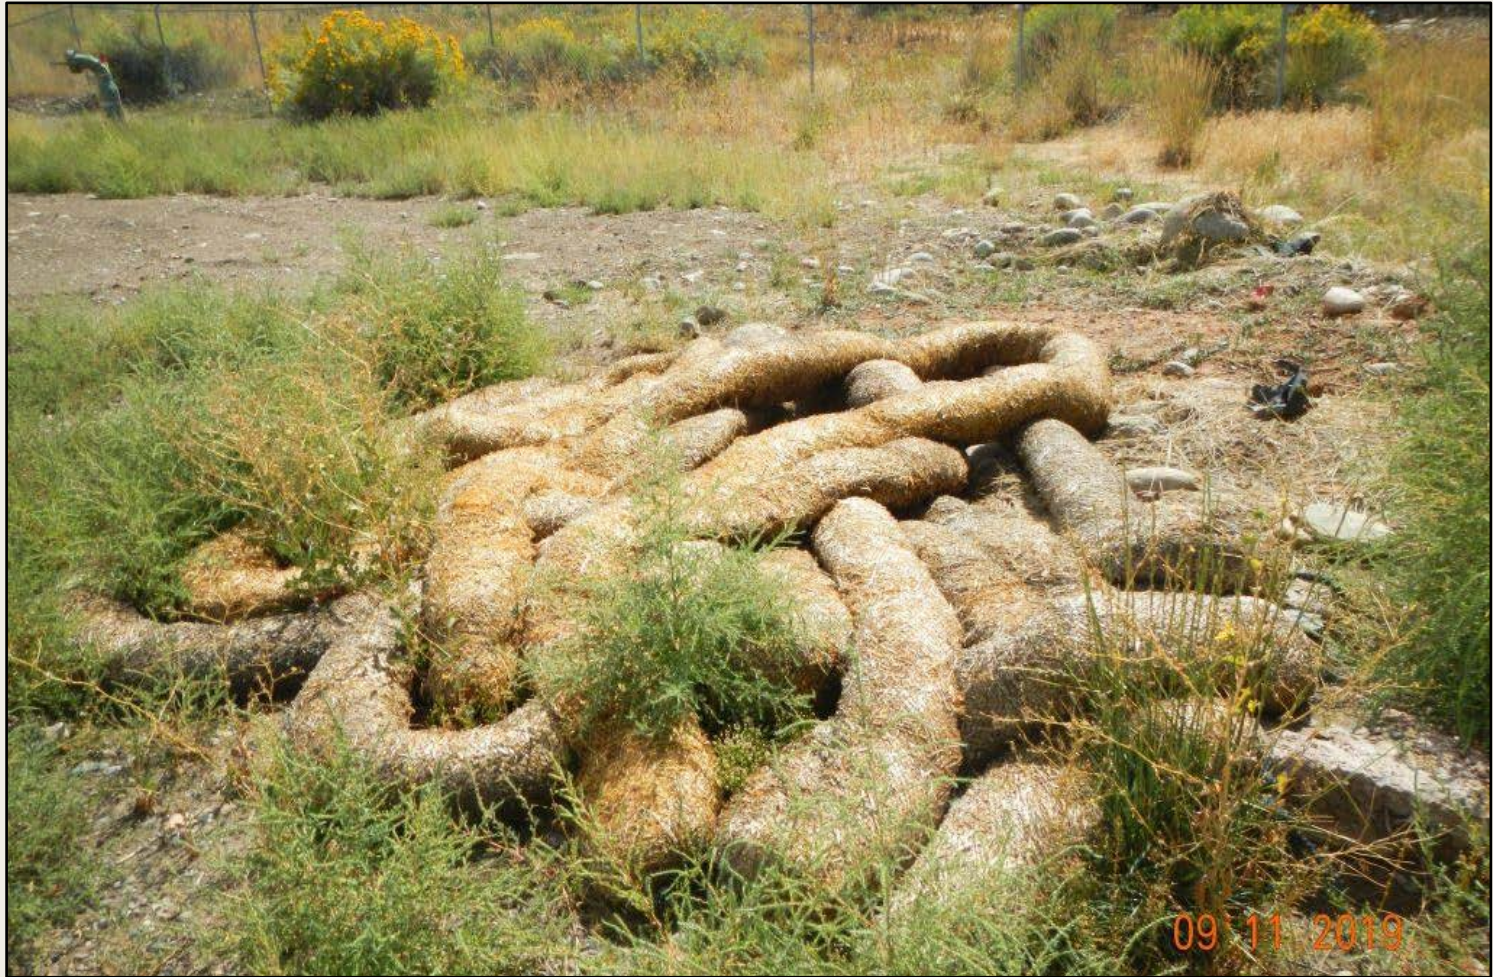
Photo 4. View of wattle debris within the well pad area.

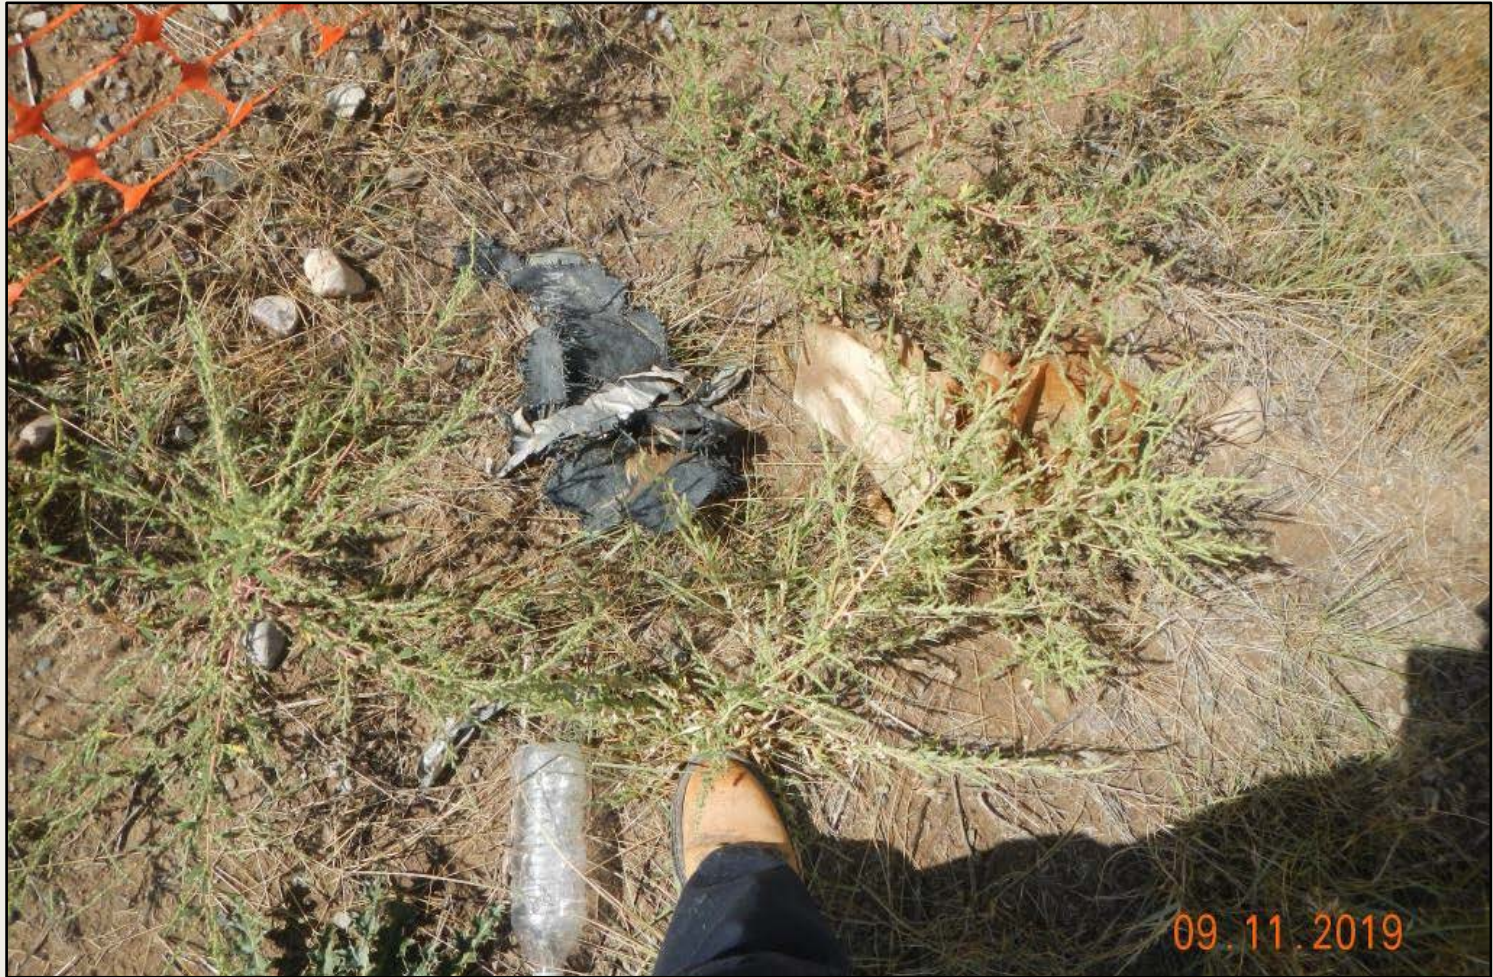
Photo 5. View of example of trash and debris within the project area.

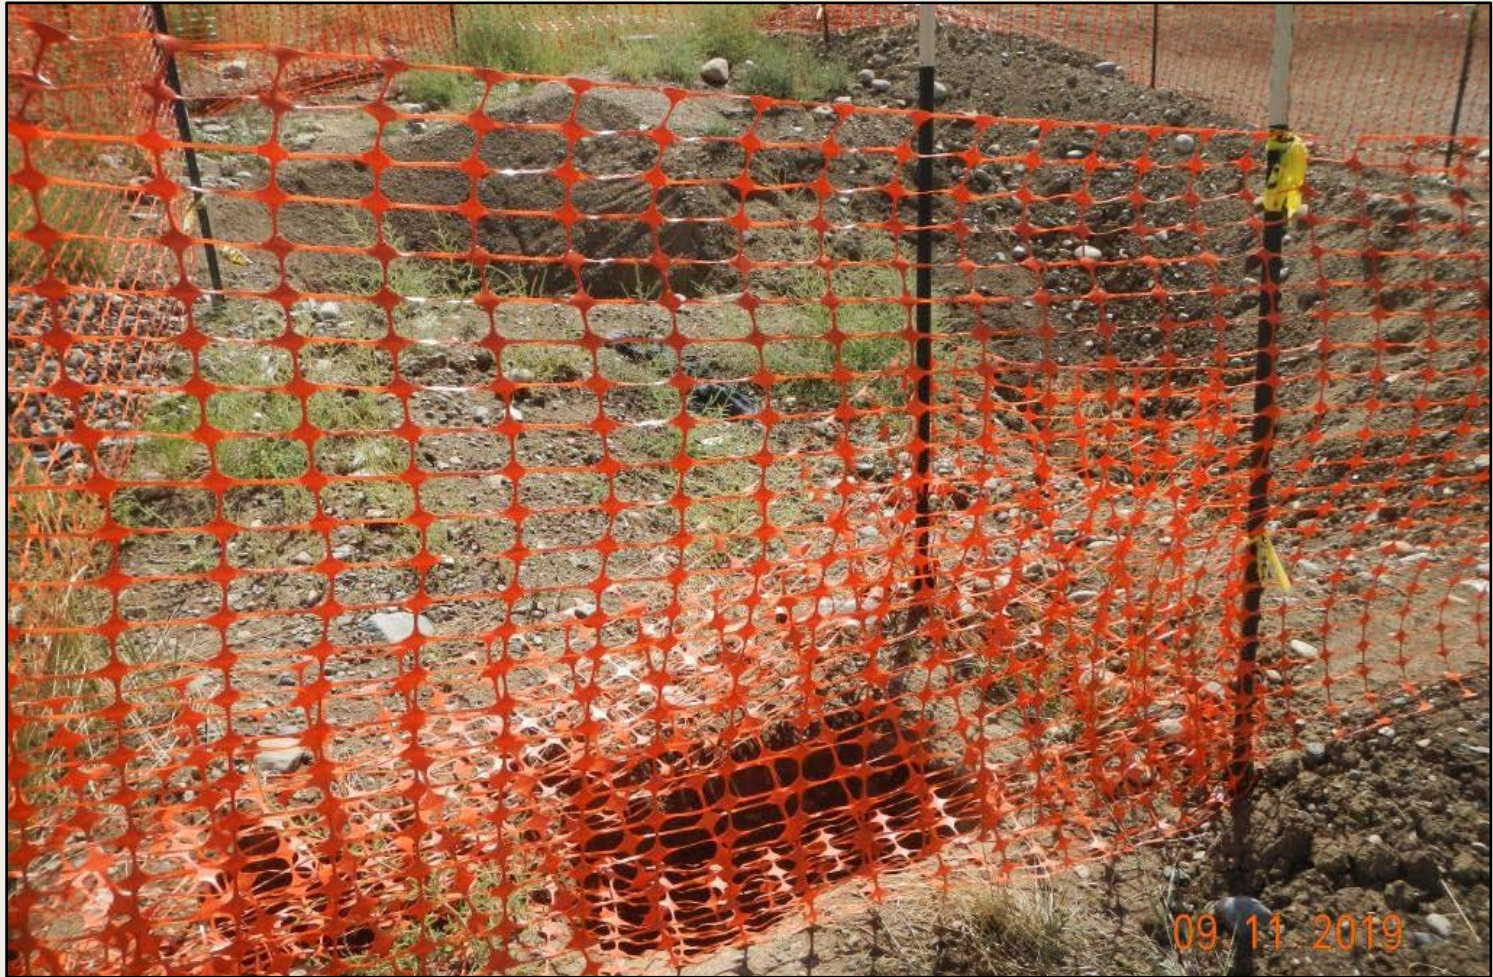
Photo 6. View of holes within the project area. Fencing is not sufficient to mitigate wildlife risk, and holes need to be filled.

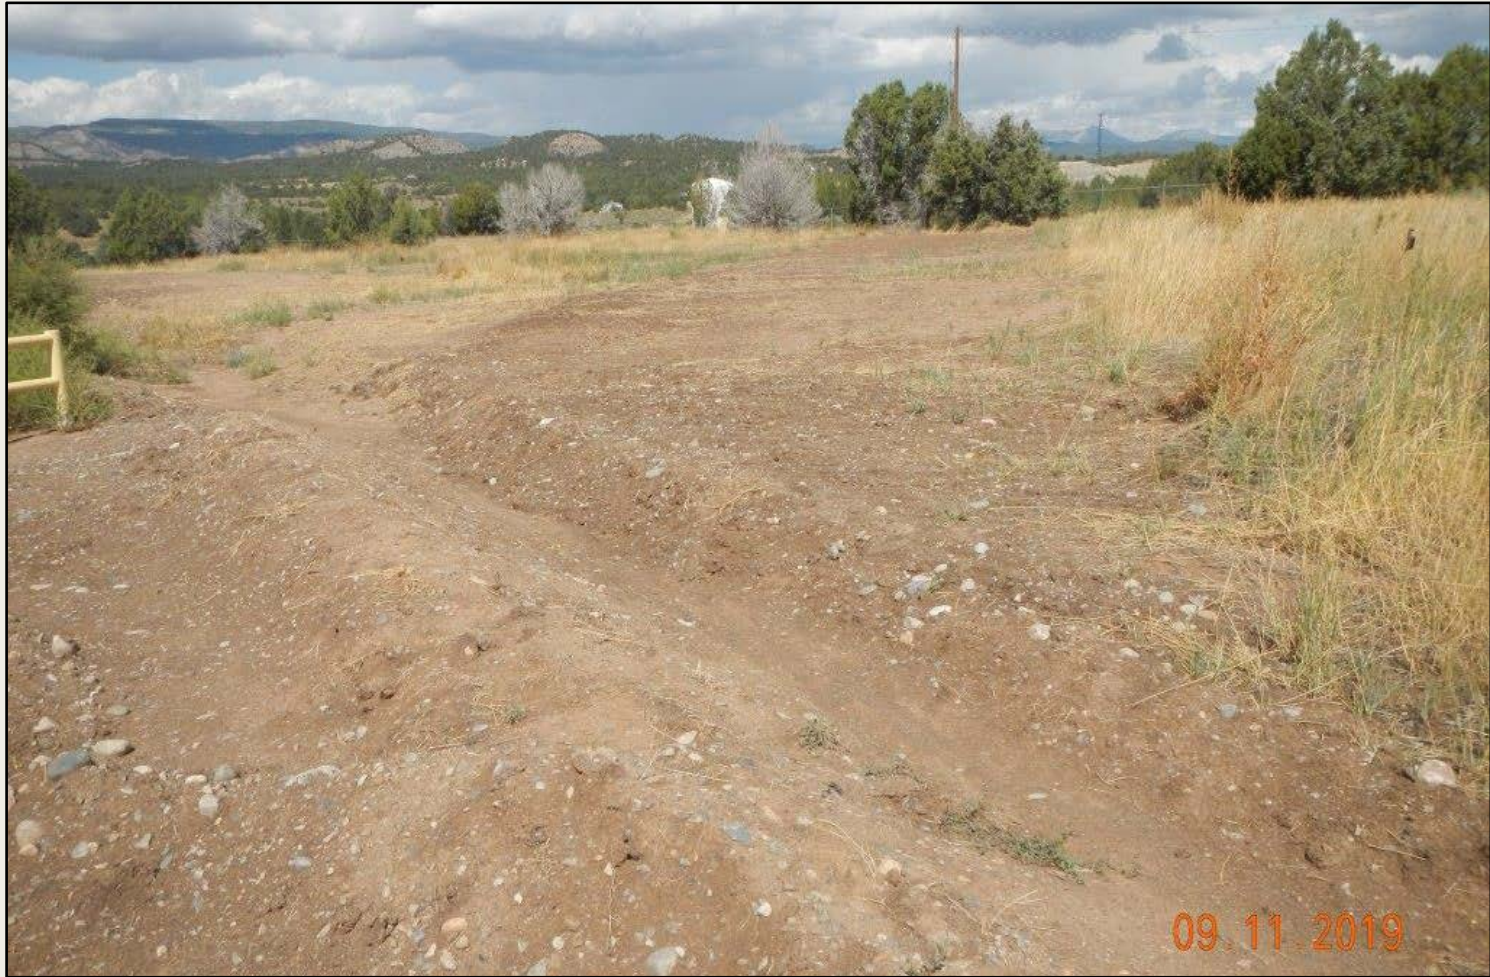
Photo 7. View of area within the eastern project area that was recently disturbed and appears to be seeded.

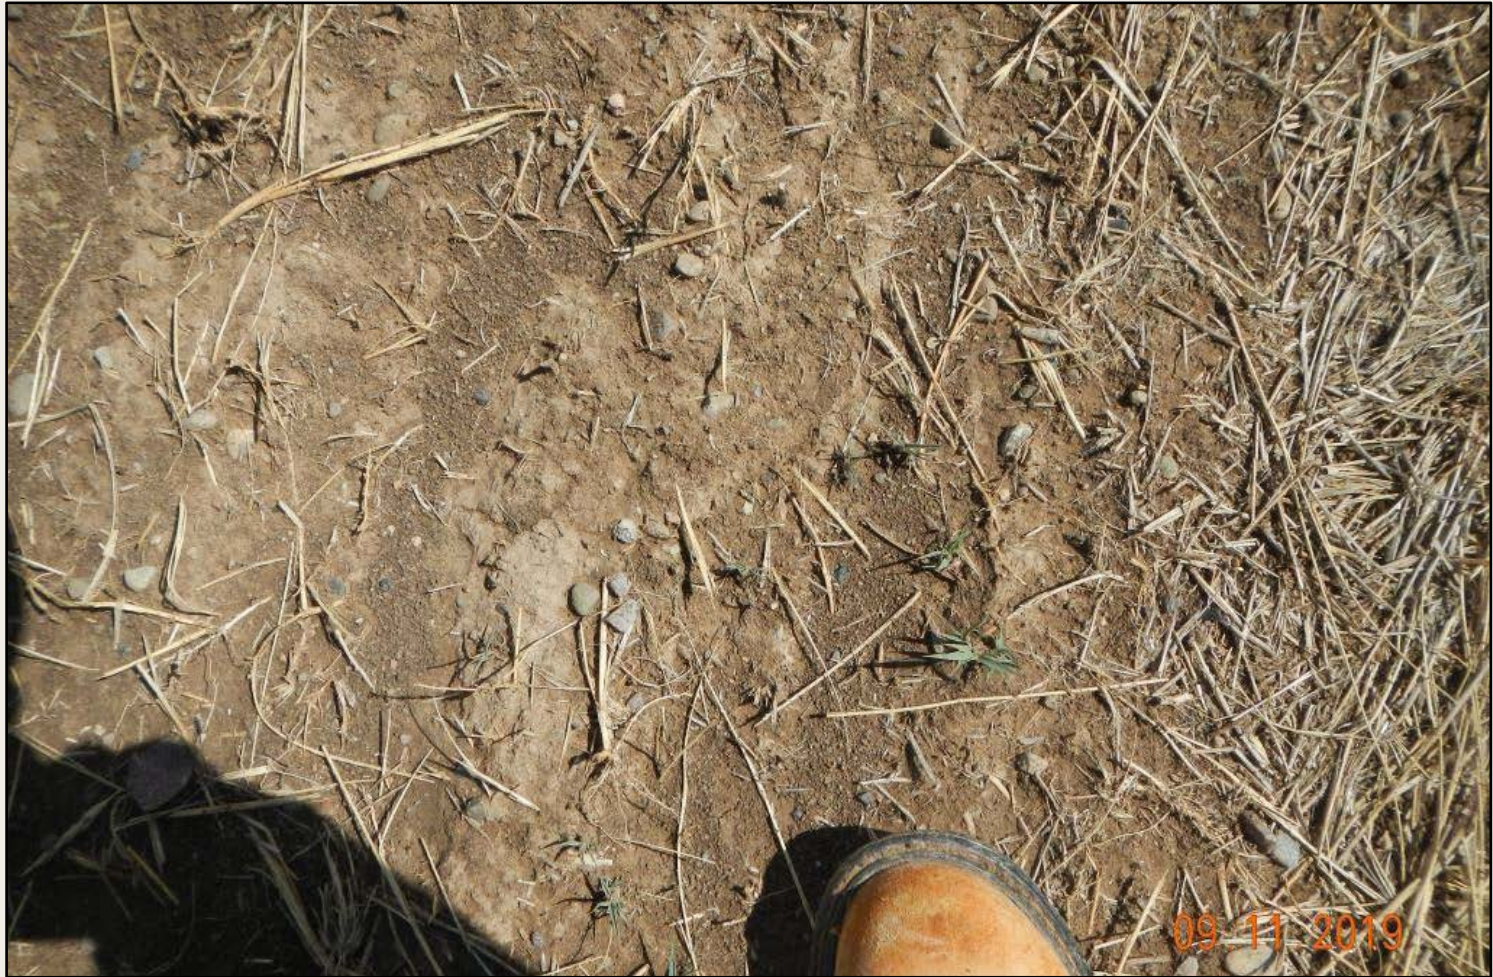
Photo 8. Birdseye view of grass seedlings observed within eastern revegetation area.

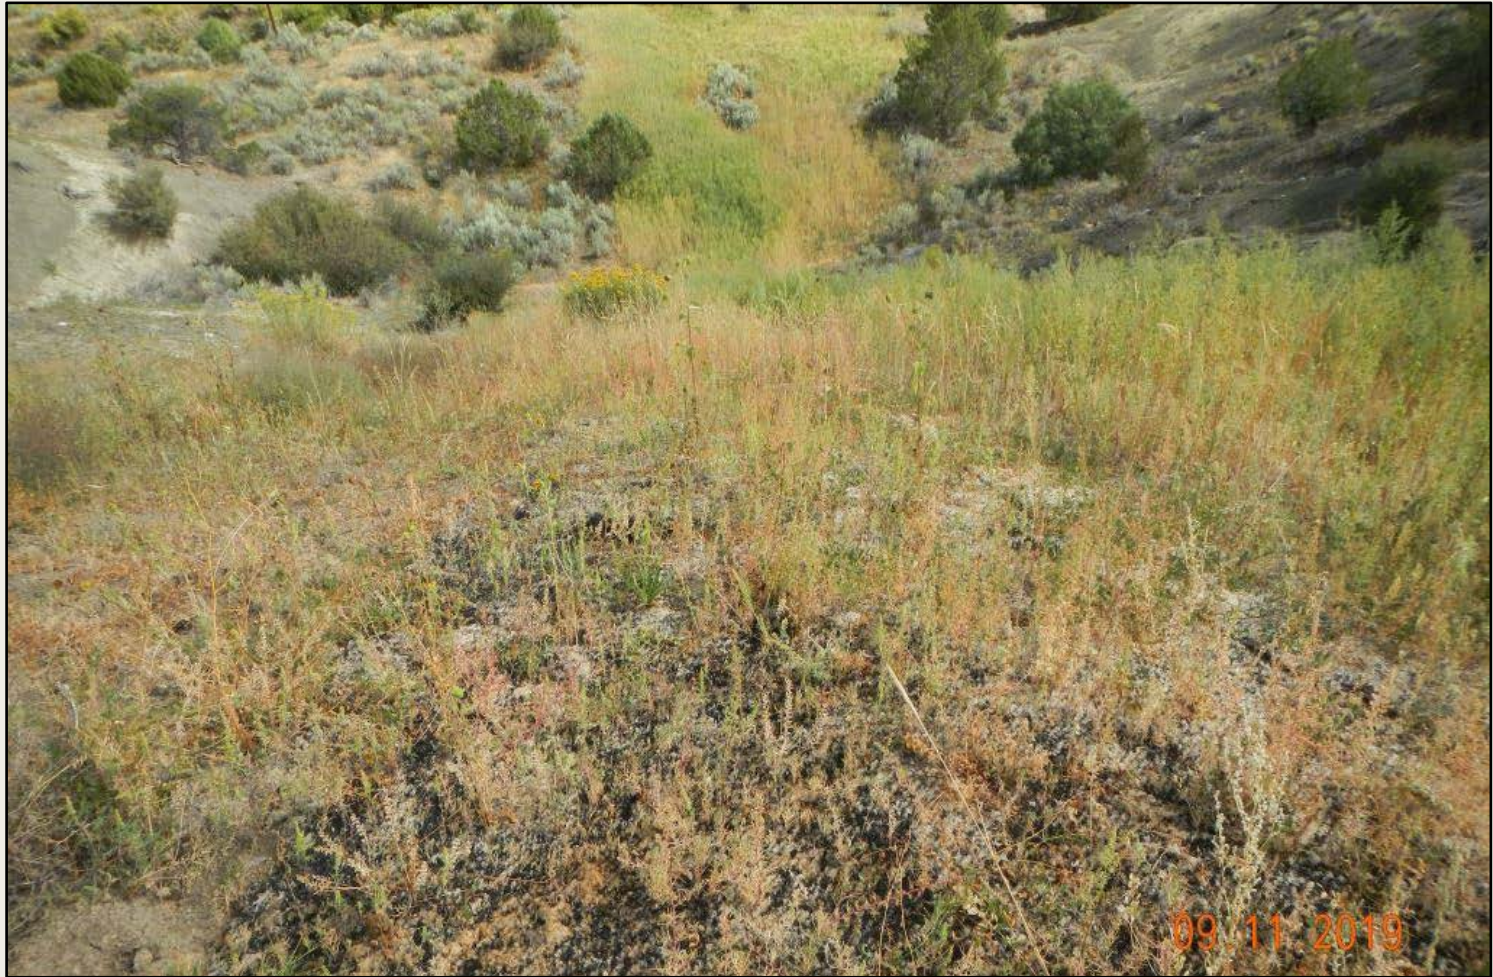
Photo 9. View of release area on hill slope. Geogrid material is installed in portions of slope and appears to be functioning at this time.

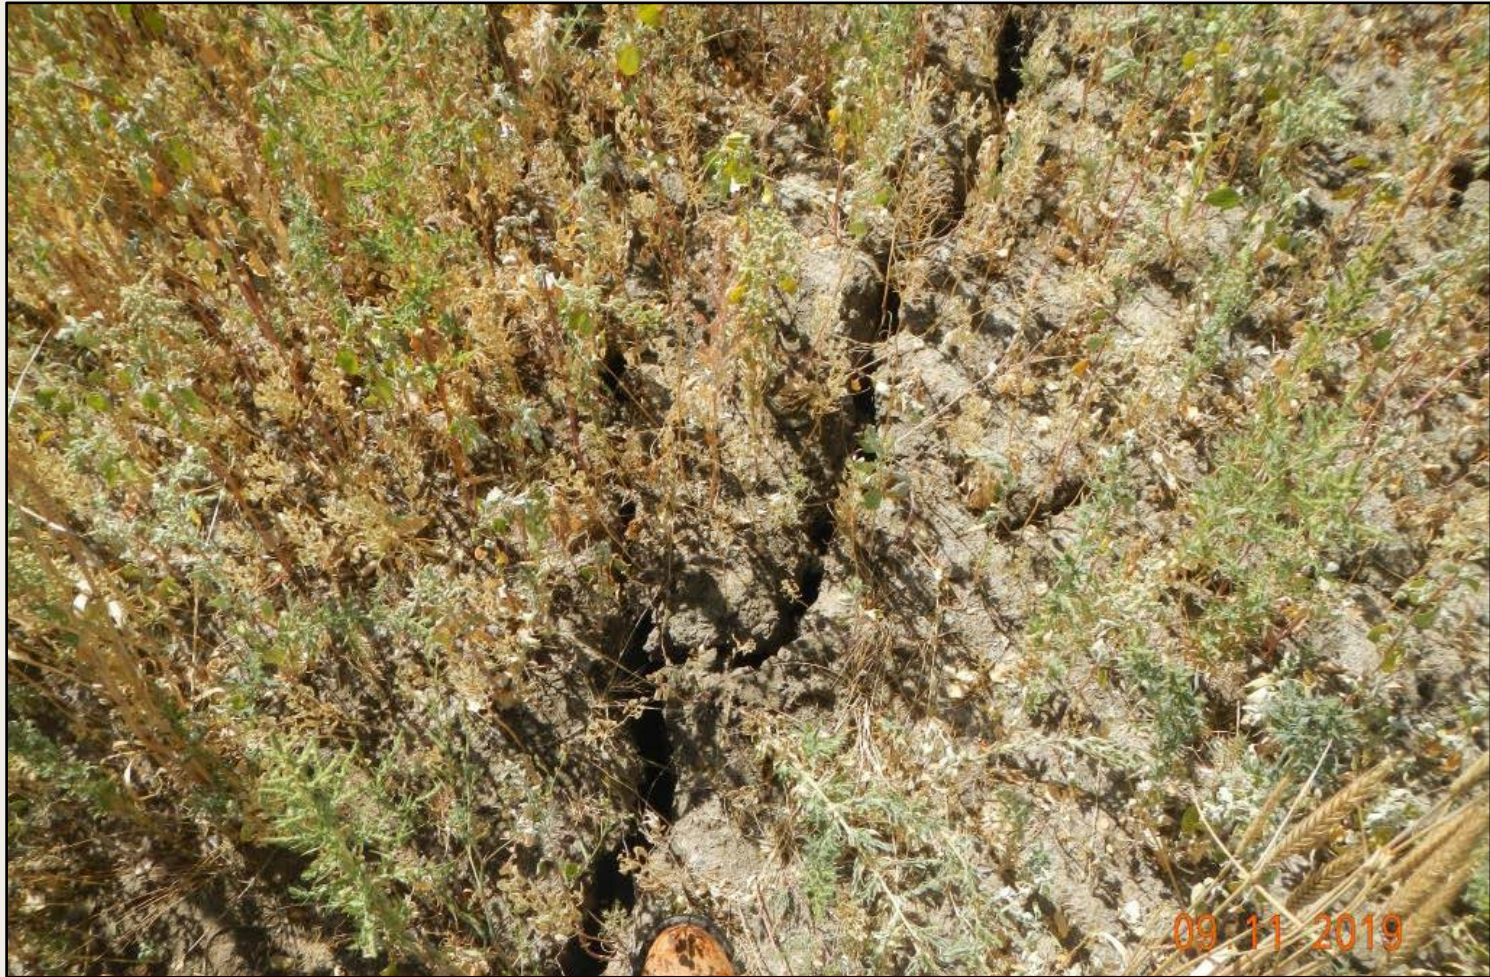
Photo 10. Birdseye view of vegetation on slope, largely comprised of weedy annual kochia, and annual covercrop wheatgrass. Cracking observed in many places of the soil appear to indicate stabilization concerns on slope.

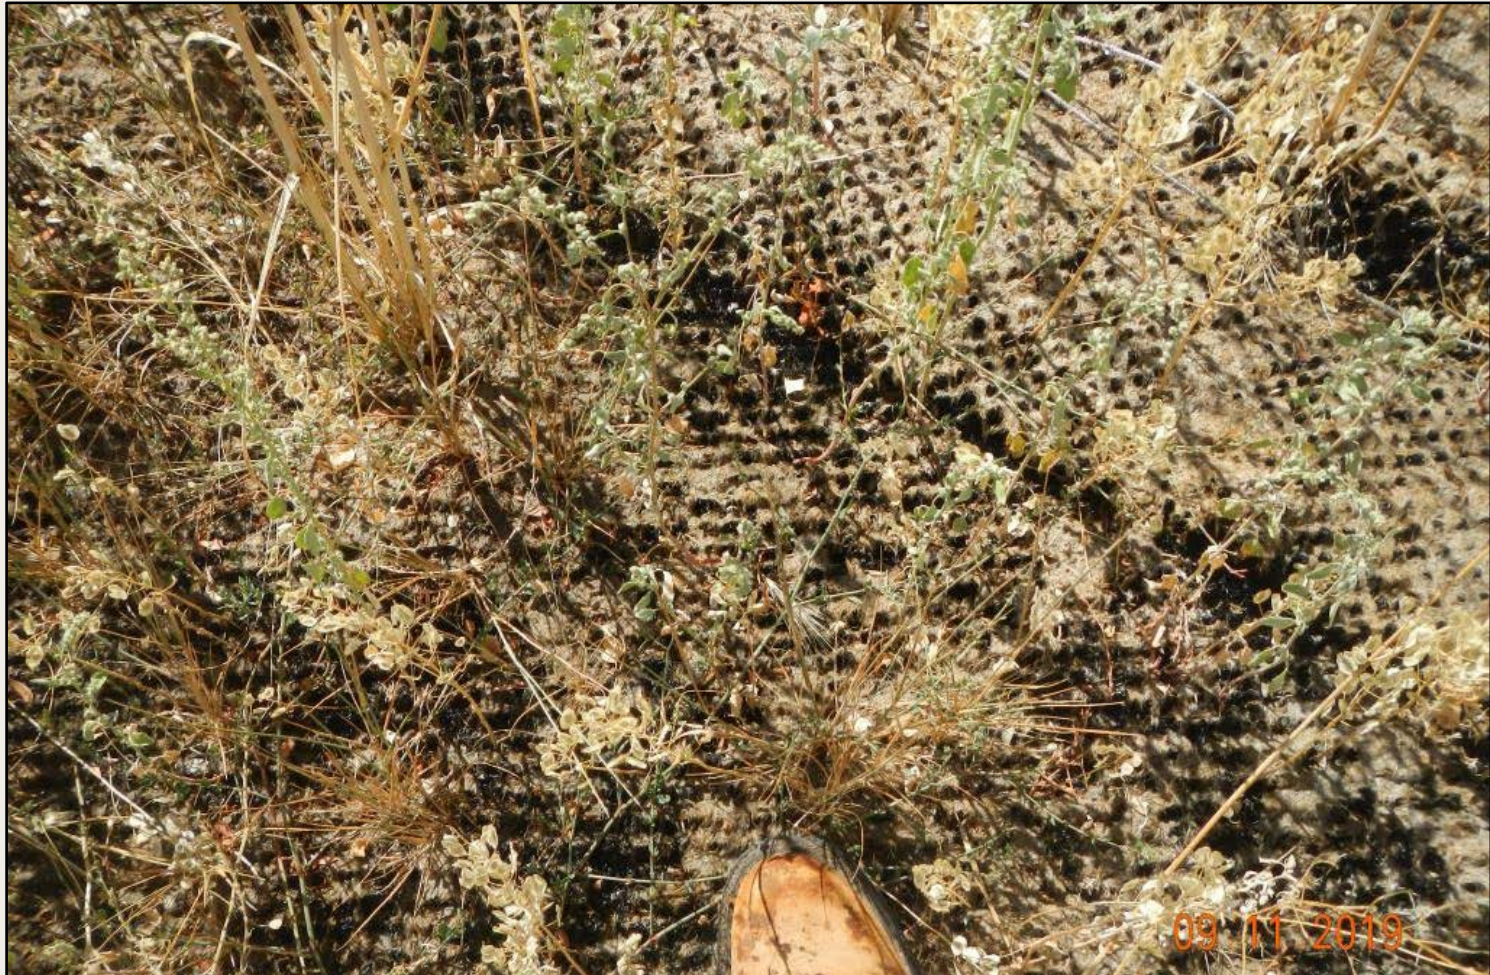
Photo 11. Birdseye view of perennial grasses growing within a portion of the release area.

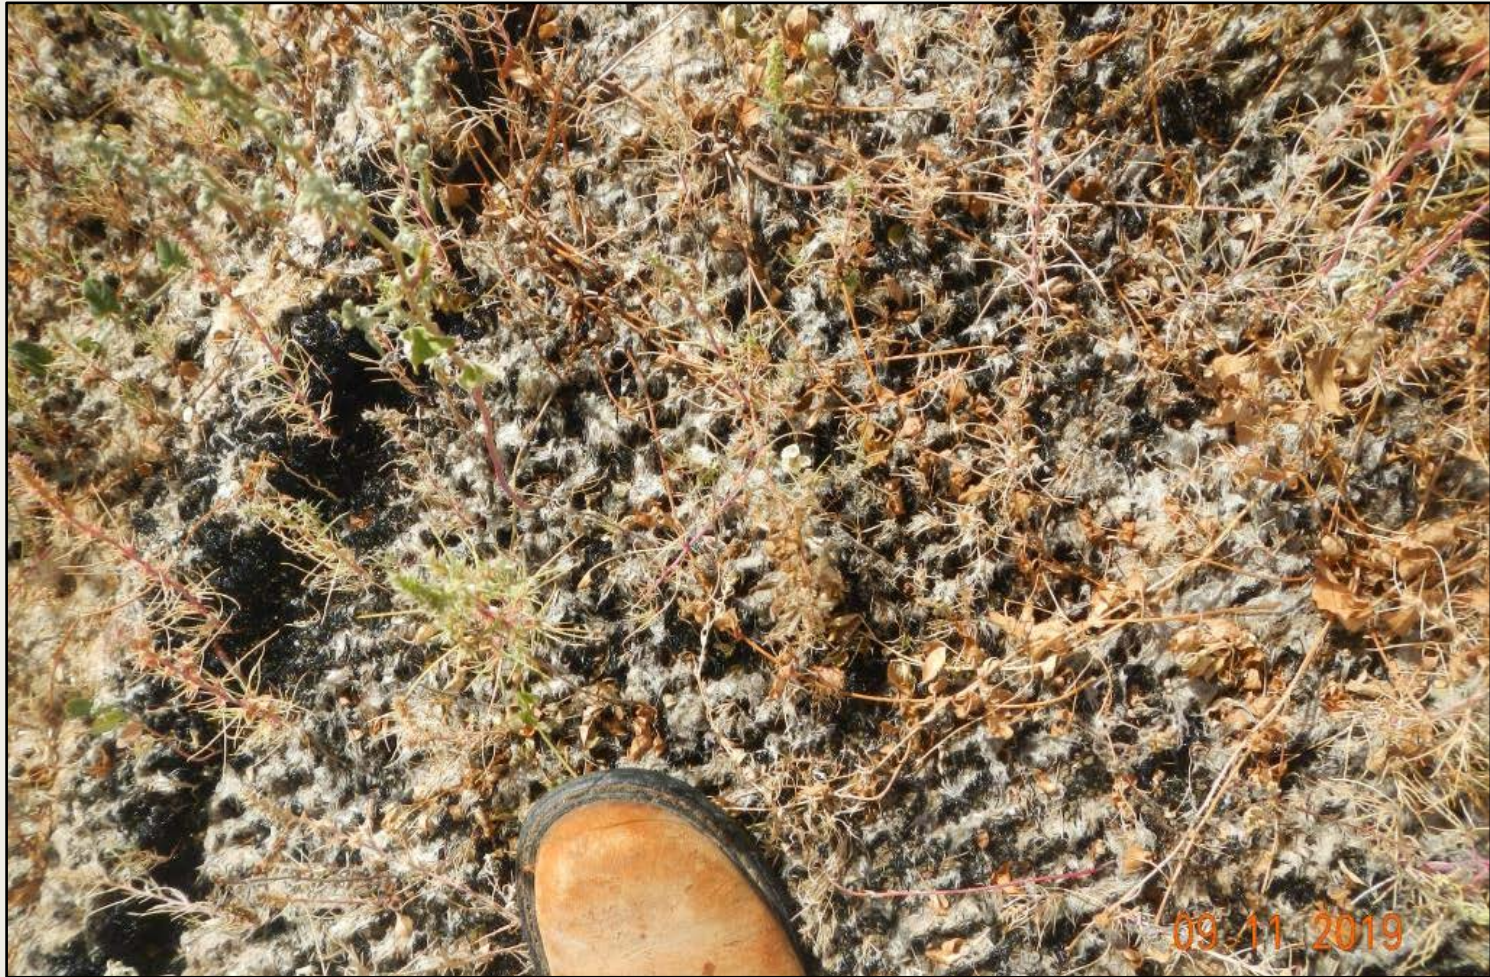
Photo 12. Birdseye view of annual weeds such as kochia, Russian thistle, and field bindweed within release area.

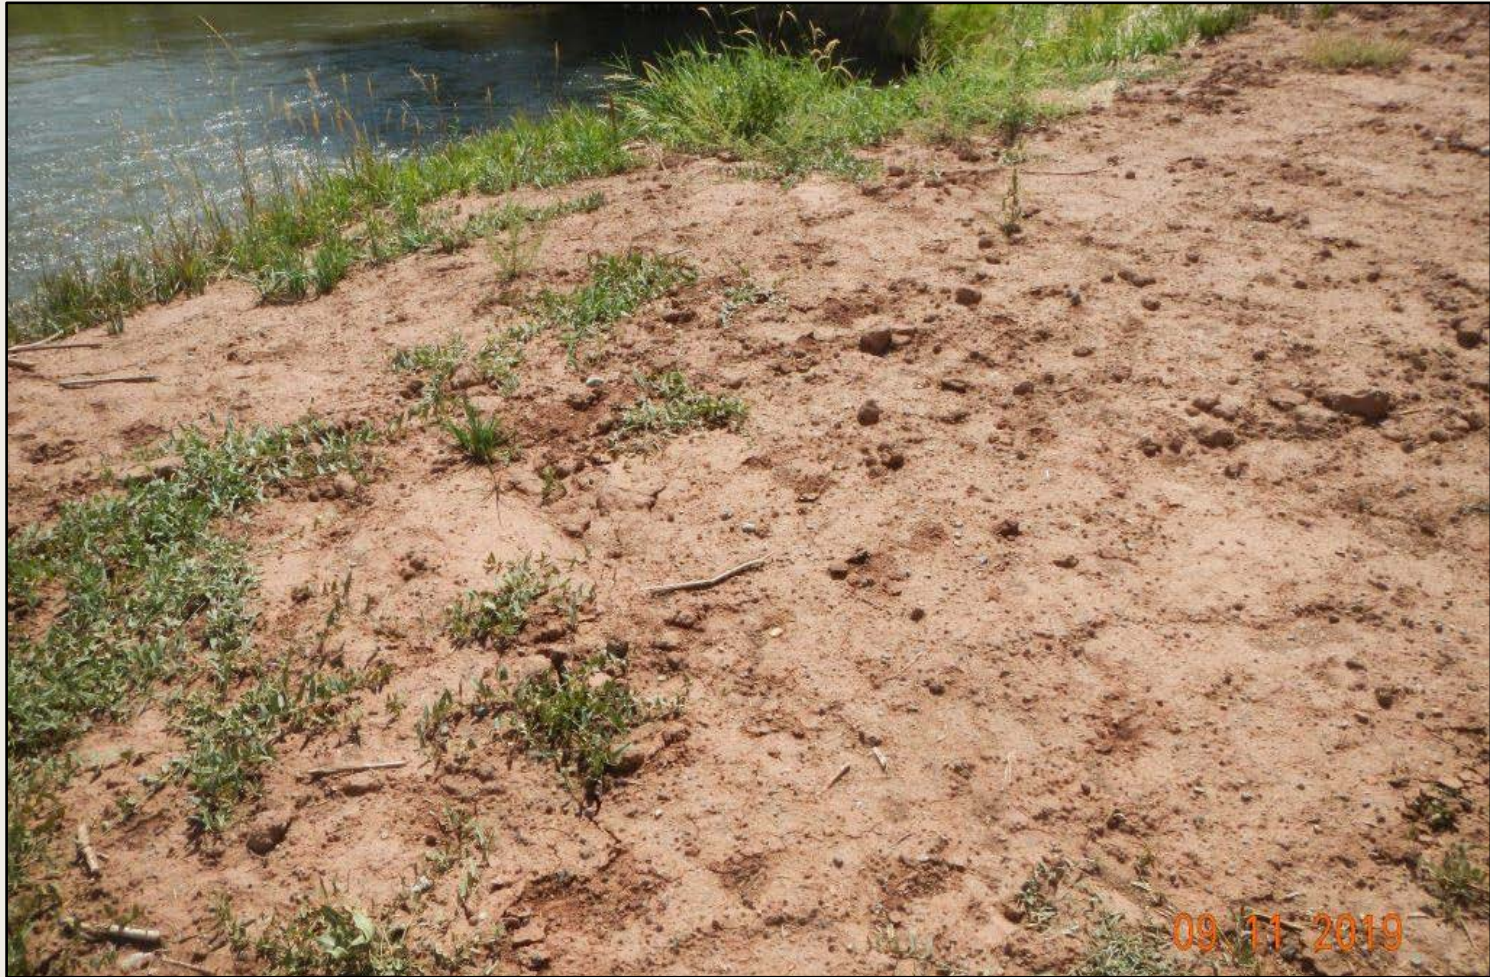
Photo 13. View of disturbance area downstream from release at irrigation canal that is adjacent to BIA 111 Road. Revegetation does not appear to be progressing here and needs to be re-seeded. Bare soils need erosion controls.

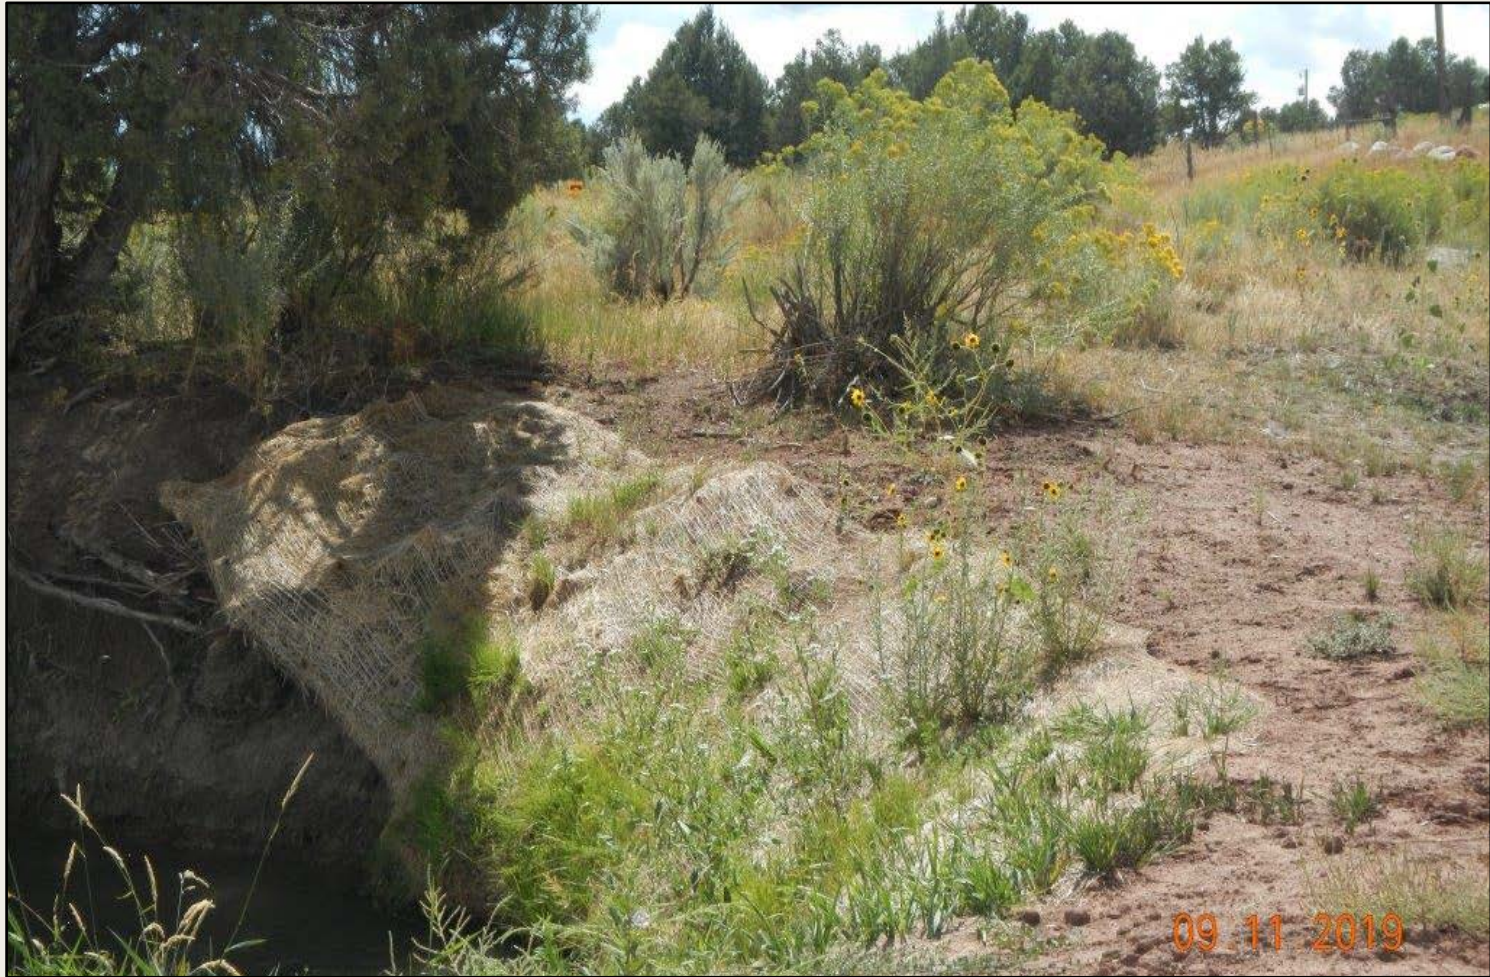
Photo 14. View of straw blanket on bank at location detailed in Photo 13. Vegetation appears to be progressing on this bank, through the blanket material.

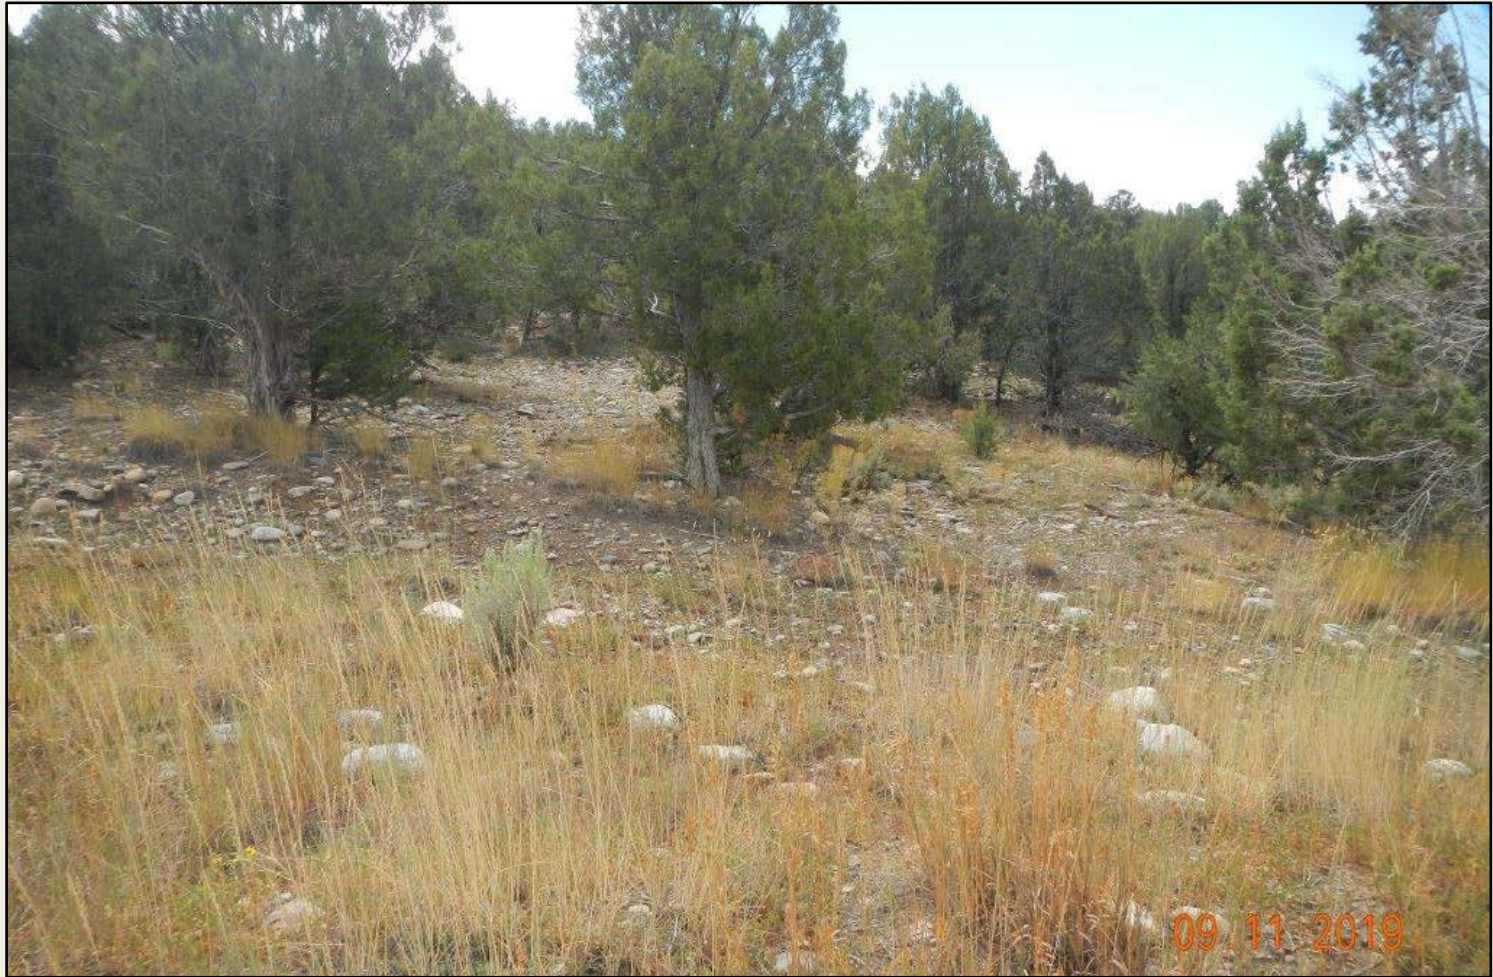
Photo 15. View of reference area for the well pad facing eastward. Vegetation is comprised of pinyon juniper woodland.
