Inspection Photos
Loc#452011
Operator: Terra
Inspection: #692401312
Inspection Date: 9/23/19

Inspection Photos: Terra Fed RU-31-17 Loc#452011

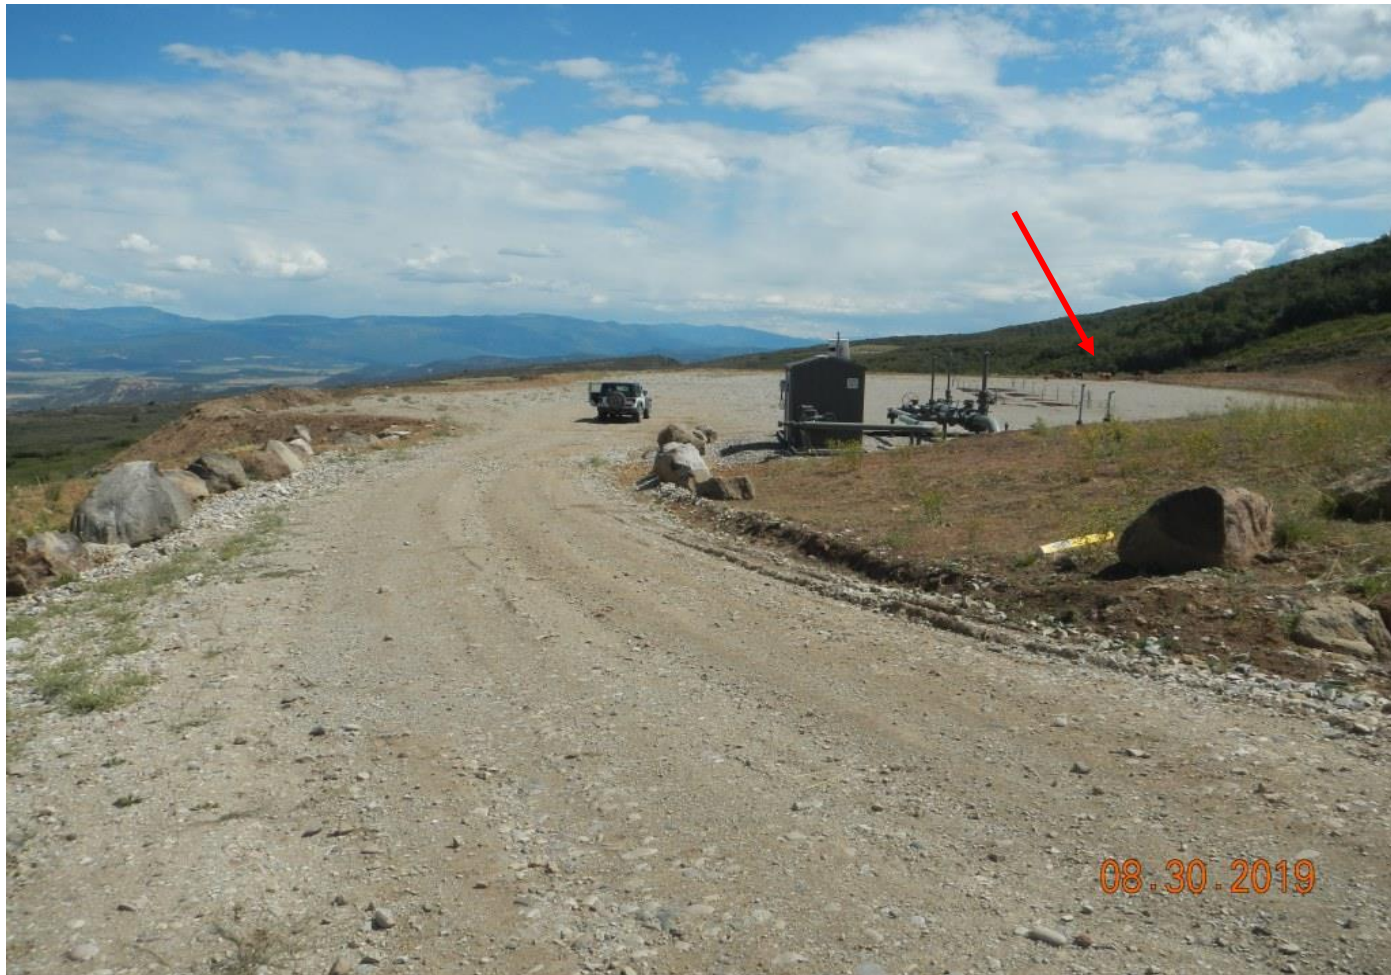
Photo#1:

Overview of Location from access road entry to Southeast. Arrow indicates cattle on site.

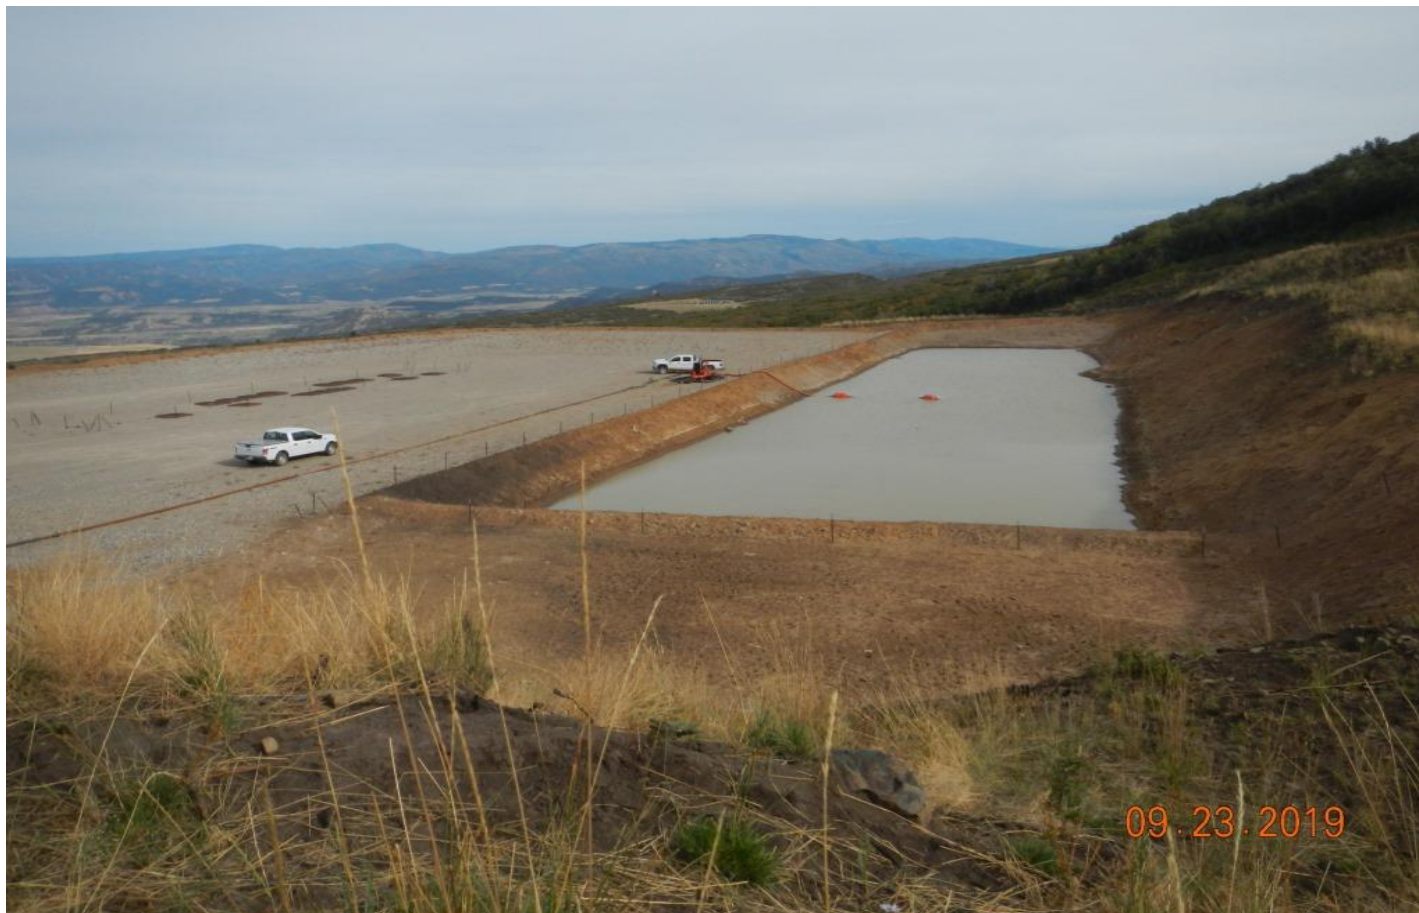
Photo#2:
Overview of Location from top of topsoil stockpile to Southeast.

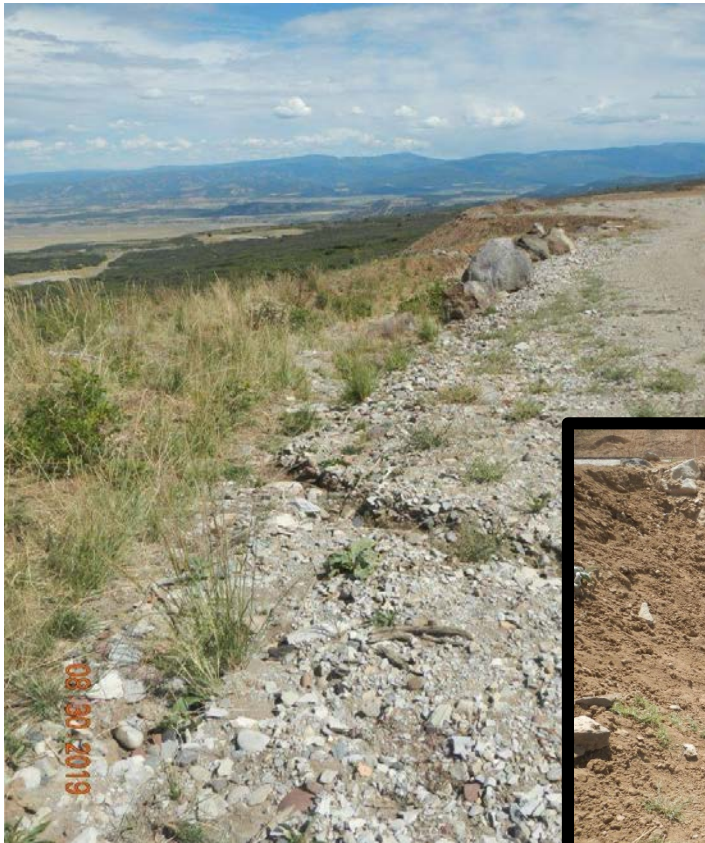
Photo#3:
View along access road entry BMPs

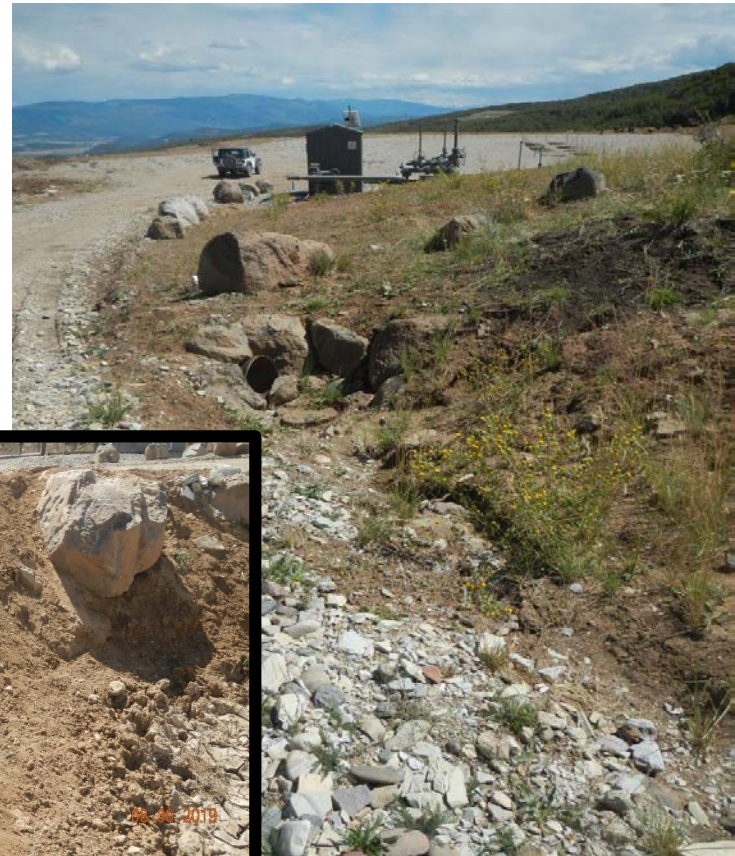
Photo#4:
View along access road entry BMPs.

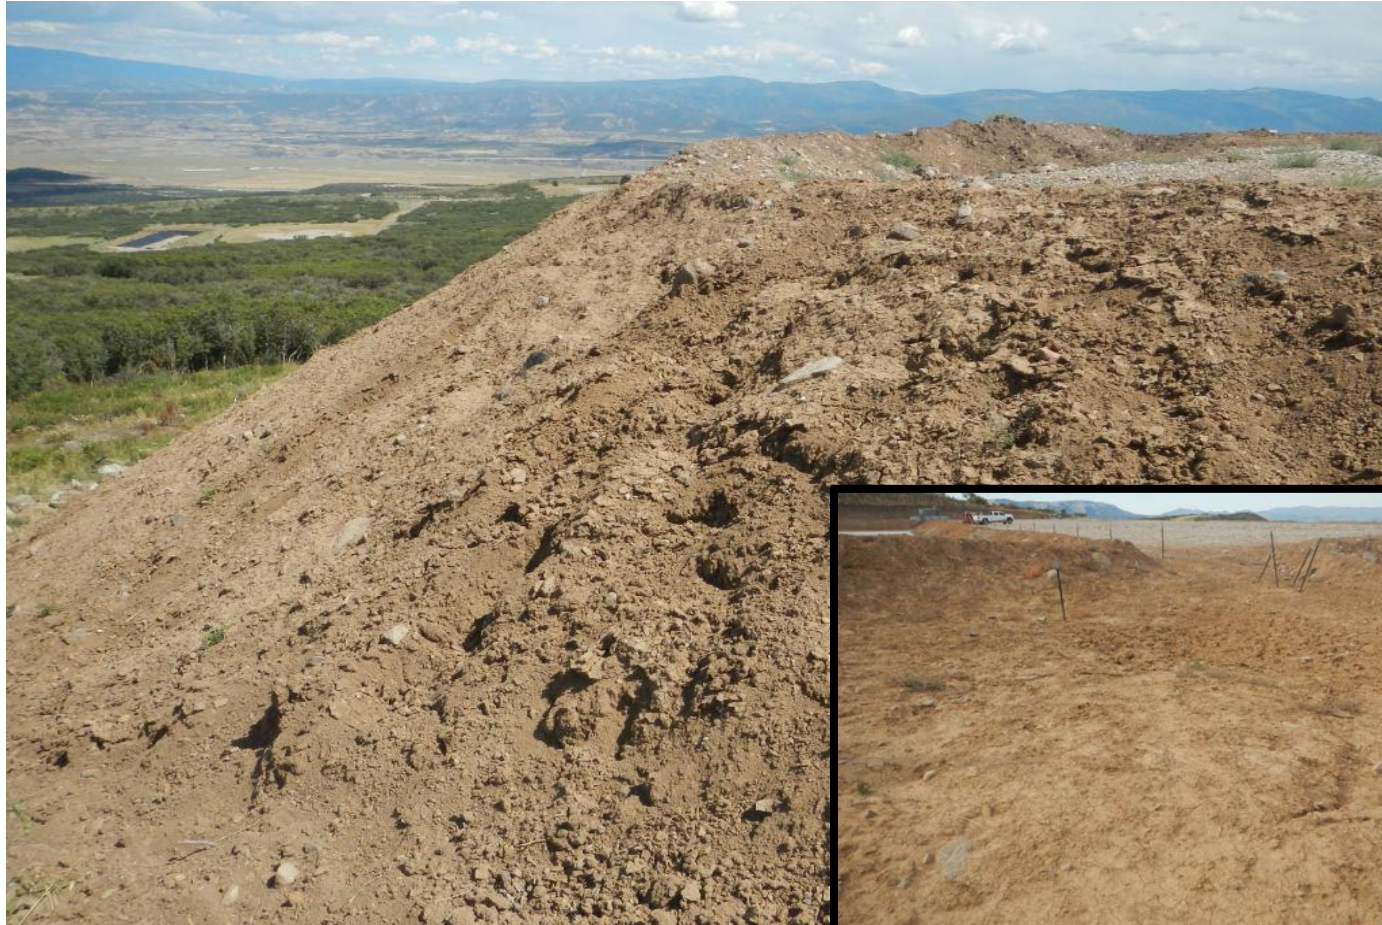
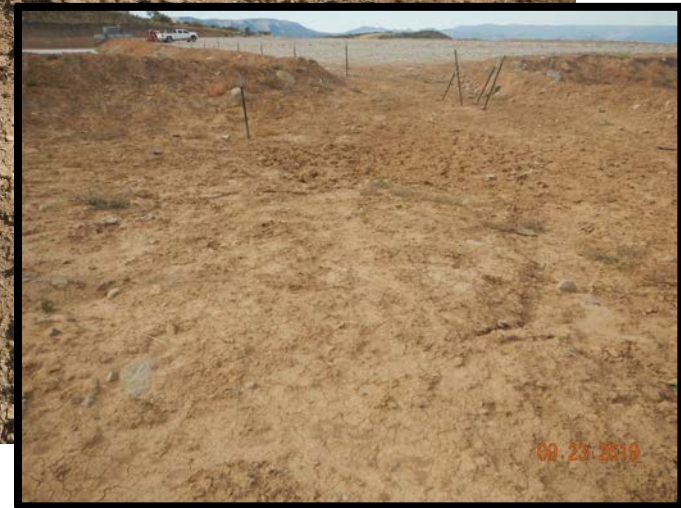
Photo#5:
Site degradation is occurring.

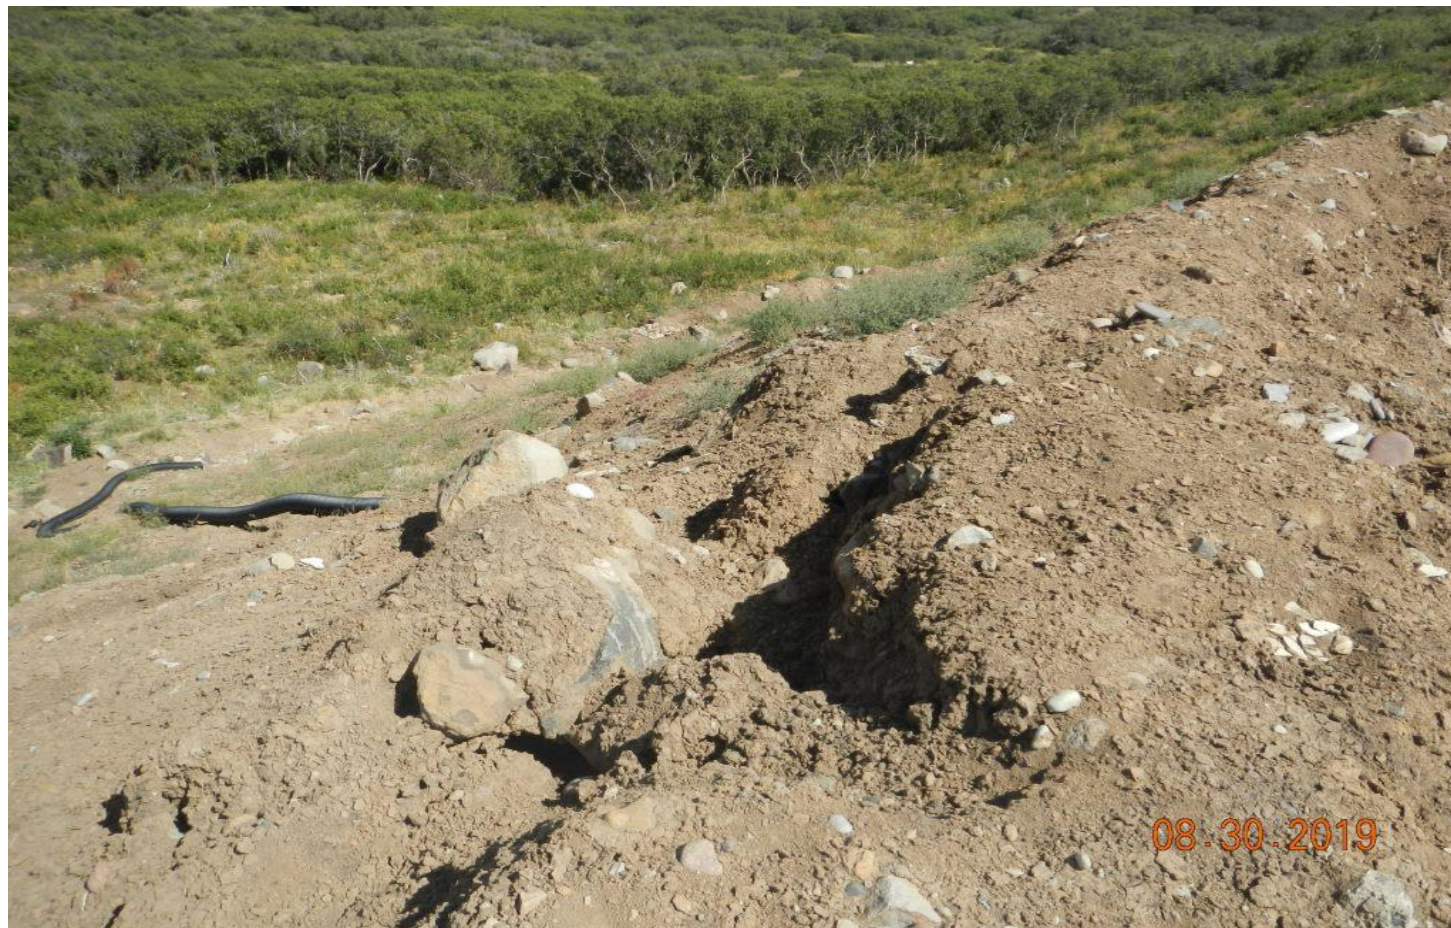
Photo#6:
Fill slopes are not stable.

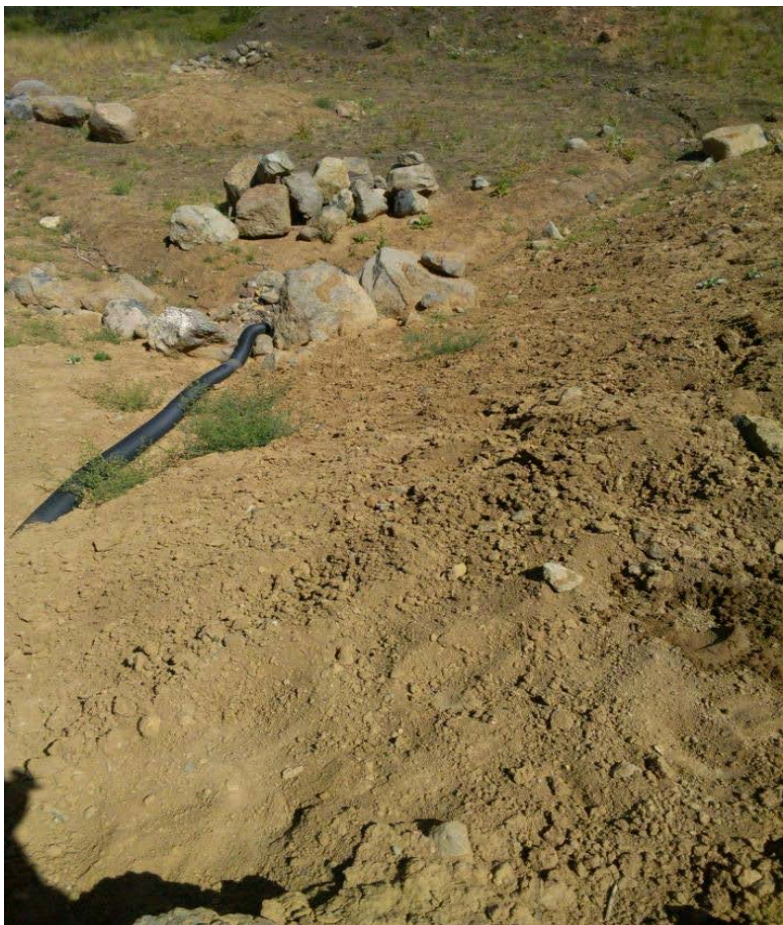
Photo#7:
Fill slopes are not stable

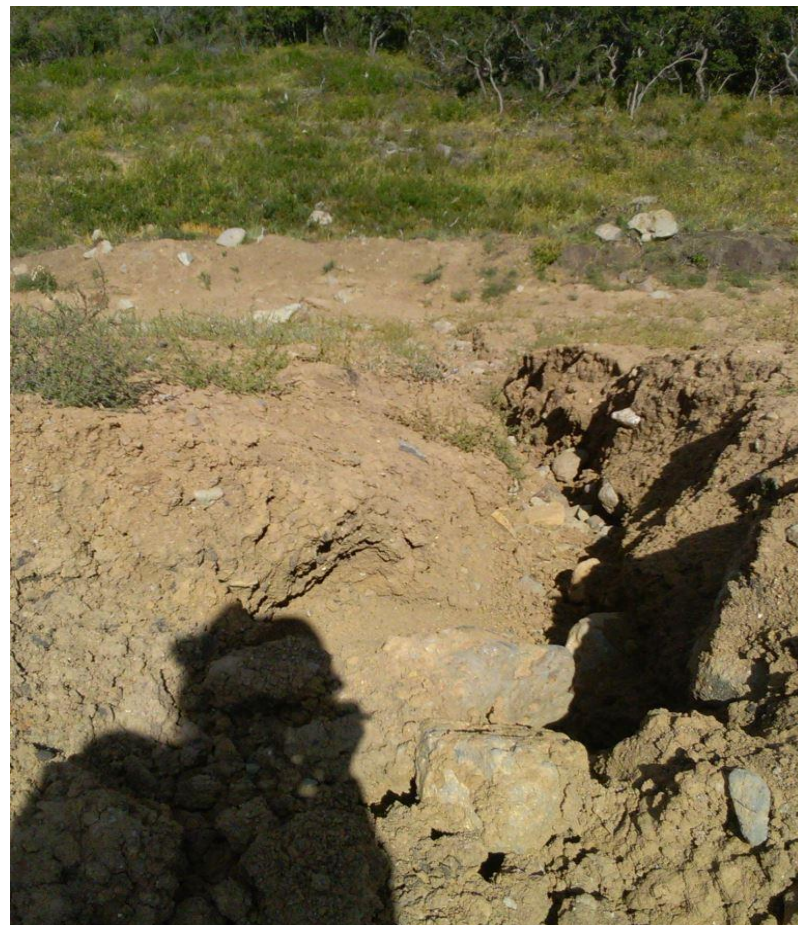
Photo#8:
Fill slopes are not stable

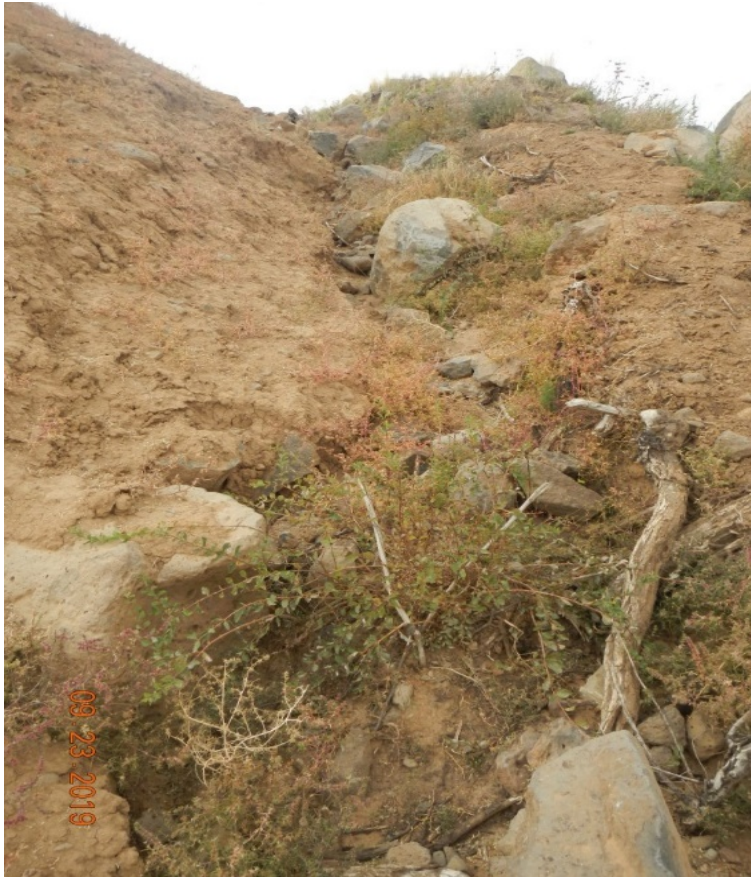
Photo#9:
Slopes are not stable.

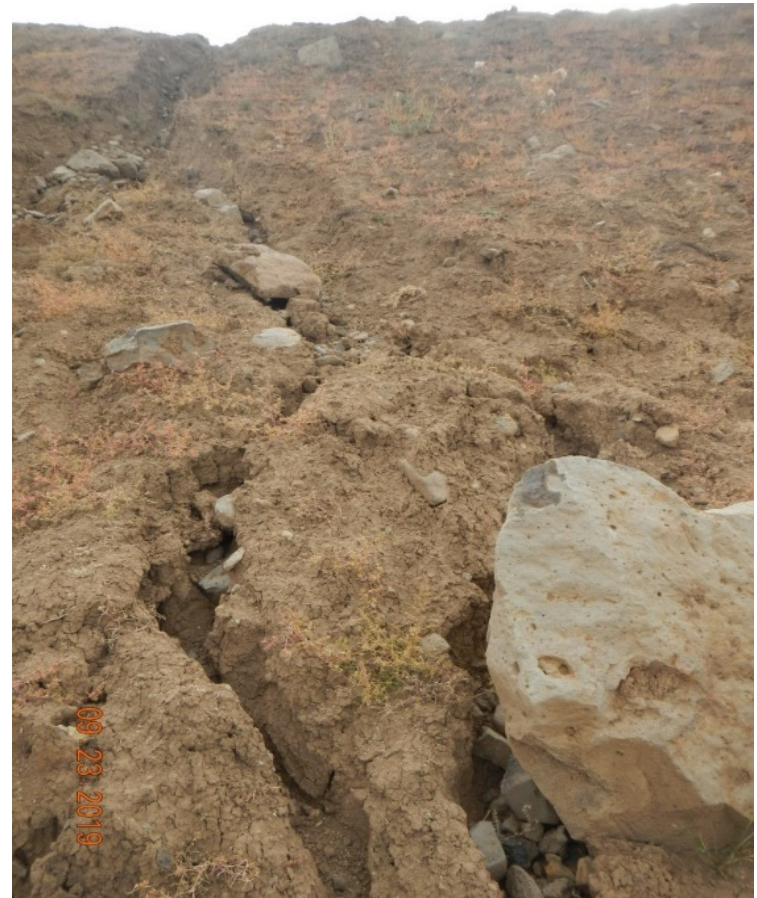
Photo#10:
Slopes are not stable

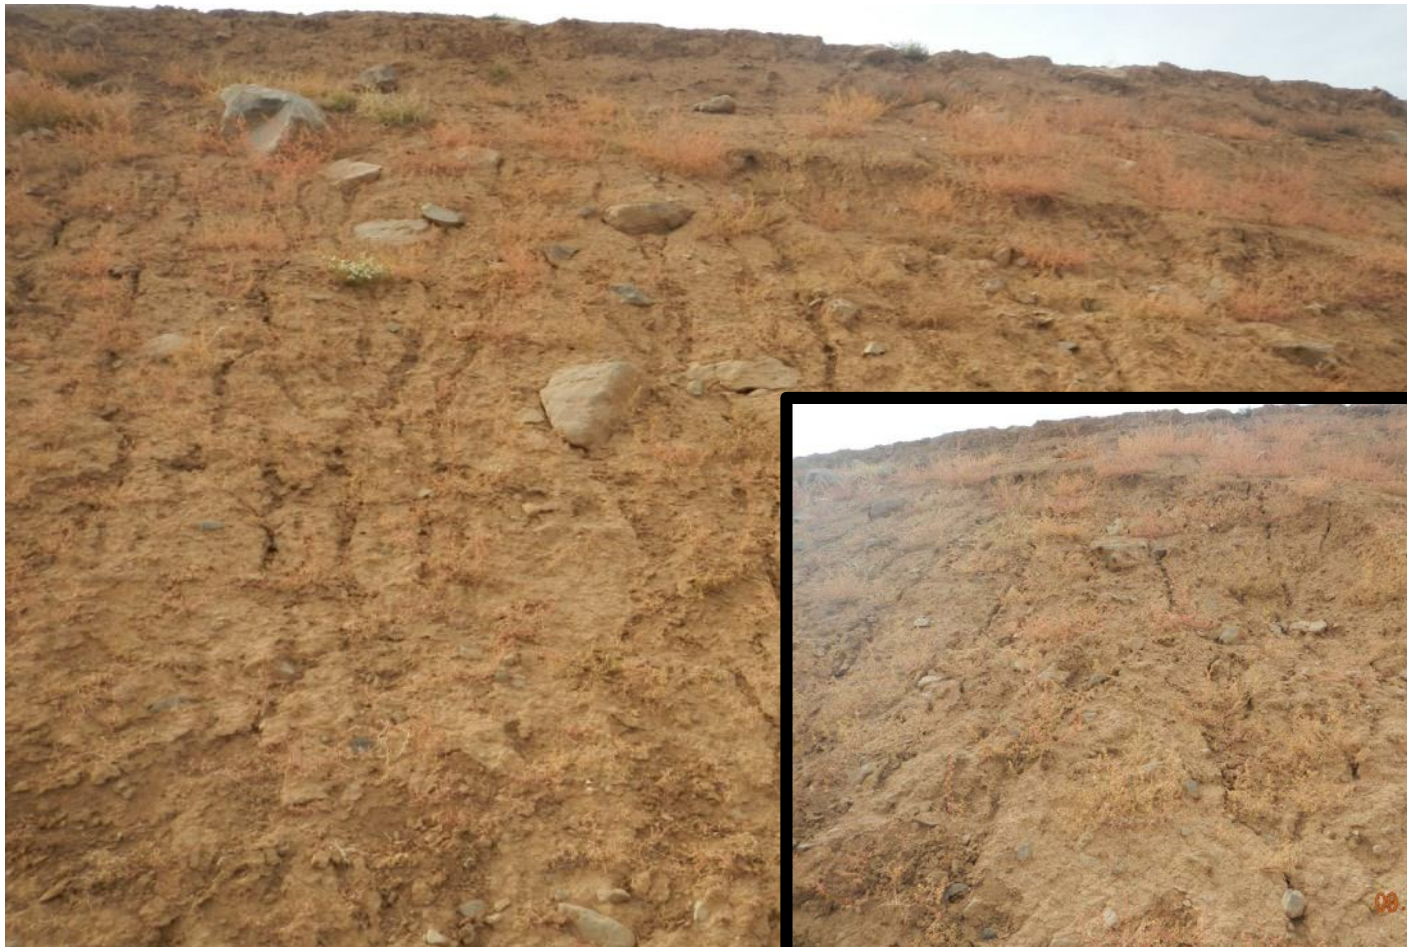
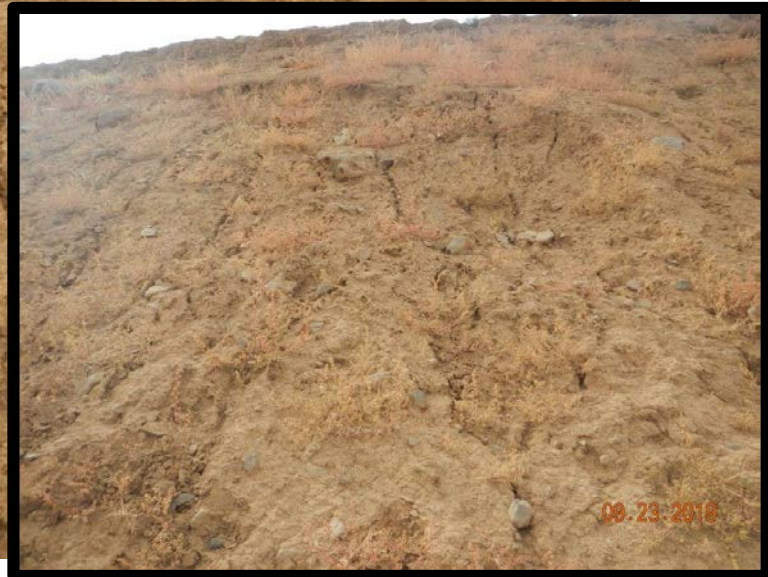
Photo#11:
Slopes are not stable.

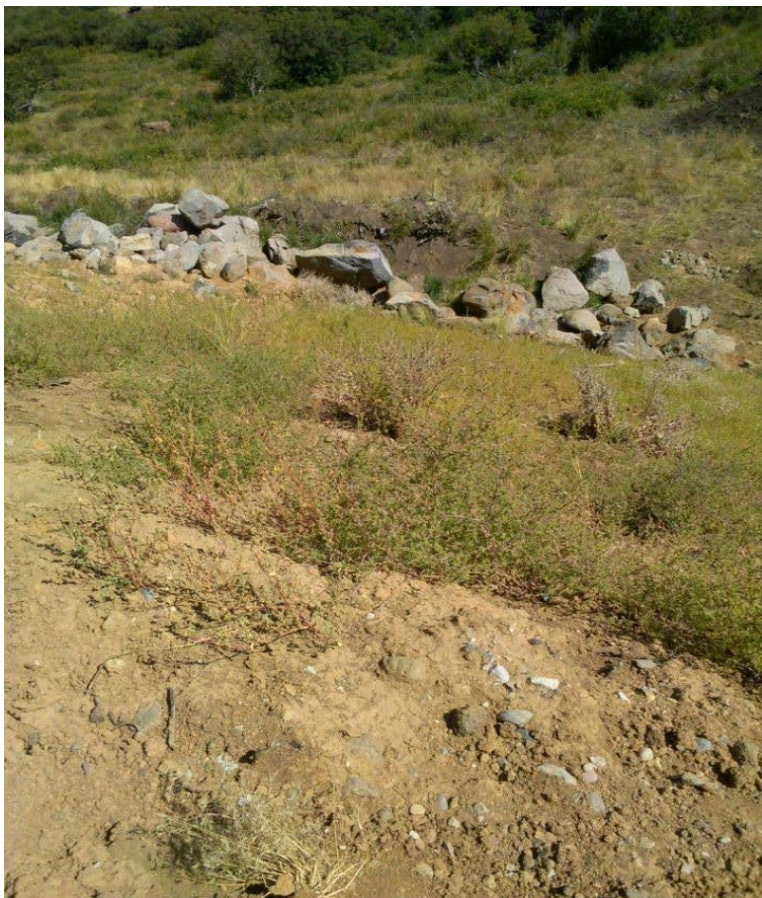
Photo#12:
Fill slopes populated with ruderal weeds.

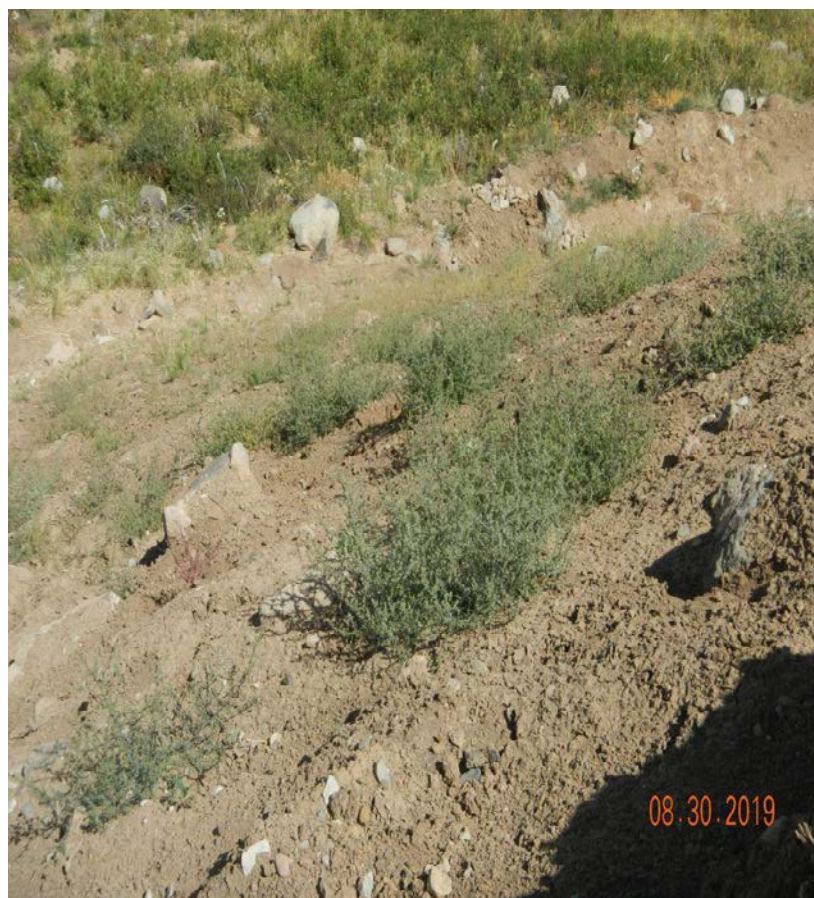
Photo#13:
Fill slopes populated with ruderal weeds.

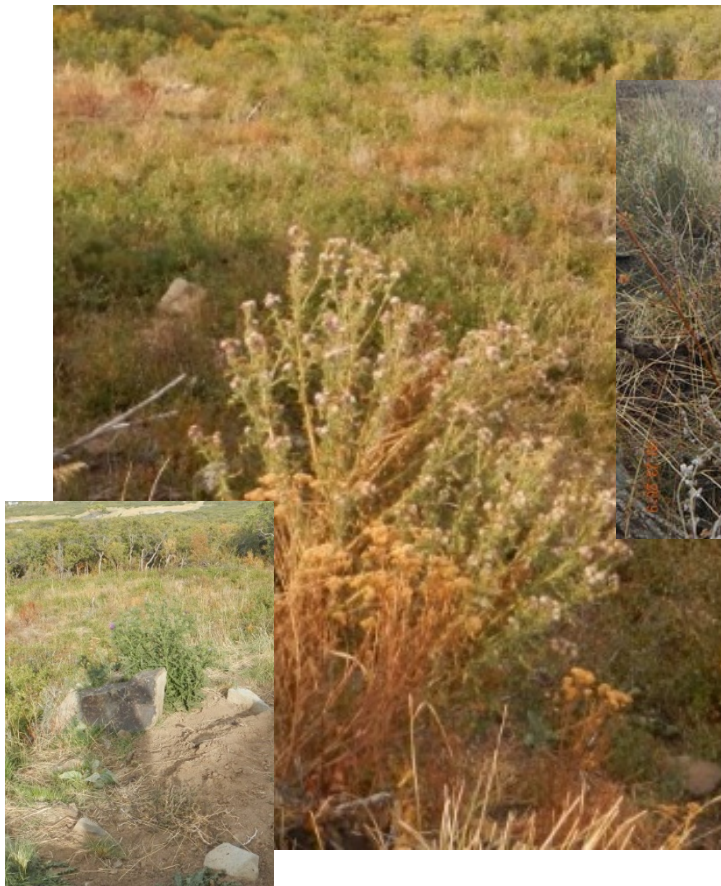
Photo#14:
Noxious weeds on site.

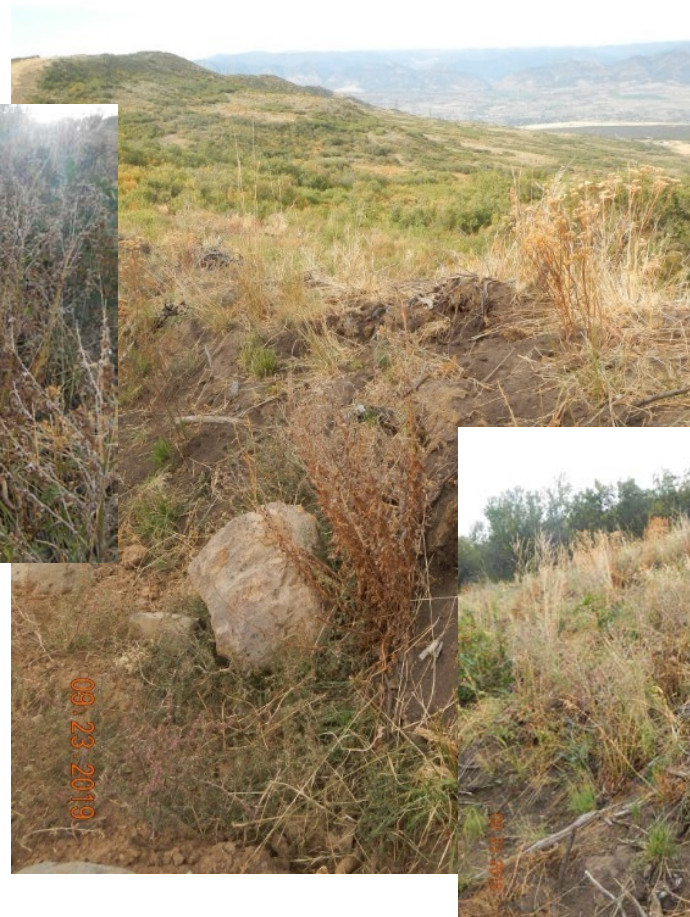
Photo#15:
Noxious weeds on site

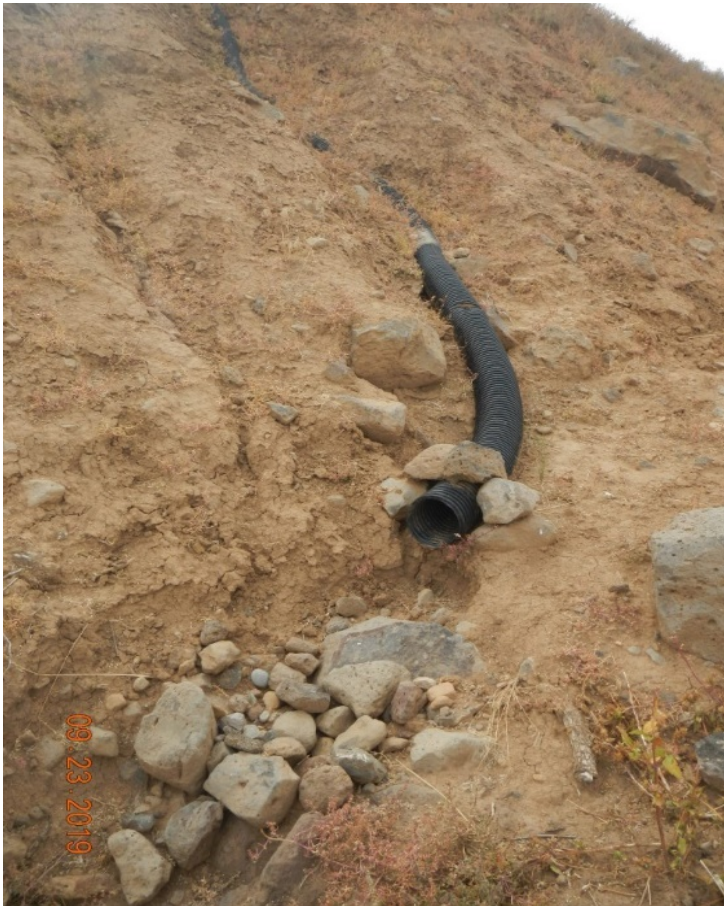
Photo#16:
Slopes are not stable.

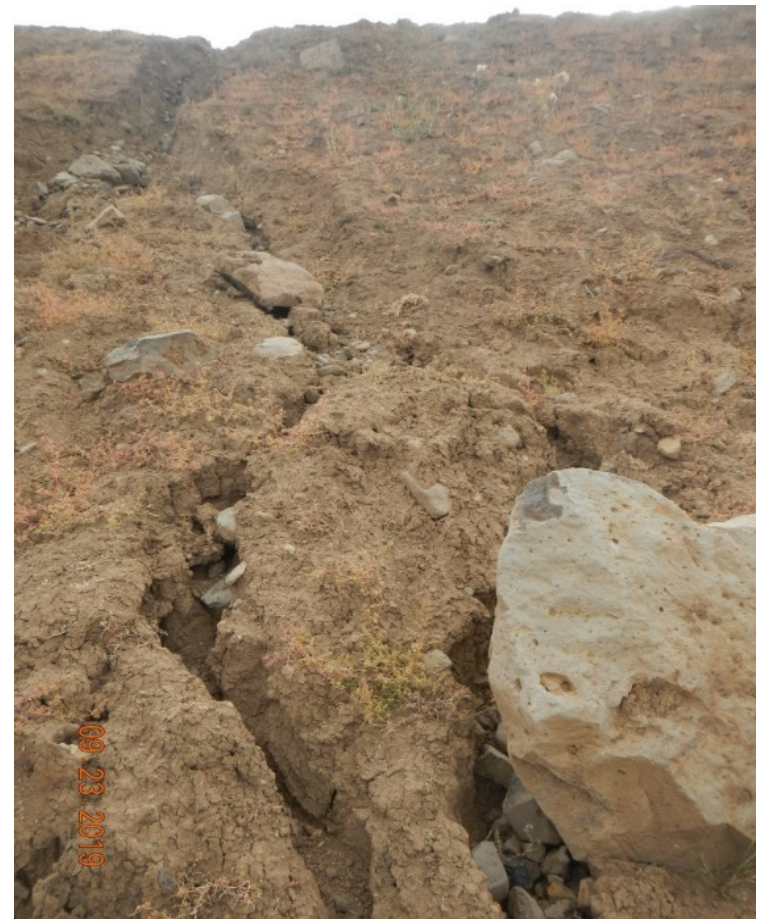
Photo#17:
Slopes are not stable.

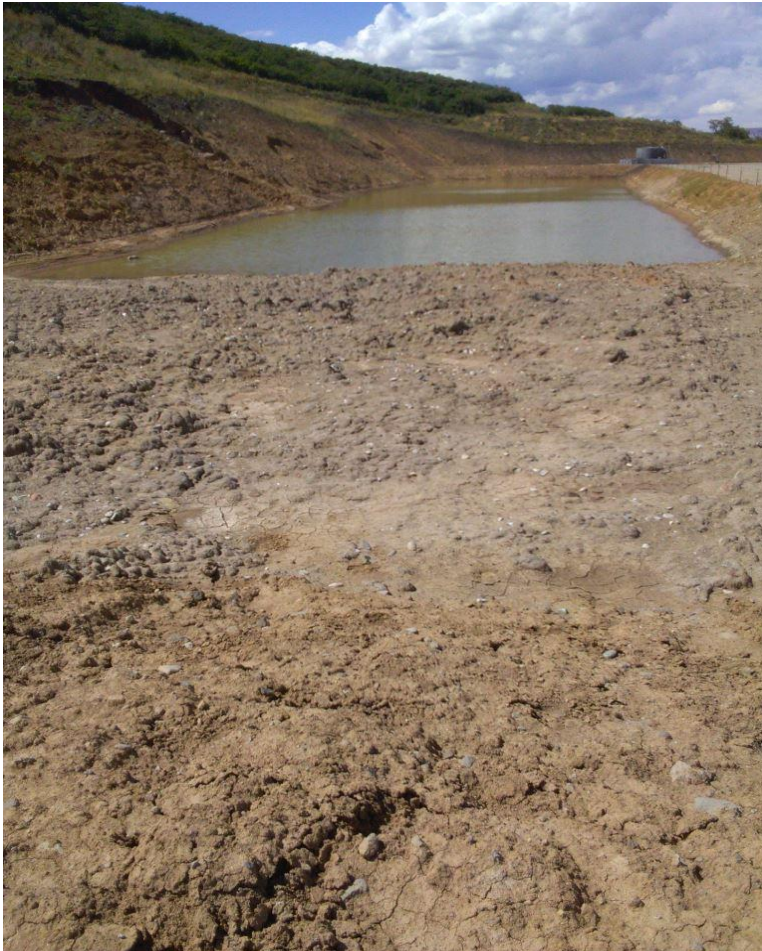
Photo#18:
View of cuttings trench from Southeast to Northwest
end. Conductor cuttings in foreground.

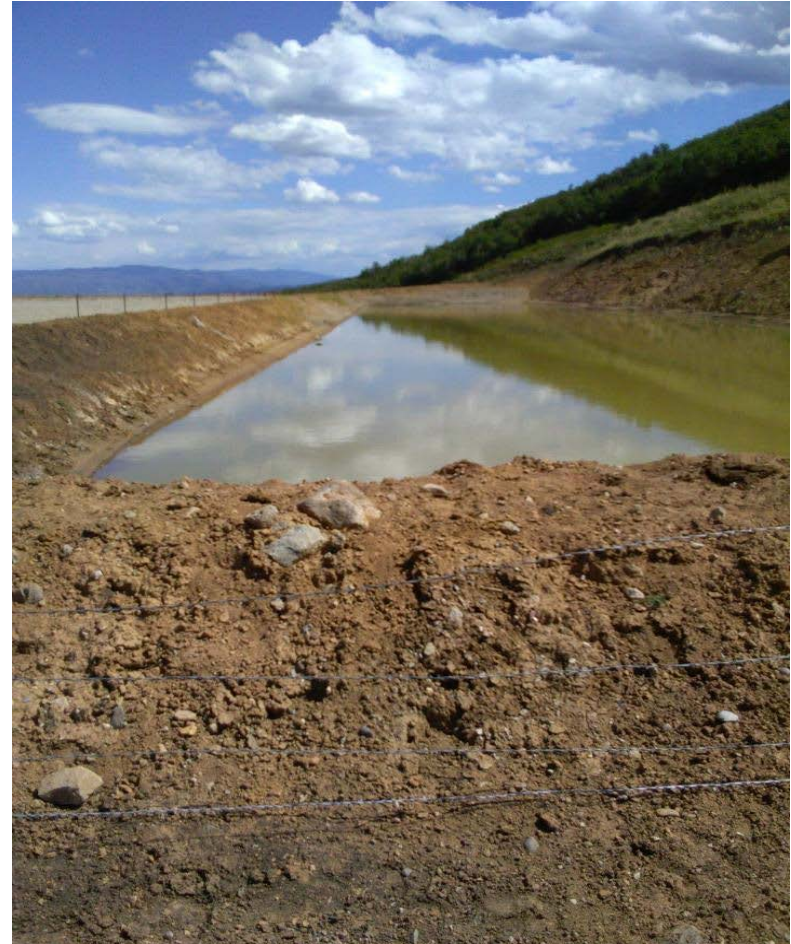
Photo#19:
View of cuttings trench from Northwest to
Southeast end.

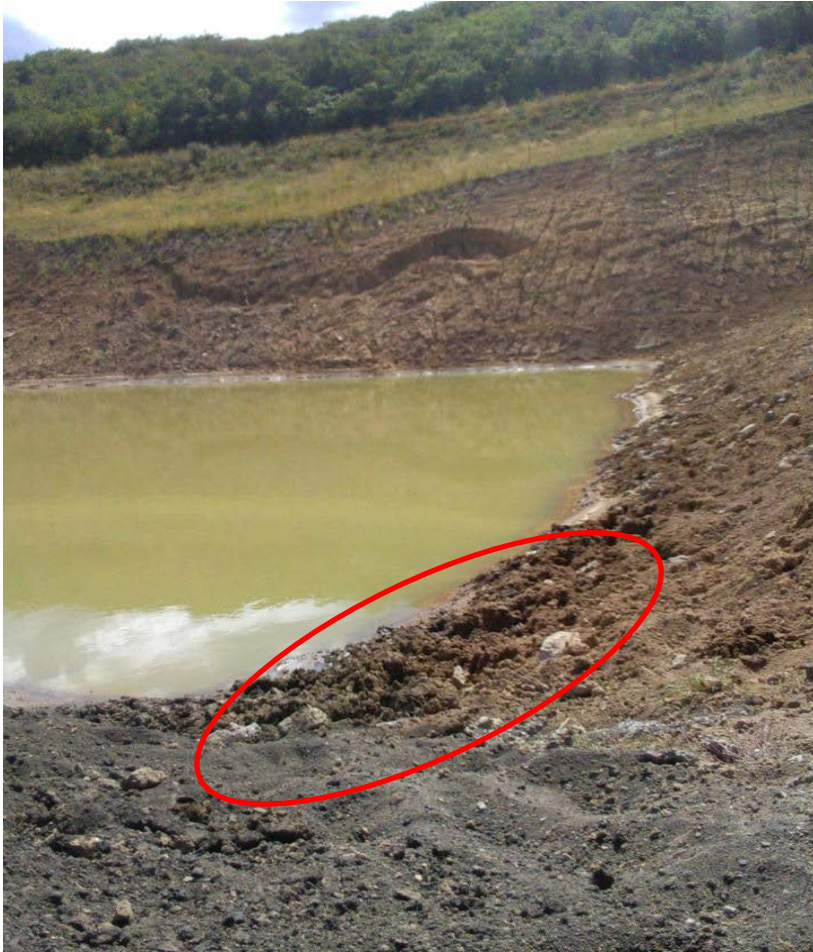
Photo#20:

Cut slope above cuttings trench is not stable. Circled area indicates where slope is less steep & cattle were watering

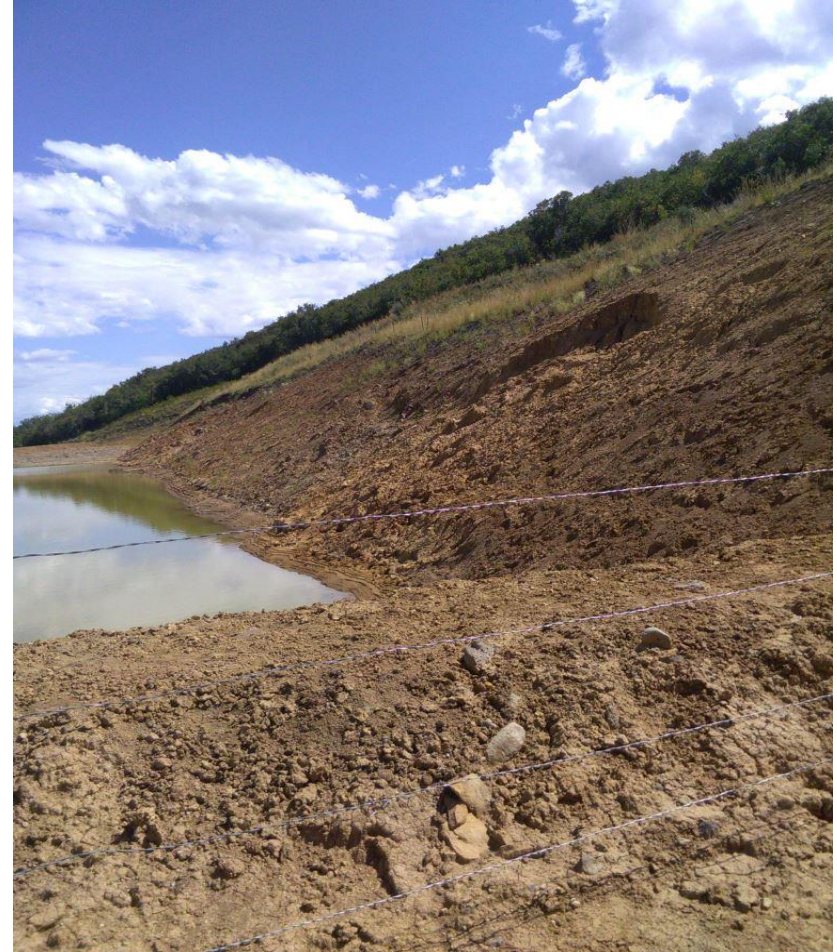
Photo#21:

Cut slope above cuttings trench is not stable.

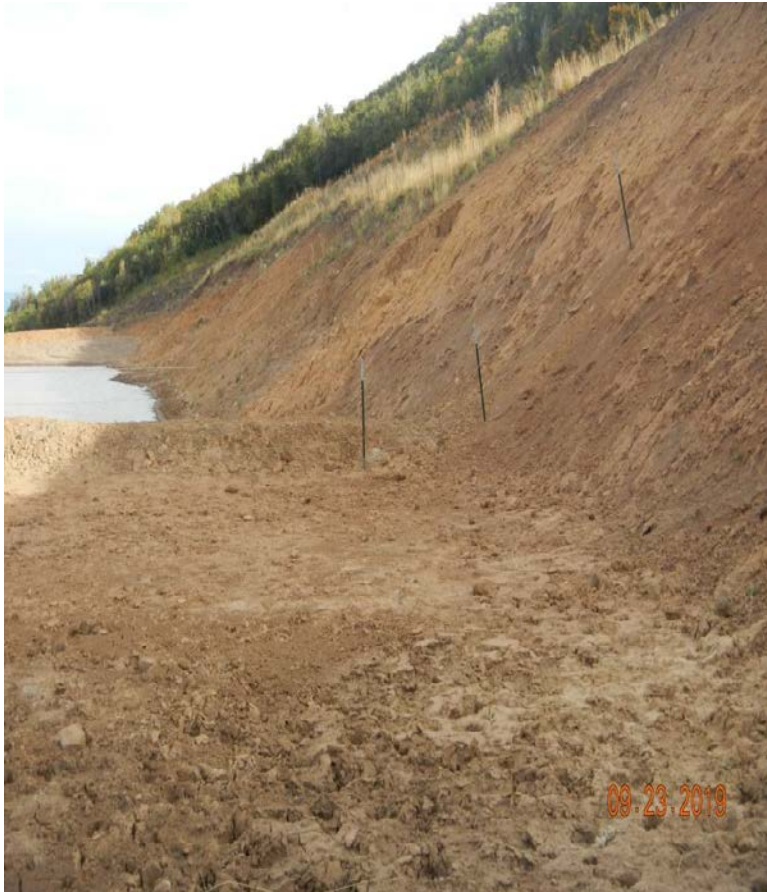
Photo#22:

Cut slope above cuttings trench is not stable. Circled area indicates where slope is less steep & cattle were watering

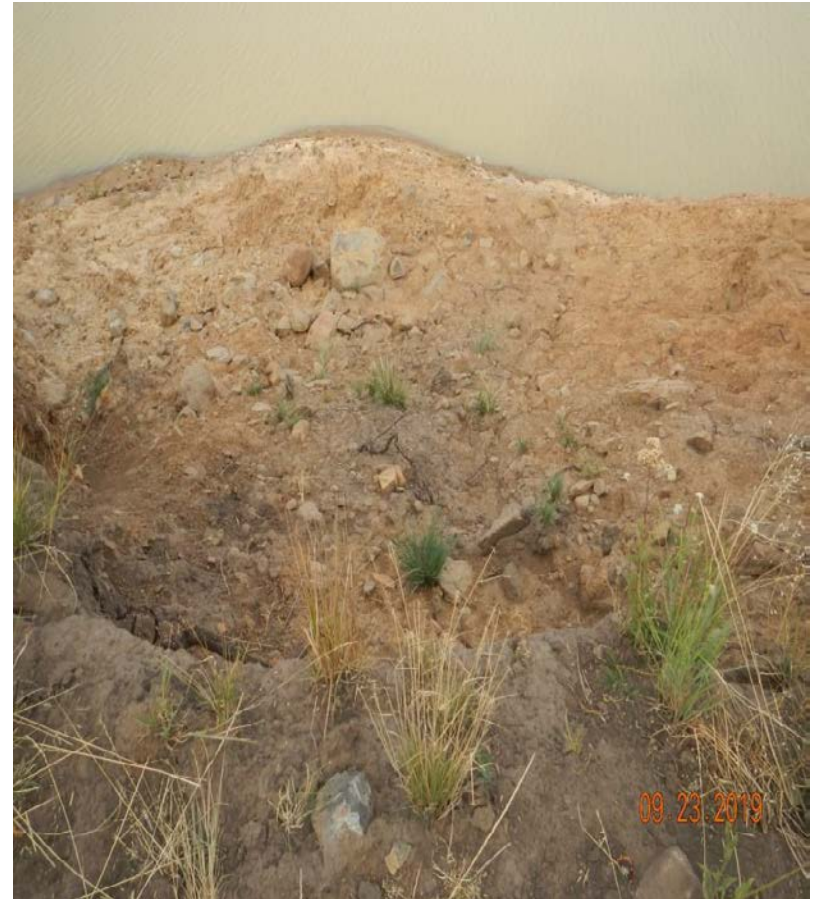
Photo#23:

Cut slope above cuttings trench is not stable.

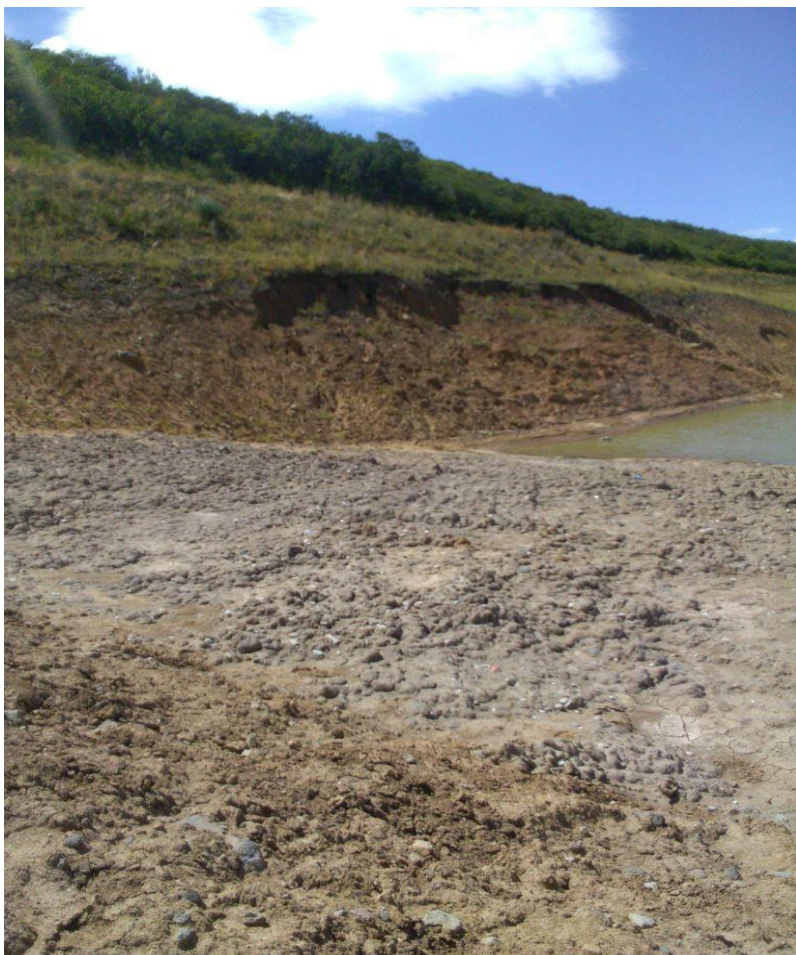
Photo#23:
View over cuttings at Southeast end of trench to cut
slope.

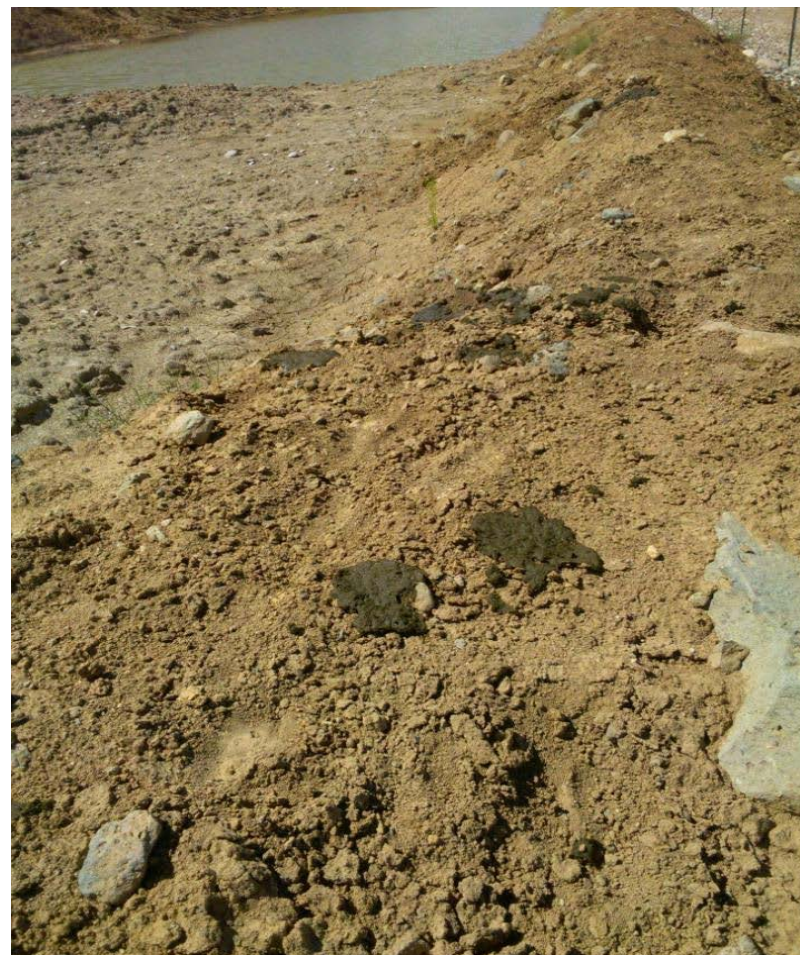
Photo#24:
Evidence of cattle inside cuttings trench area.

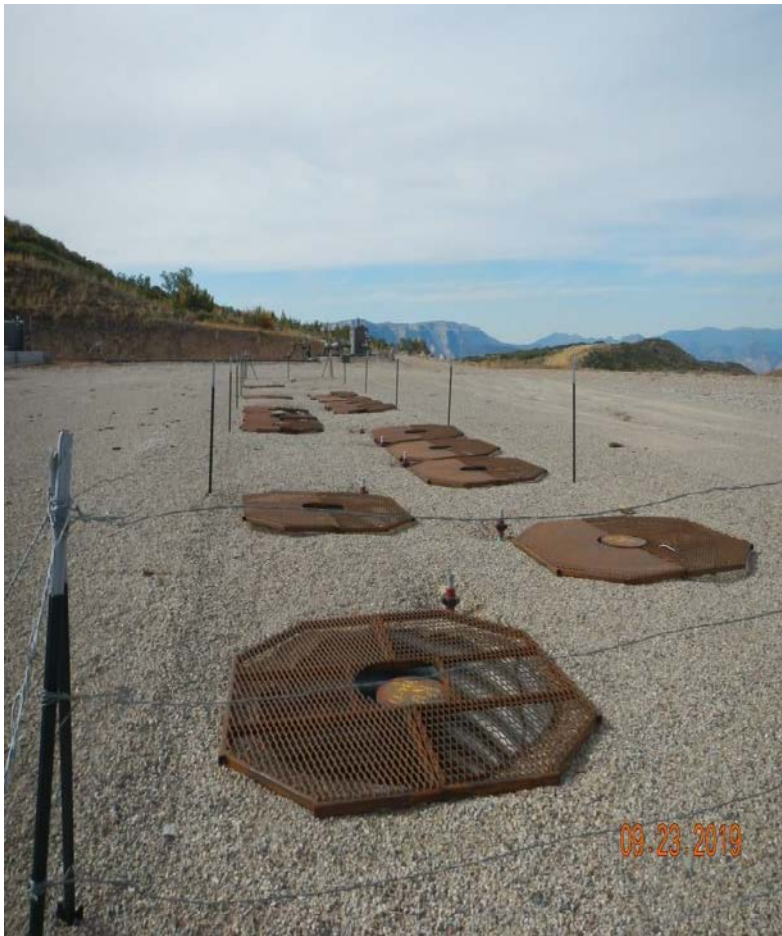
Photo#25:
Conductors set; not covered to prevent ingress by wildlife.

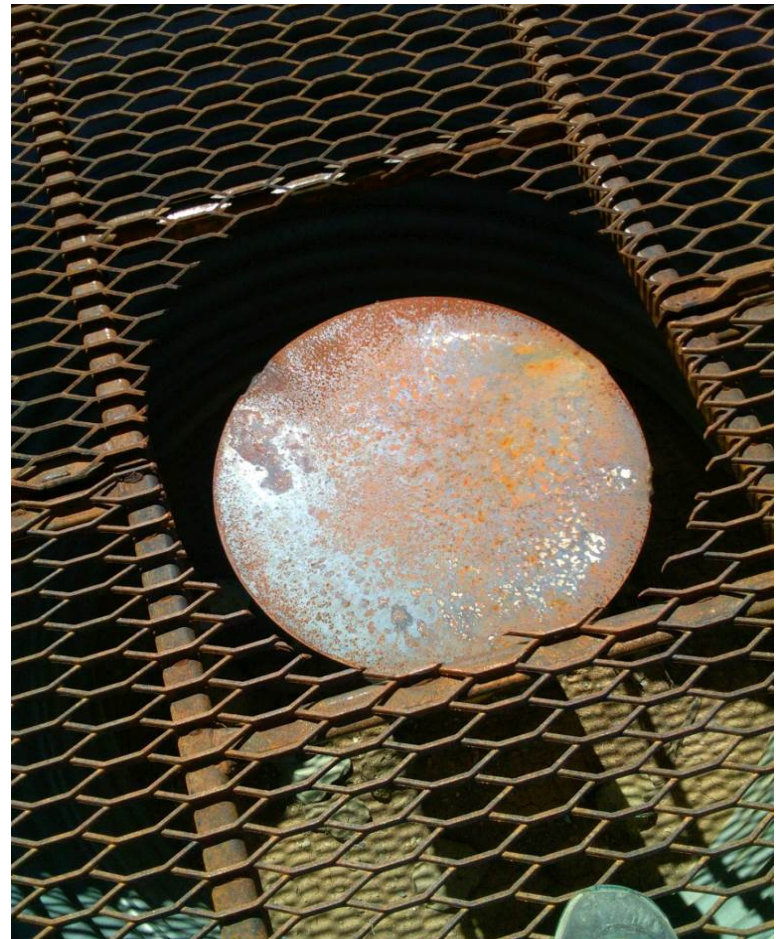
Photo#26:
Conductors set; not covered to prevent ingress by wildlife.
