KP Kauffman - COGCC Inspection Photos
Location: Charter Schneider Tank Battery
Facility ID #444630
REM #9522

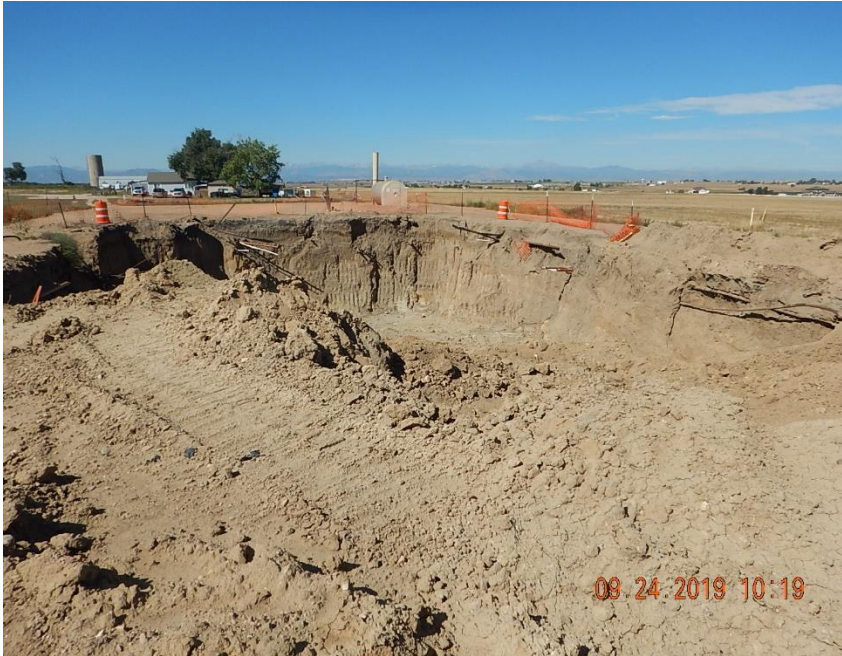
View of excavation (flowlines exposed in walls/ view west).

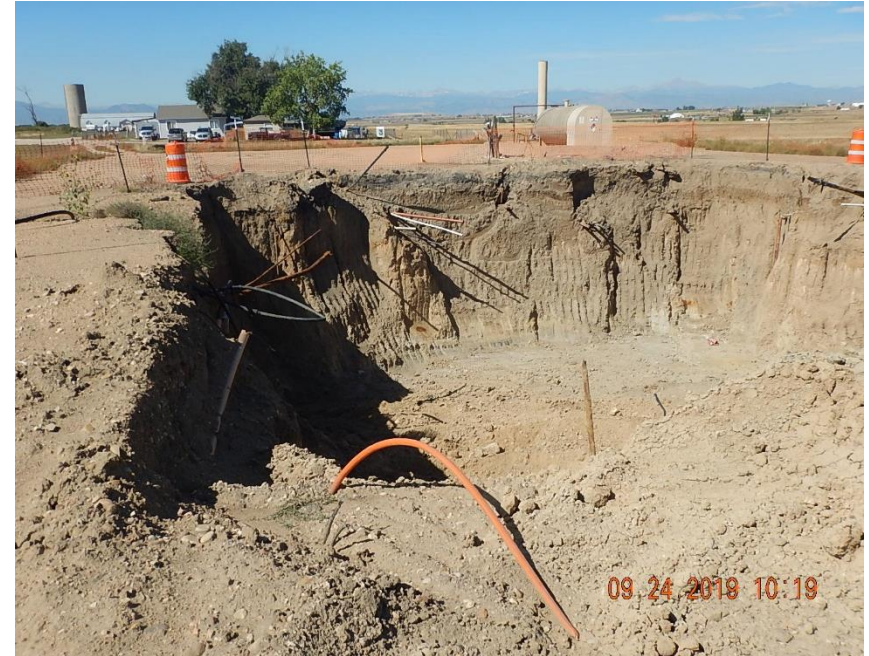
Cut ends of flowlines exposed in excavation (view to west).

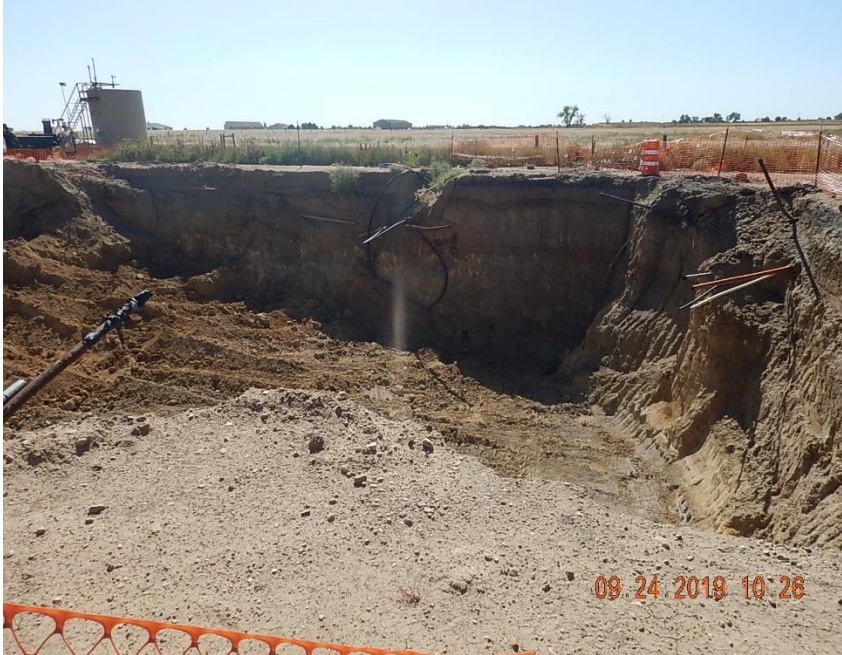
View of excavation (flowlines exposed) looking south.

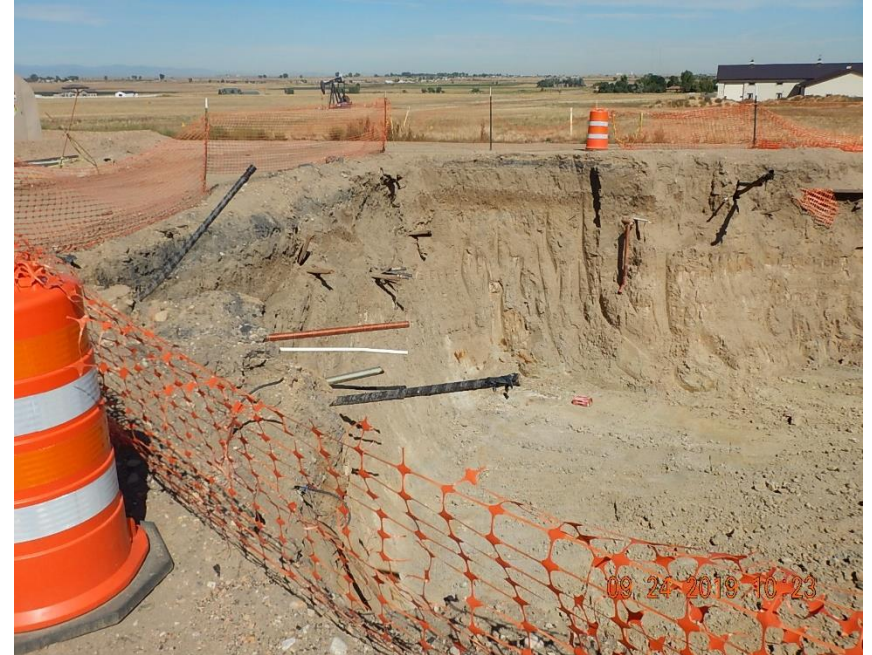
View of excavation (flowlines exposed) looking NW.

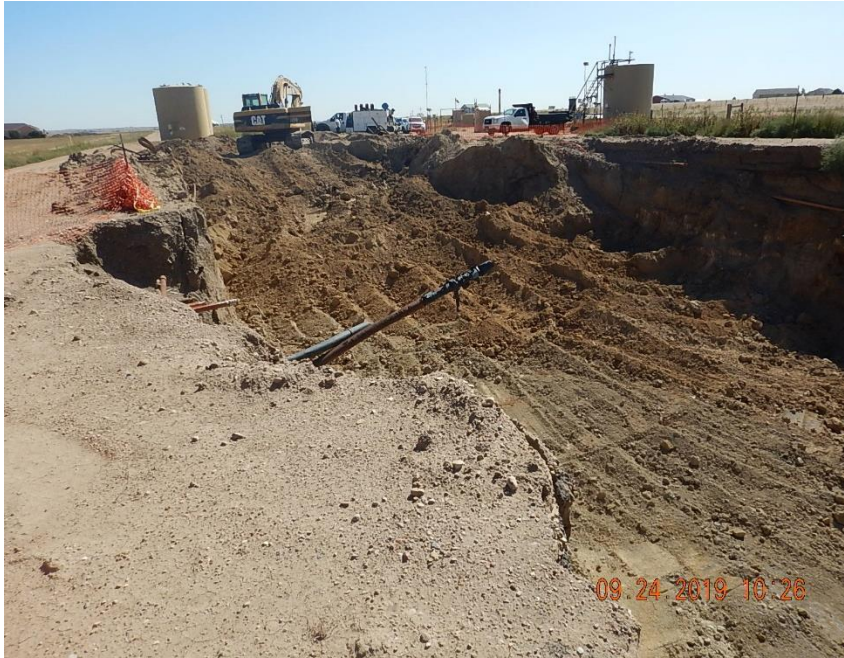
East side of excavation, tanks and equipment on location.

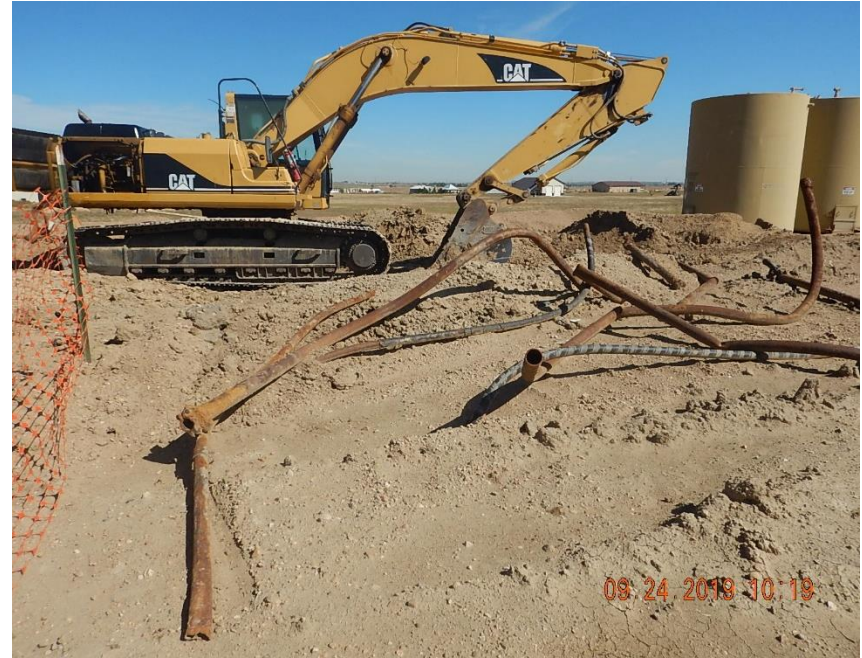
Flowline segments cut out/ removed from excavation.
