Inspection Photos
Operator: Kinder Morgan
Location/API #: 083-06649
Date: 9-18-2019

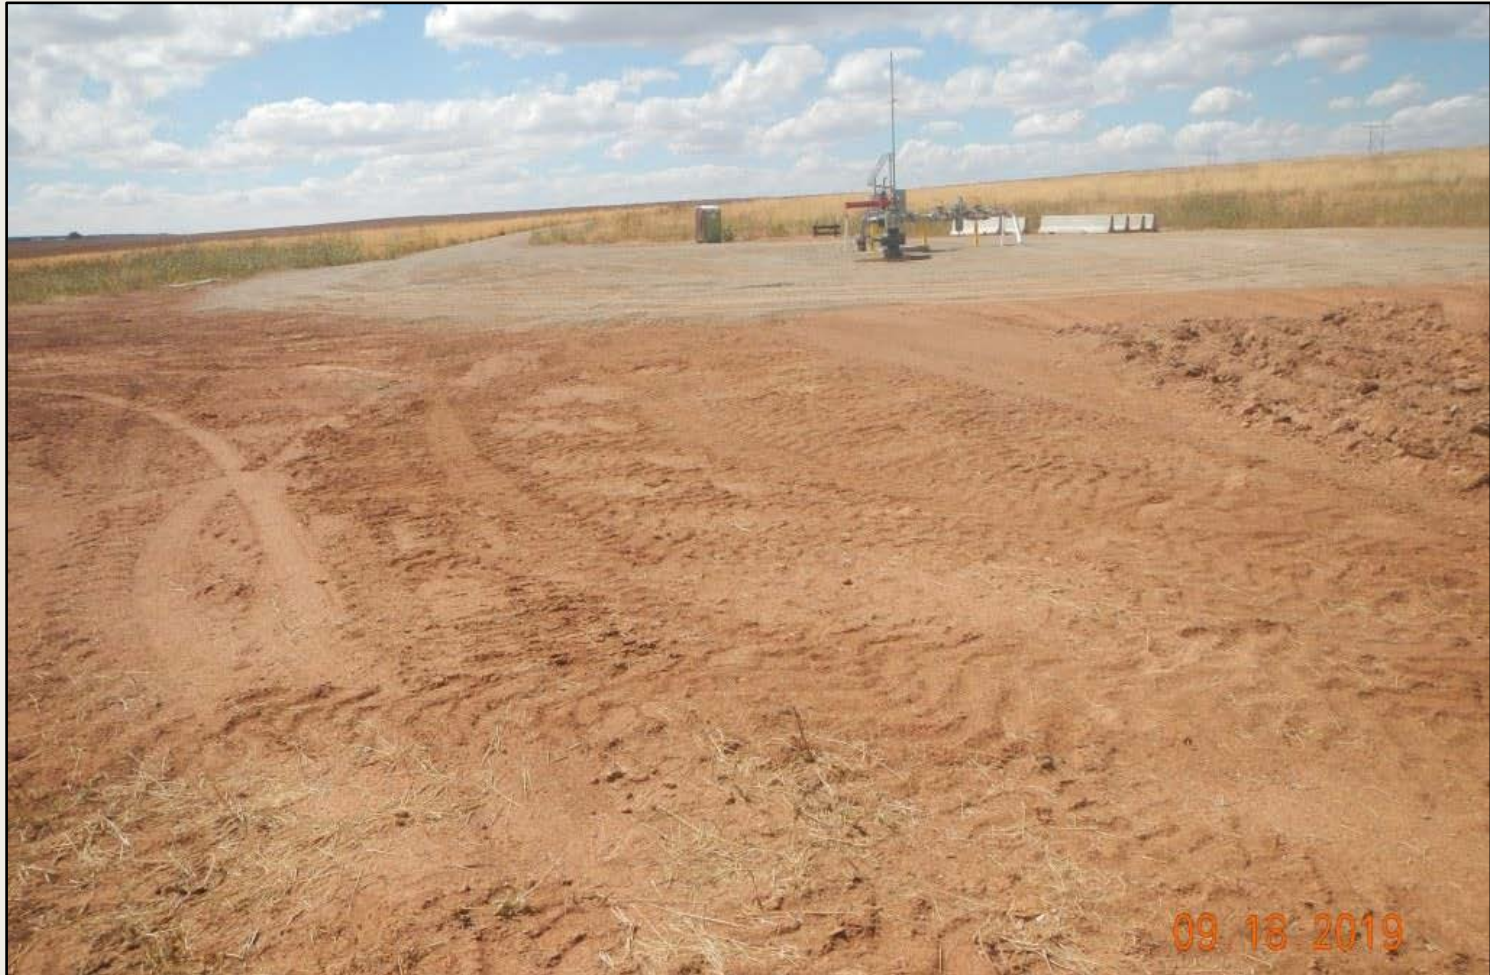
Photo 1. View of the project area from the eastern edge facing center.

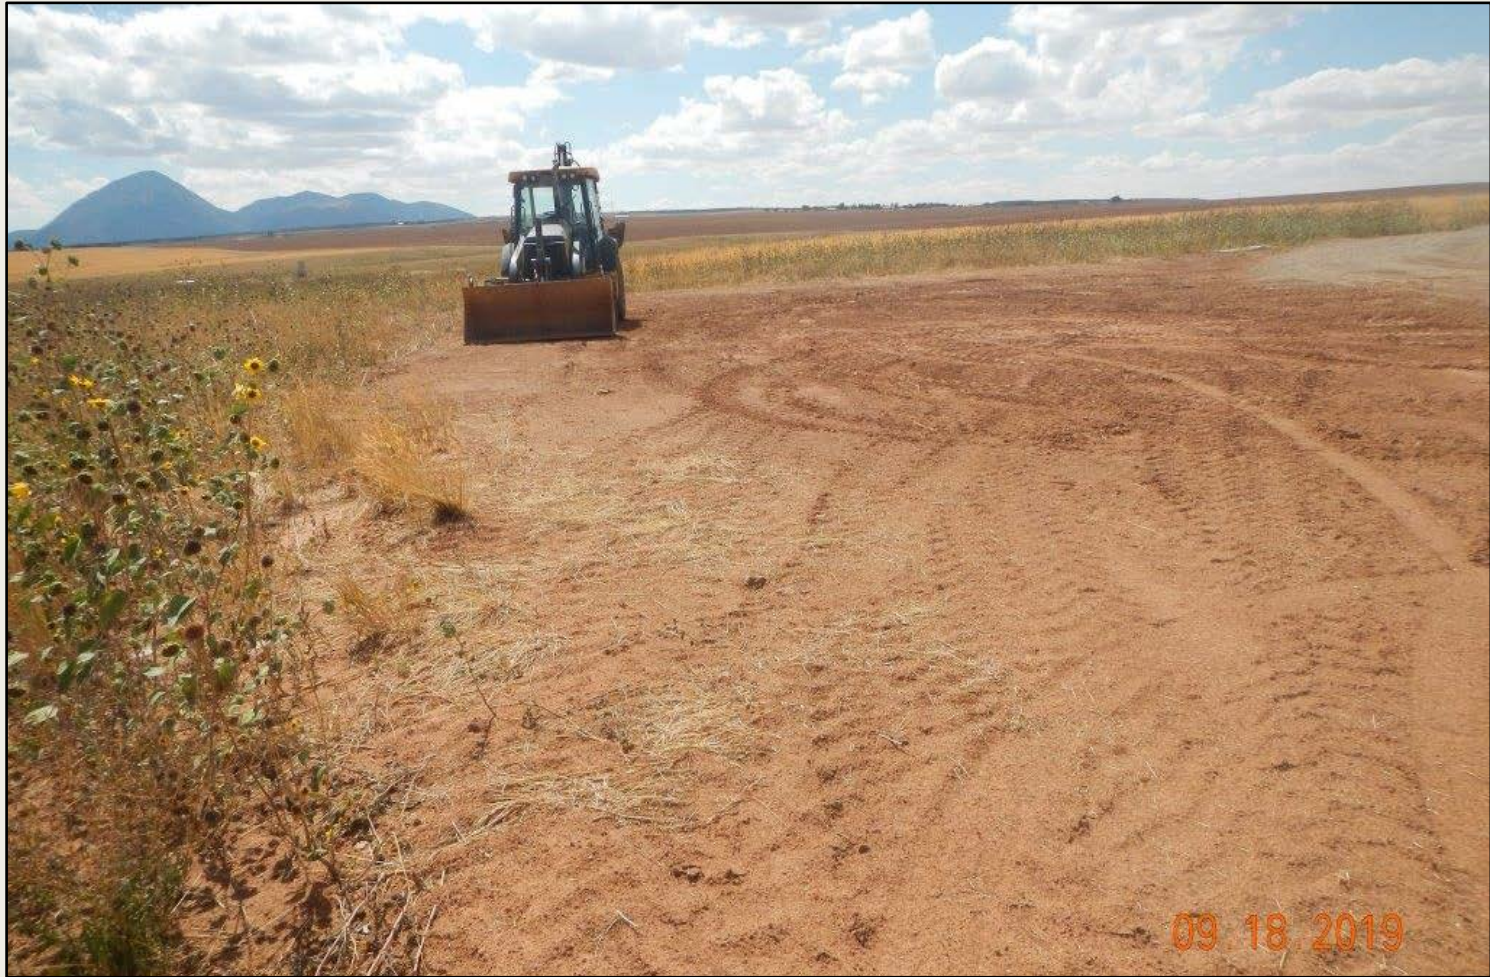
Photo 2. View of the southeastern project area from the eastern edge facing southward. Portions of reclamation area are recently disturbed and need revegetation.

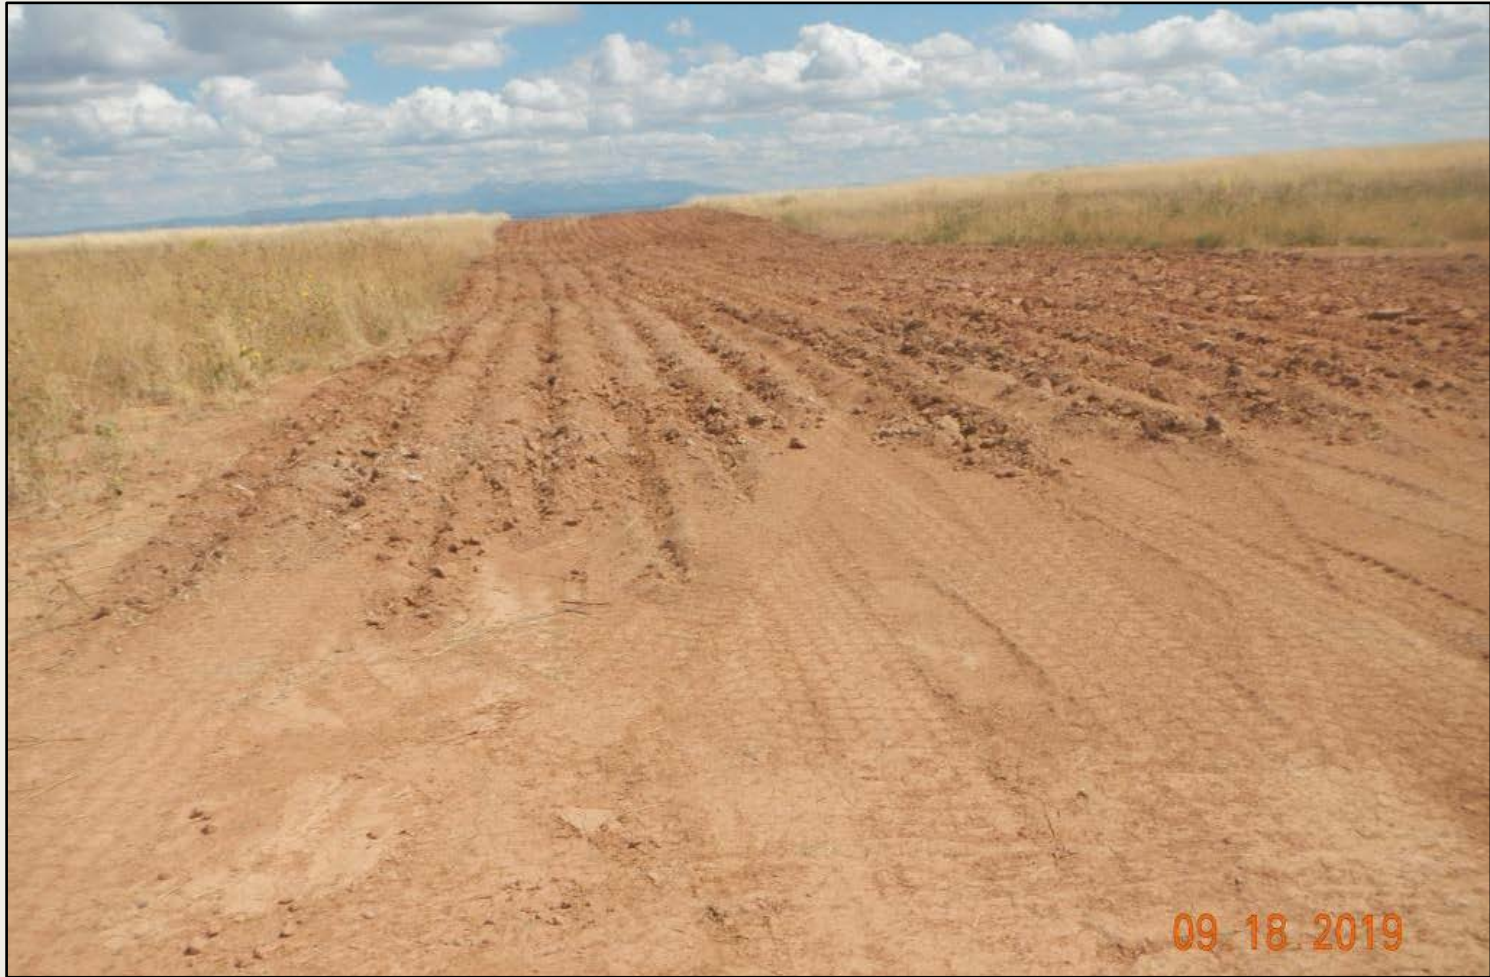
Photo 2. View of what appears to be pipeline corridor where vegetation is cleared. Area needs revegetation.

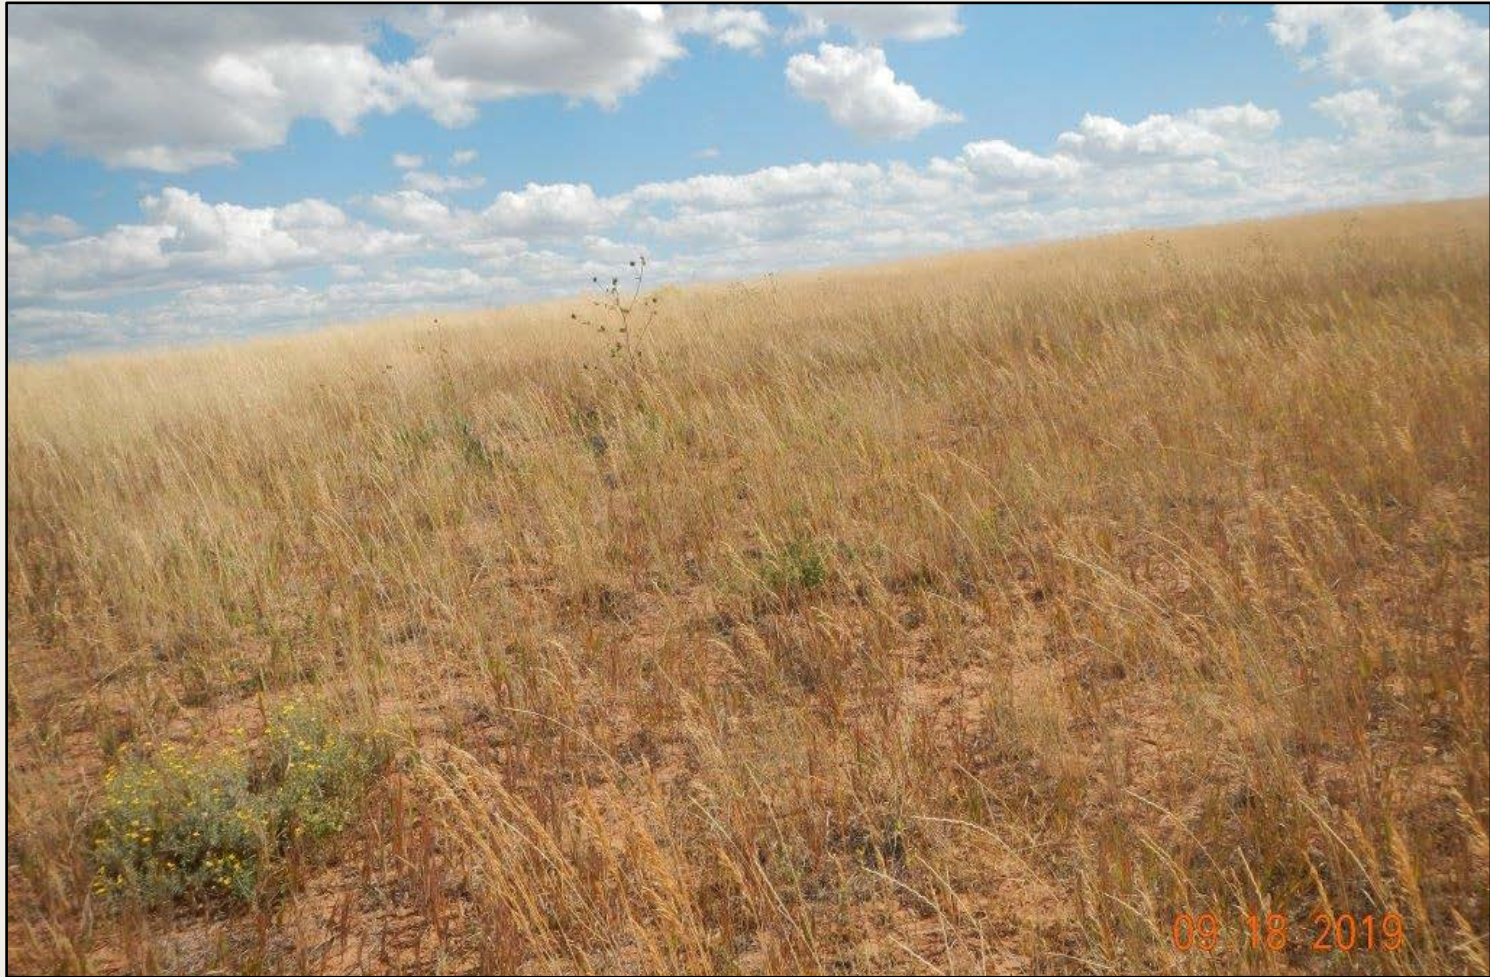
Photo 3. View of reference area vegetation comprised of dryland grass field with herbaceous species such as smooth brome (*Bromus inermis*), crested wheatgrass (*Agropyron cristatum*), and western wheatgrass (*Pascopyrum smithii*).
