Taiga Mountain 6-22
API: 05-103-08920
Inspection: 679705629

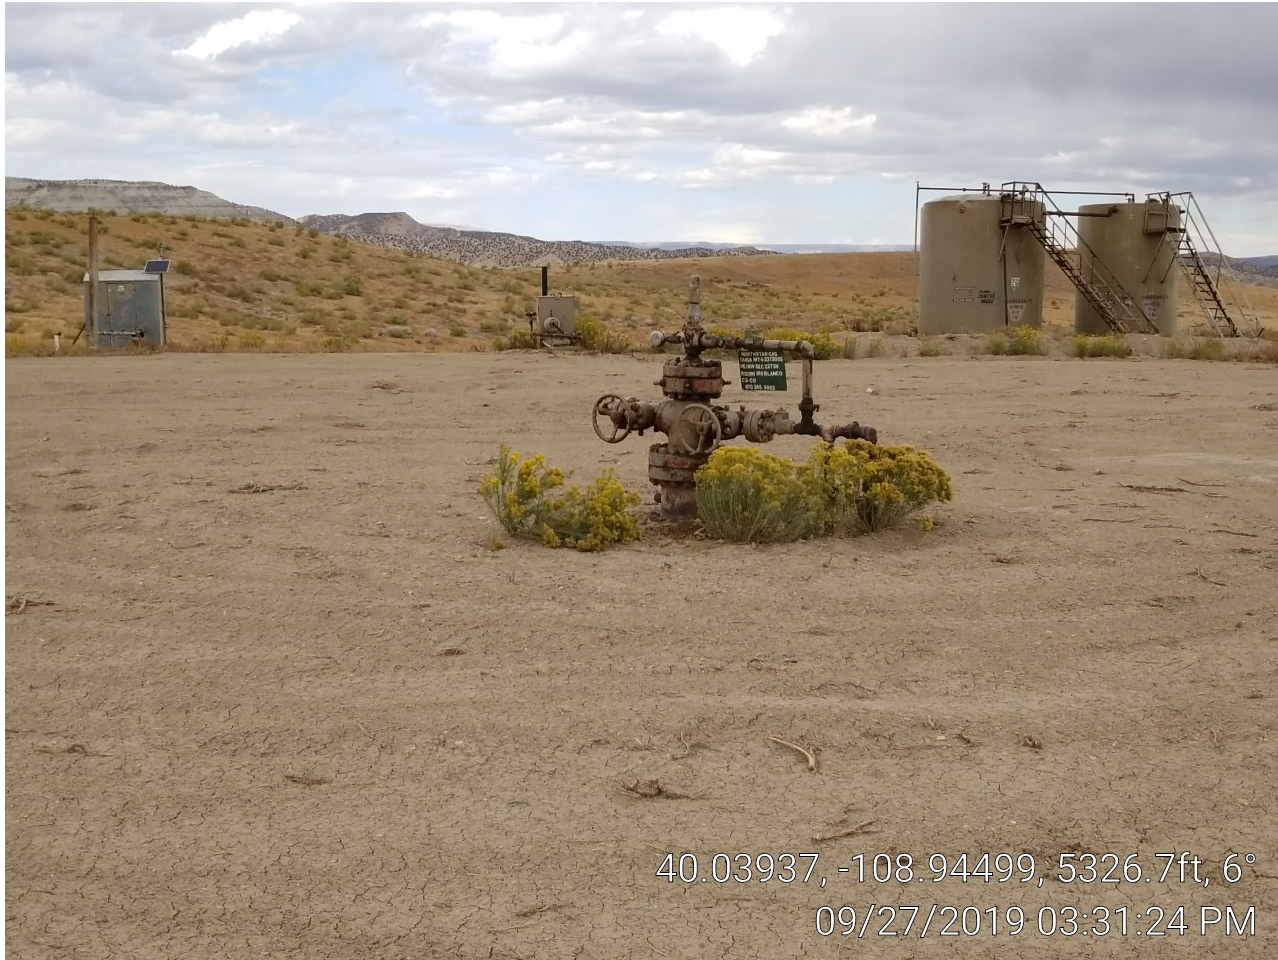
Photo 1. Location.

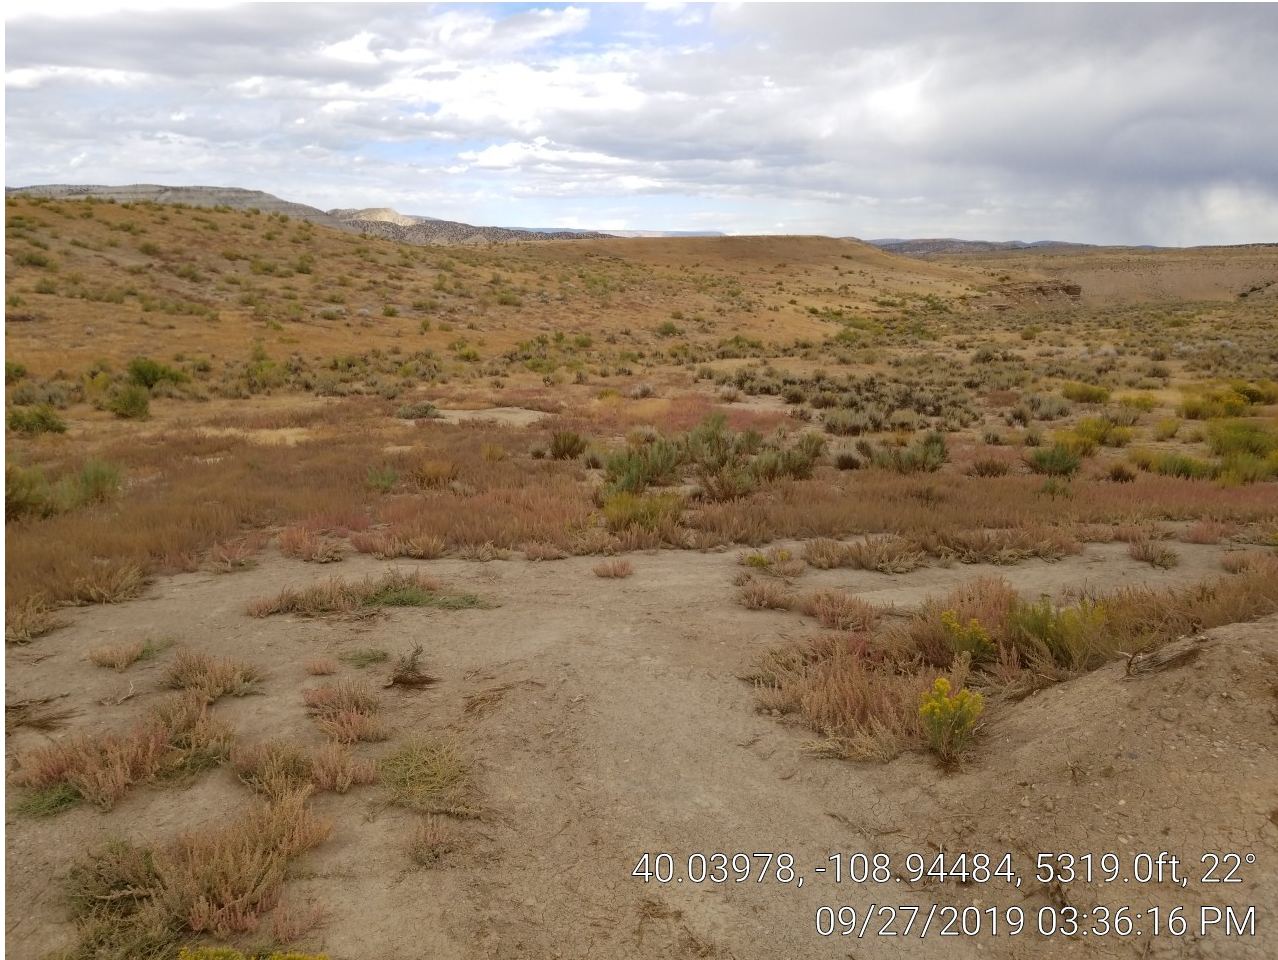
Photo 2. North of location.

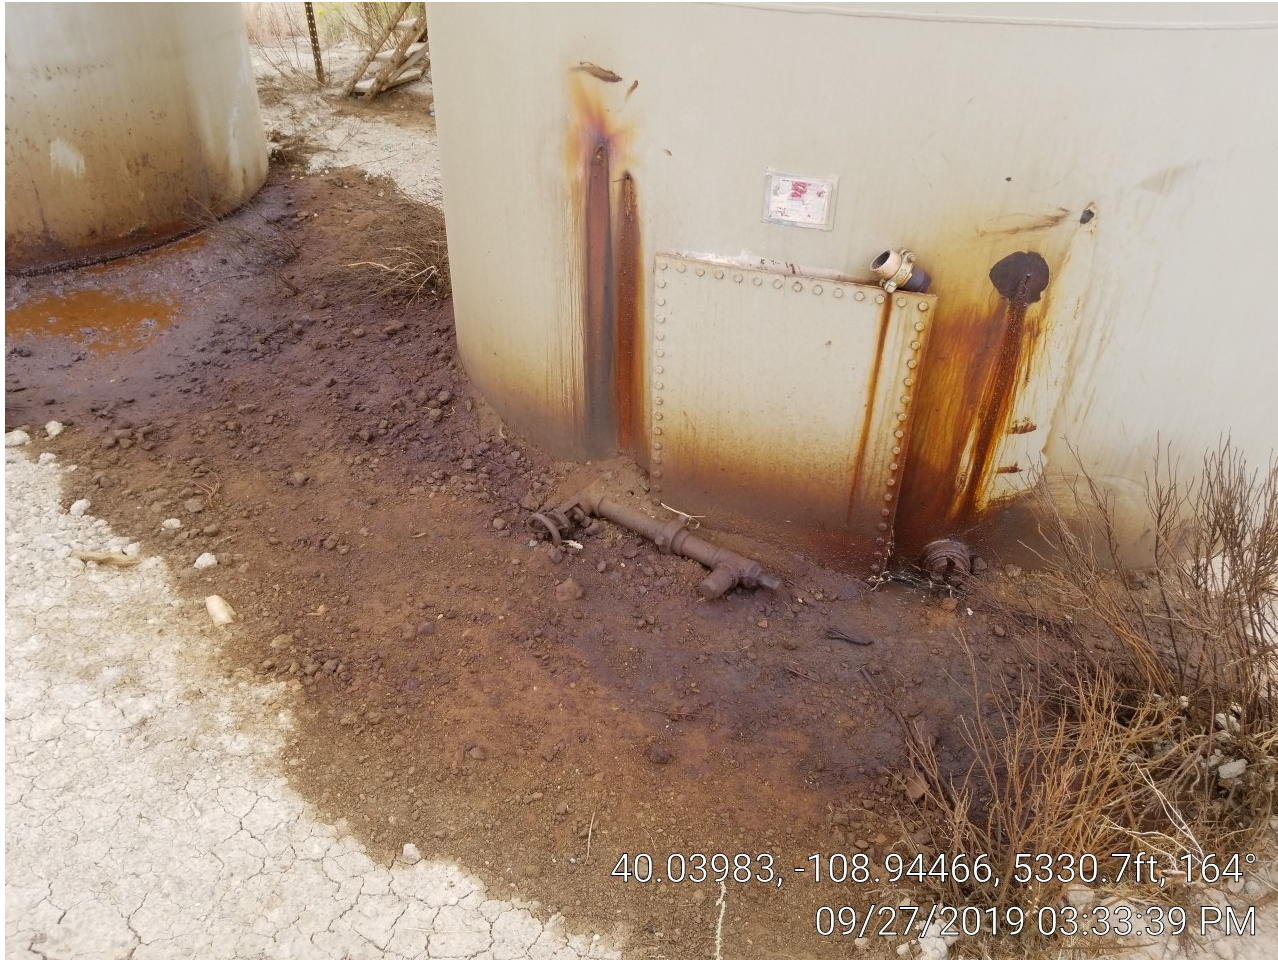
Photo 3. North side of tanks.

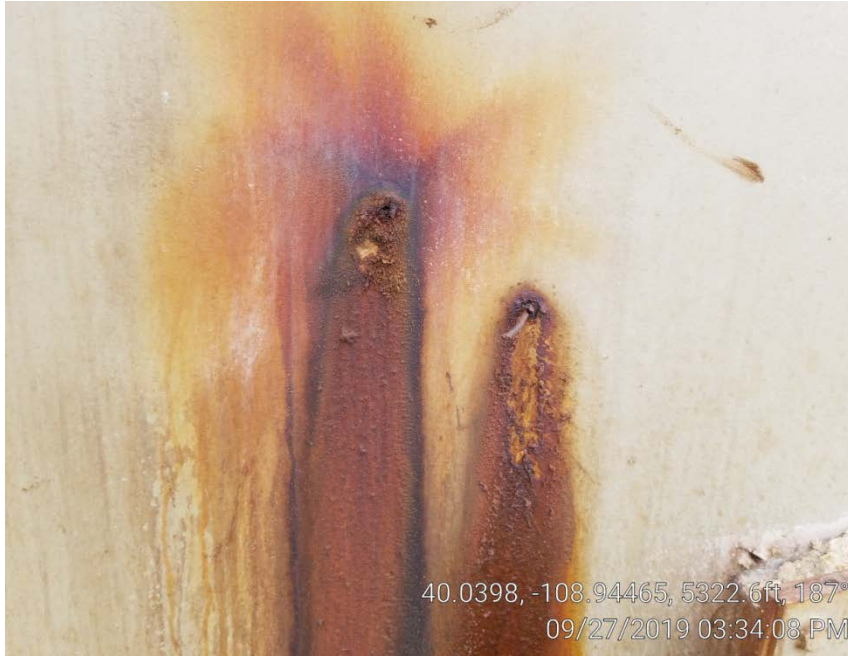
Photo 4. Tank holes.

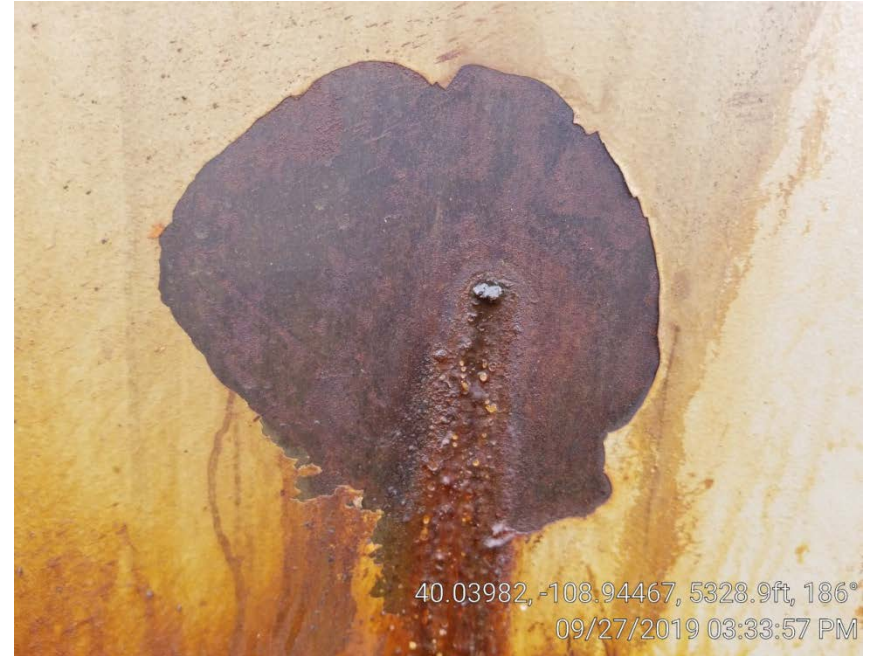
Photo 5. Tank hole.

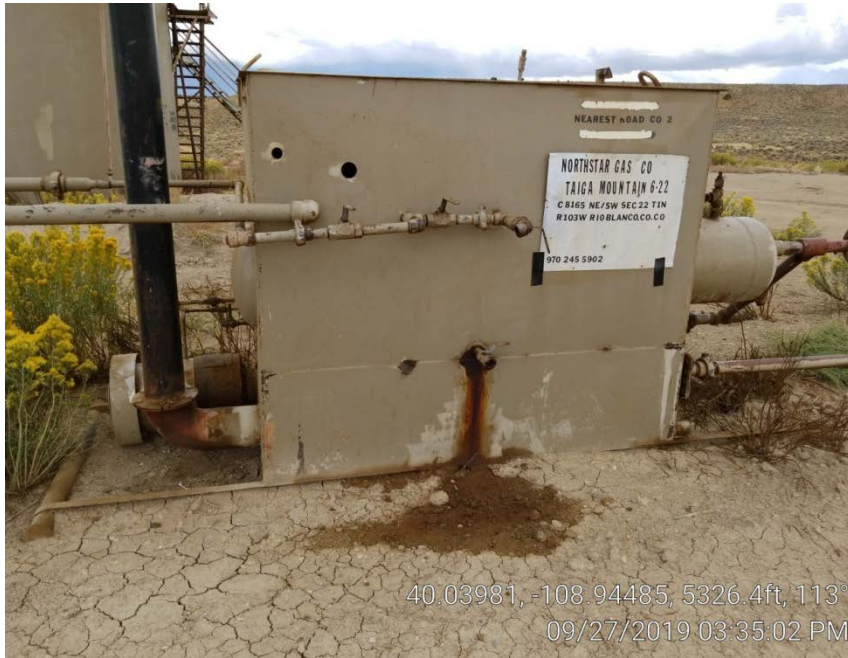
Photo 6. Separator leak – 9/27/2019

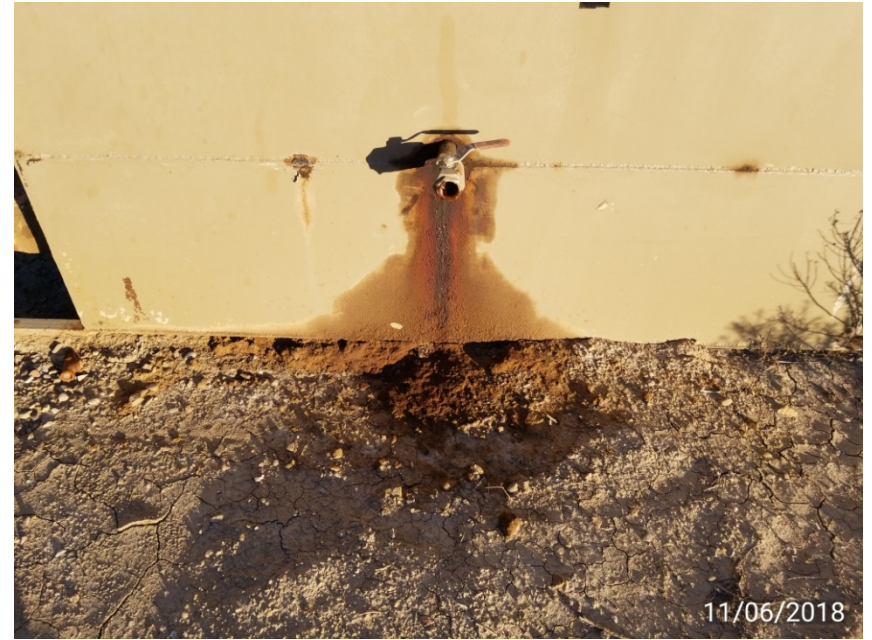
Photo 7. Separator leak – 11/06/2018

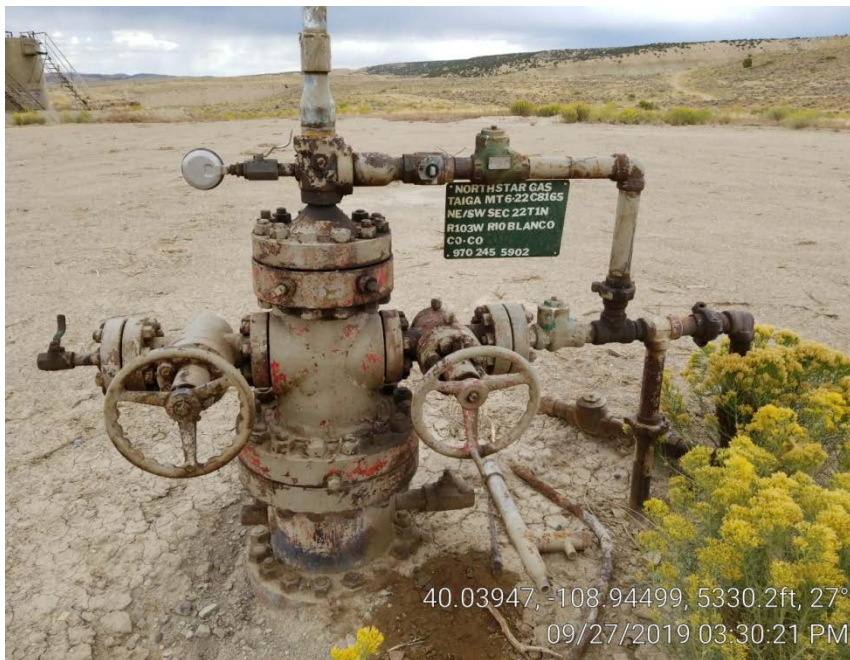
Photo 8. Well head.

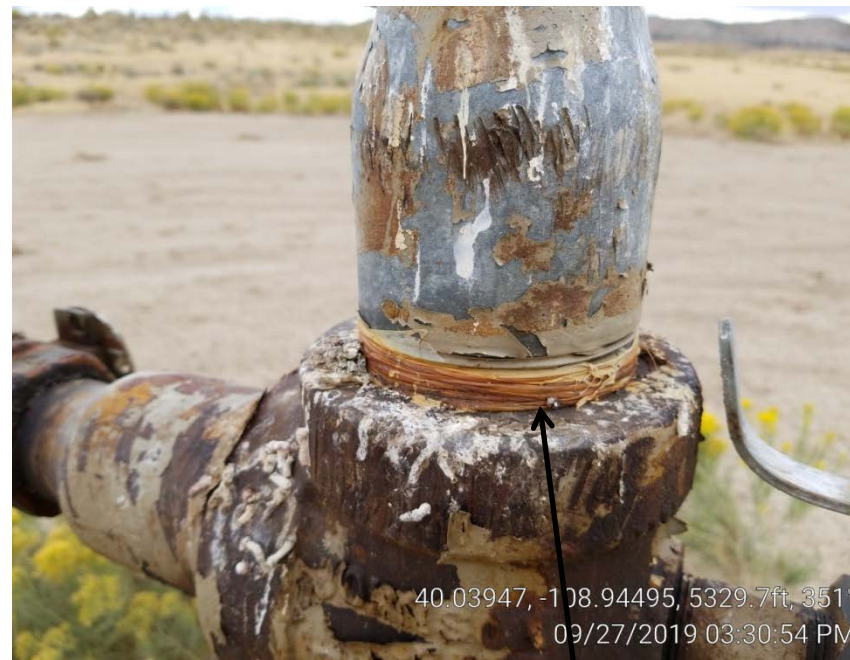
Photo 9. Well head gas leak.

Gas leak
