**Inspection Photos**  
**Location Name: Marvin E Schutt Unit #1**  
**Location ID: 318480**

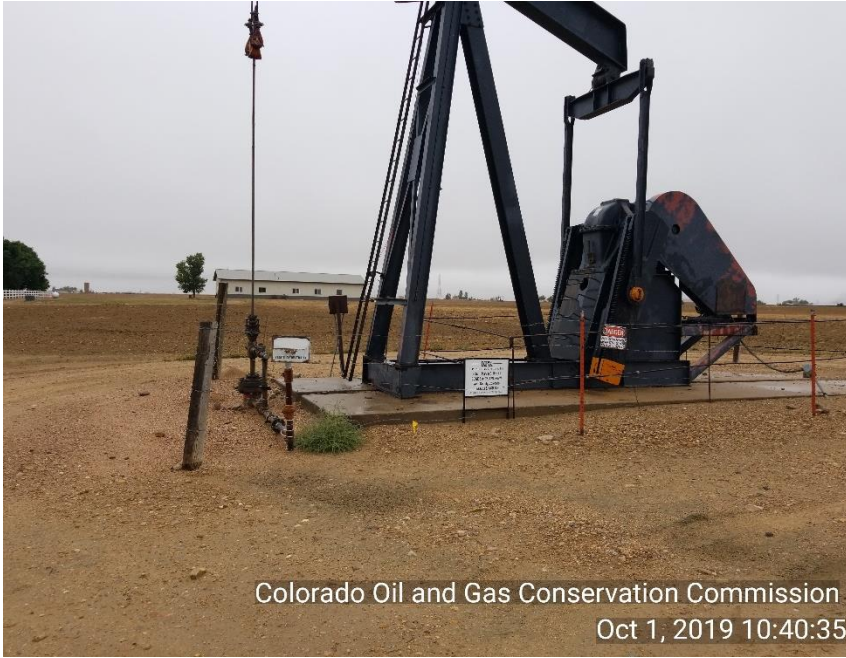
**Photo 1 PH and PU. WH sign**

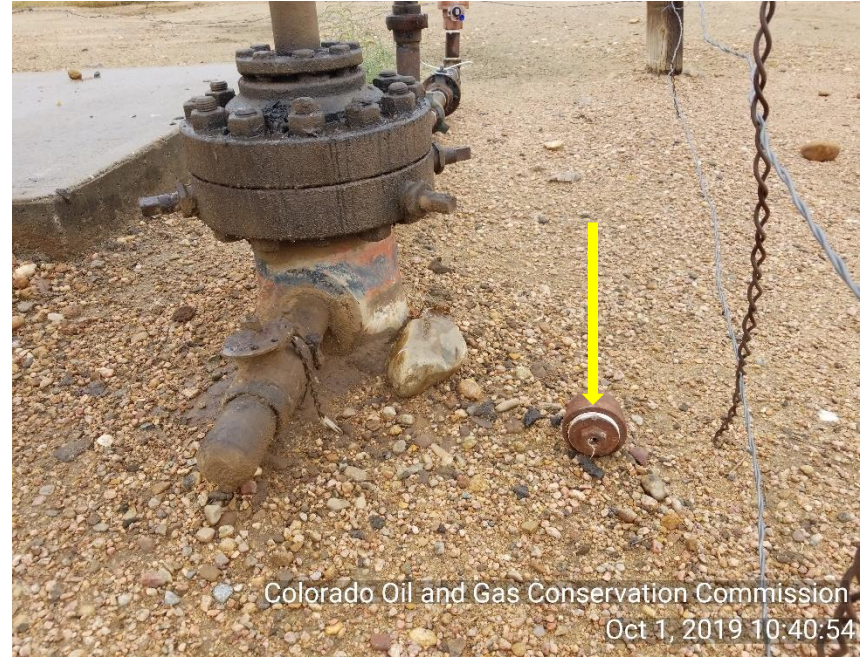
**Photo 2 Mechanical issue Braden head 1/4 hole open on 2" bushing.**

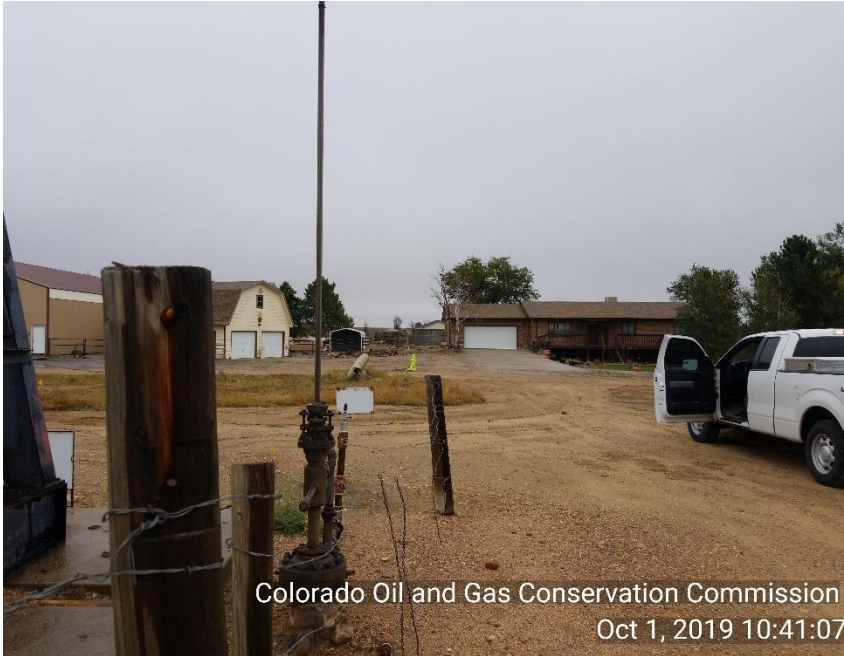
**Photo 3 WH approx. 90ft from resident**

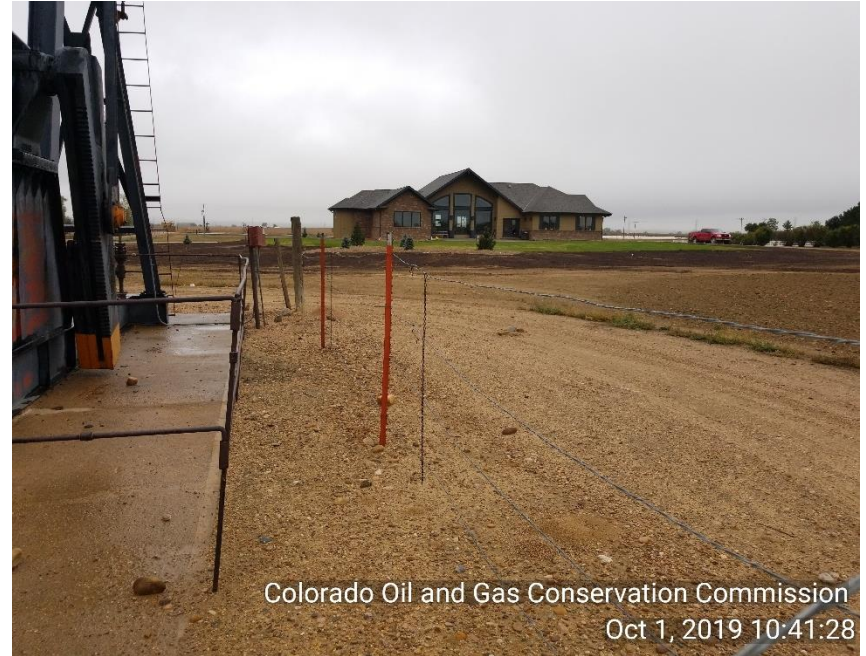
**Photo 4 WH approx. 100ft from resident**

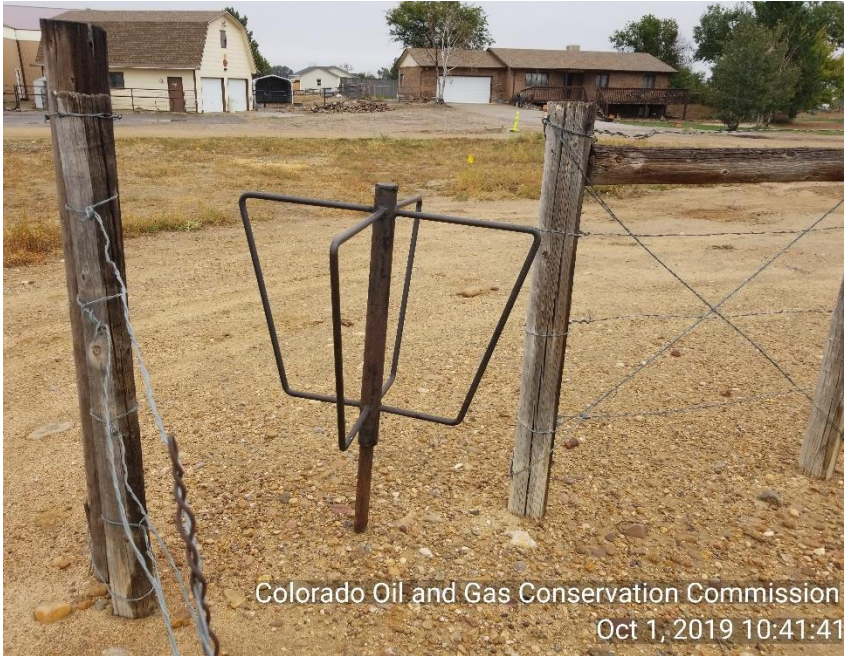
**Photo 5 entrance to PU in barb wire fence**

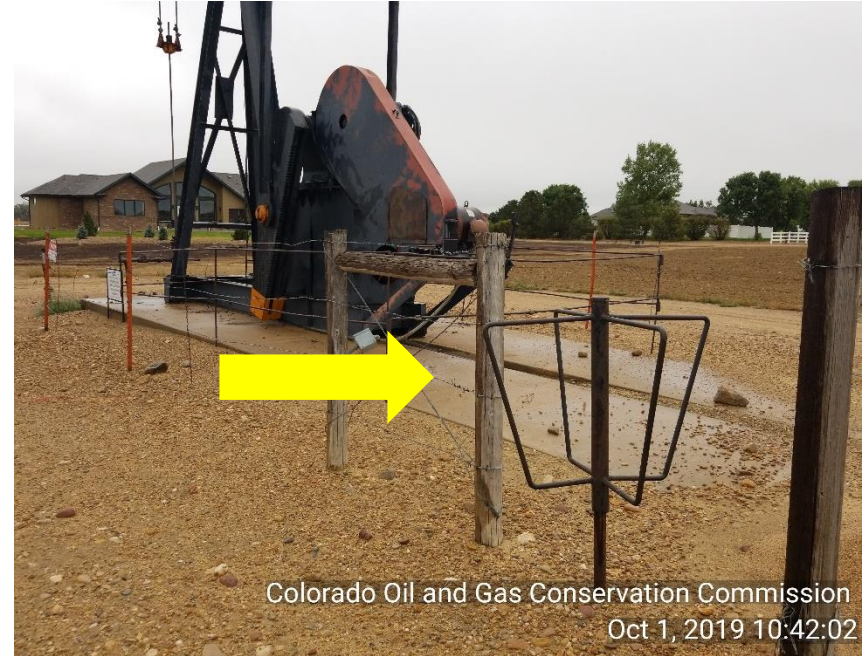
**Photo 6 Barb wire fence with walk in opening.**

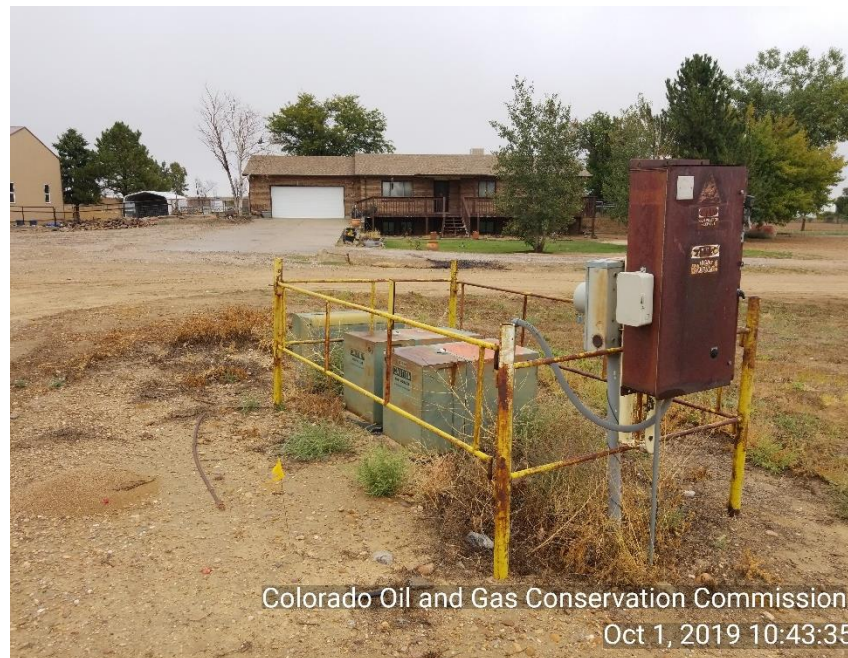
**Photo 8 Debris around electric panel. Electric panel approx. 45ft from residents home.**

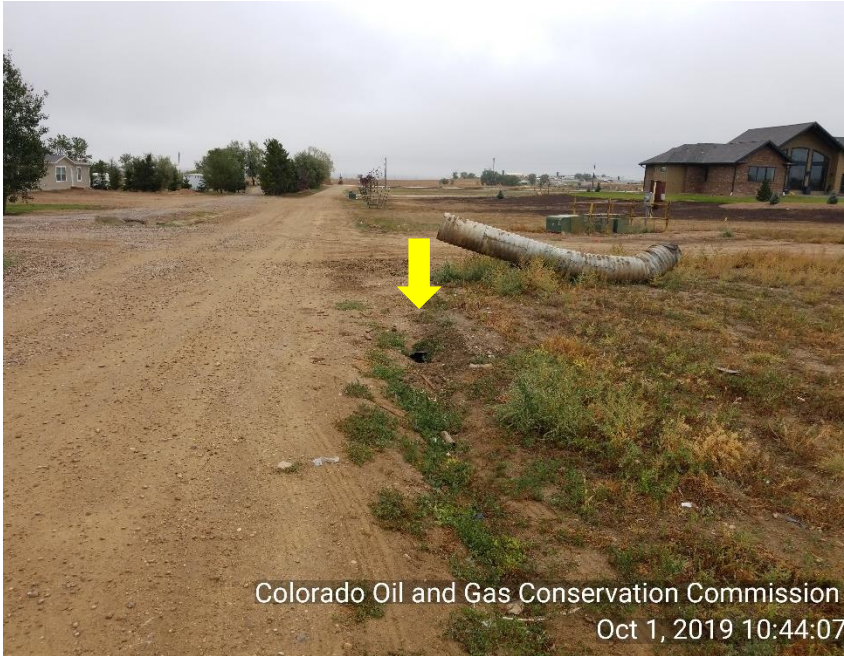
**Photo 9 Storm water BMP: Partial culvert removed and drainage ditch and to opening of culvert not maintained at entrance to well site.**

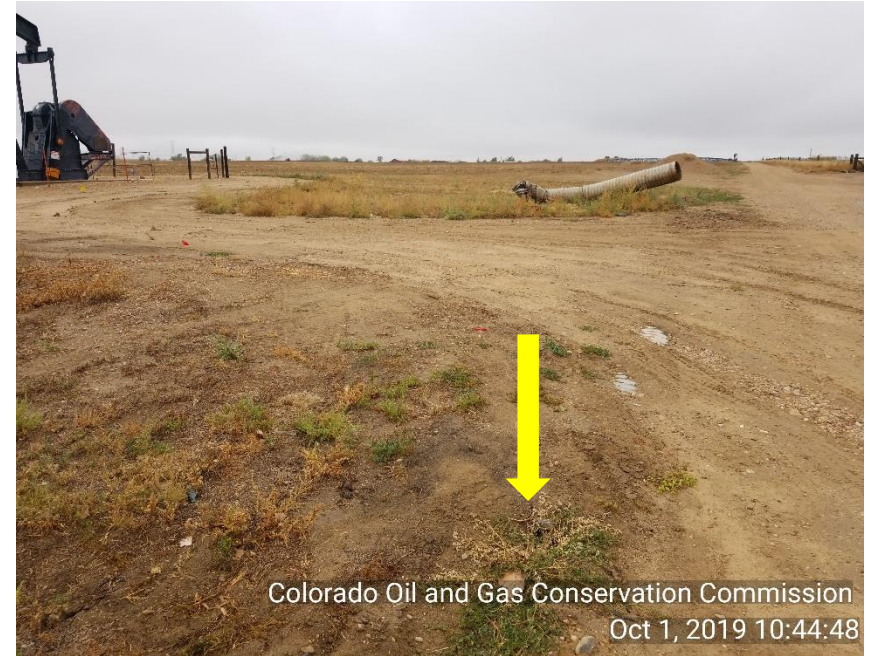
**Photo 10 Storm water BMP: Culvert outlet and drainage ditch not maintained. Top of culvert exposed not proper cover at entrance to well site.**
