**Inspection Photos**  
**Location Name: Cleveland #2**  
**Location ID: 332884**

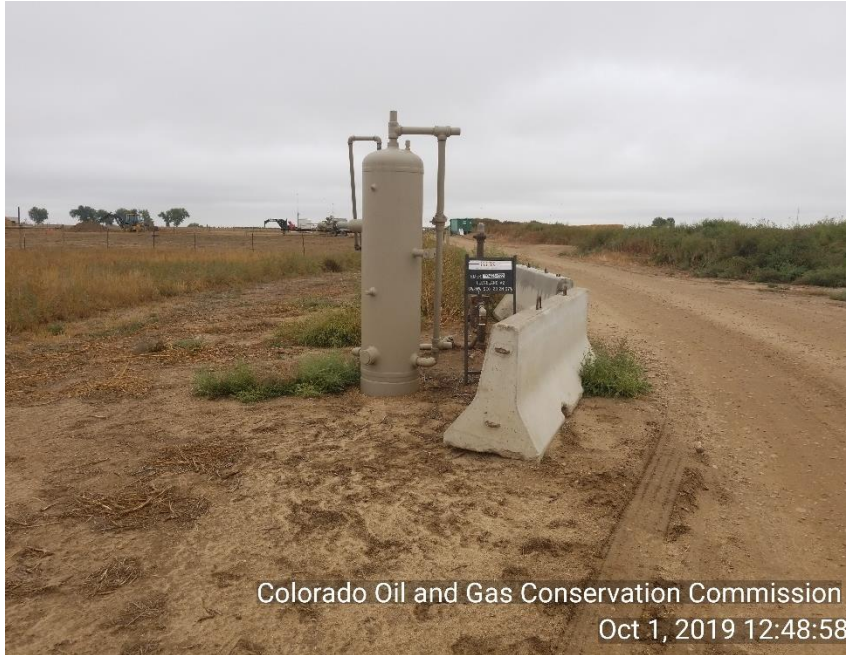
**Photo 1 WH sign Weeds around well head**

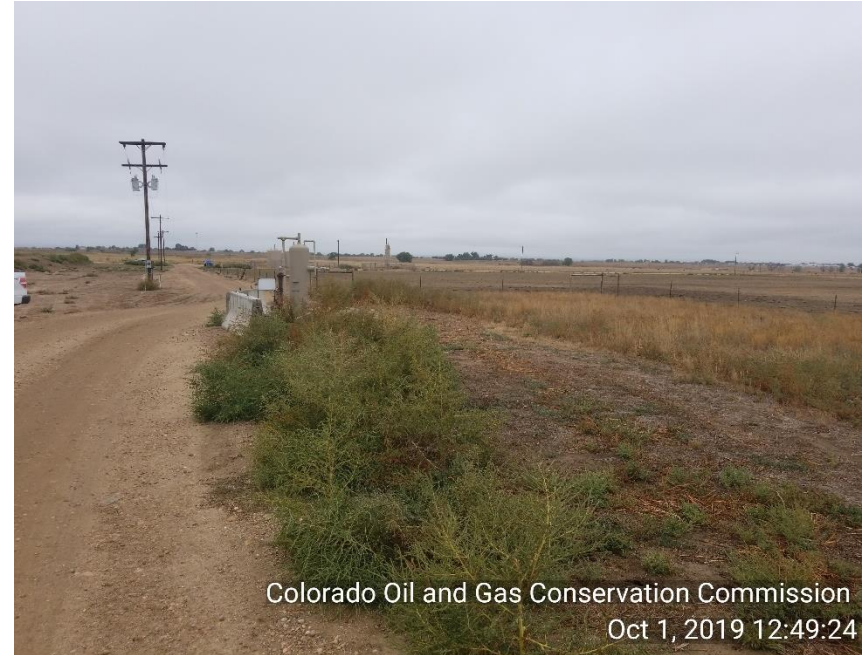
**Photo 2 Weeds on well site**

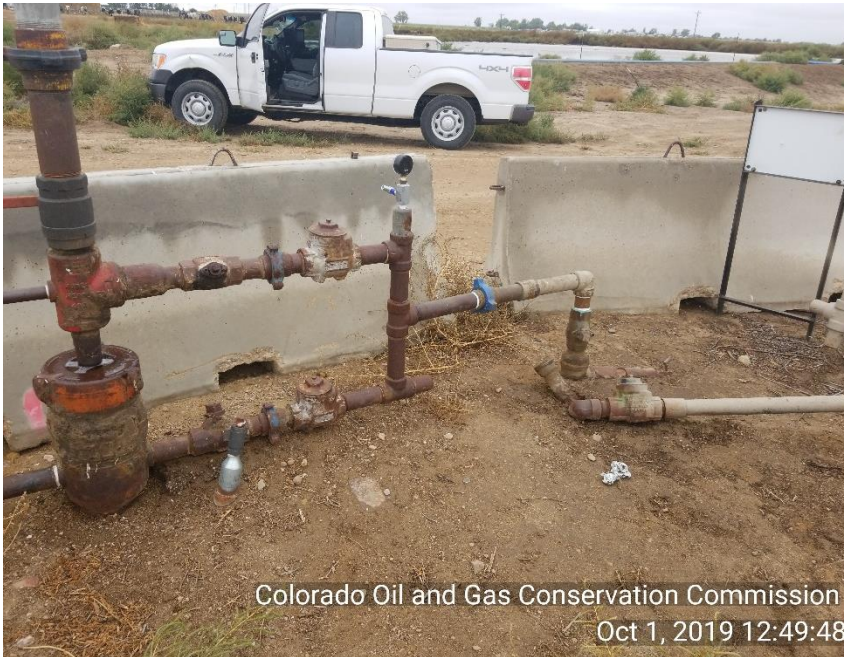
**Photo 3** appears KPK has hooked up production lines from well head to vertical separator since last inspection and opened flow line valves.

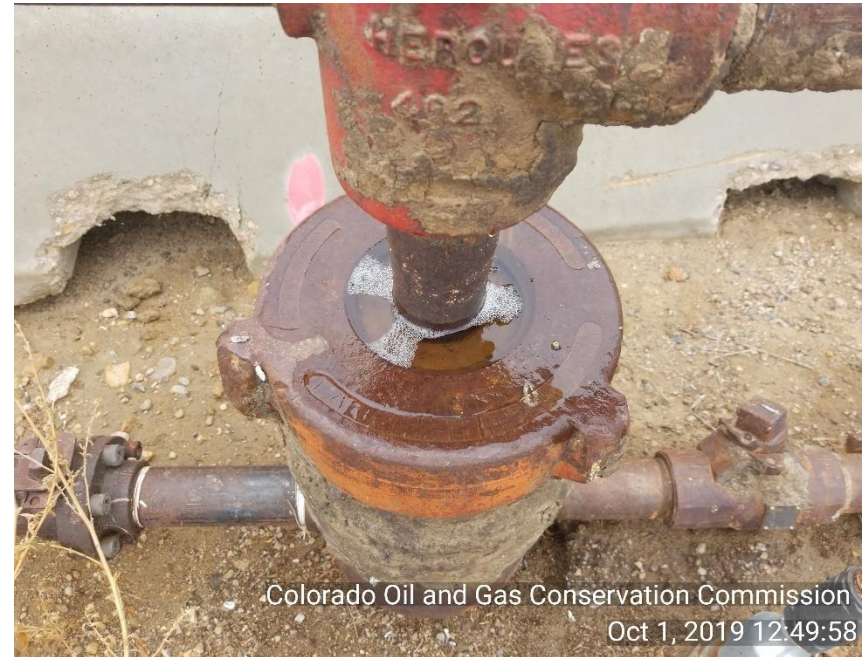
**Photo 4 VENTING:** bubbles show what appears to be well head leaking at the tubing.

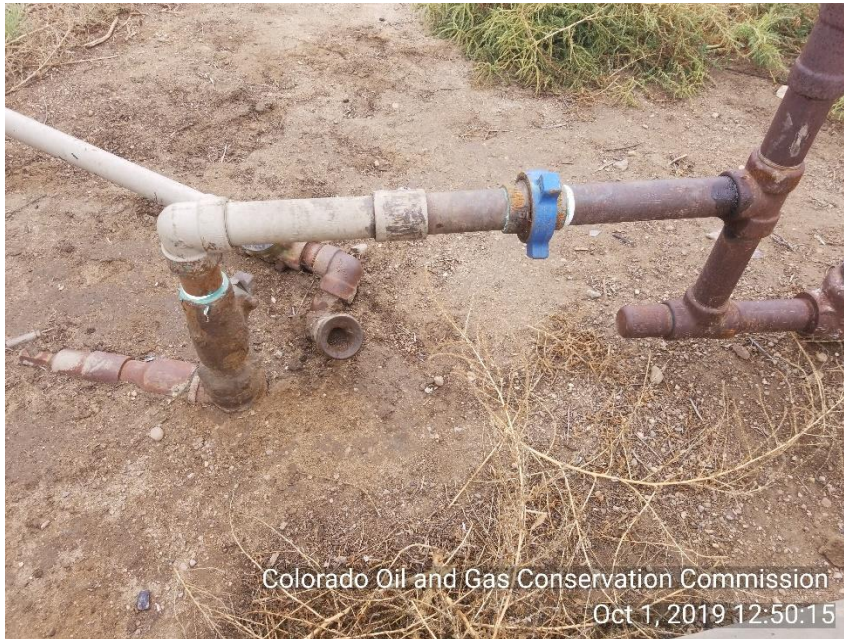
**Photo 5 unused equipment: Unmarked not LOTO riser on flow line.**

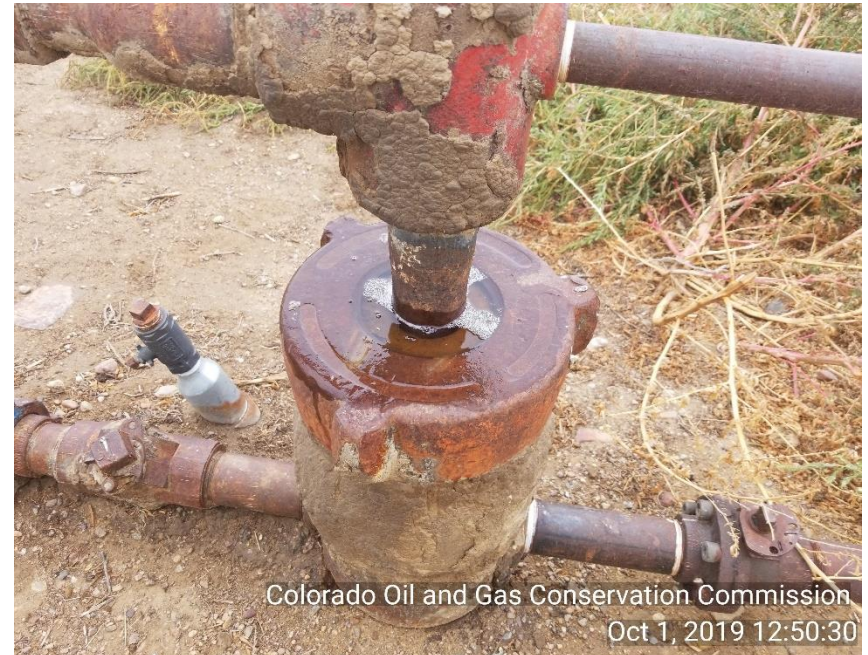
**Photo 6 VENTING: bubbles show what appears to be well head leaking at the tubing.**

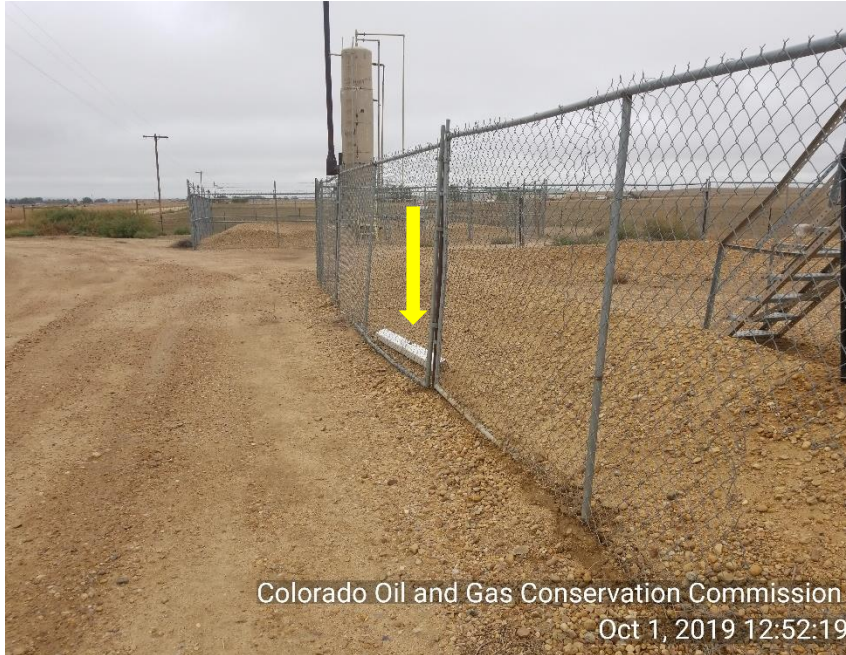
**Photo 7 TRASH along TNK BTRY fence**

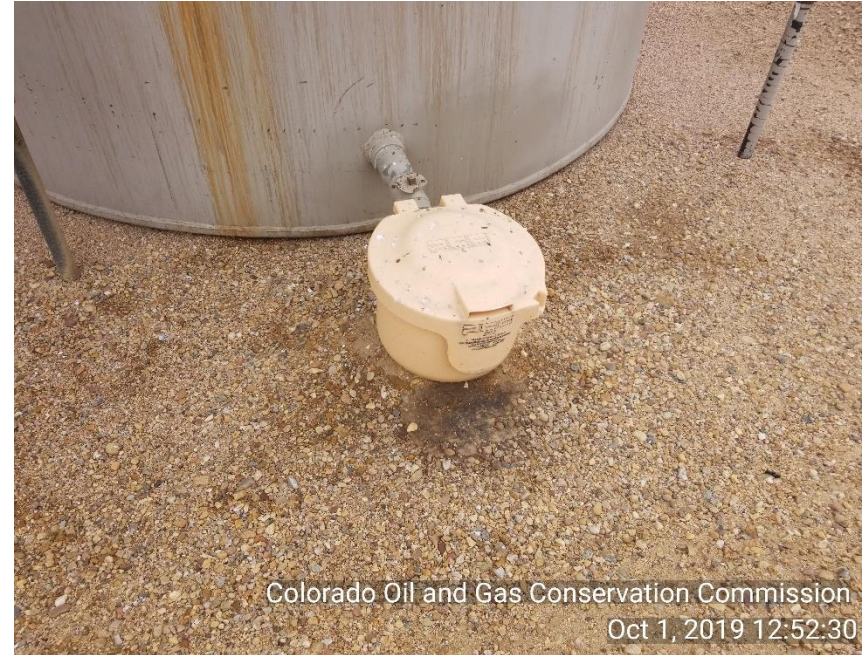
**Photo 8 Stained soil under Produced water load line.**

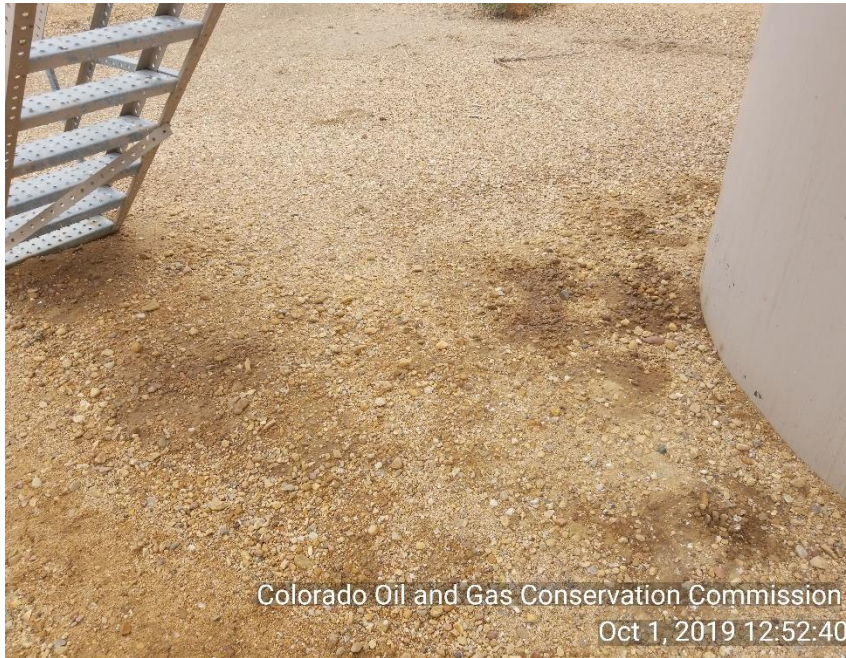
**Photo 9 Stained soil around crude oil tank**

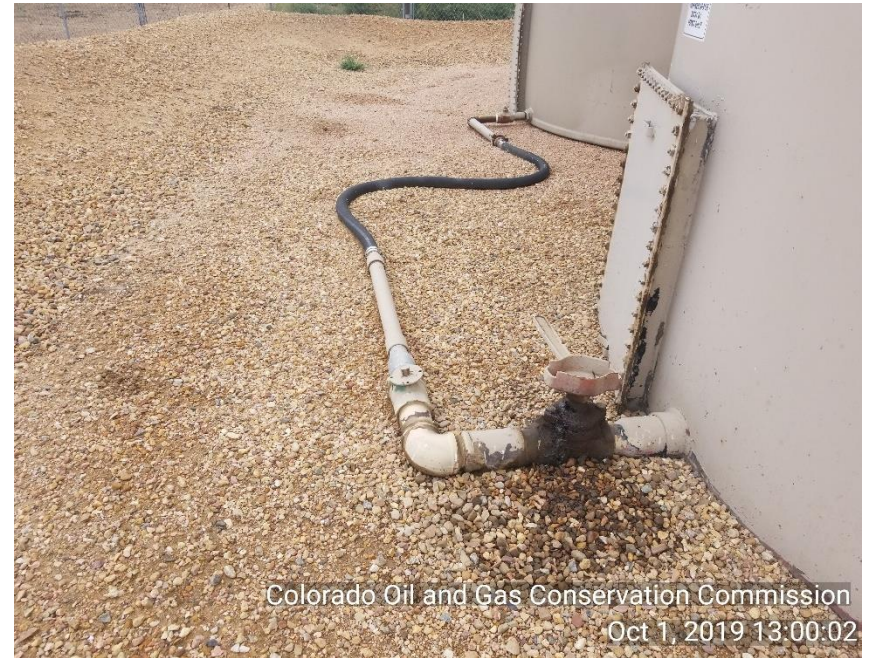
**Photo 10 stained soil around crude oil tank load line.**

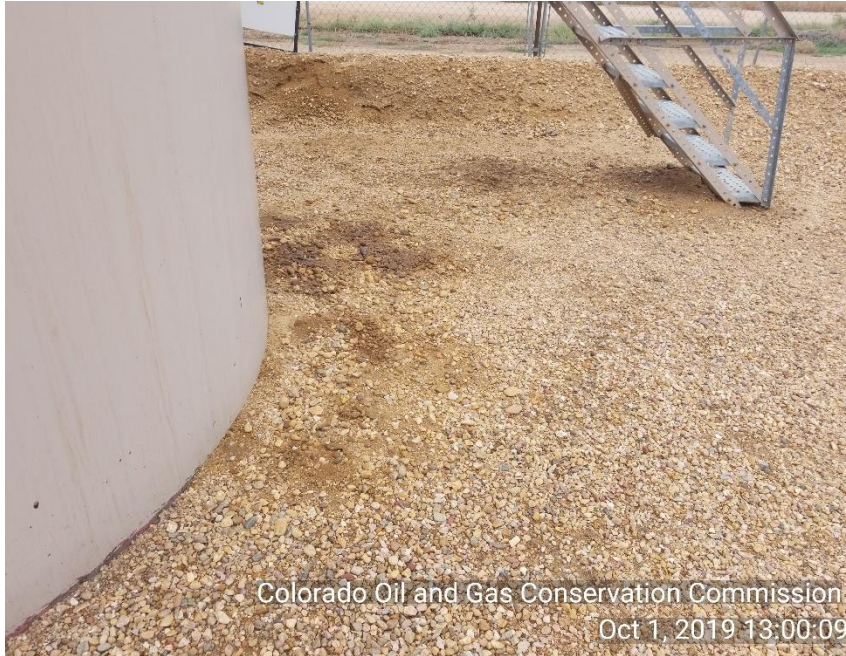
**Photo 11 stained soil around crude oil tank**

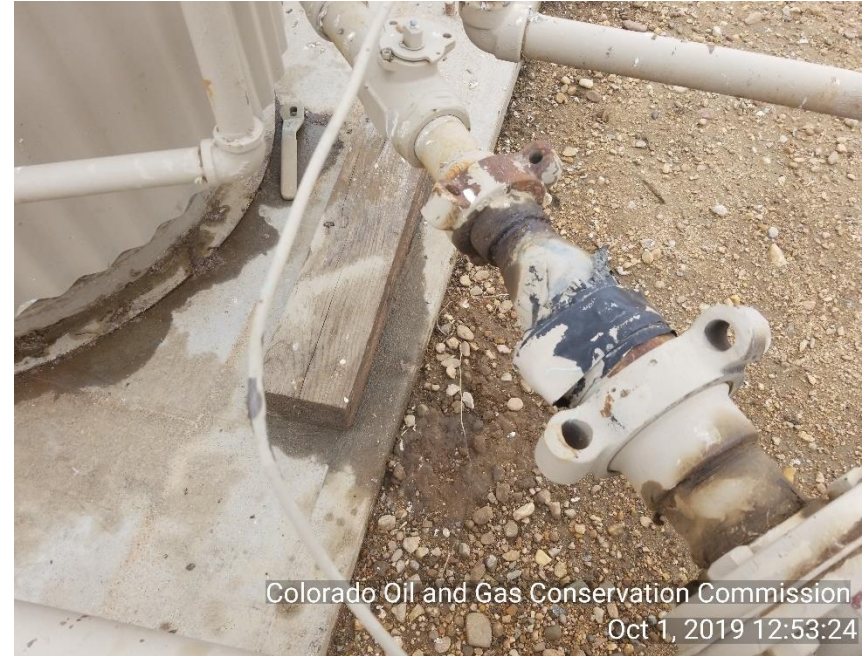
**Photo 12 Stained soil and mechanical issues on Vertical heated separator.**

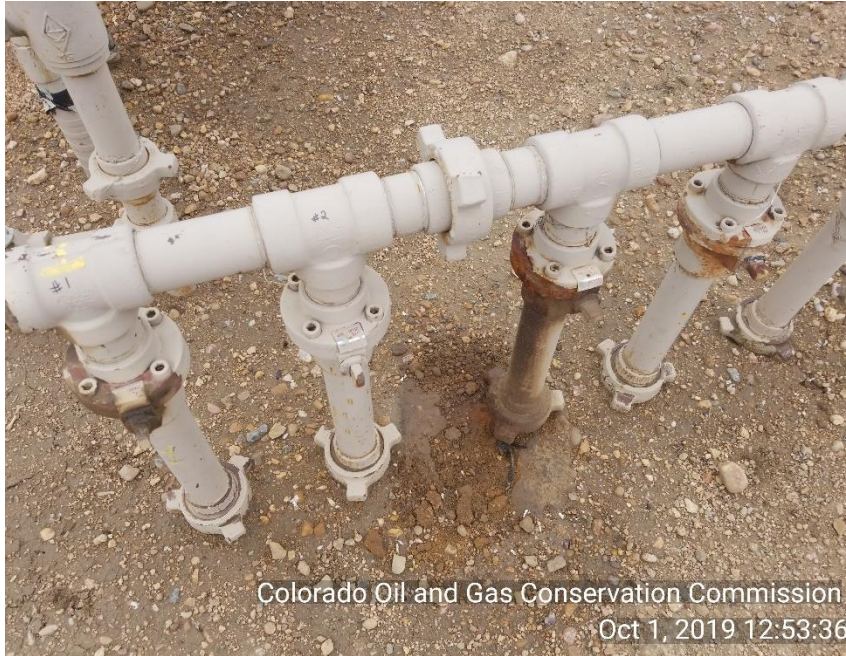
**Photo 13 stained soil and mechanical issues on flow lines to vertical heated separator.**

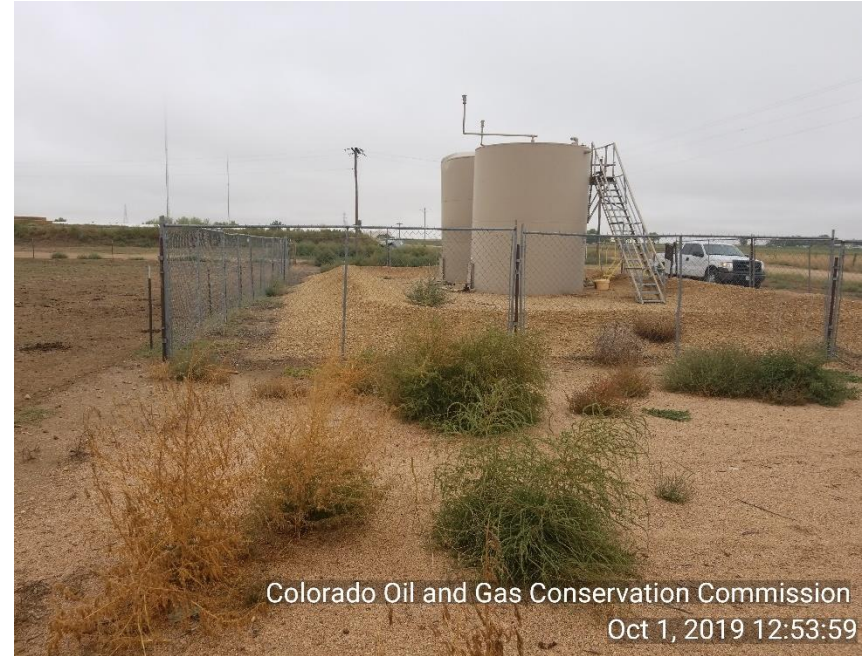
**Photo 14 Weeds in and around TNK BTRY**

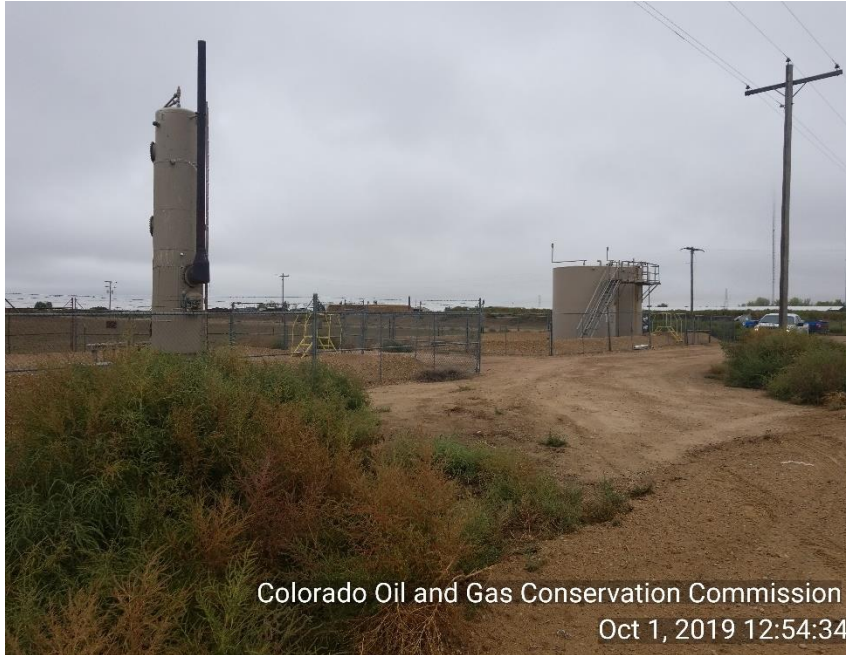
**Photo 15 Weeds On TNK BTRY site**

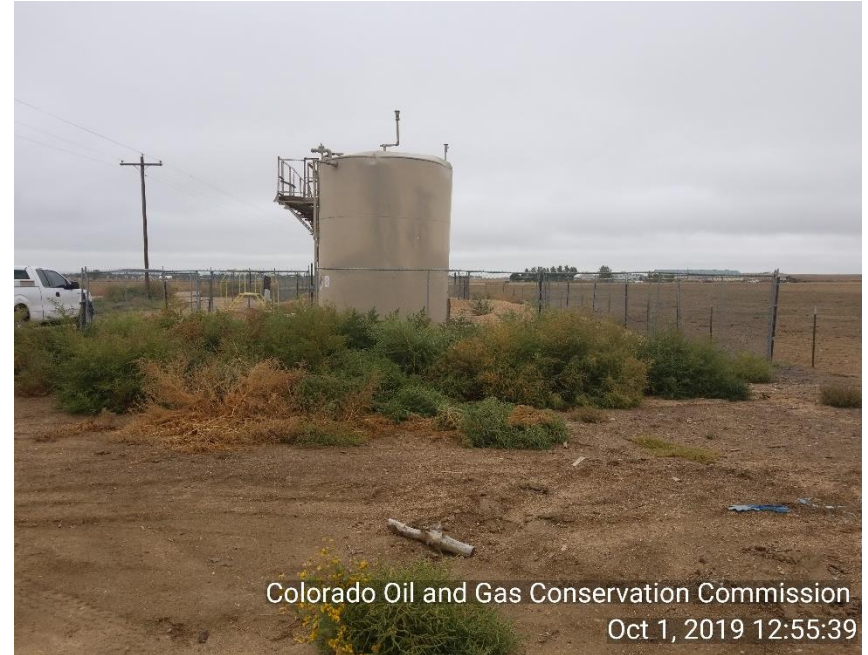
**Photo 16 Weeds on TNK BTRY site**
