**Inspection Photos**  
**Operator: Hilcorp Energy**  
**Location/API #: 067-07578**  
**Date: 9-24-2019**

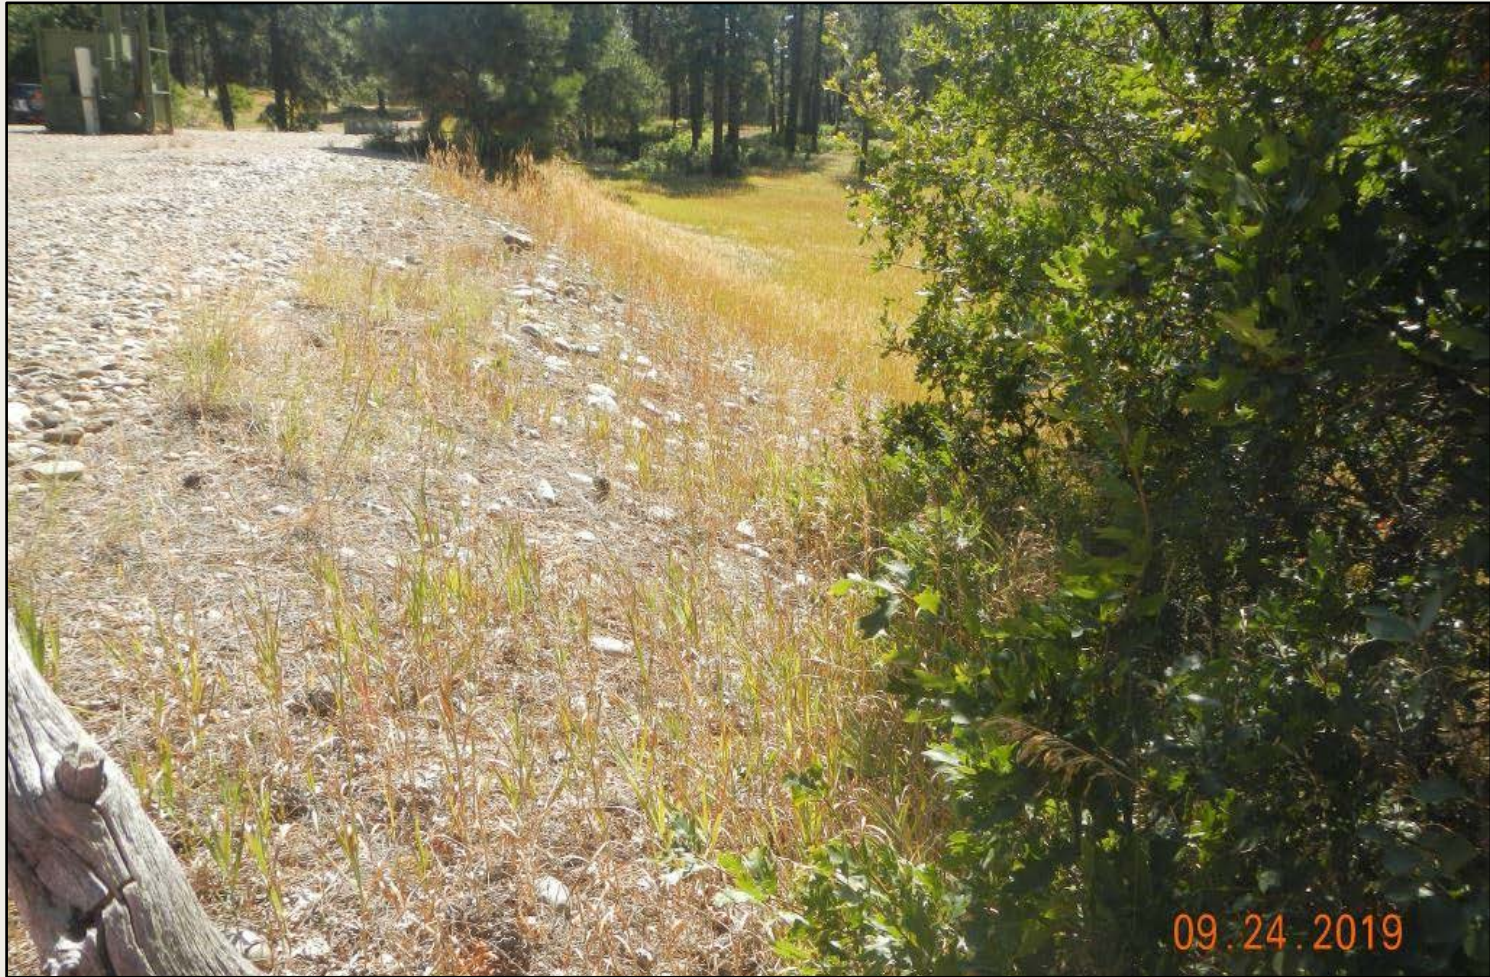
Photo 1. View of western fill slope from the northwestern edge facing southward. Revegetation is largely comprised of smooth brome and gambel oak trees.

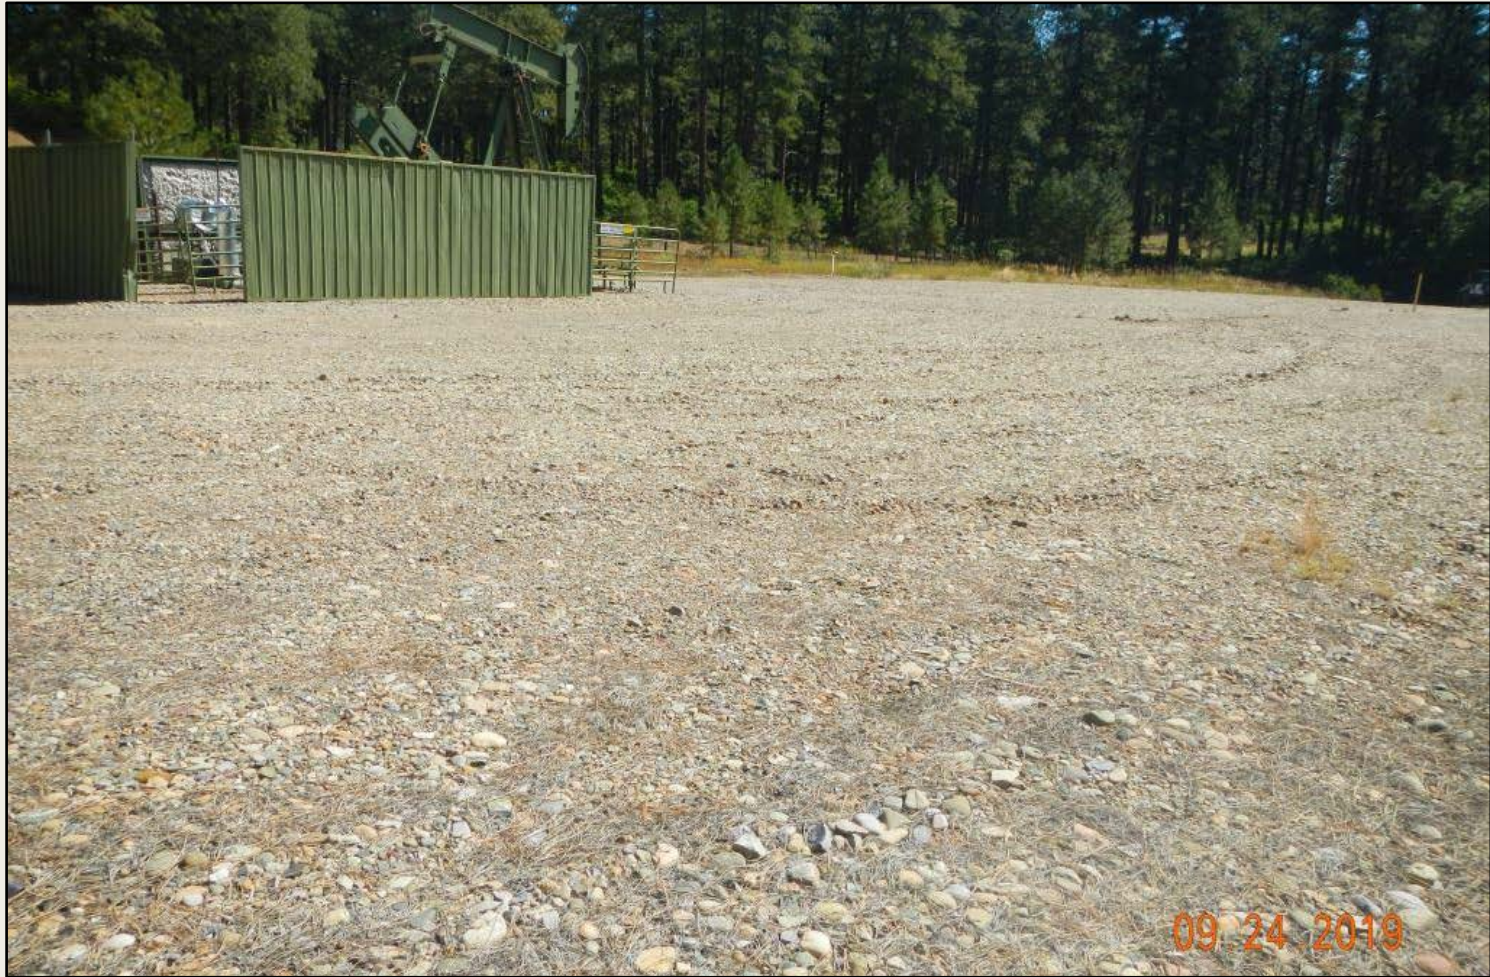
Photo 2. View of the project area from the northwestern corner facing center.

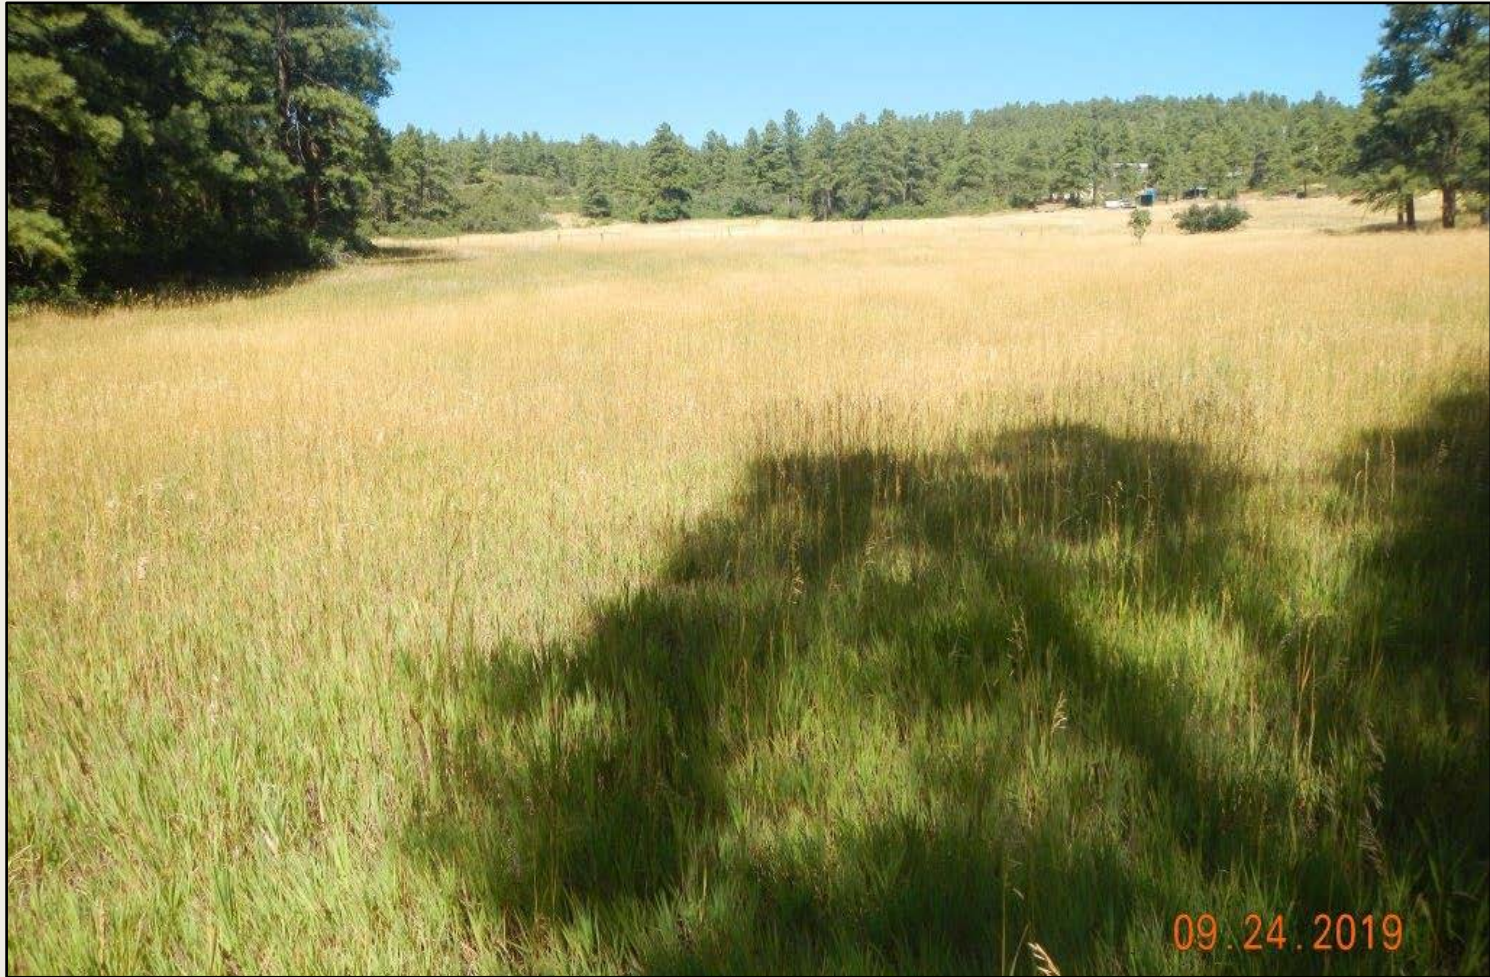
Photo 3. View of reference area vegetation, comprised of open grass field surrounded by mixed ponderosa pine and gambel oak woodland.
