Inspection Photos
Operator: BP America
Location/API #: 067-07175
Date: 9-30-2019

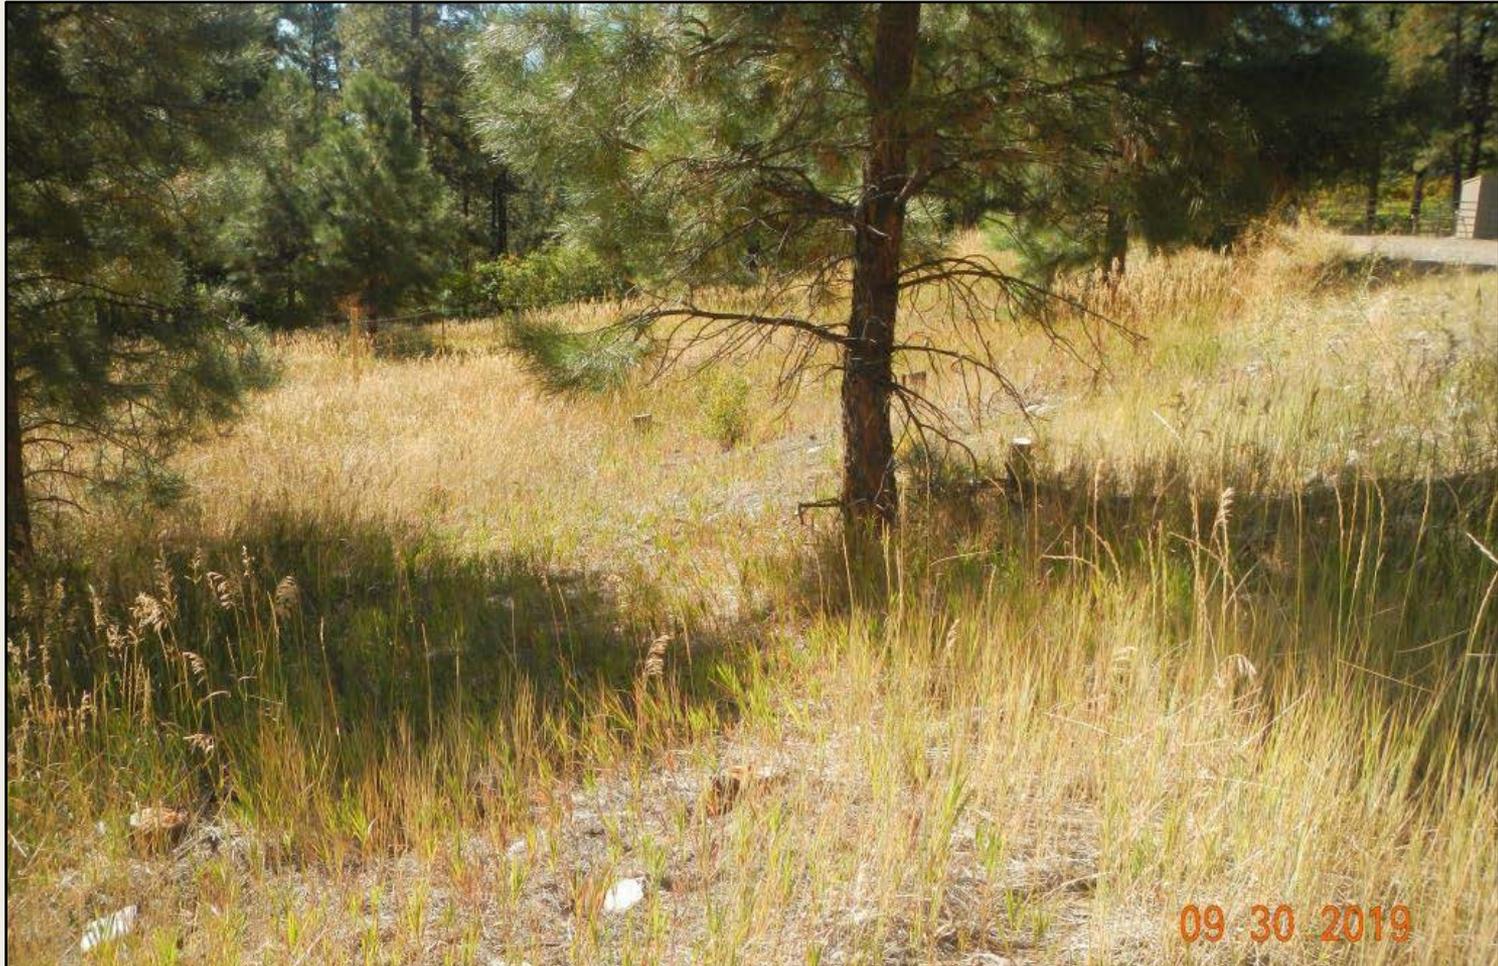
Photo 1 View of the fill slope in the eastern project area from the northeastern corner facing southward. Revegetation is comprised of smooth brome and western wheatgrass, with young ponderosa pine trees.

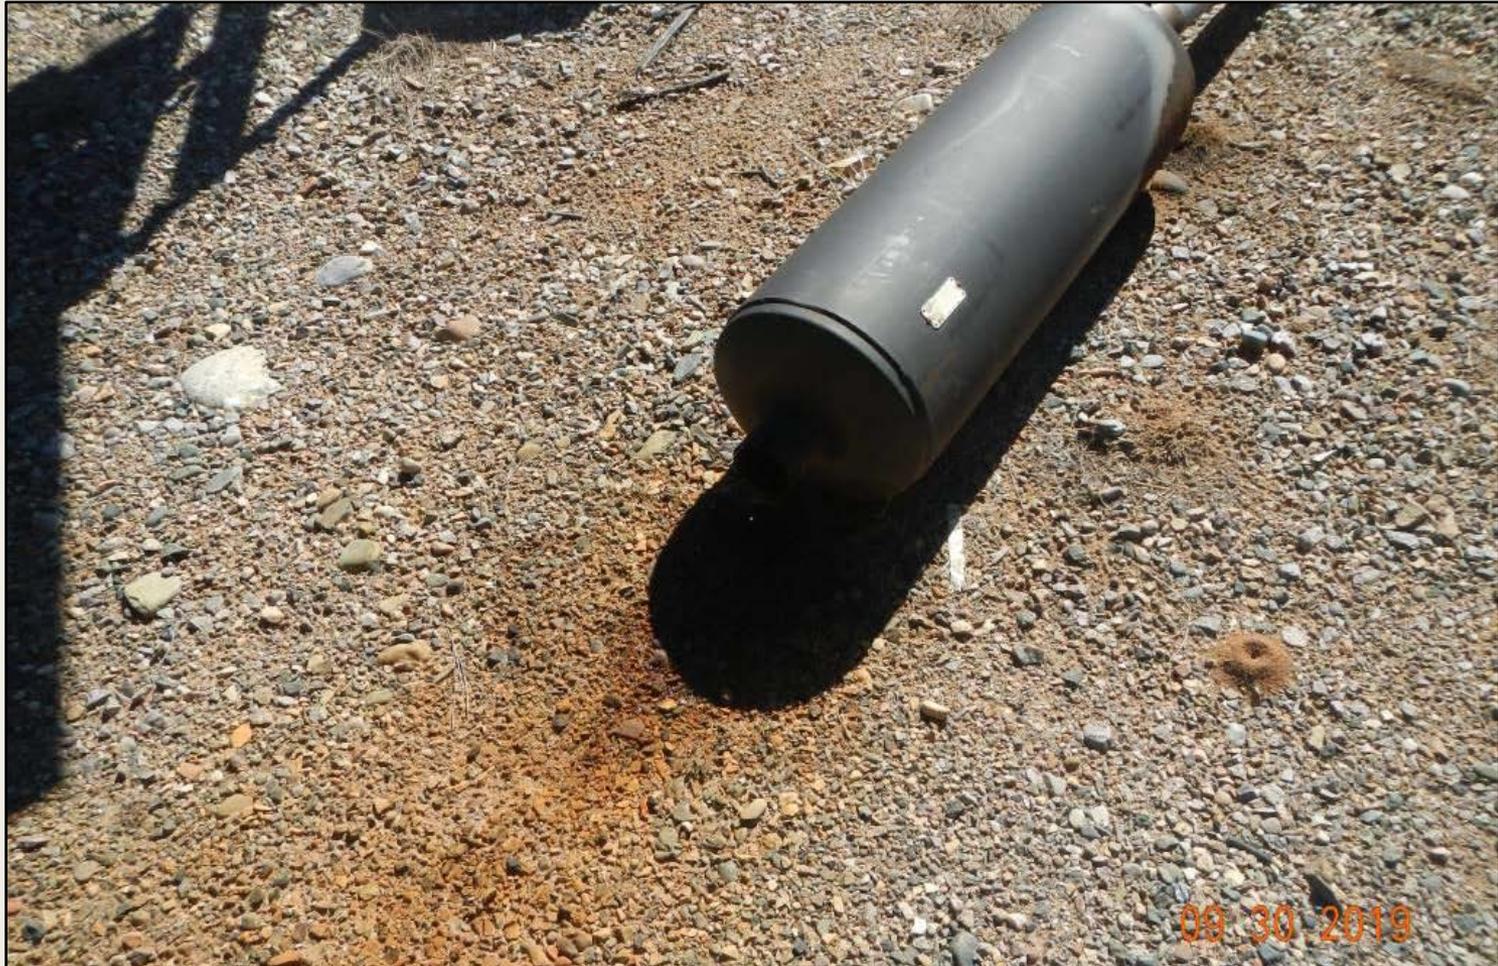
Photo 2. View of oily material on well pad surface. Liquid observed on soil surface. This material is a potential stormwater pollutant.

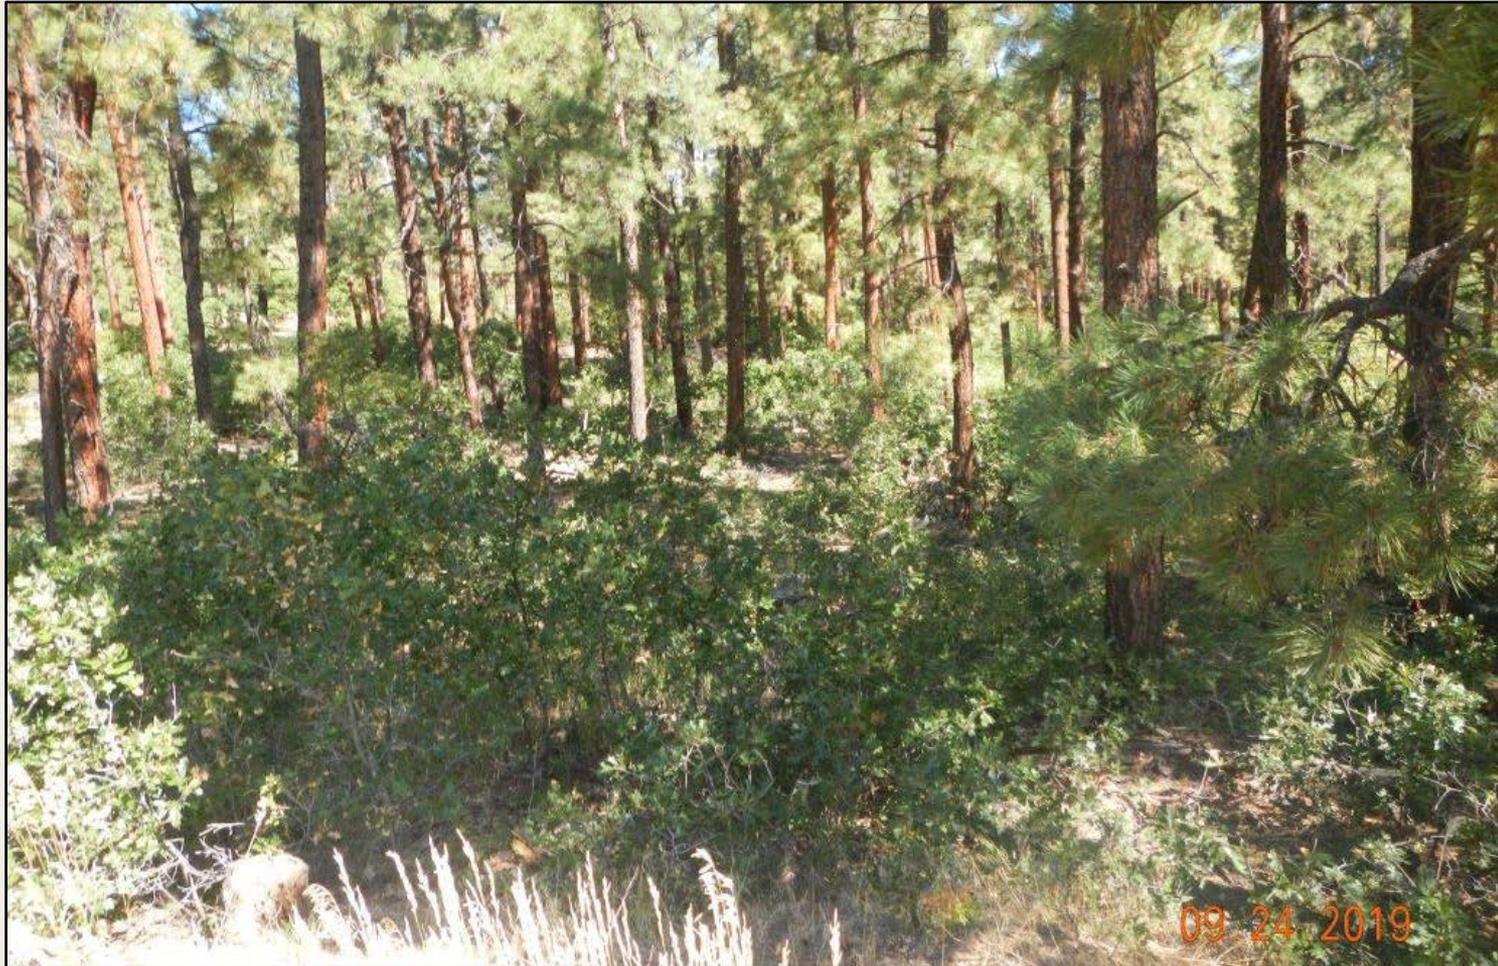
Photo 3. View of reference area vegetation, comprised of ponderosa pine forest with gambel oak and herbaceous understory.
