Inspection Photos
Location Name: BROWN-66N63W /2SENW
Location #: 306163

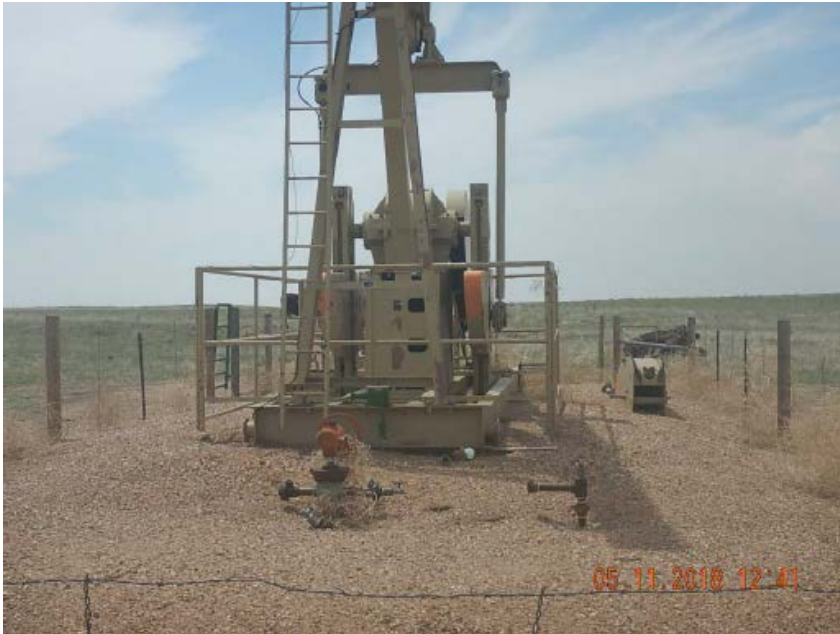
Photo #1
Brown 22-2 (05-123-24094) Wellsite
Temporarily Abandoned | TA
prior insp.

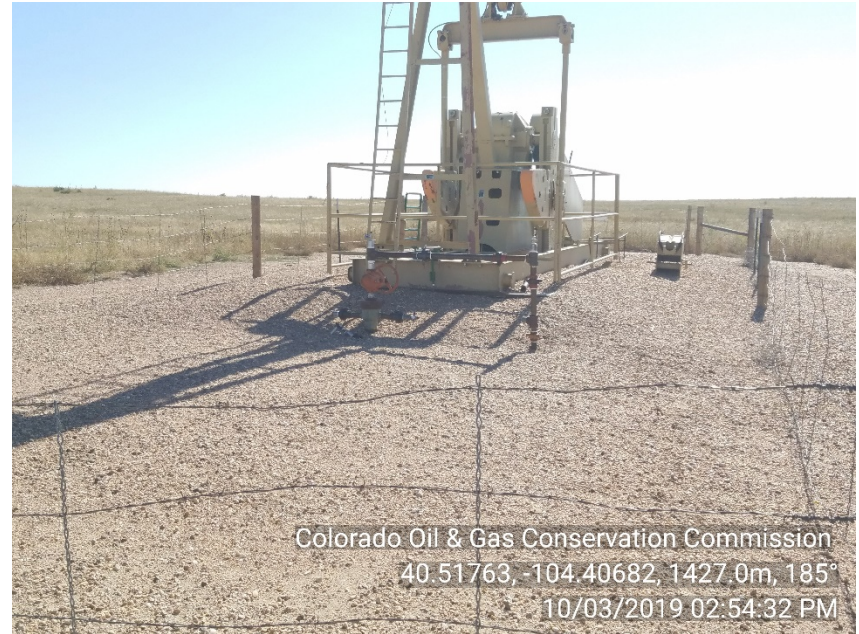
Photo #2
Brown 22-2 Wellsite
Shut-In | SI

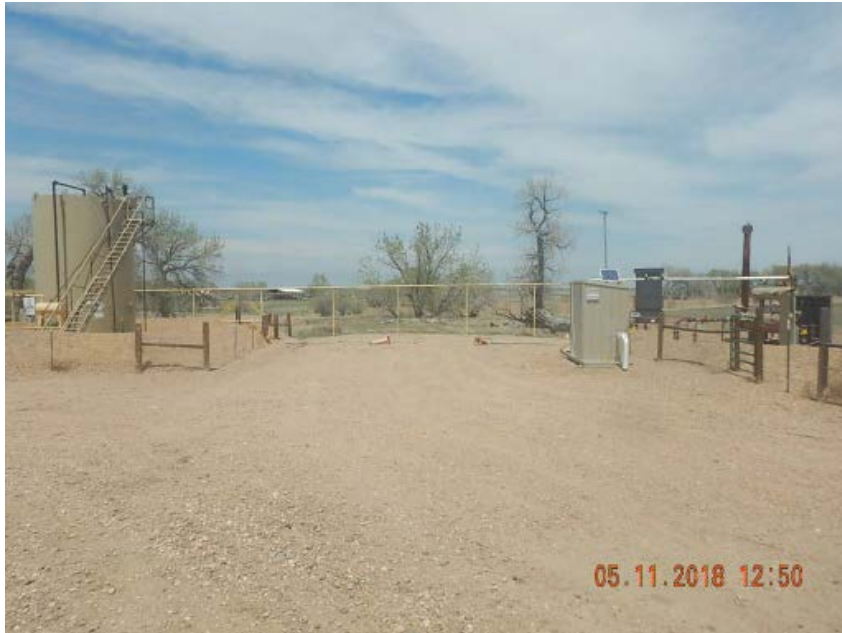
Photo #3
Brown 22-2 Battery
Shut-down | Inactive
prior insp.

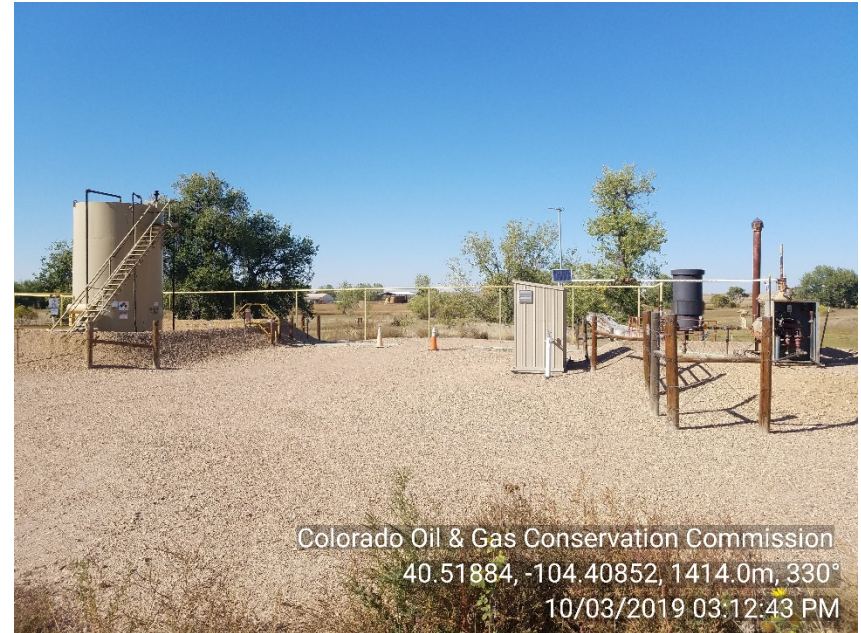
Photo #4
Brown 22-2 Battery
Shut-down | Inactive

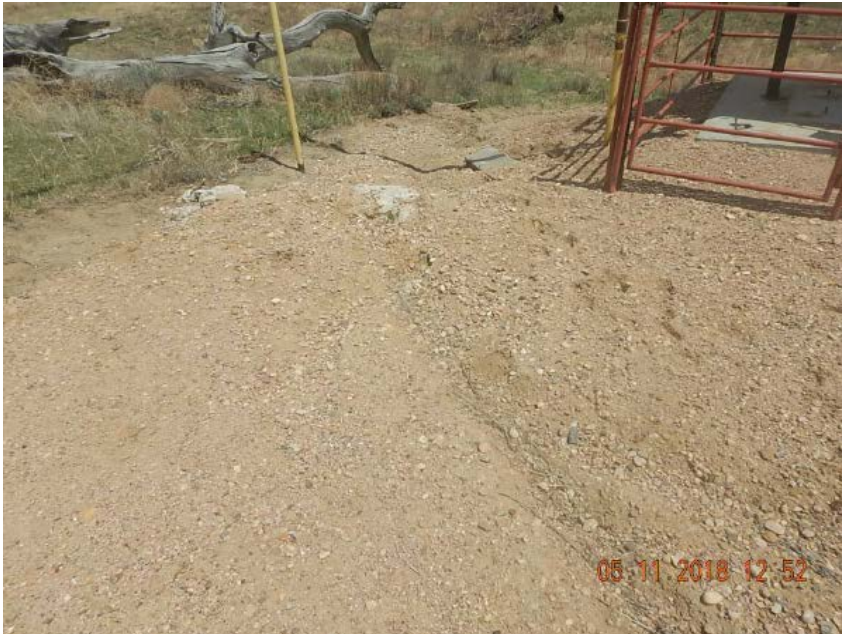
Photo #5
Brown 22-2 Battery
NE Corner – Stormwater erosion
prior insp.

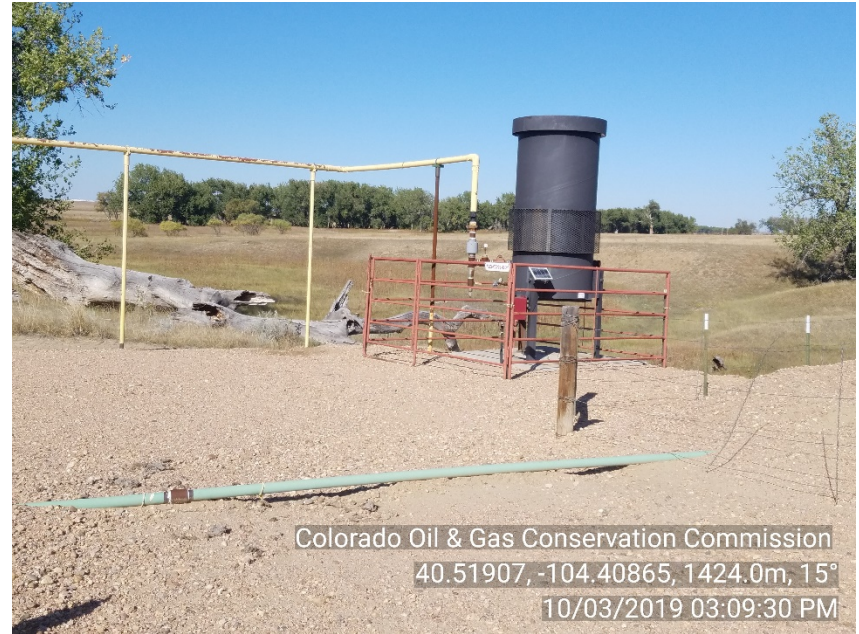
Photo #6
Brown 22-2 Battery
NE Corner – Stormwater erosion
NOW Appears mitigated

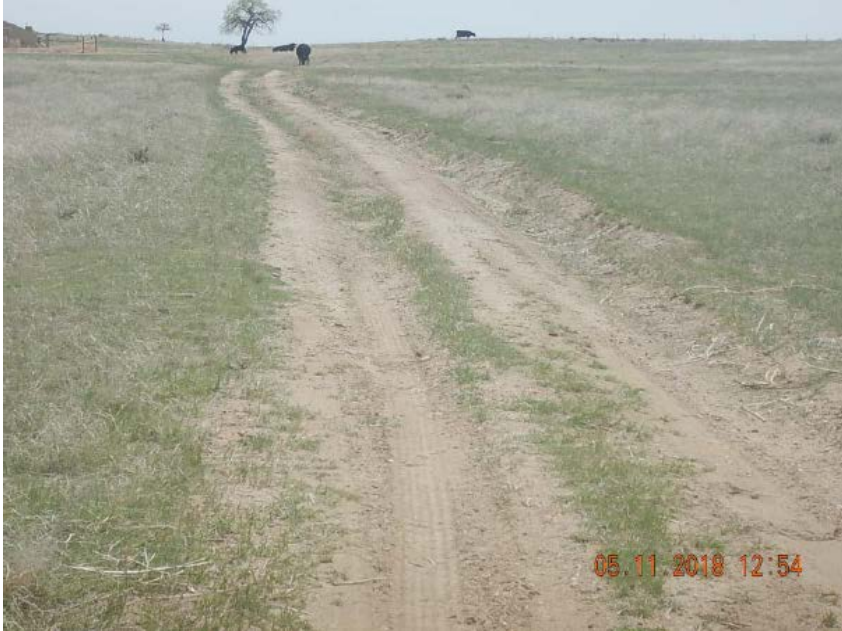
Photo #7

Brown 22-2 Well access road
NE Corner – Stormwater rutting
prior insp.

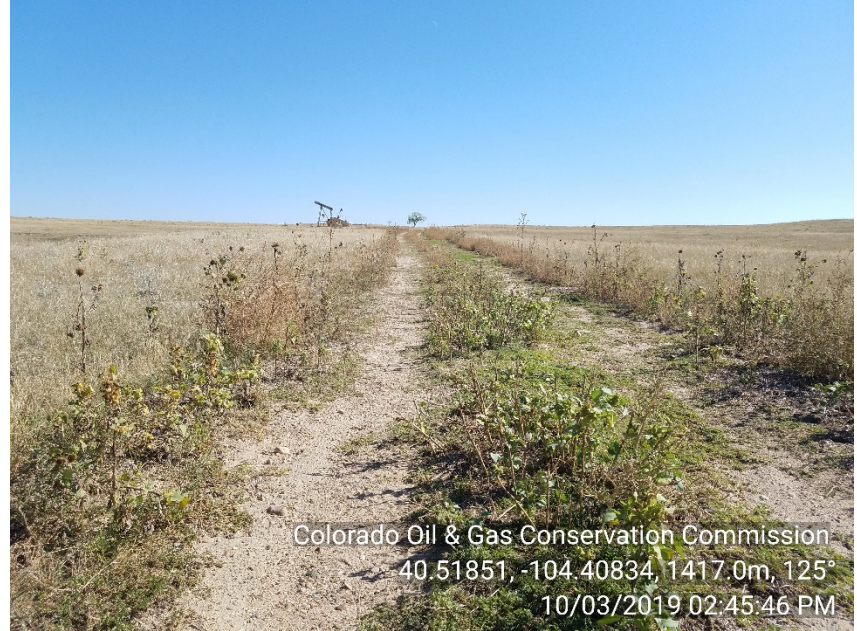
Photo #8

Brown 22-2 Battery
NE Corner – Stormwater rutting
NOW Appears mitigated
