Interim Reclamation Inspection

May 30, 2019

Operator: NOBLE ENERGY INC - #100322

Location Name: EHRlich STATE PC F /36-32D

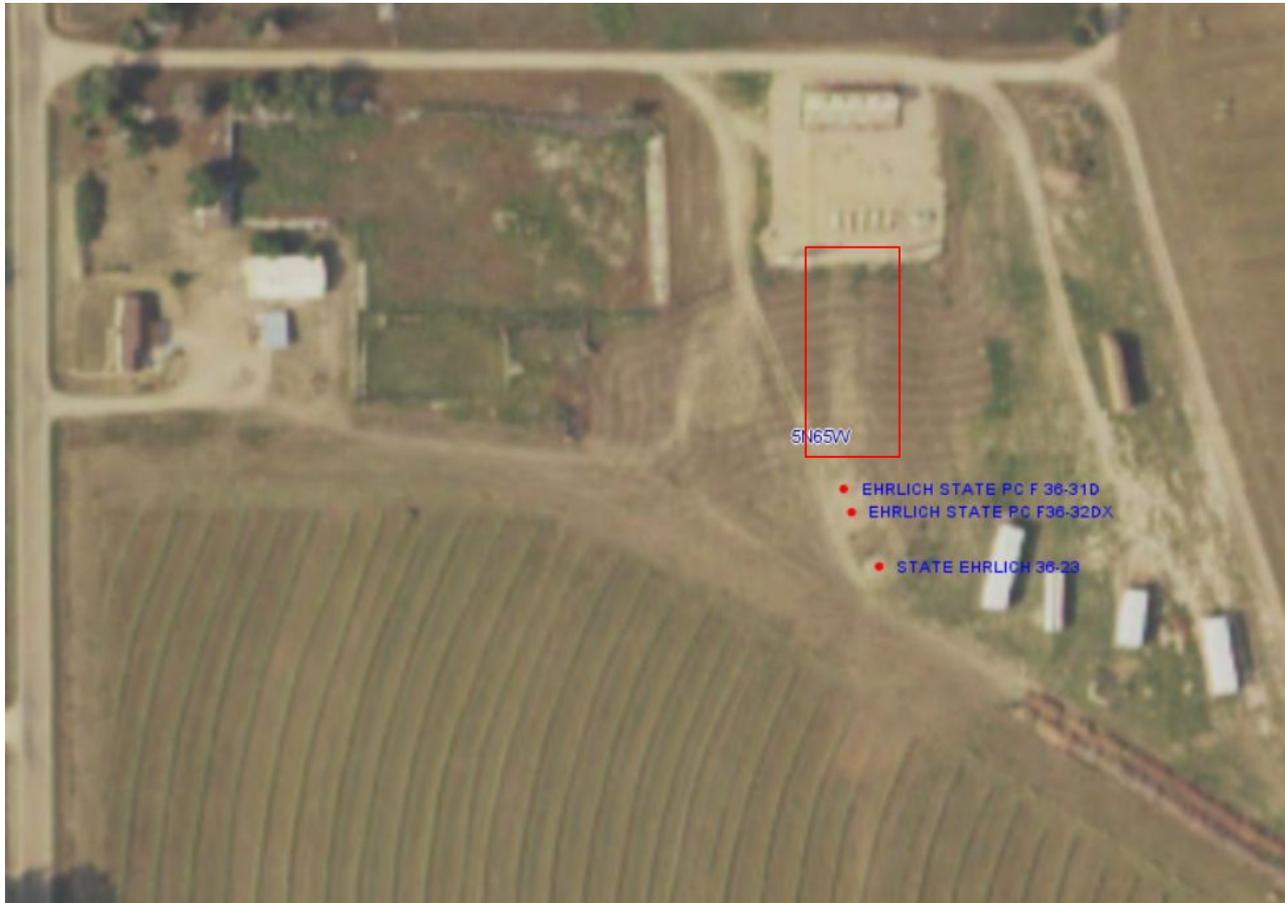
Aerial imagery taken in 2017. Aerial imagery shows a flowline area in which the Operator disturbed within the last 1-2 years and has failed to properly reclaim per Reclamation rules.

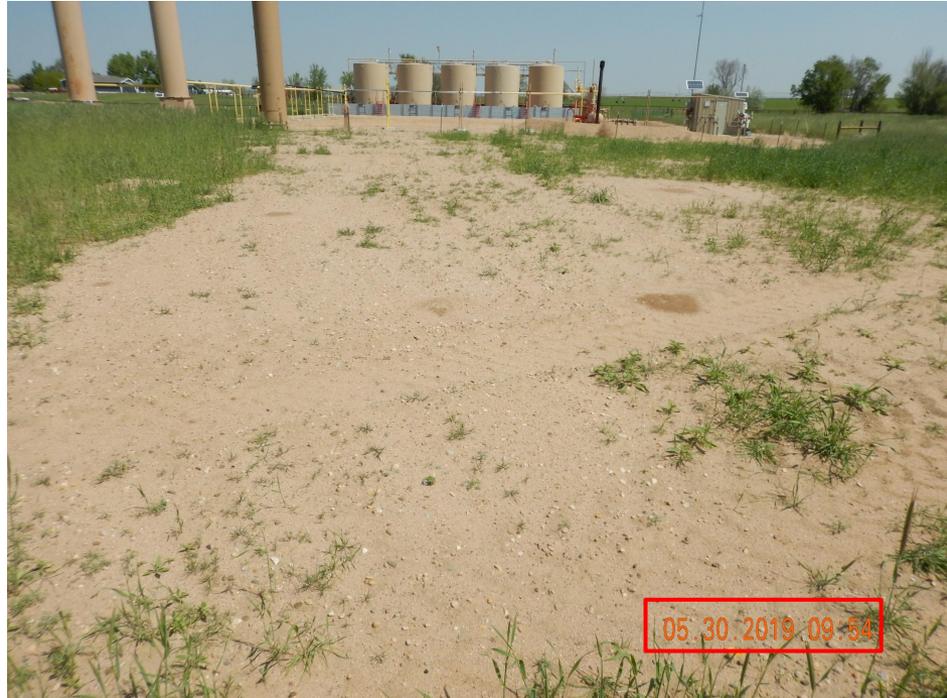
Photo 1. Photo taken from a portion of the flowline area on May 30, 2019, facing North. Photo illustrates a flowline area disturbance that has not been properly reclaimed per Reclamation rules. Photo illustrates bare ground with little, to no, establishment of reference area species.

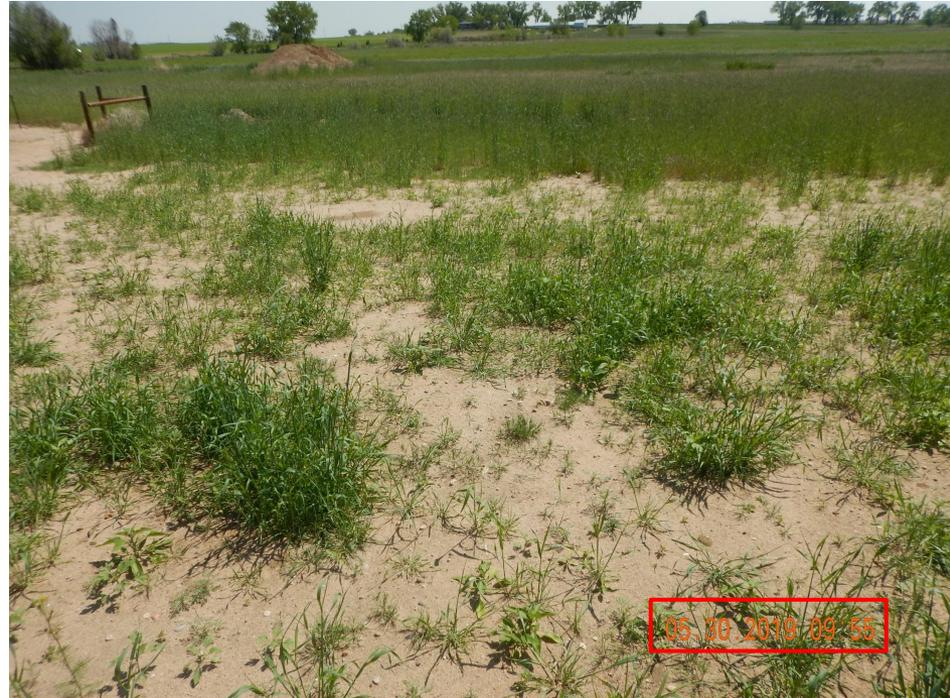
Photo 2. Photo taken from a portion of the flowline area on May 30, 2019, facing East. See comments under Photo 1.

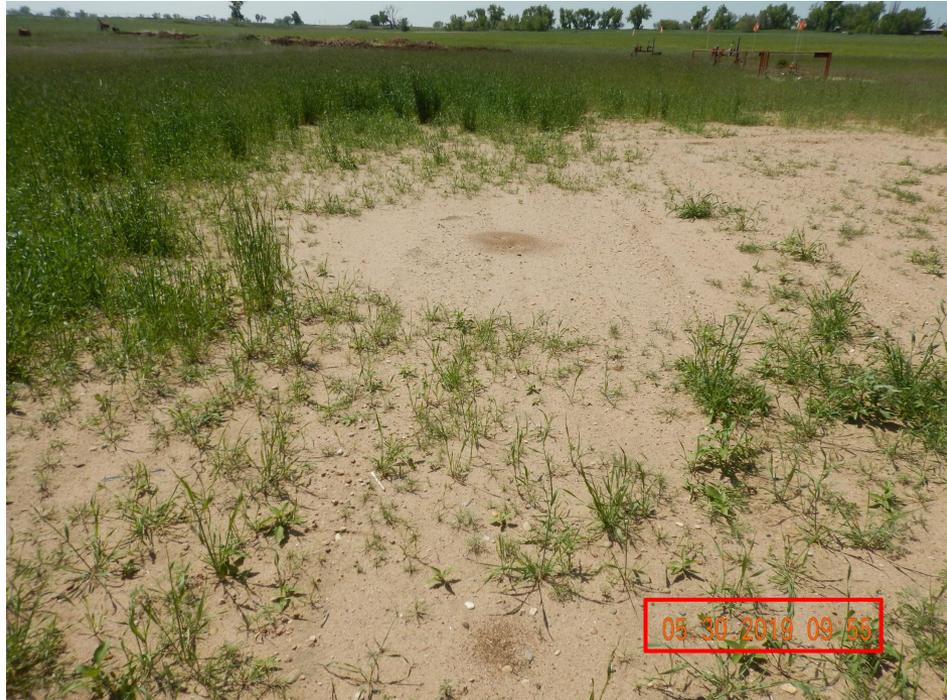
Photo 3. Photo taken from a portion of the flowline area on May 30, 2019, facing South. See comments under Photo 1.

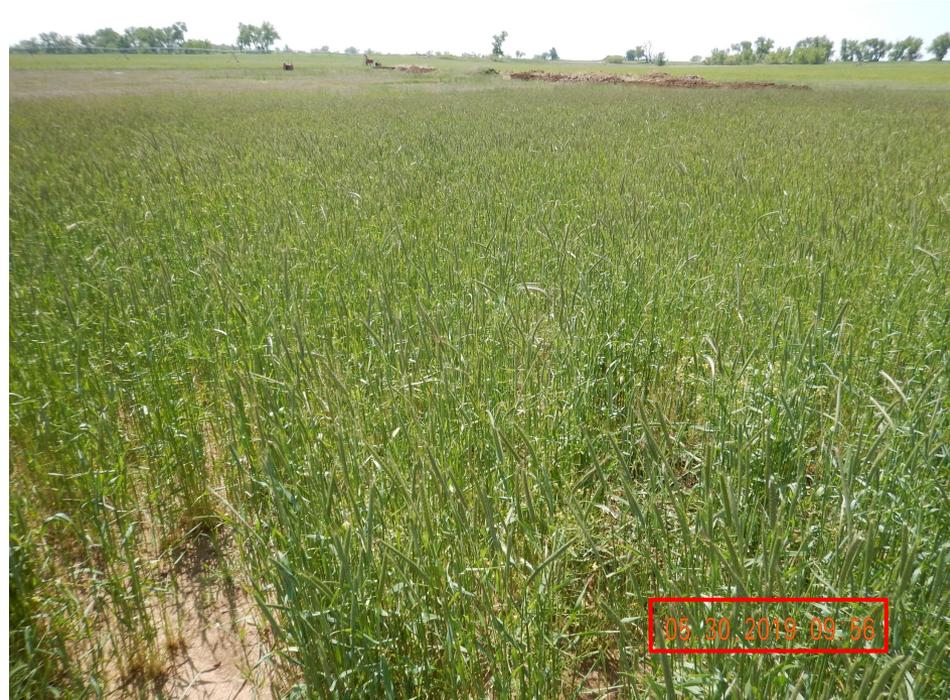
Photo 4. Reference photo taken southeast from the flowline area on May 30, 2019, facing South. See comments under Photo 1.

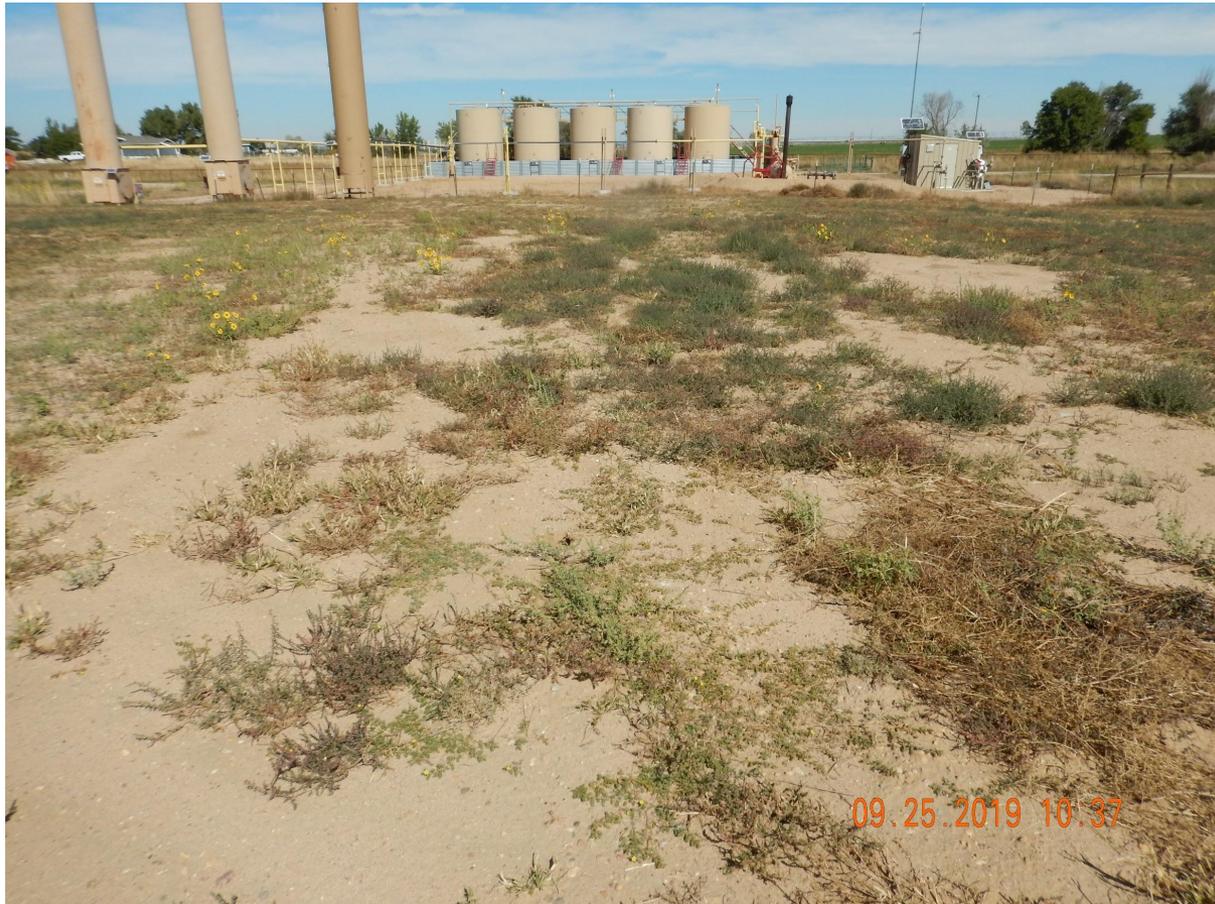
Photo 5. Photo taken from a portion of the flowline area, facing North. Photo illustrates similar conditions from the prior inspection (i.e., flowline area disturbance that has not been properly reclaimed per Reclamation rules). Operator has failed to respond to the previous complaint filed in May 2018 by contacting the landowner to determine mitigating measures that will allow reclamation work to be conducted in such a manner as to not interfere with agricultural activities or crop production.

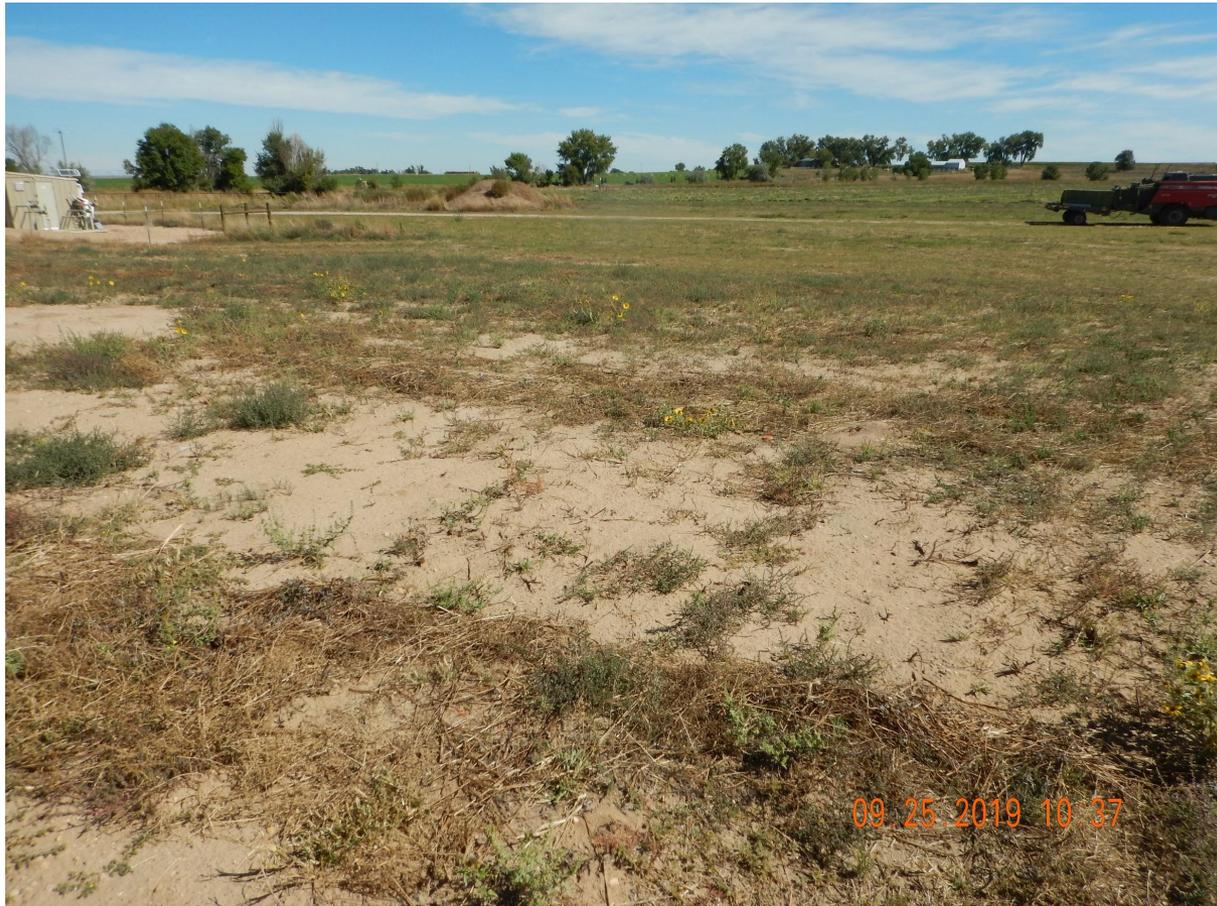
Photo 6. Photo taken from a portion of the flowline area, facing East. See comments under Photo 5.

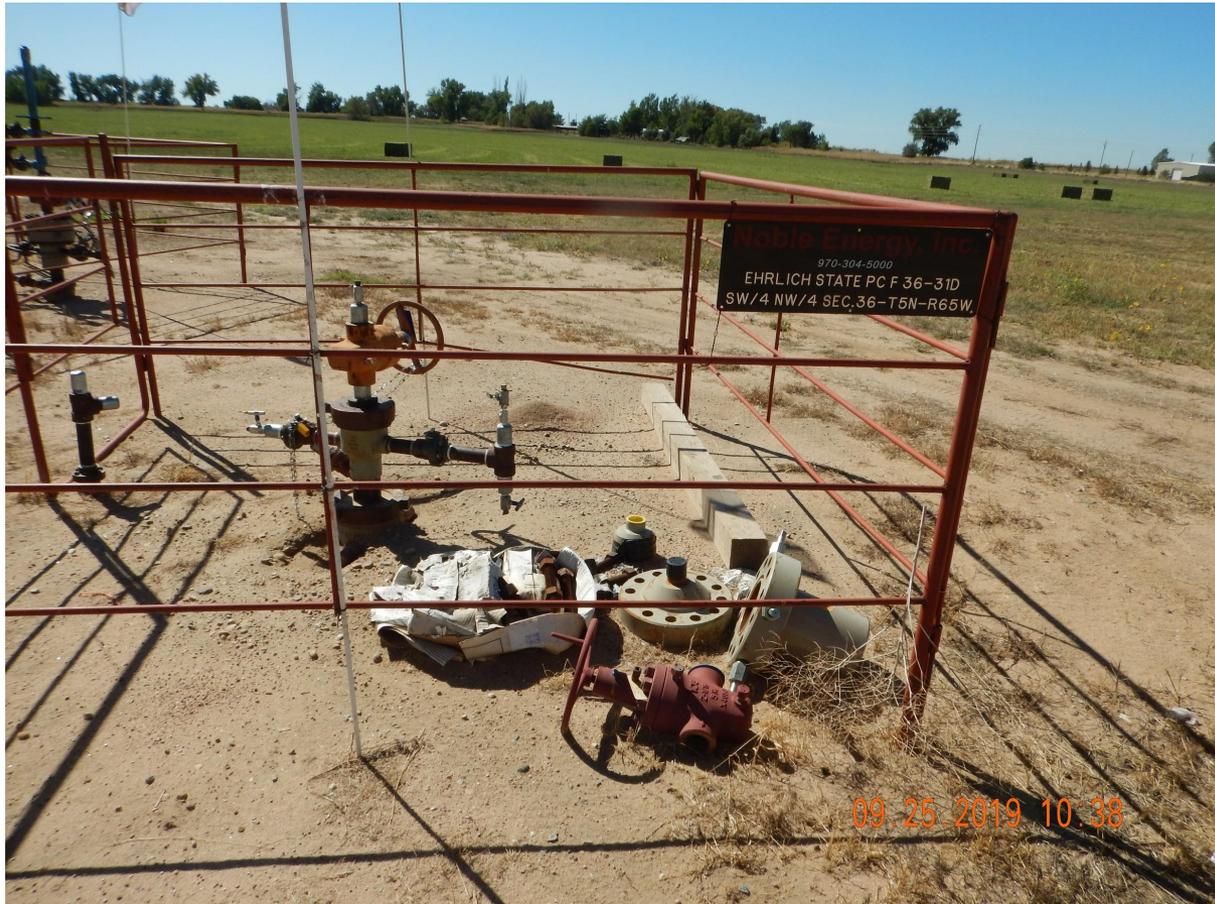
Photo 7. Photo taken from the nearby well (API#123-32549), facing South. Photo illustrates unused equipment that shall be removed per Rule 603.f.
