Inspection Photos
Location Name: Argenta CPD
Facility ID #467437

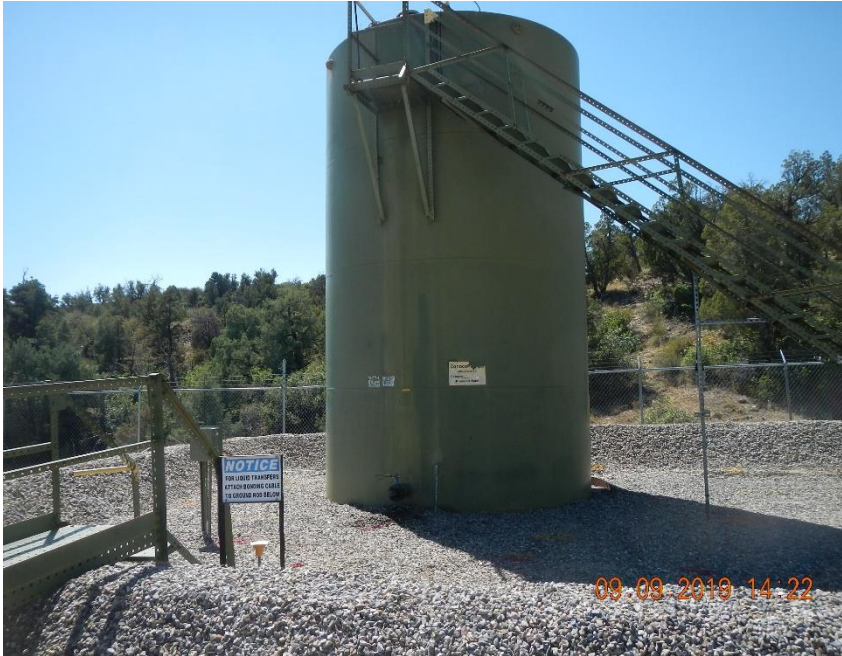
Heated AST does not have signage required by Rule 210.d.

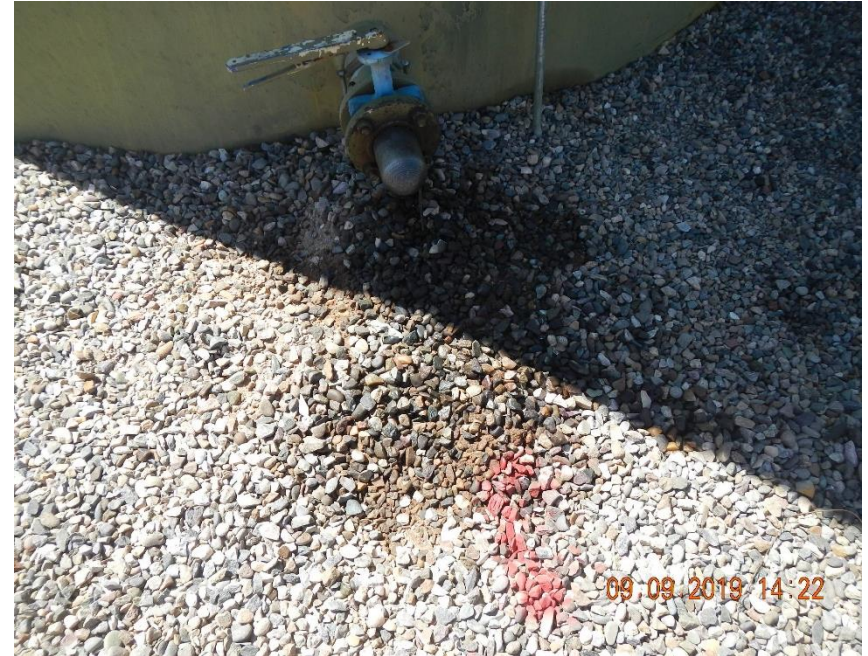
Stained gravel below load out valve.

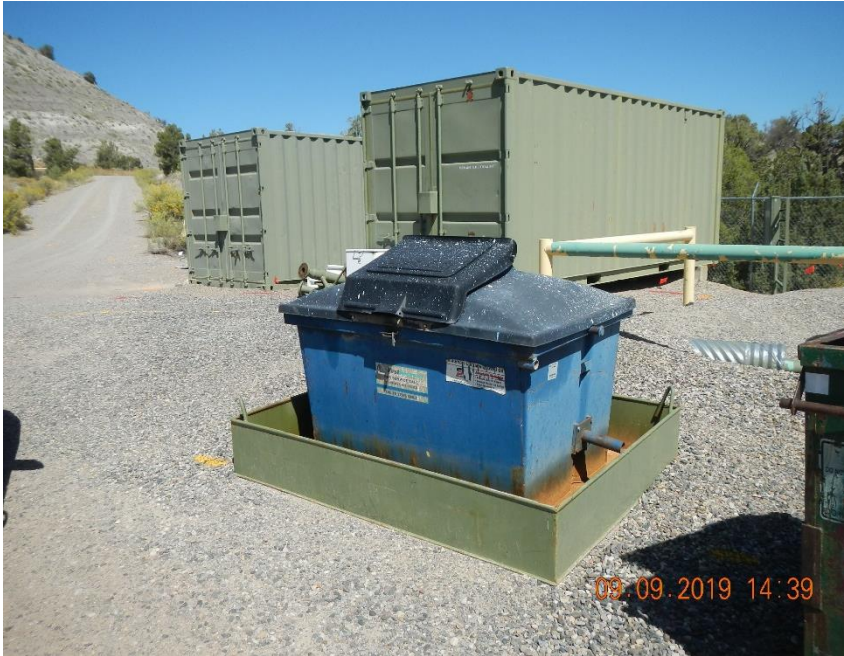
Filter dumpster inside secondary containment.

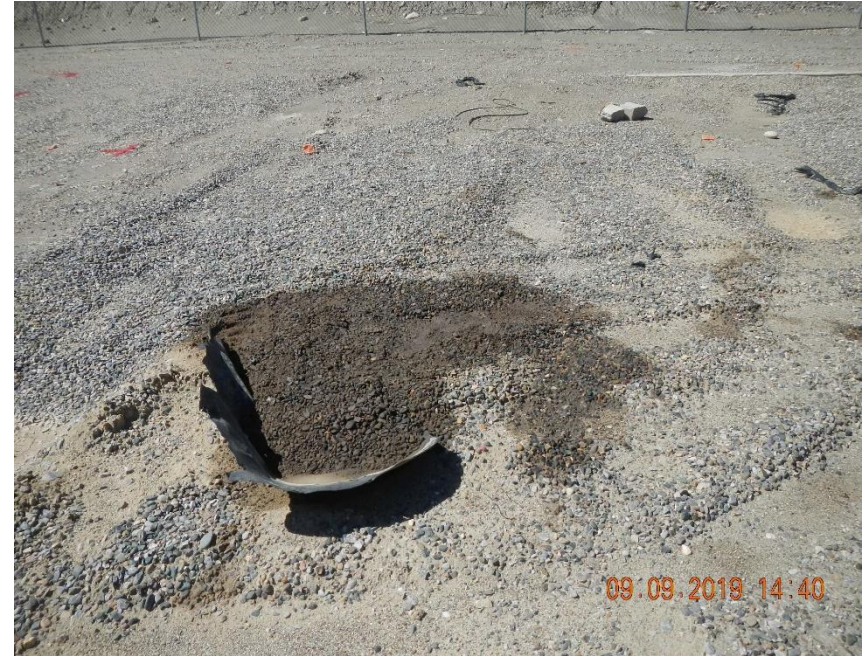
Stained soil and gravel near northern edge of location.

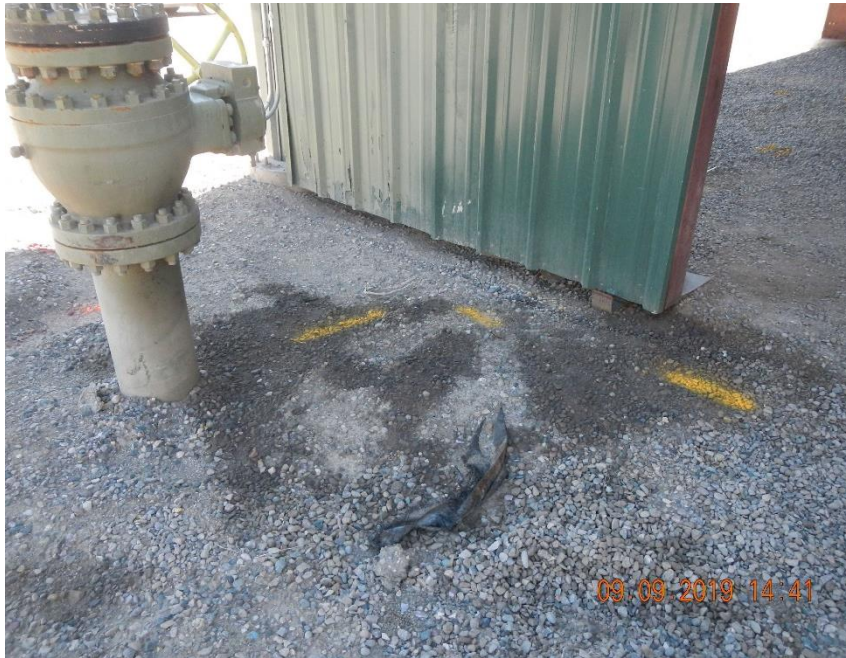
Stained soil and gravel at northern edge of compressor building.

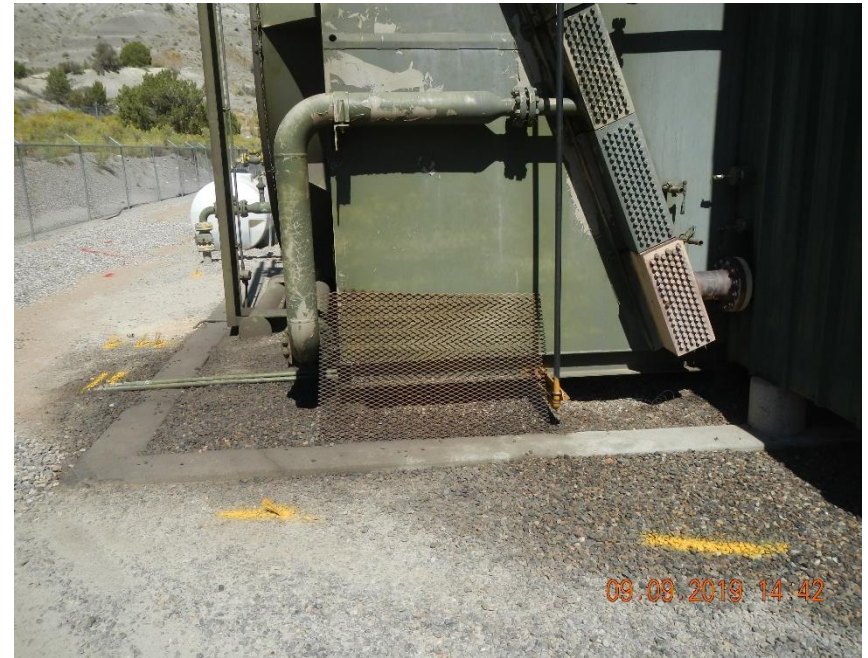
Stained soil and concrete around southernmost compressor.

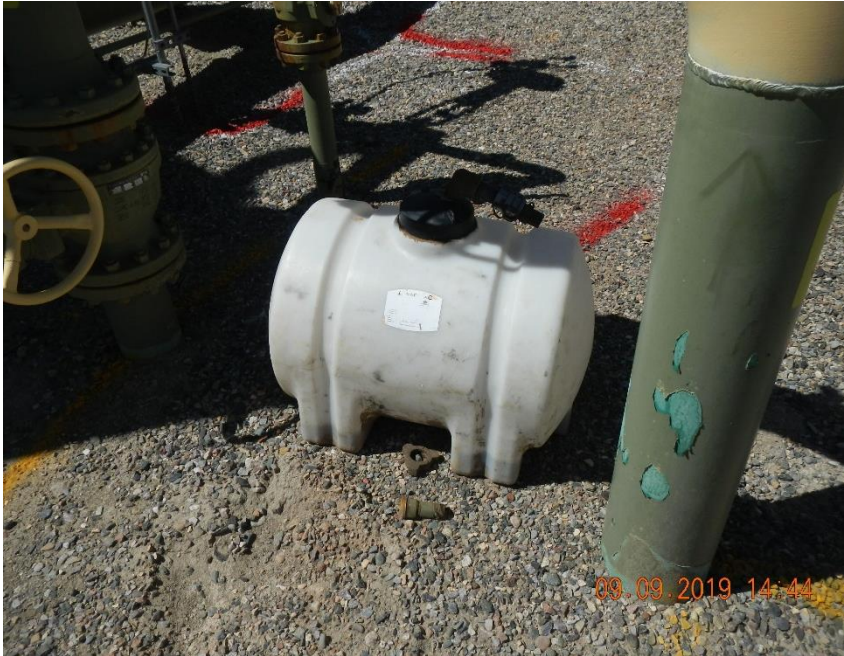
Unlabeled, unused chemical container.

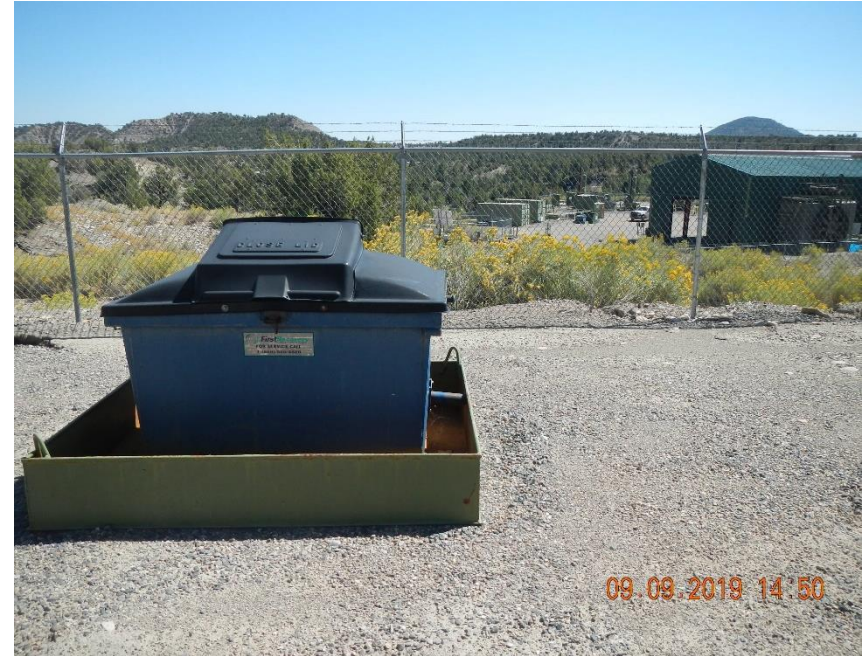
Filter dumpster in secondary containment on upper level of facility.

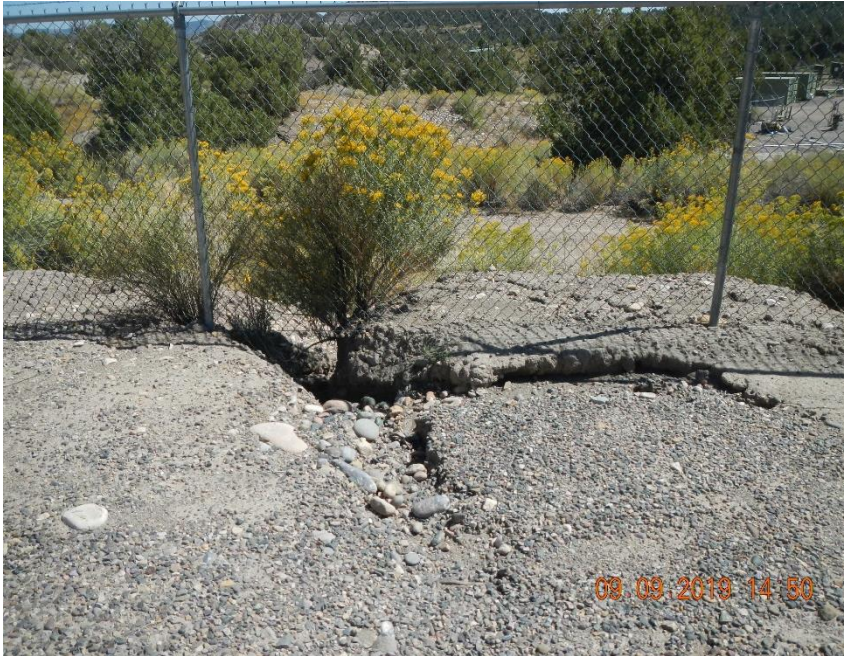
Storm water erosion along SE edge of upper level of facility.

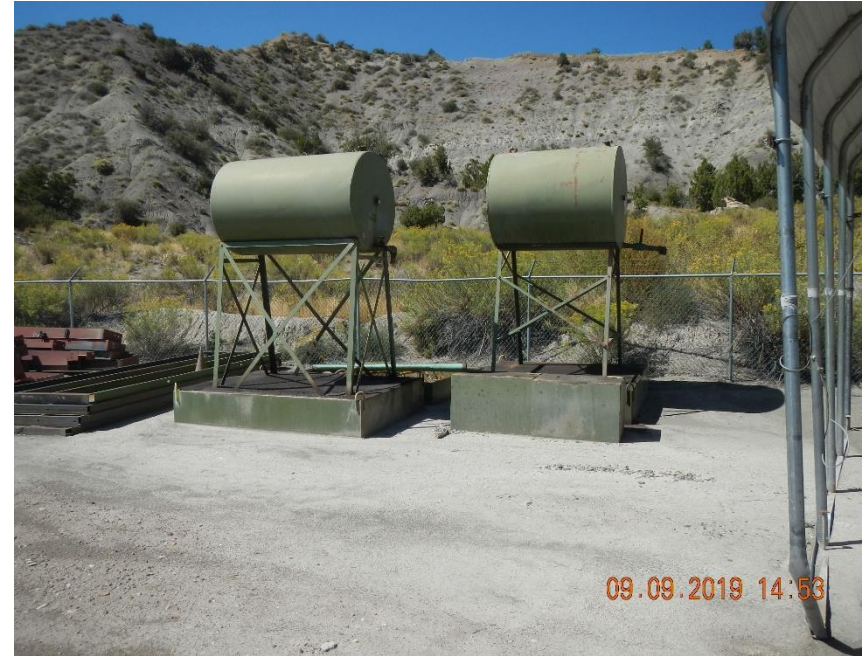
Unused equipment stored on upper level of facility.

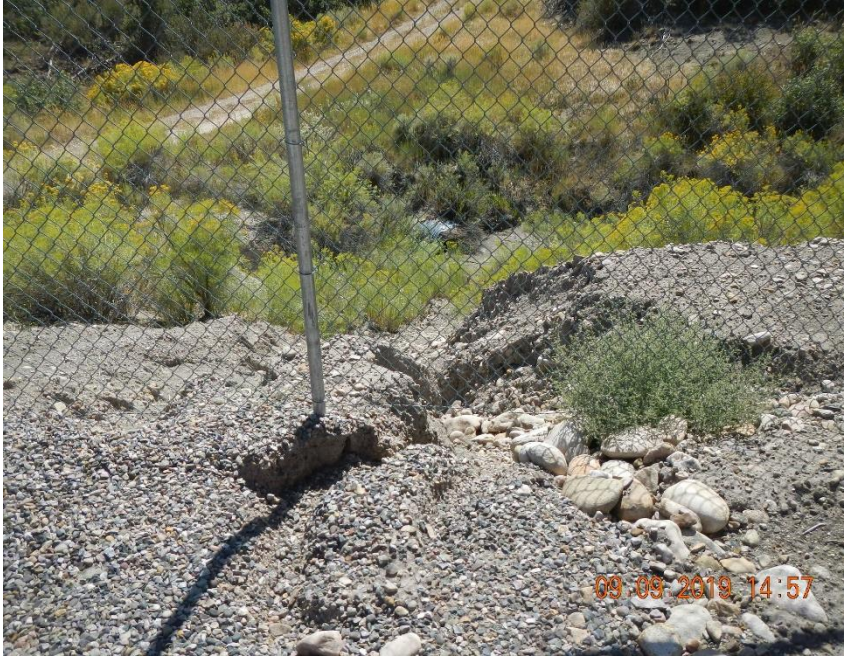
Storm water erosion in SW corner of upper level of facility.

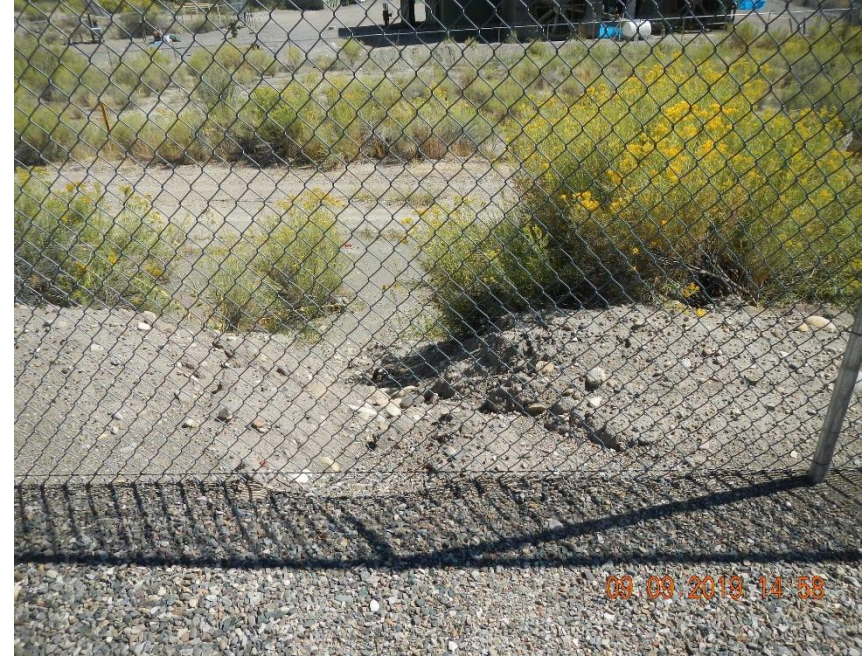
Erosional channel along southeastern edge of upper level.
