Inspection Photos

API#045-06481

Operator: Maralex

Inspection: #692401406

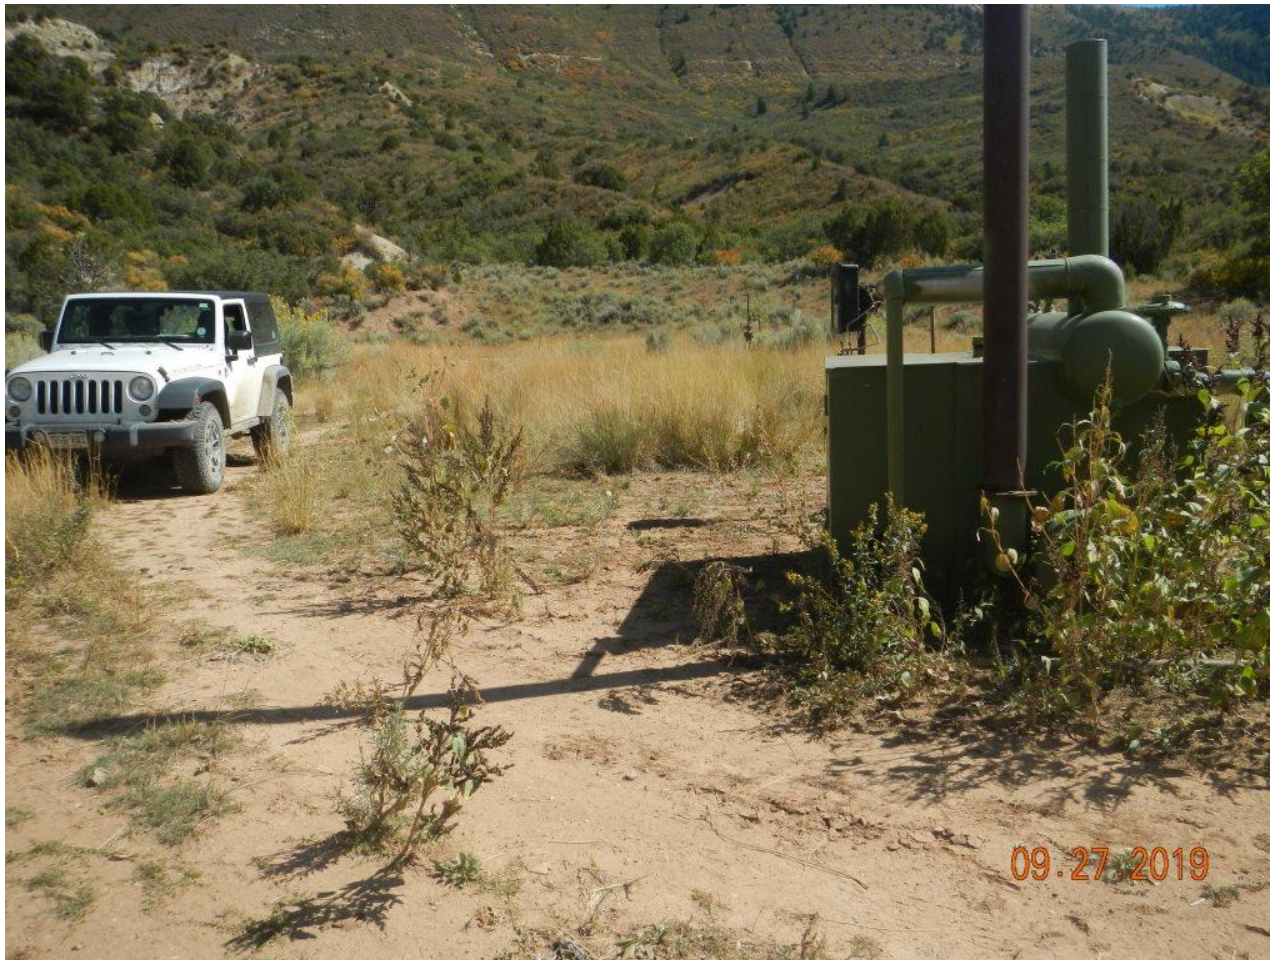
Photo#1:
Overview of Location to Southeast. Note debris weeds around equipment.

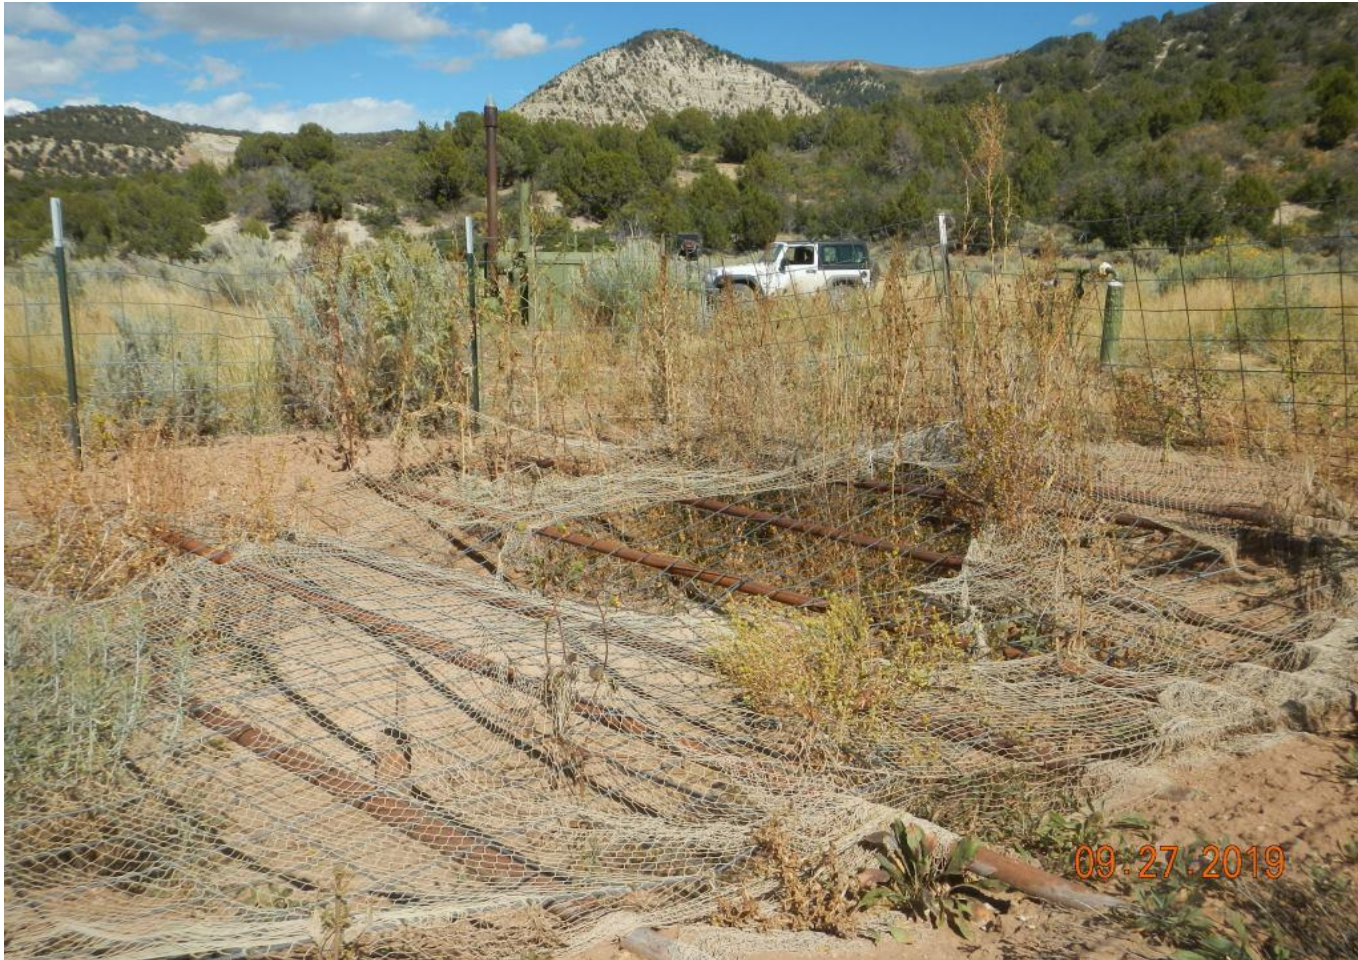
Photo#2:

View over Blowdown Pit. Maintenance of netting and weeds has not been performed.

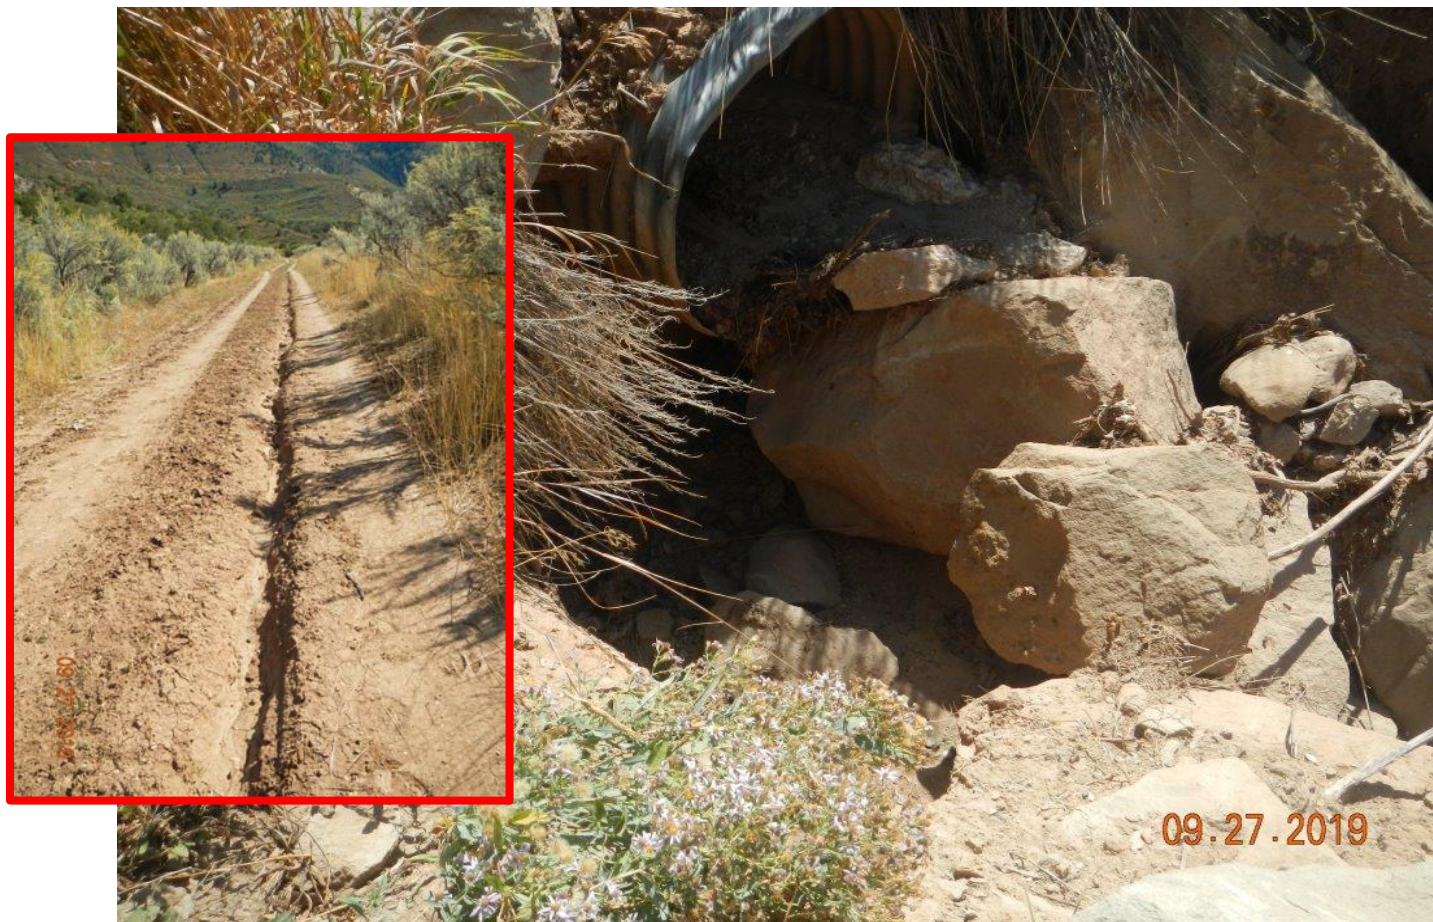
Photo#3:

Stormwater is undercutting Rip Rap at NW side of access road culvert & eroding ditch. Erosion is also occurring on access road.
