Inspection Photos
Operator: BP America
Location/API #: 067-08630
Date: 9-30-2019

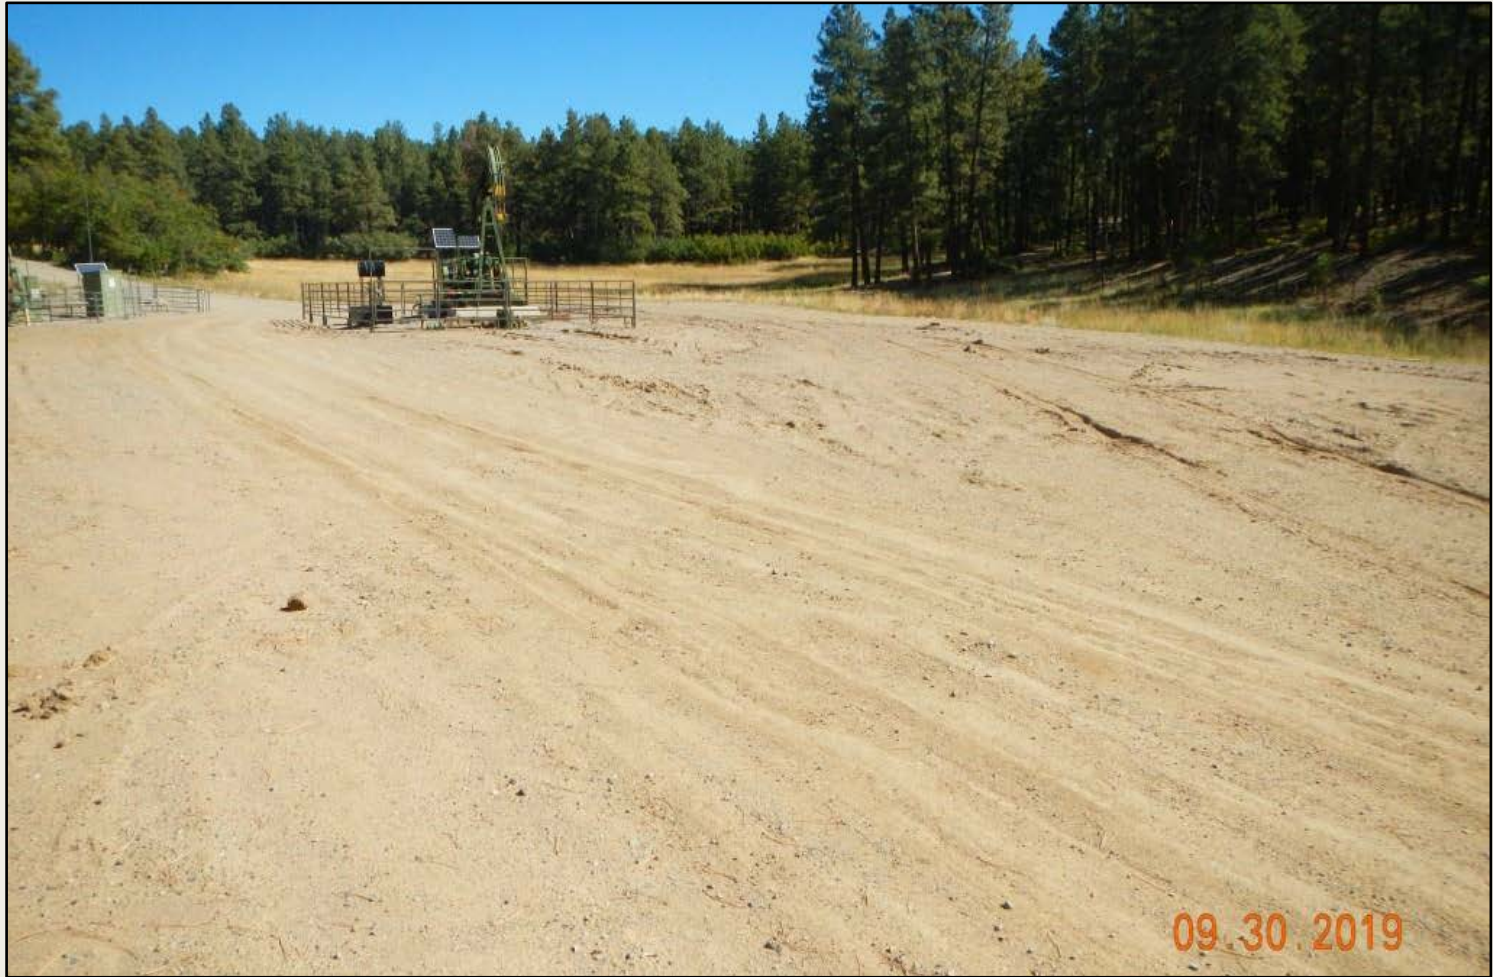
Photo 1 View of the project area from the well pad entrance facing center.

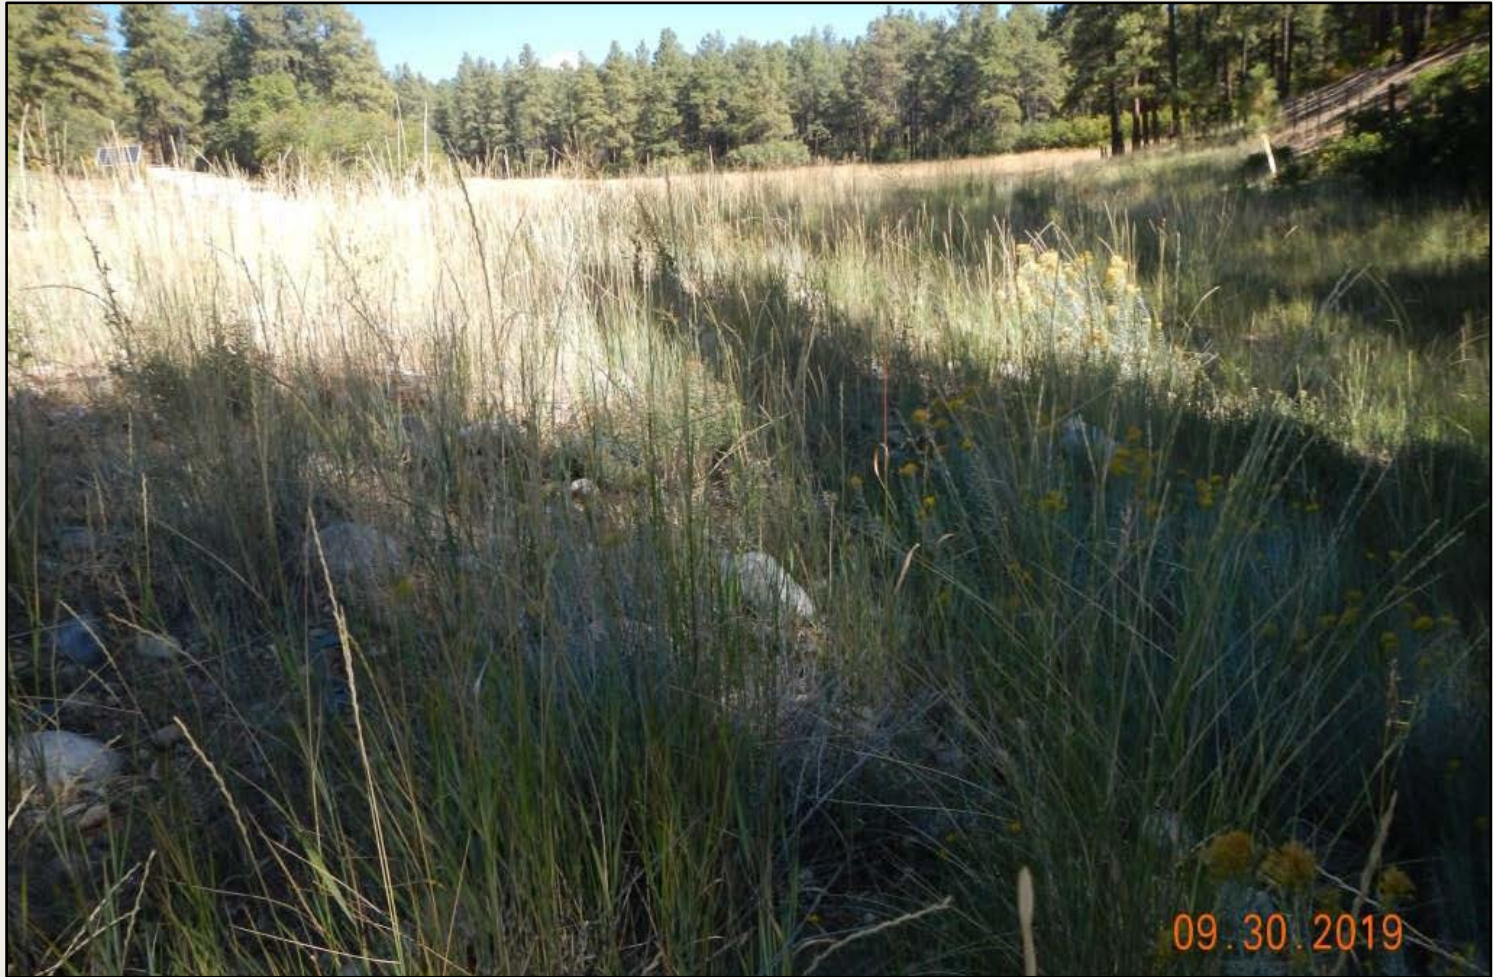
Photo 2. View of the fill slope in the eastern project area from the southeastern corner facing northward. Revegetation is comprised of grasses such as western wheatgrass, sand dropseed, and slender wheatgrass.

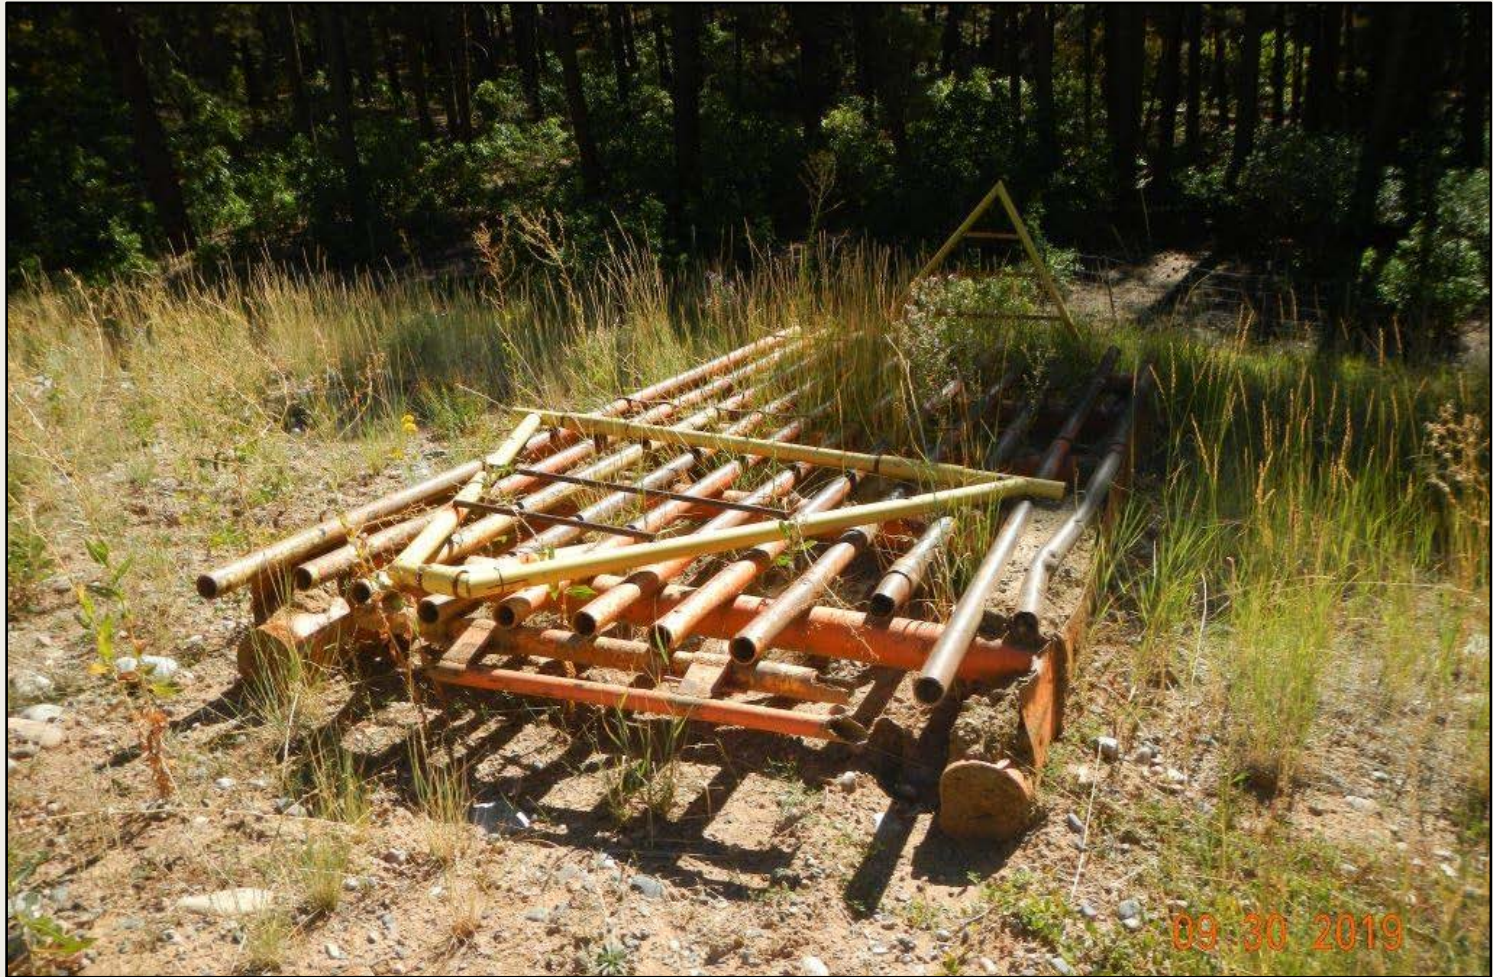
Photo 3. View of cattle guard within the southeastern portion of the interim reclamation area, needs to be removed.

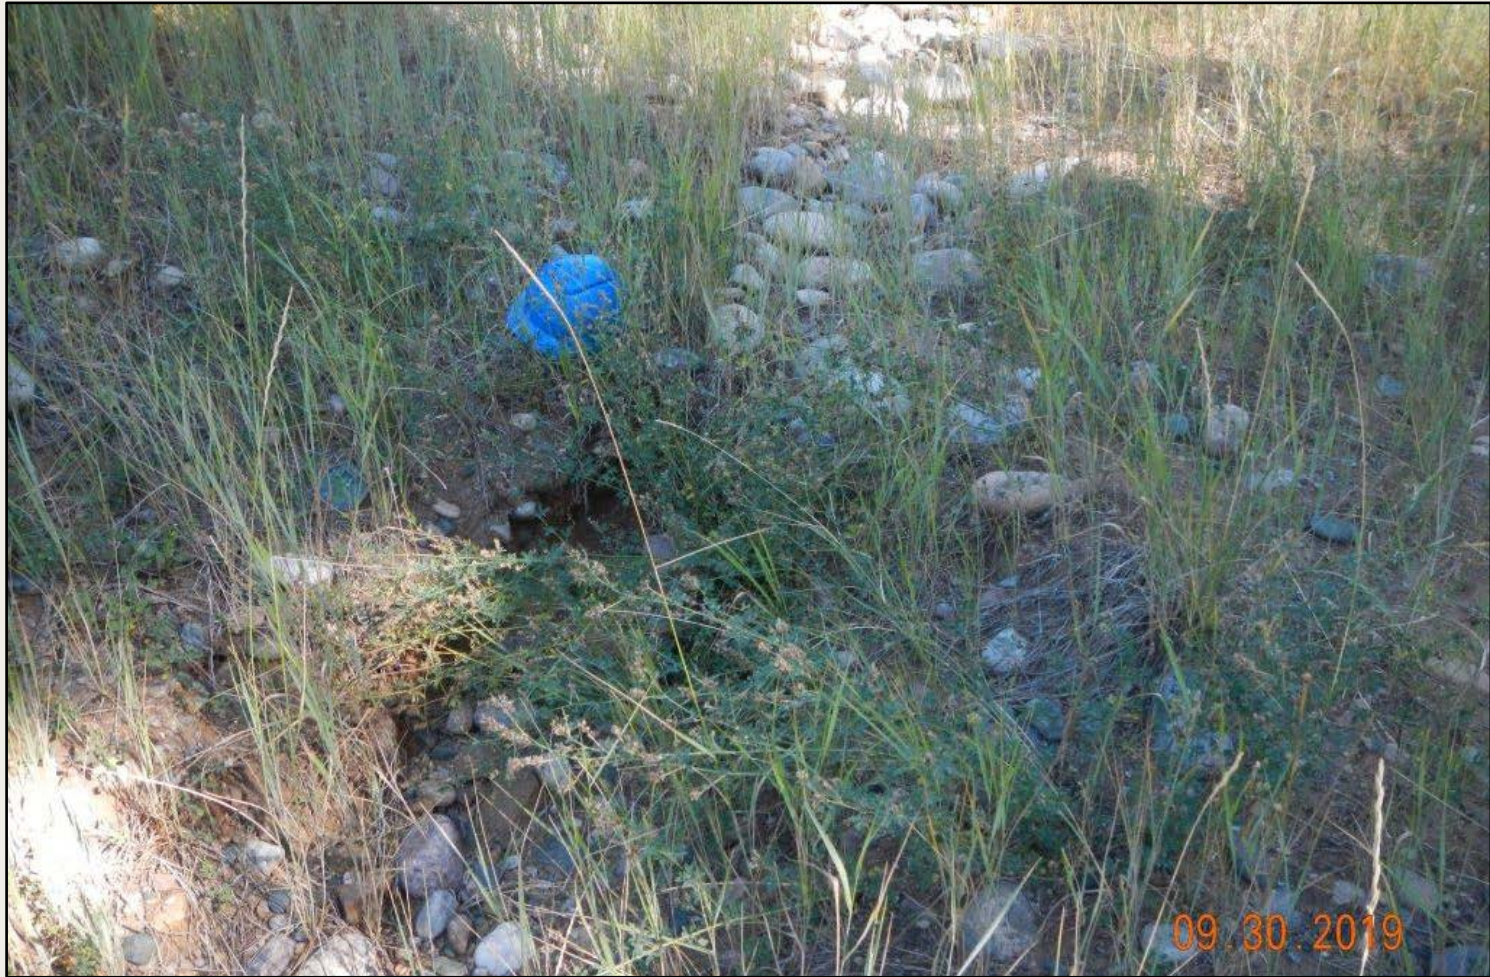
Photo 4. View of headcut within the eastern project area. Erosion appears to be continuing here as cobble is not sufficient to stabilize erosion.

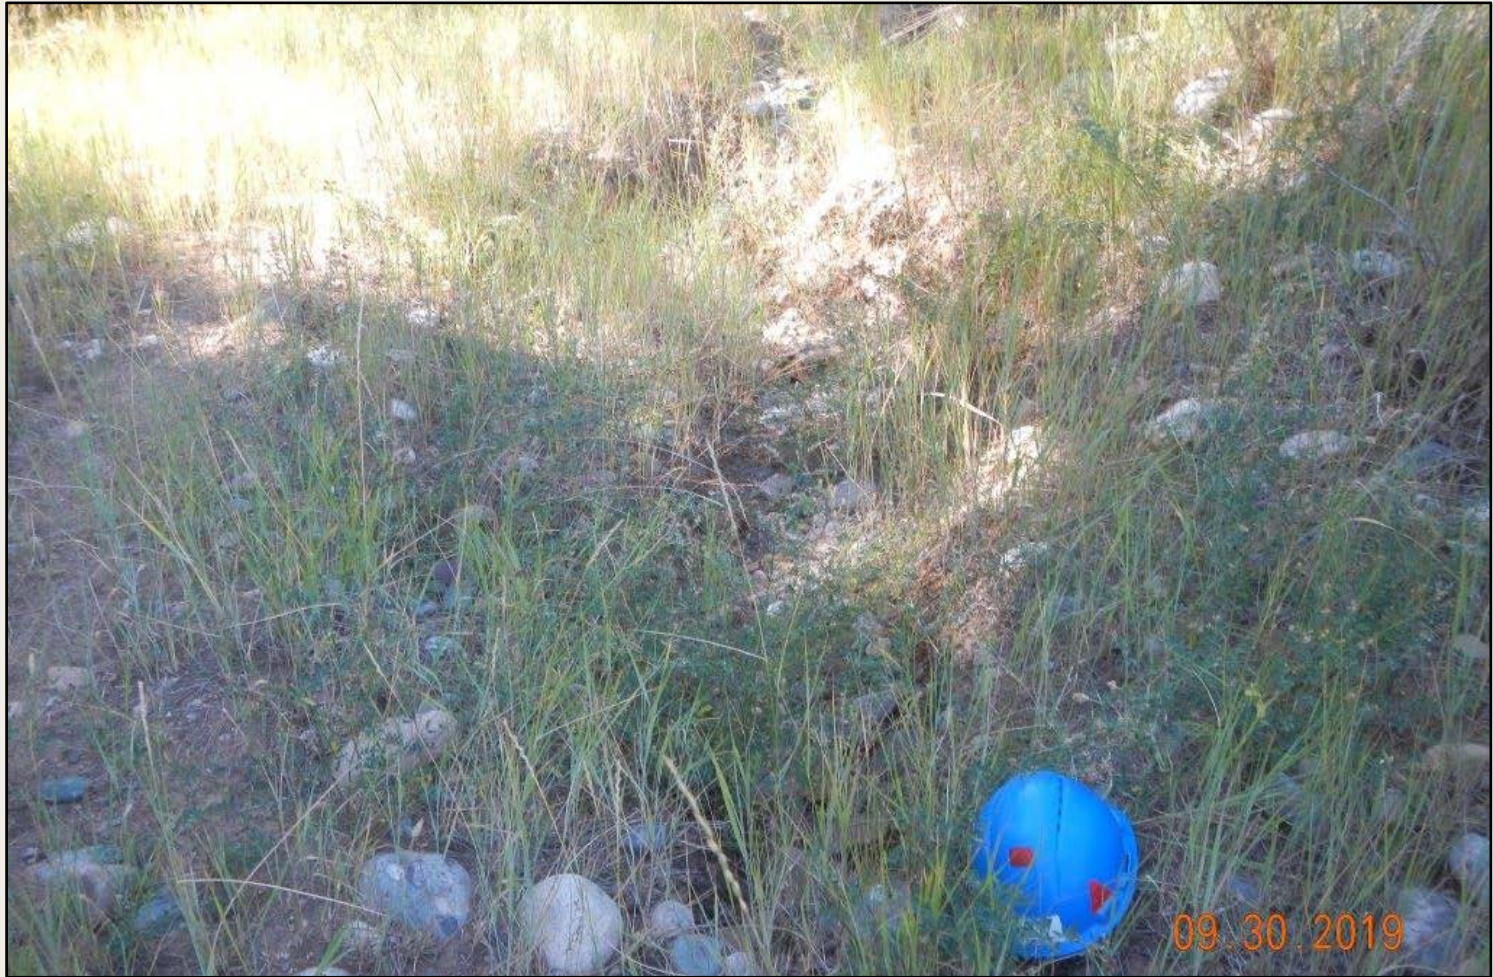
Photo 5. View from headcut (next to hardhat) facing downslope. Erosional channel is approx. 2 feet wide and deep.

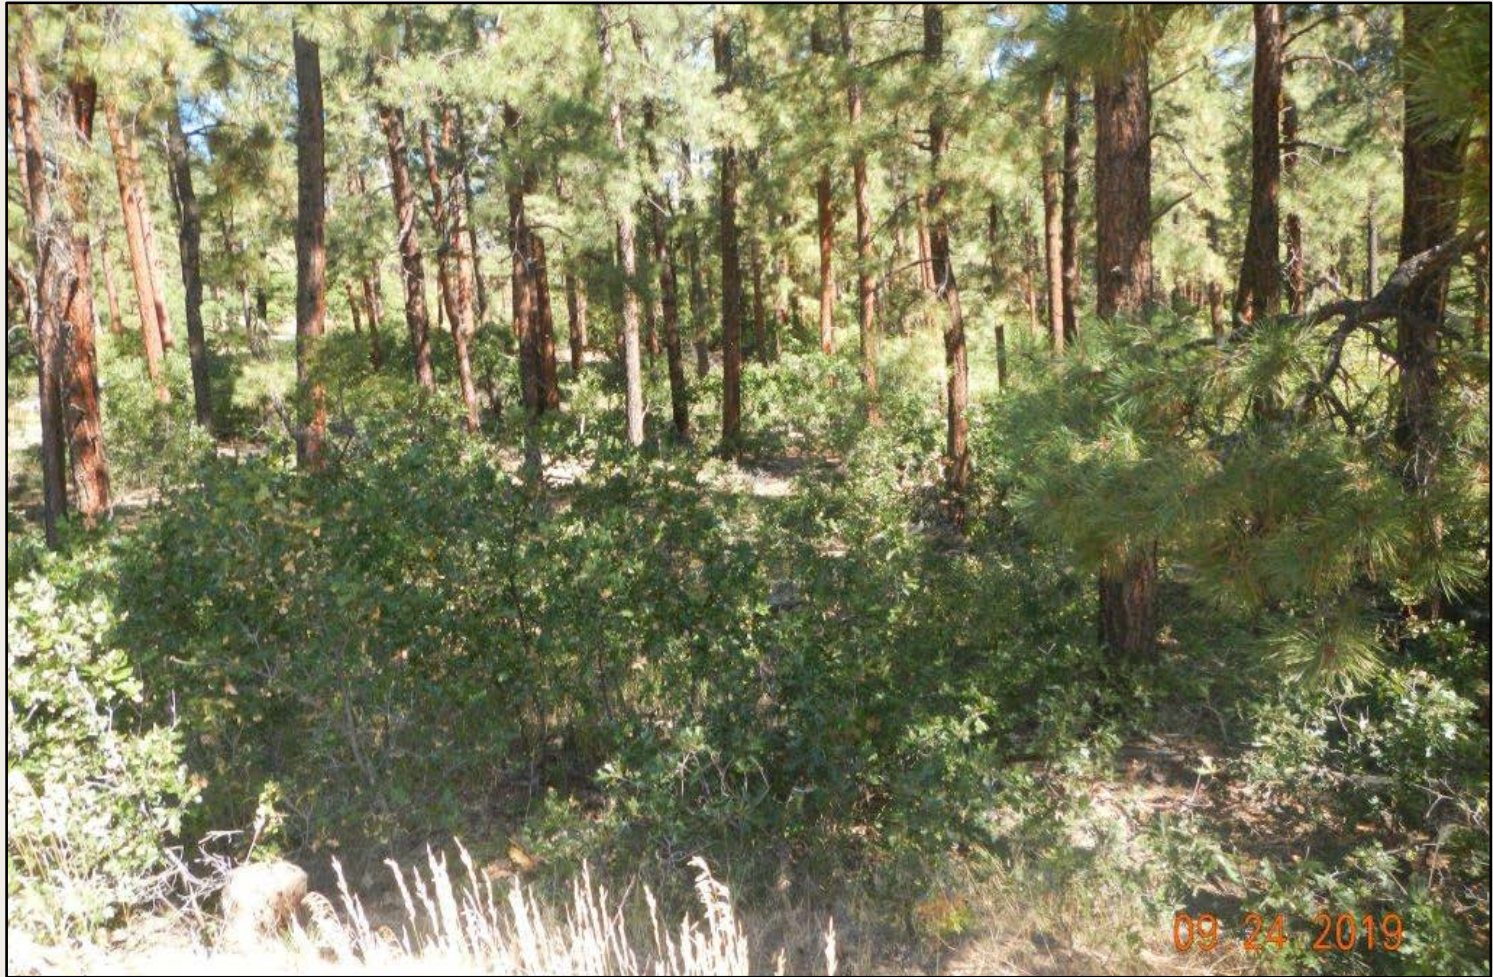
Photo 6. View of reference area vegetation, comprised of ponderosa pine forest with gambel oak and herbaceous understory.
