Inspection Photos
Location Name: Federal RU 31-17
Location ID: 452011
Inspection Date: September 23, 2019

COLORADO
Oil & Gas Conservation
Commission
Department of Natural Resources

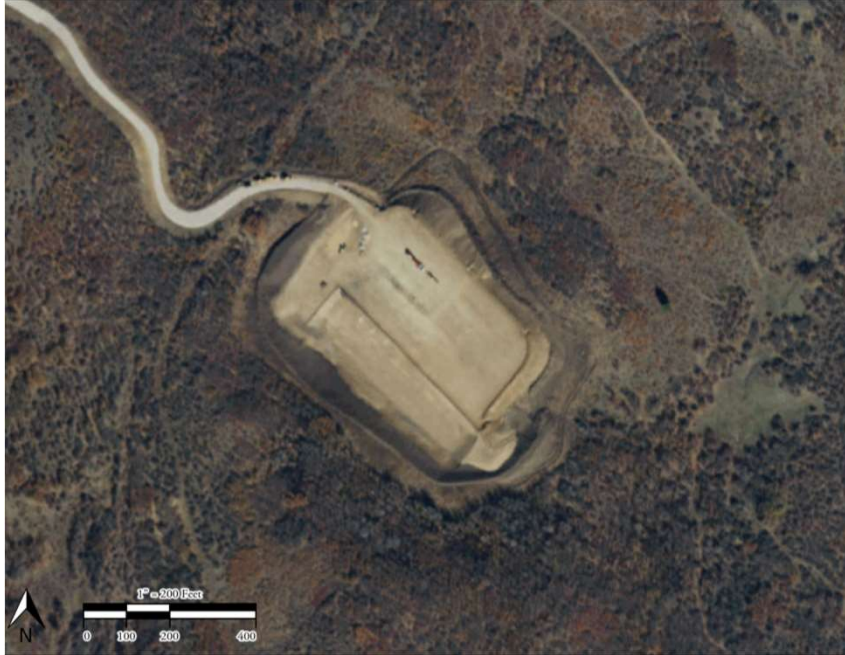
Photo #1 – Aerial view of the location.

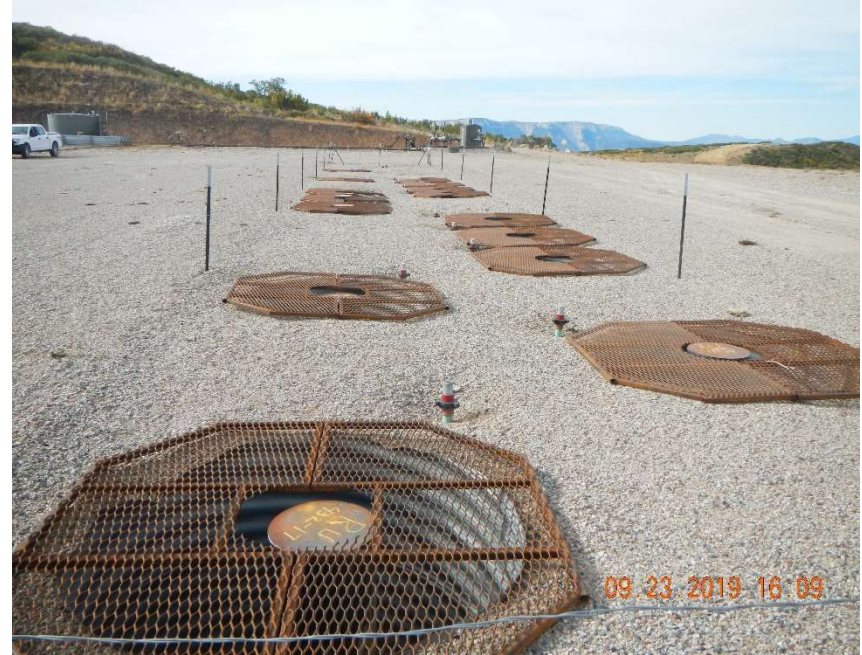
Photo #2 – View of the risers around the well conductors.

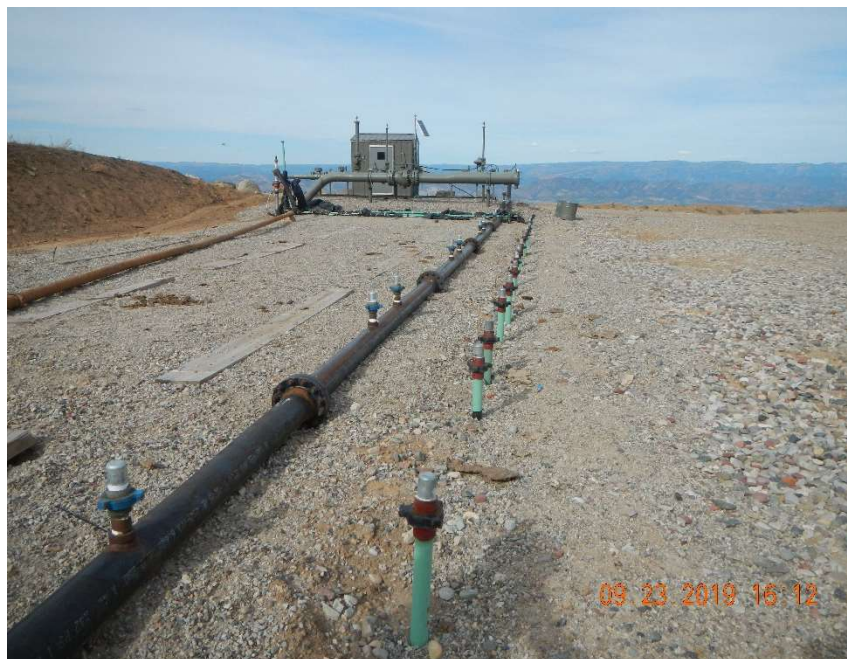
Photo #3 – View of the risers located northwest of the well conductors on the northwest corner of the well pad.

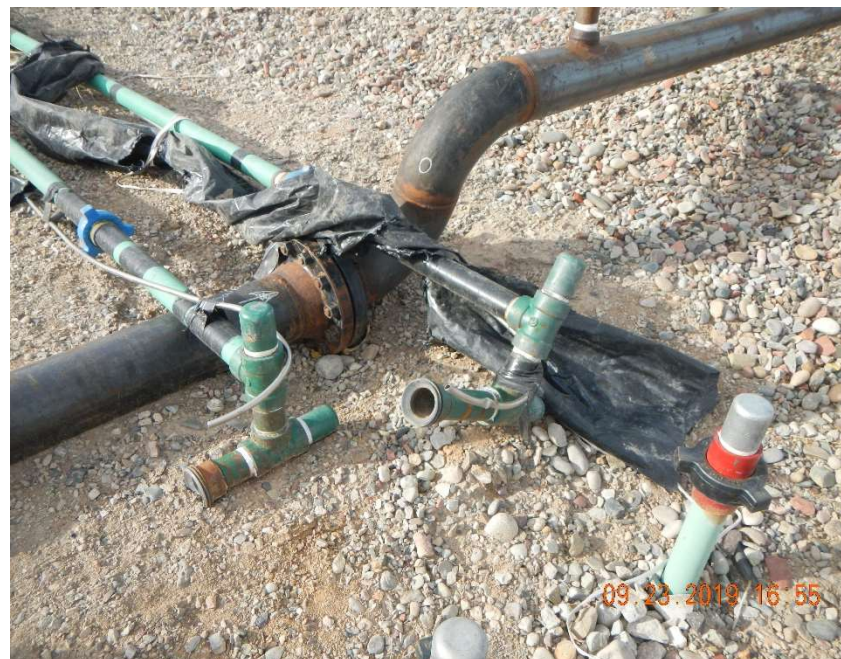
Photo #4 – View of uncapped, unmarked flowlines.

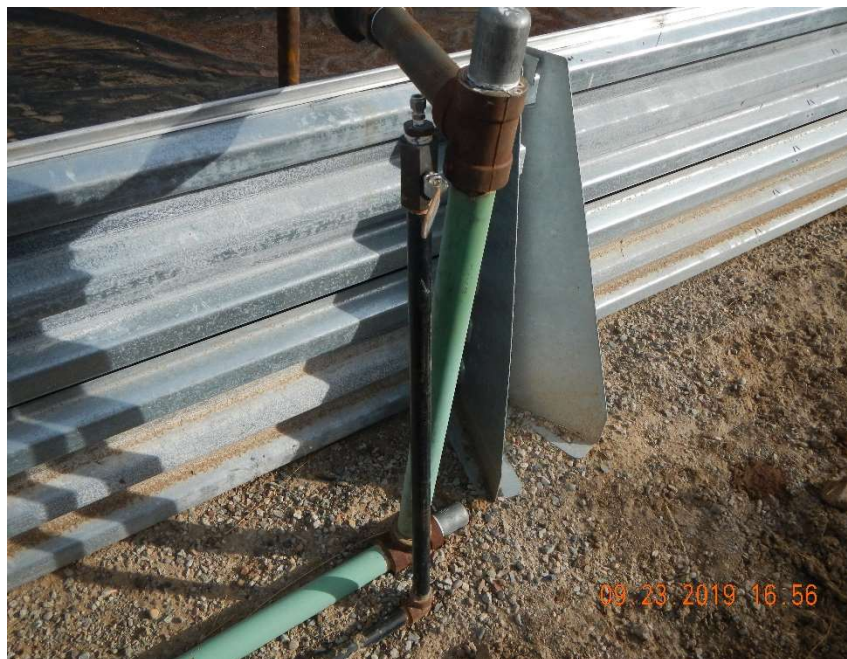
Photo #5 – View of the flowline located northwest of the tank battery.

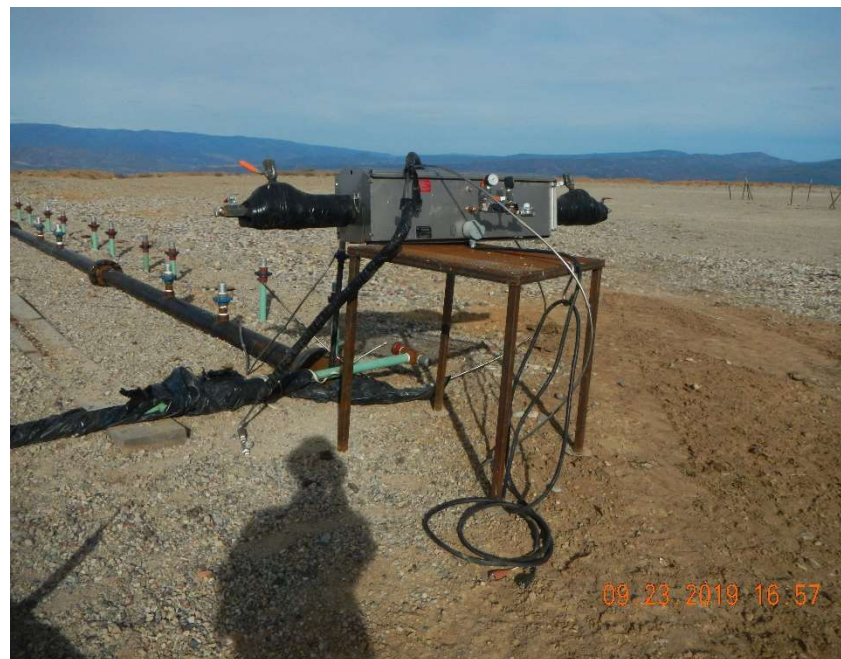
Photo #6 – View of the unused flowline manifold.

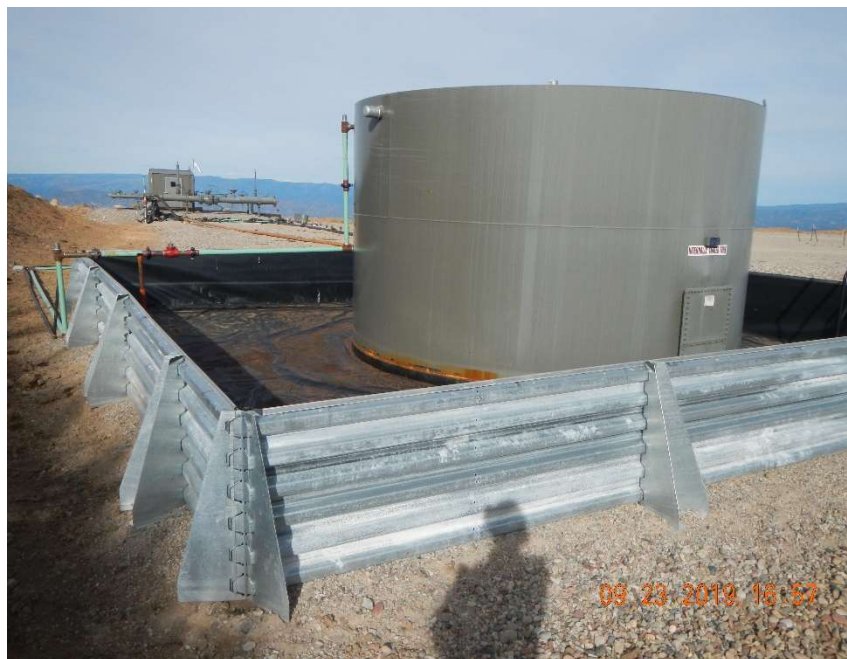
Photo #7 – View of the unlabeled tank and battery.

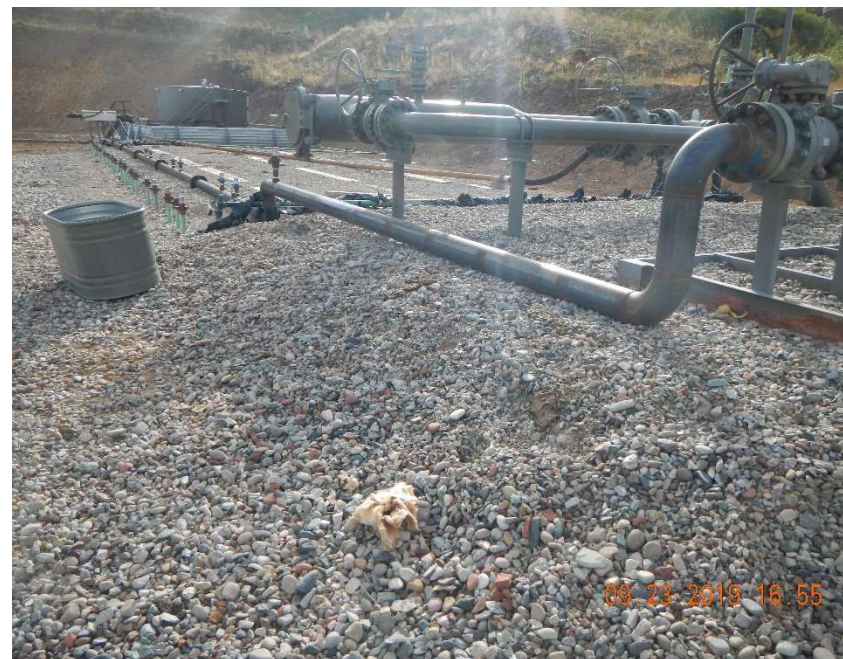
Photo # - View of the unused trough and risers located on the northwest corner of the well pad.

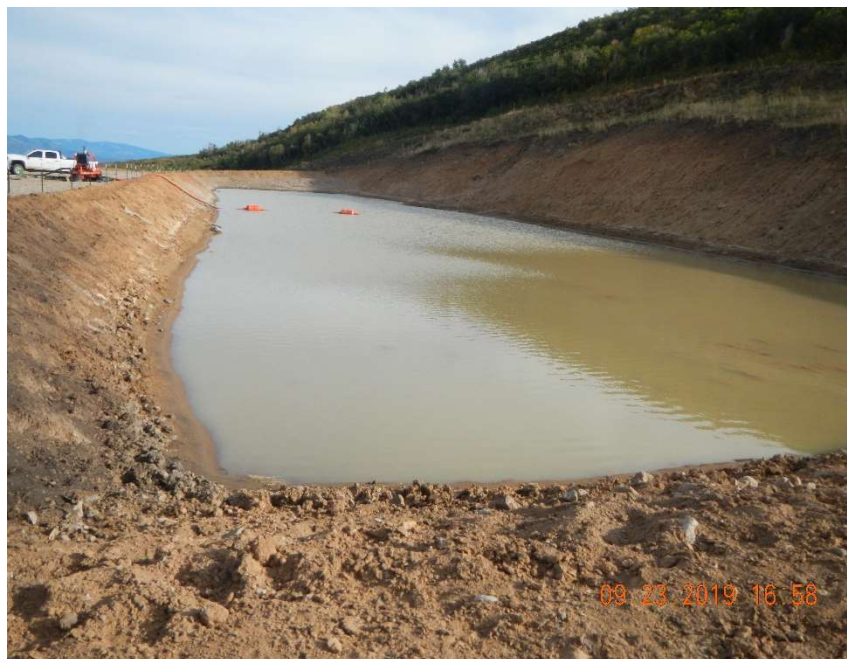
Photo #9 – View of the cuttings trench looking southeast.

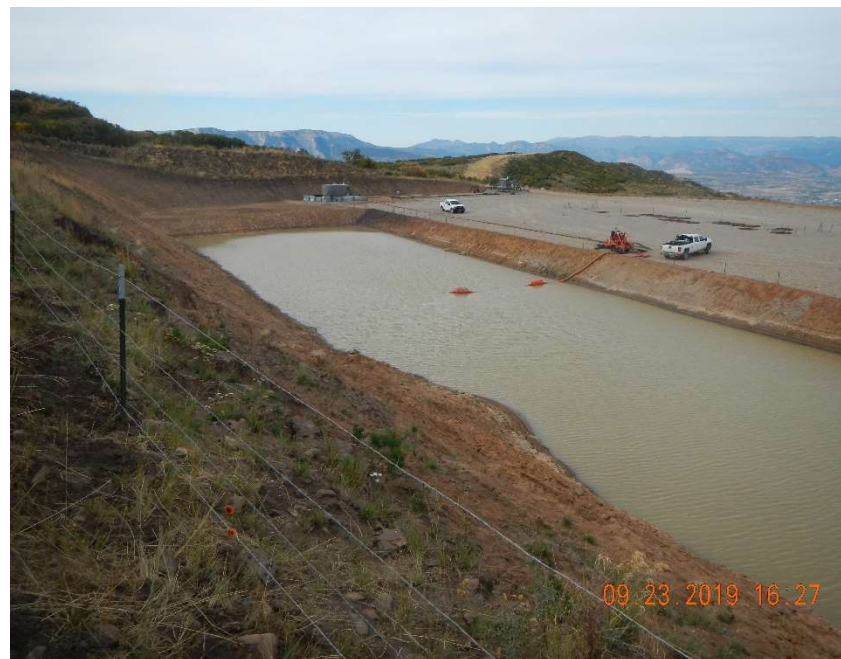
Photo #10 – View of the cuttings trench looking northwest.

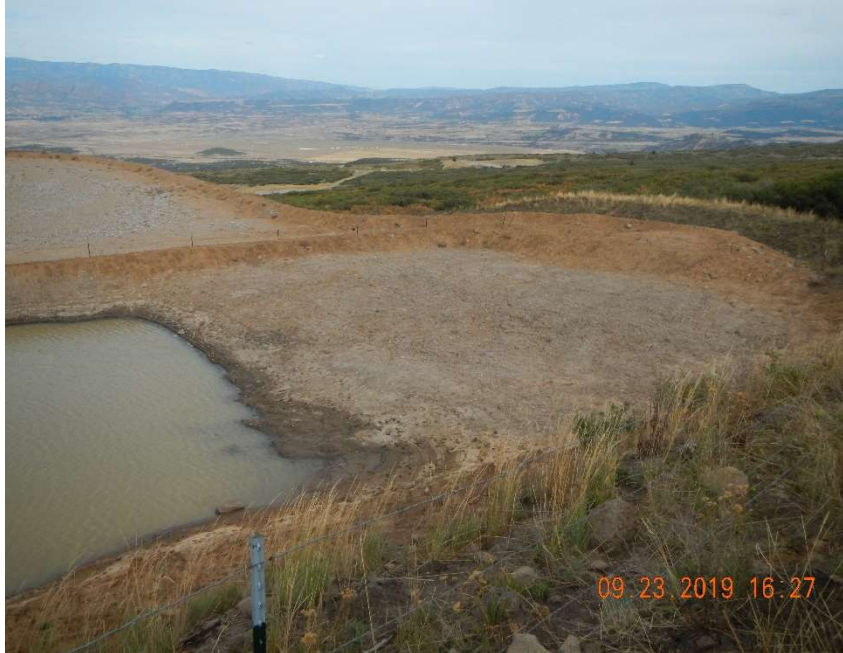
Photo #11 – View of the surface casing cuttings on the southeast side of the cuttings trench.

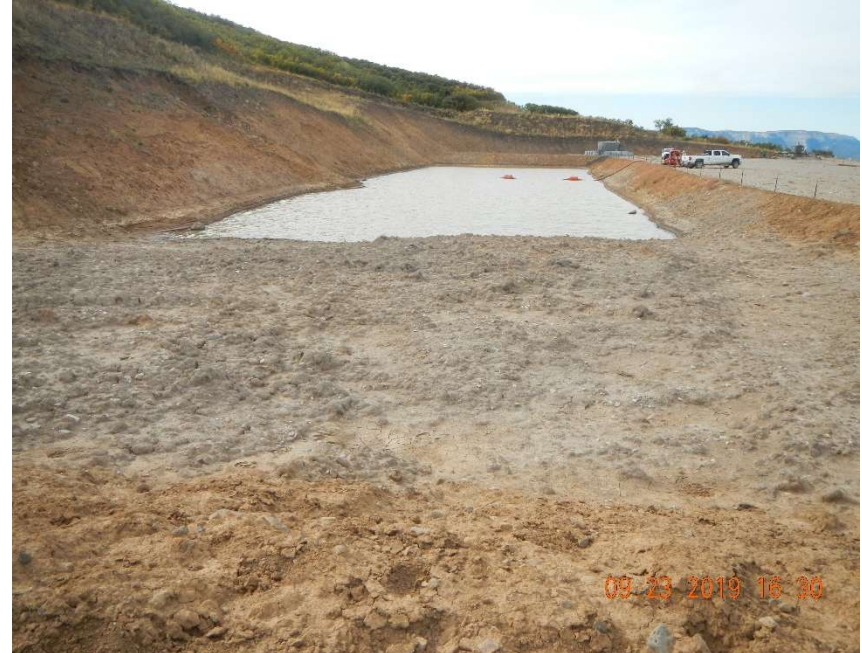
Photo #12 – View of the surface casing cuttings and the cuttings trench looking northwest.
