# Final Reclamation Inspection

Operator: HIGHPOINT OPERATING CORPORATION- 10071

Location ID: 323189

Inspection Document #: 697500656

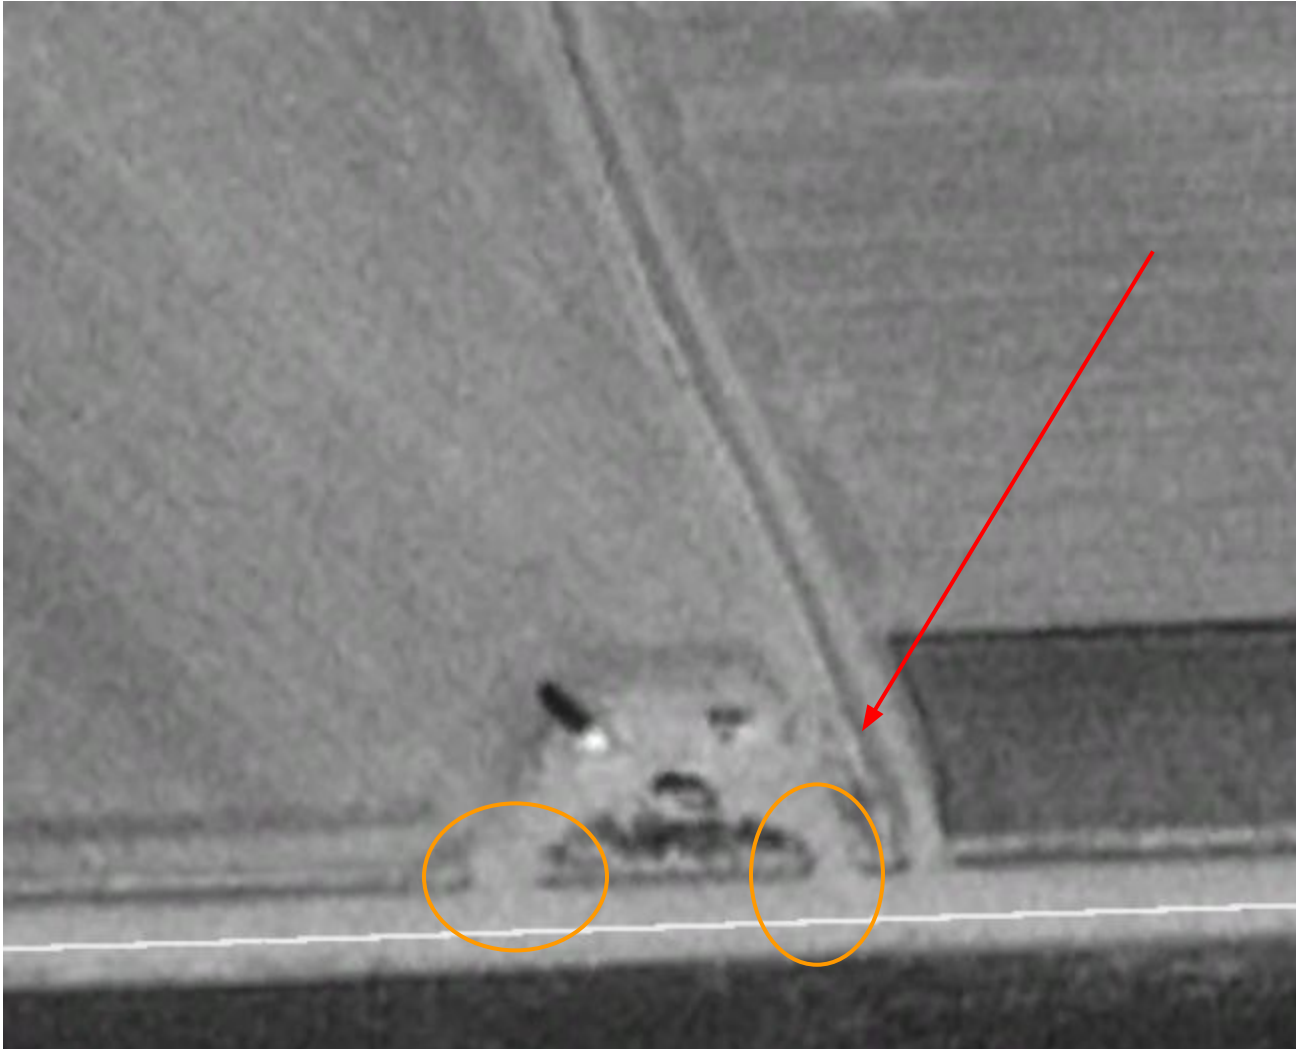
**Photo 1.** Google Earth aerial imagery taken 10/3/1999. Imagery is illustrating that the original access was limited to two entry points off CR 70 (orange circles). Red arrow illustrates a bar ditch along a two-track.

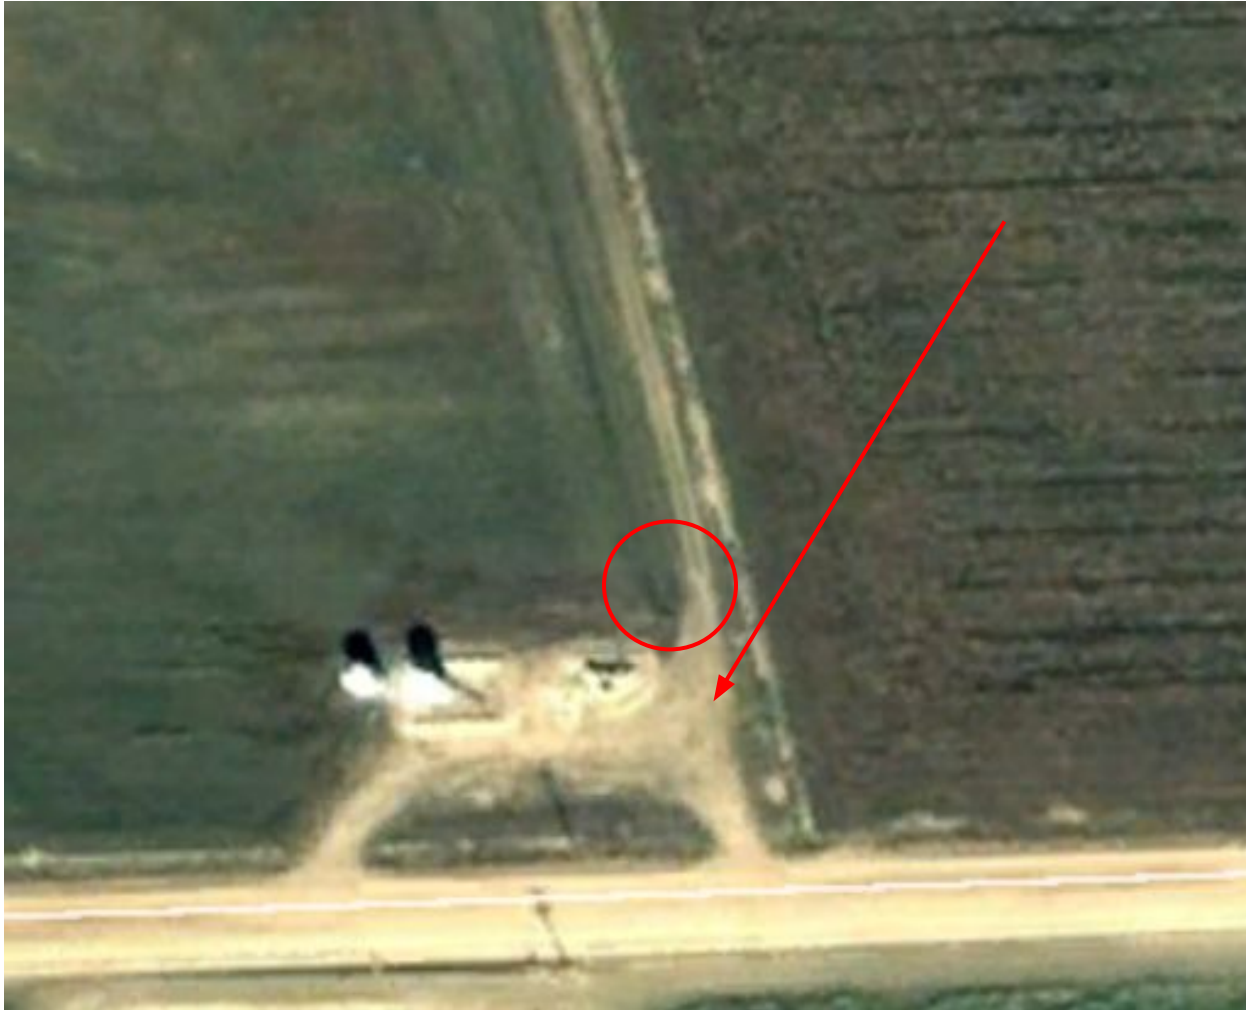
**Photo 2.** Google Earth aerial imagery taken 10/7/2004. Imagery is illustrating that an additional access (red arrow) was installed along the eastern perimeter of the location; therefore, a culvert (red circle) was installed and a section of the bar ditch along the eastern perimeter of the location was removed. As of 10/7/2019, Operator has failed to remove the culvert (orange circle) and put the bar ditch back in.

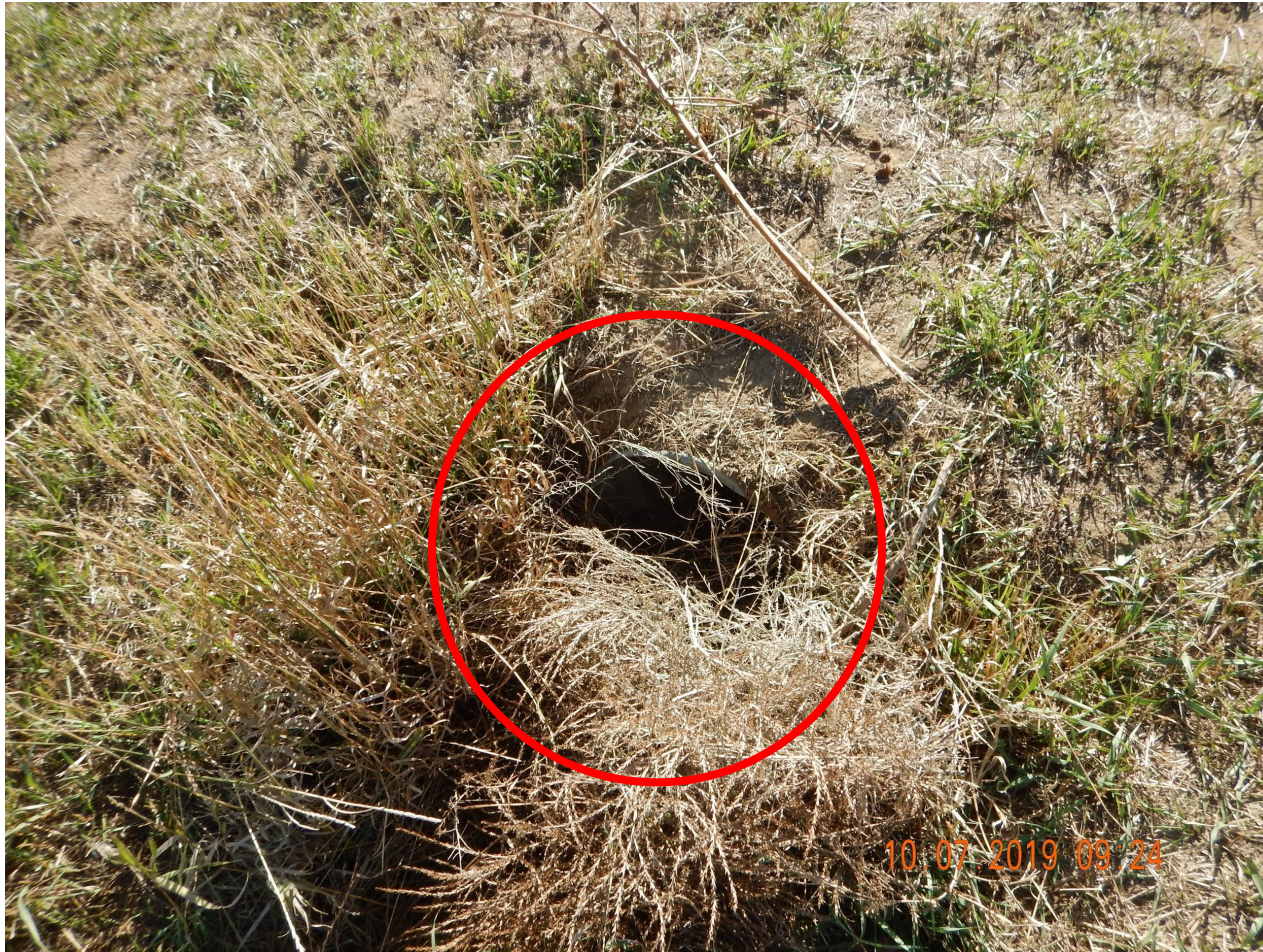
**Photo 3.** Photo taken of the culvert from the tank battery location that was illustrated in the previous aerial imagery.

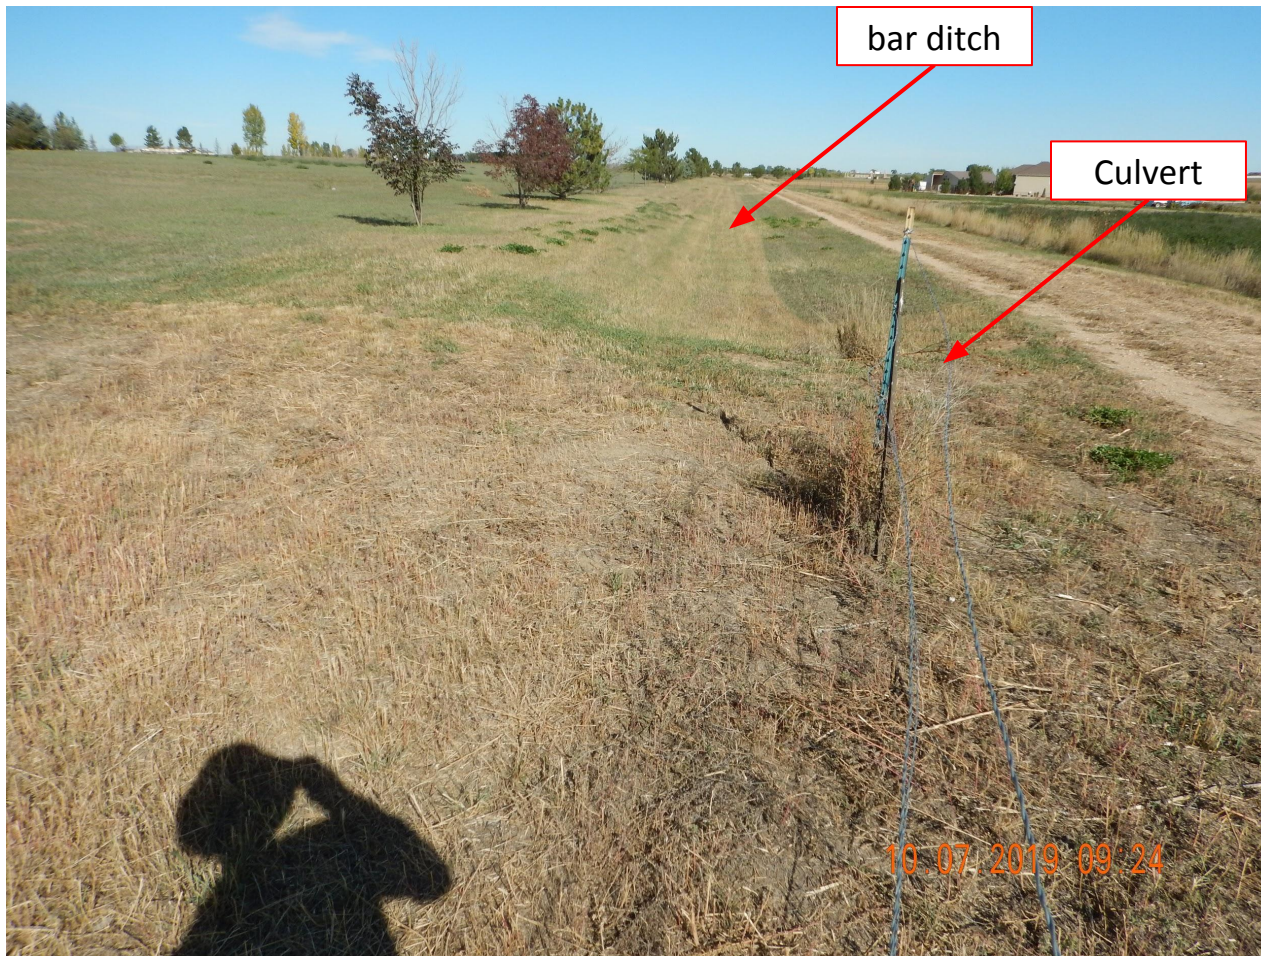
**Photo 4.** Photo taken from the eastern tank battery location, facing North. Photo illustrates the Operator has failed to remove the culvert and put the bar ditch back in. Bar ditch plays an important role as this area is flooding irrigated.

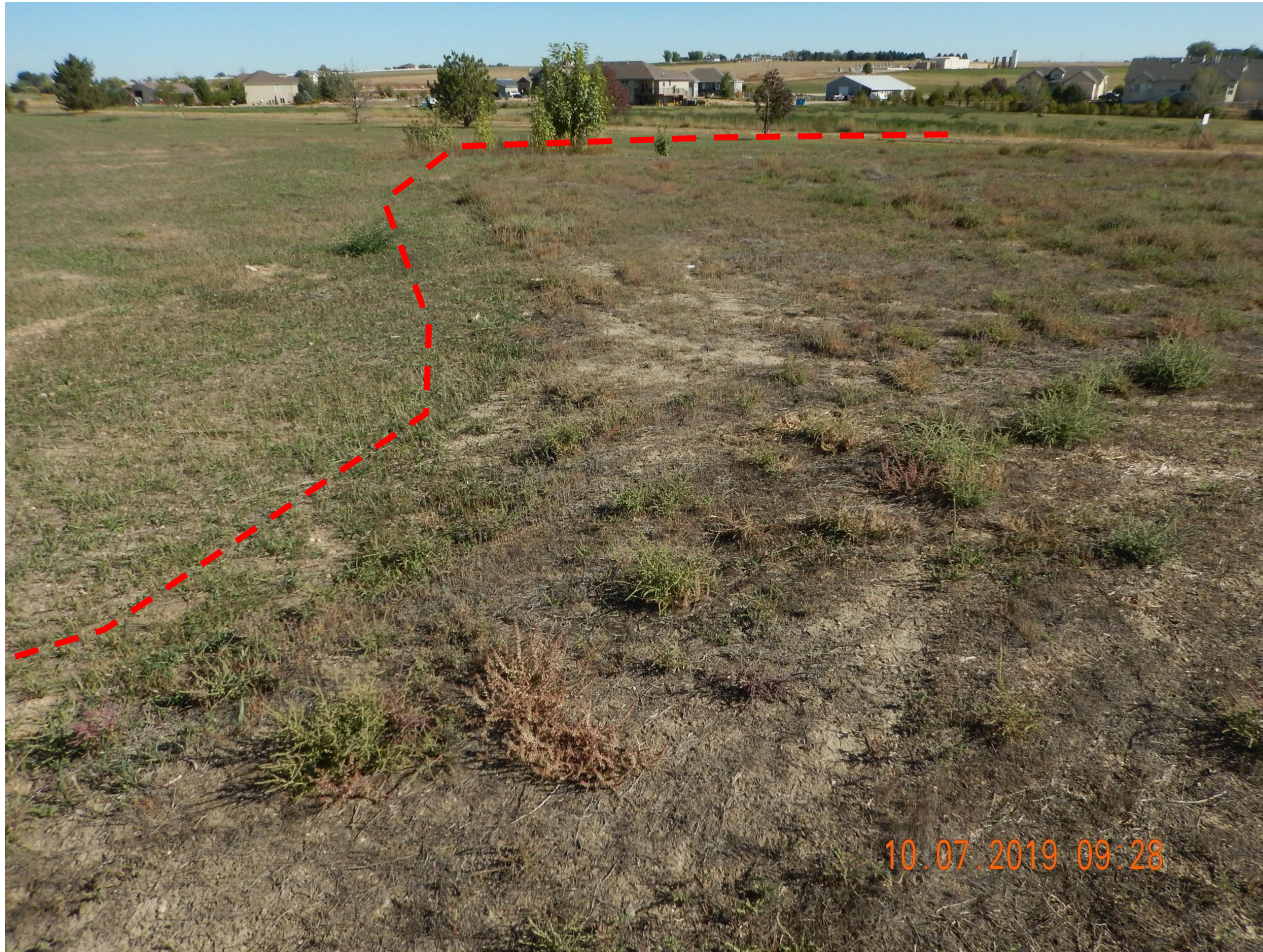
**Photo 5.** Photo taken from the southwestern tank battery location, facing Northeast. Photo illustrates the Operator failed to properly contour the location to match the surrounding landscape to allow for successful flood irrigation. There appears to be a perimeter ditch along the outside and the location itself is elevated compared to the surrounding landscape. Location is to the right of the red-dashed line.

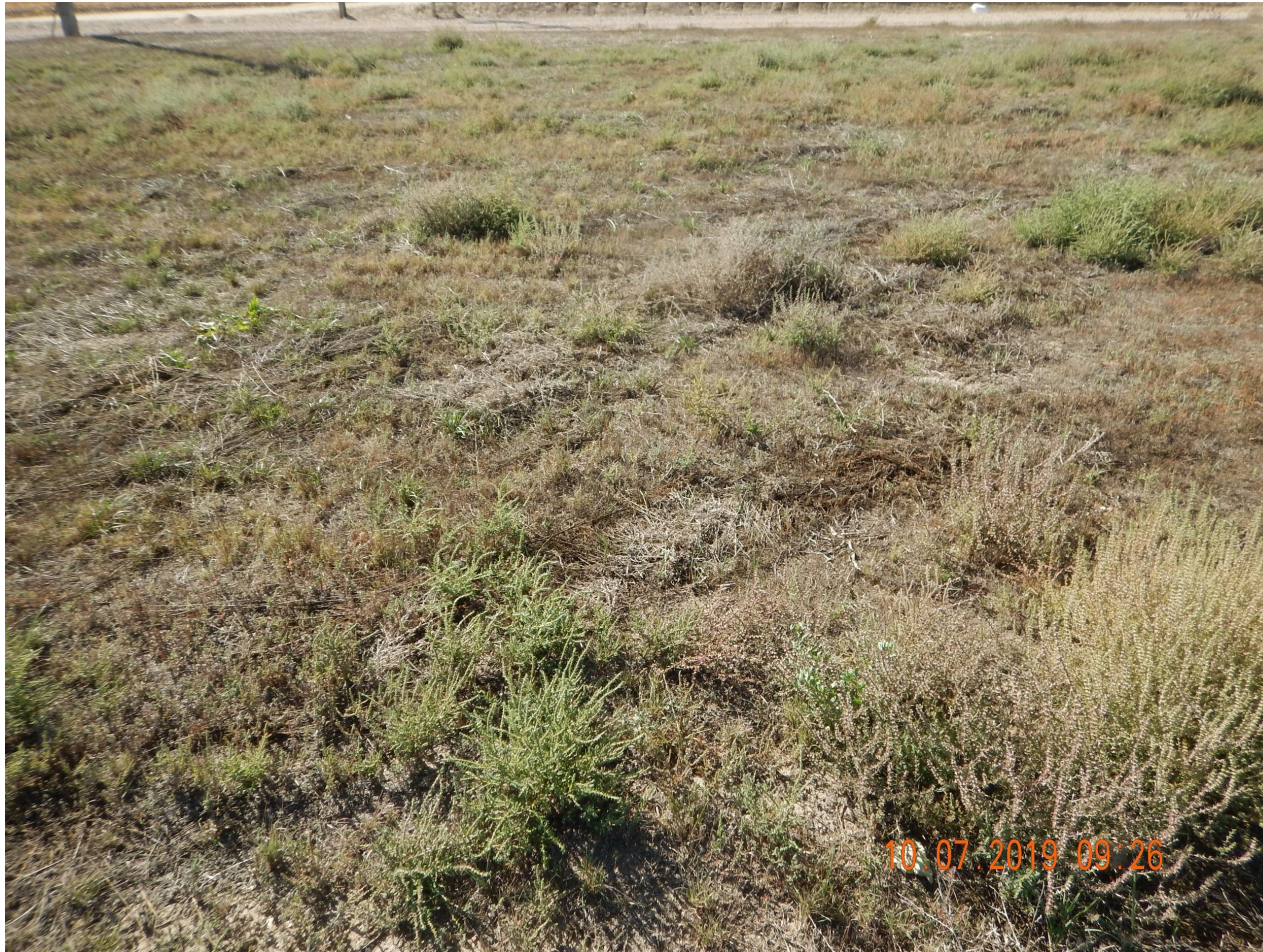
**Photo 6.** Photo taken from the central tank battery location, facing South. Photo illustrates the location appears to have been mowed this season. Undesirable species (Kochia and Russian thistle) were observed. Note: Even though the Operator claims to use a seed mix approved by the Surface Owner, it is not reflective of reference area vegetation.

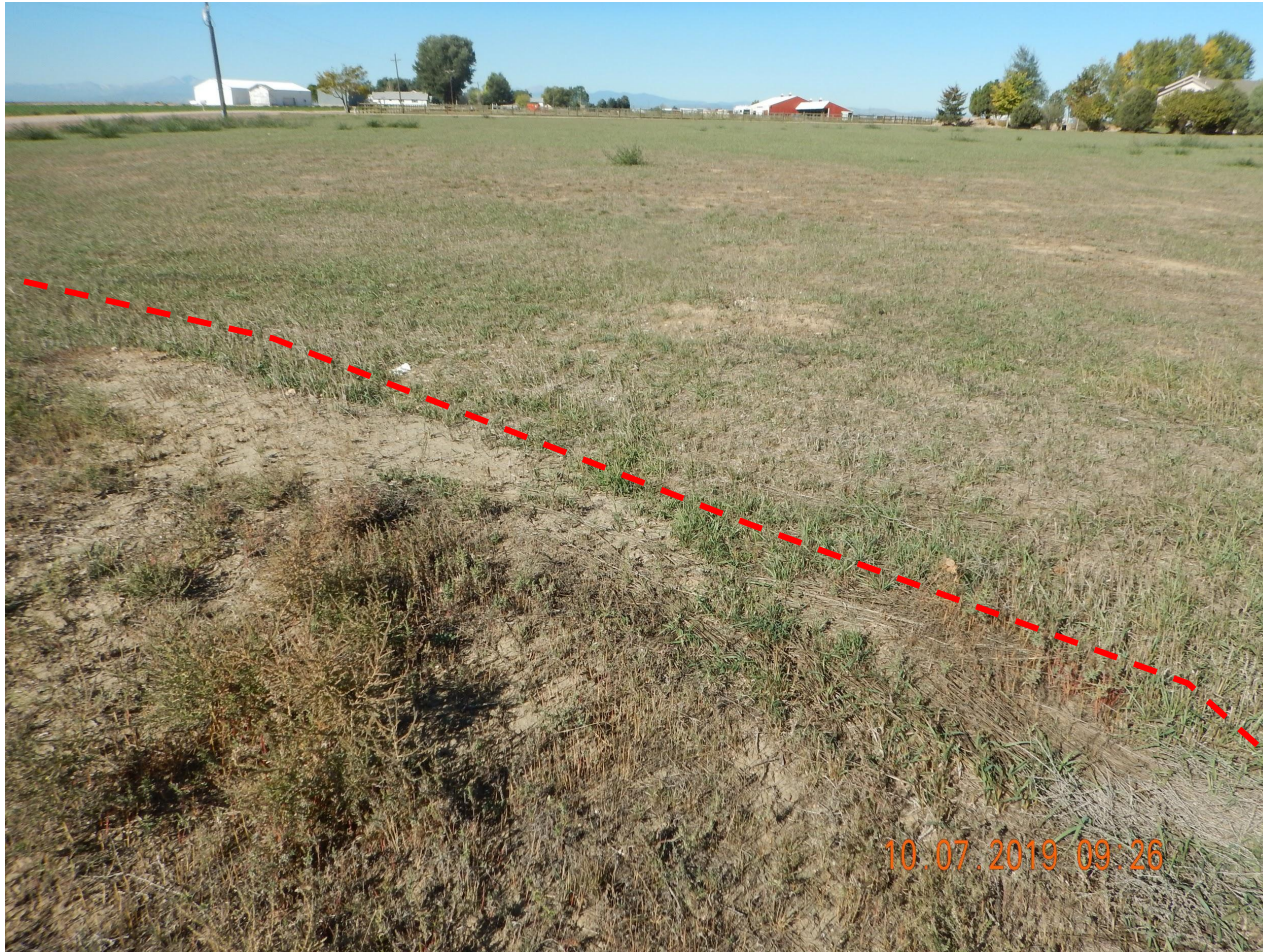
**Photo 7.** Photo taken from the western tank battery location, facing West. Photo illustrates the reference area vegetation is mostly comprised of Smooth brome. Location is in the foreground of the photo, below the red-dashed line.
