Inspection Photos
Location Name: Vaneta DAF
Location 324752, CE&P Facility 463141

COLORADO
Oil & Gas Conservation
Commission
Department of Natural Resources

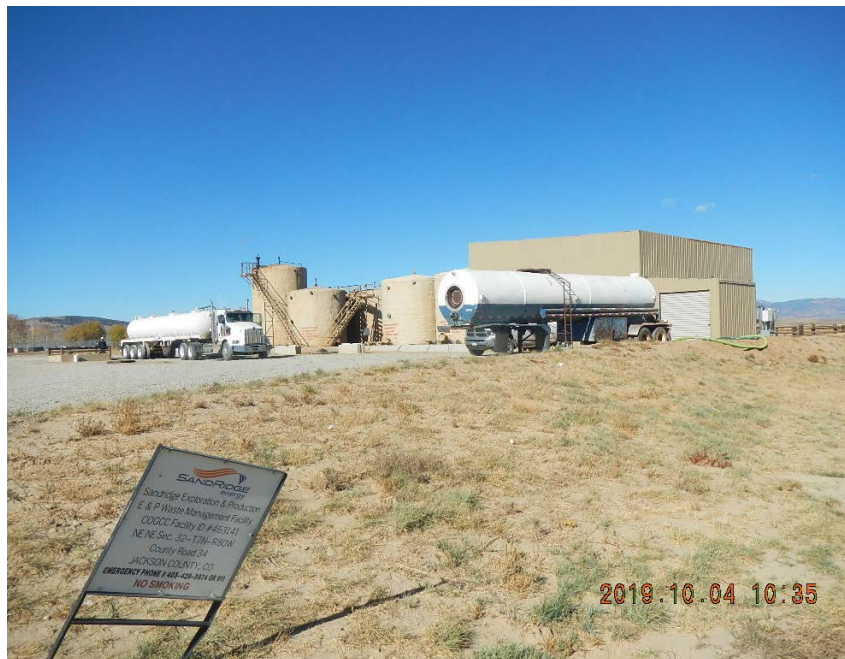
Off loading operations, left side of picture.

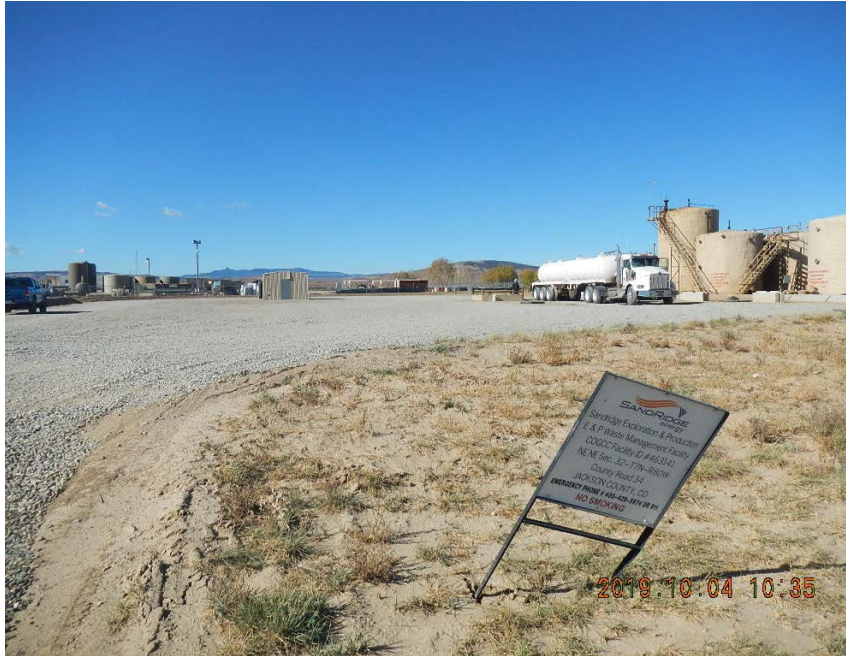
Off loading operations in process.

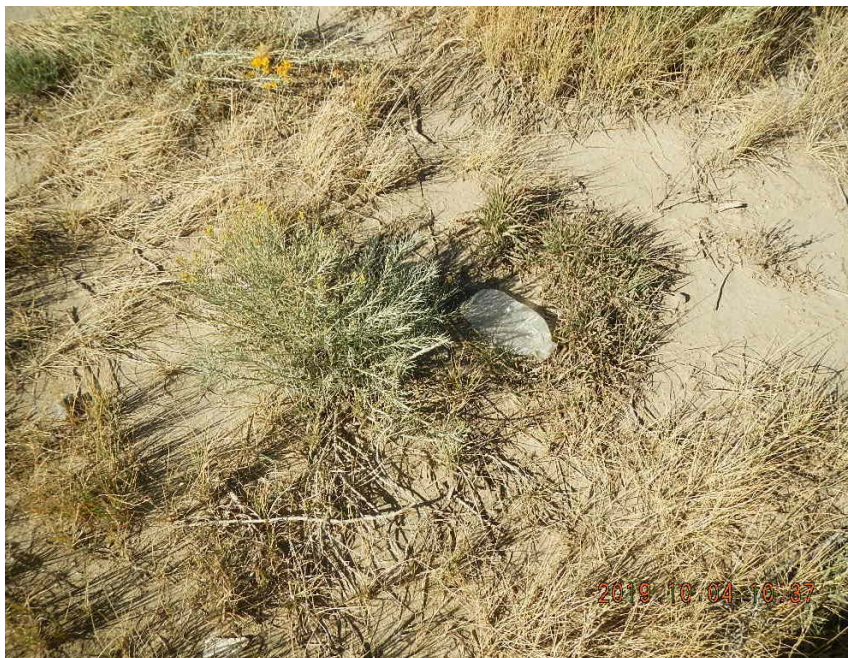
Trash just off of the Location.

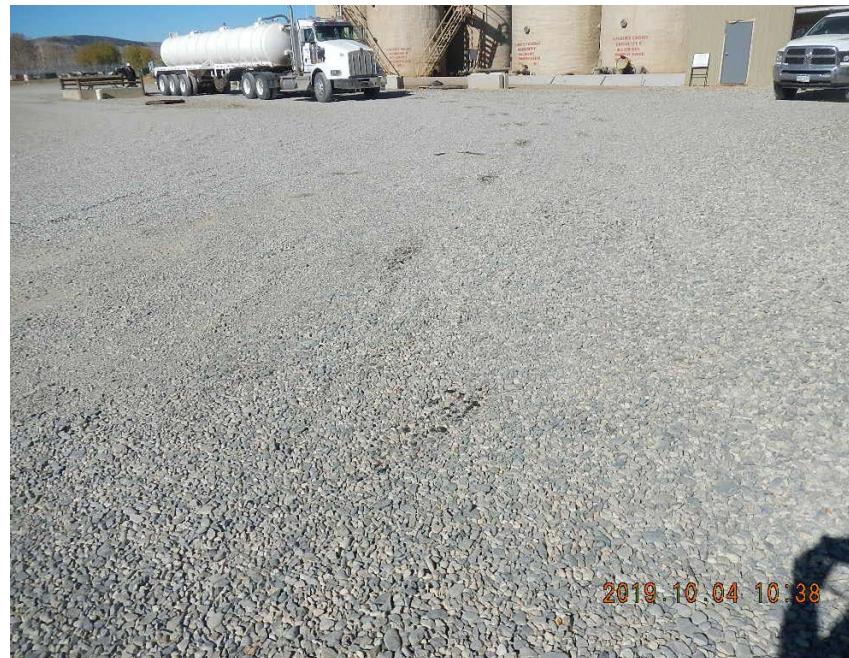
Stained soil/gravel in multiple areas of Location and vehicle tracking.

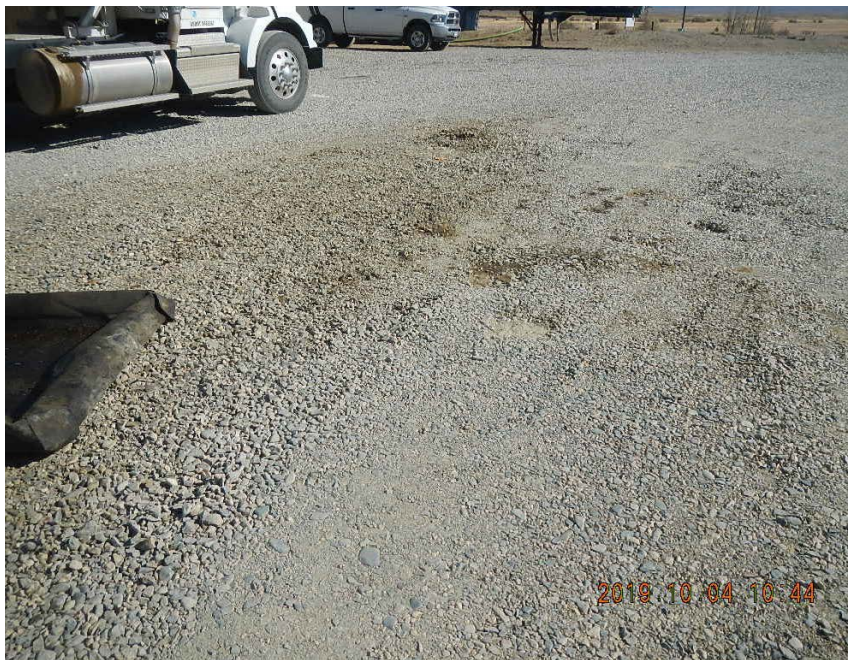
Stained soil/gravel in multiple areas of Location and vehicle tracking.

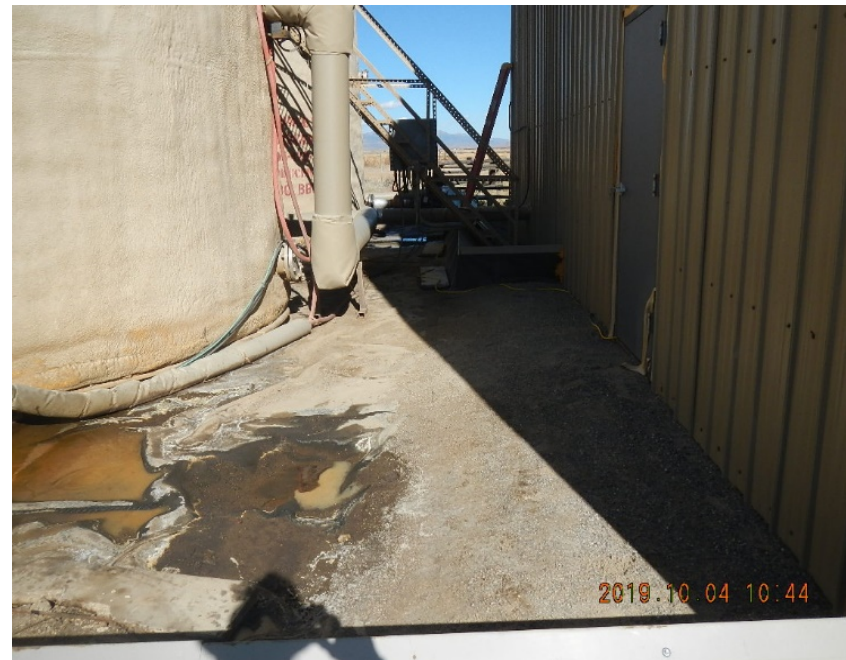
Oily water/fluids pooled on liner in secondary containment.

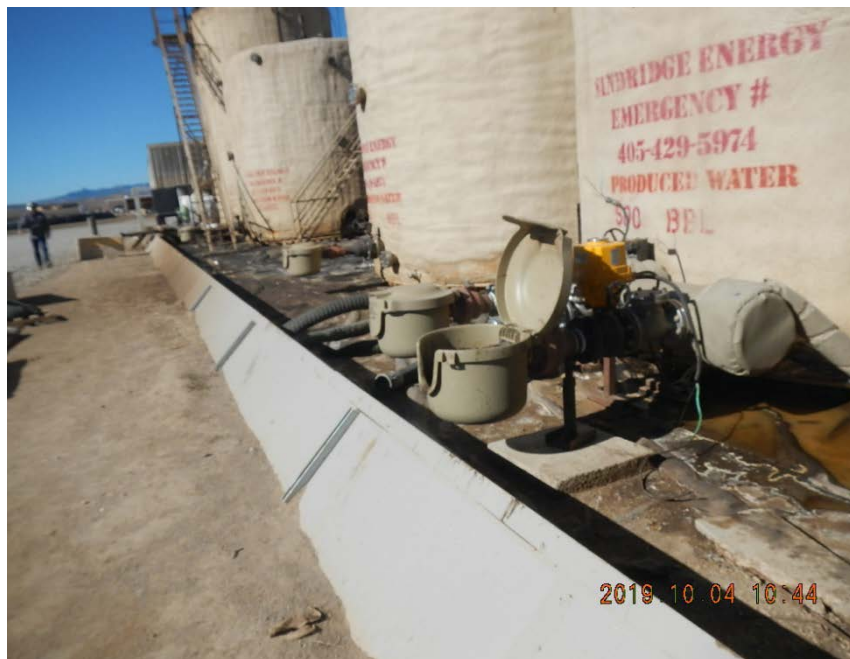
Oily water/fluids pooled on liner in secondary containment.

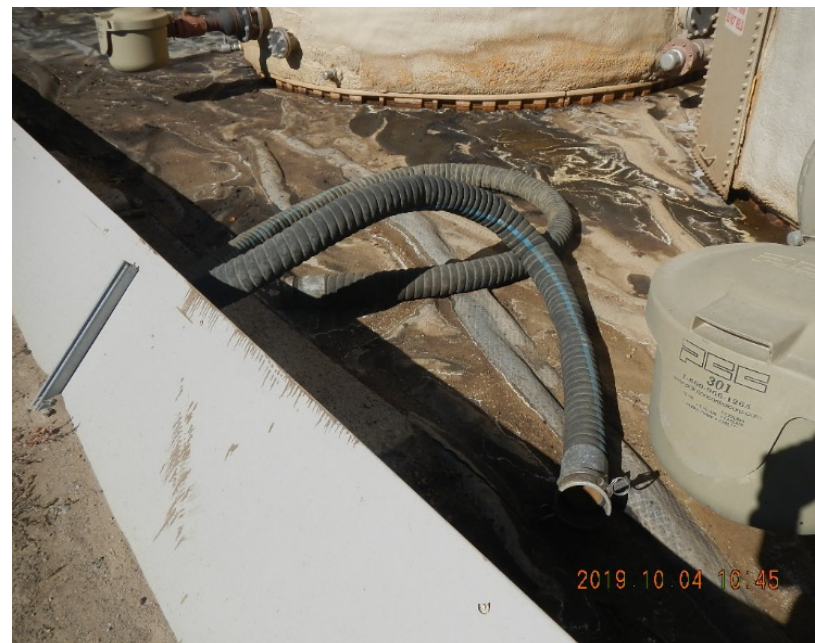
Delivery hose directly on liner of secondary containment.

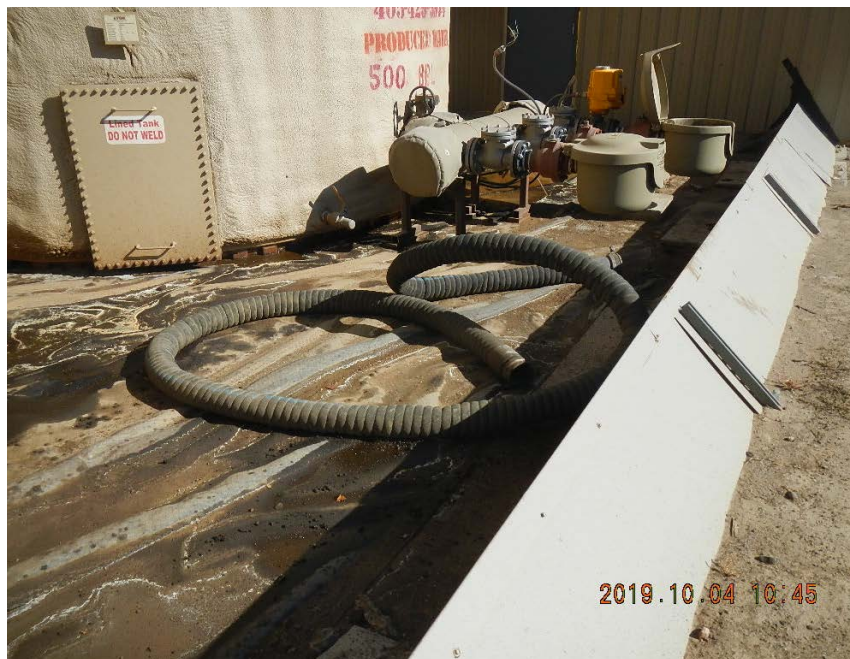
Delivery hose directly on liner of secondary containment and residual oil and salt staining.

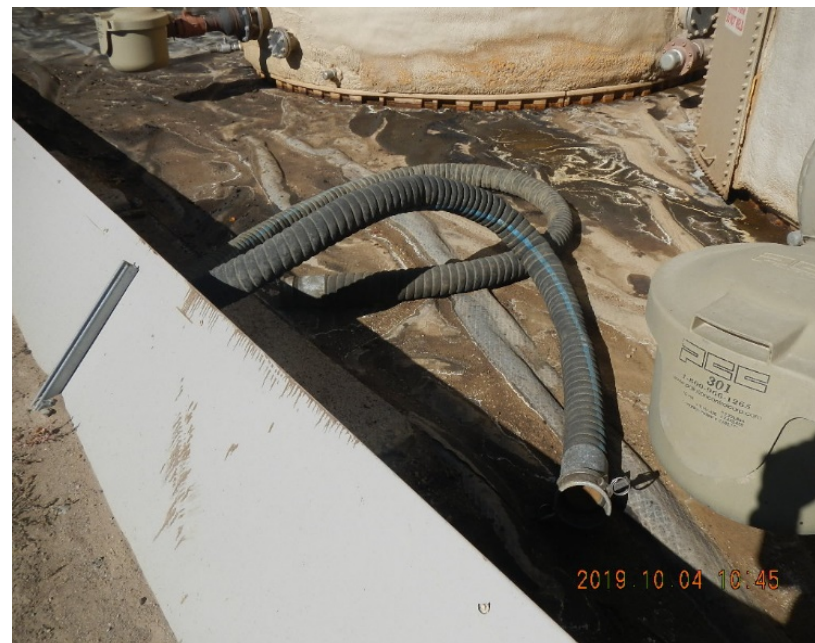
Delivery hose directly on liner of secondary containment.

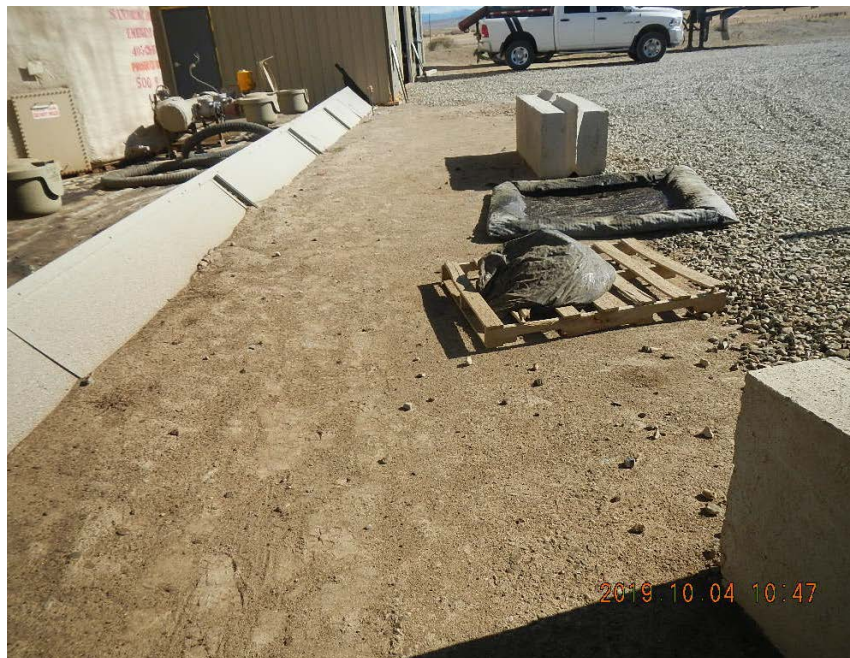
Black bag on pallet and oily soaked catch mat.

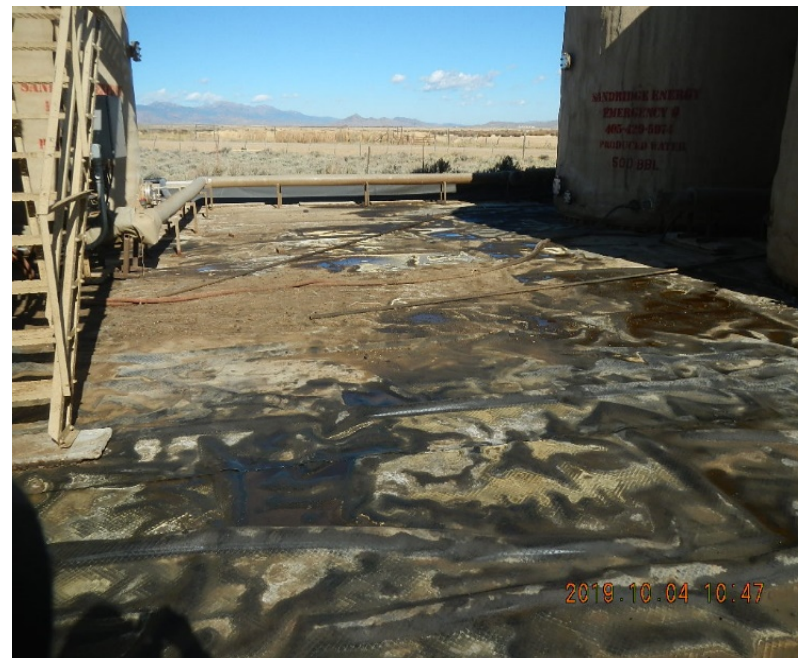
Oily water/fluids pooled on liner in secondary containment, 1" by app 30' pipe directly on liner of secondary containment.

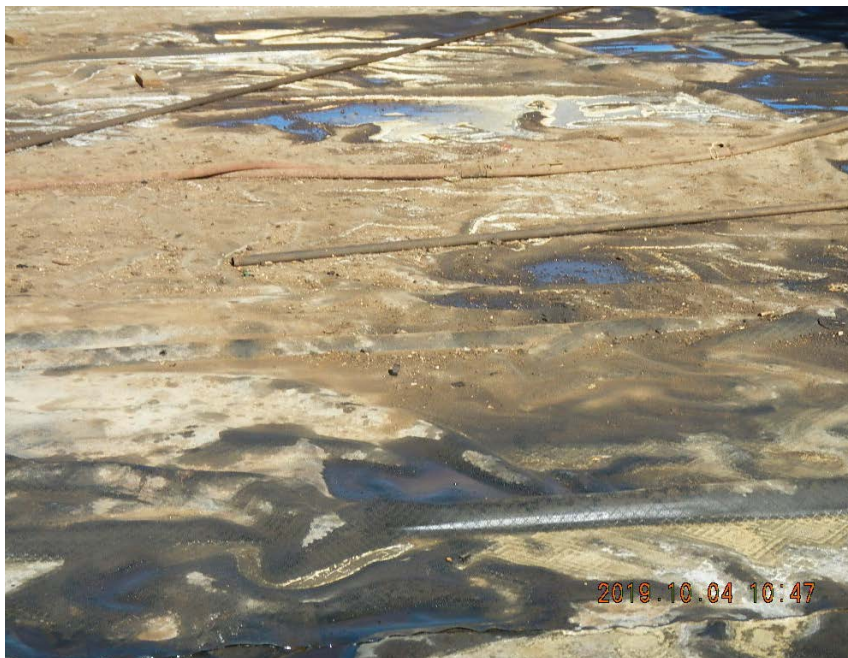
Oily water/fluids pooled on liner in secondary containment, 1" by app 30' pipe directly on liner of secondary containment.

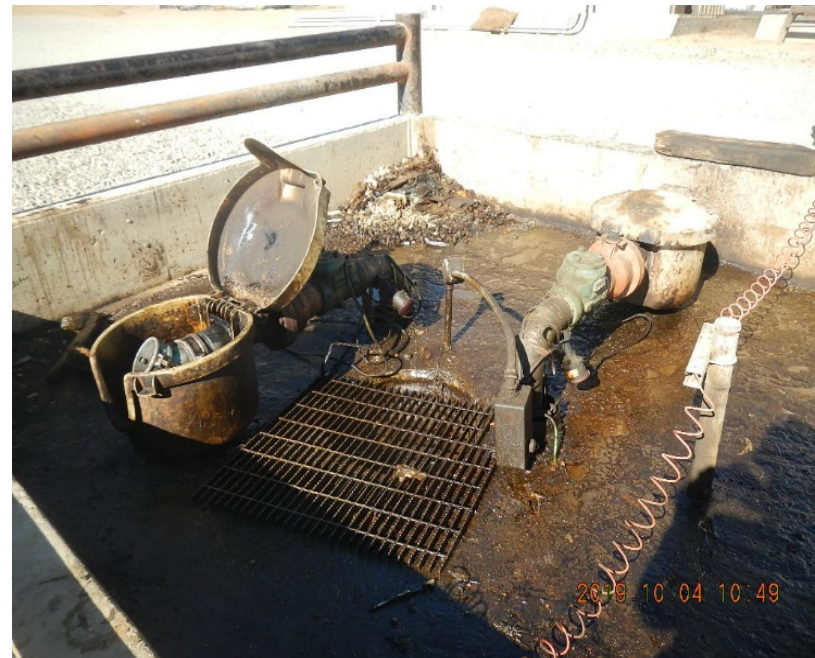
Trash/debris in off load area, impacted by oily waste and is now considered E&P waste.

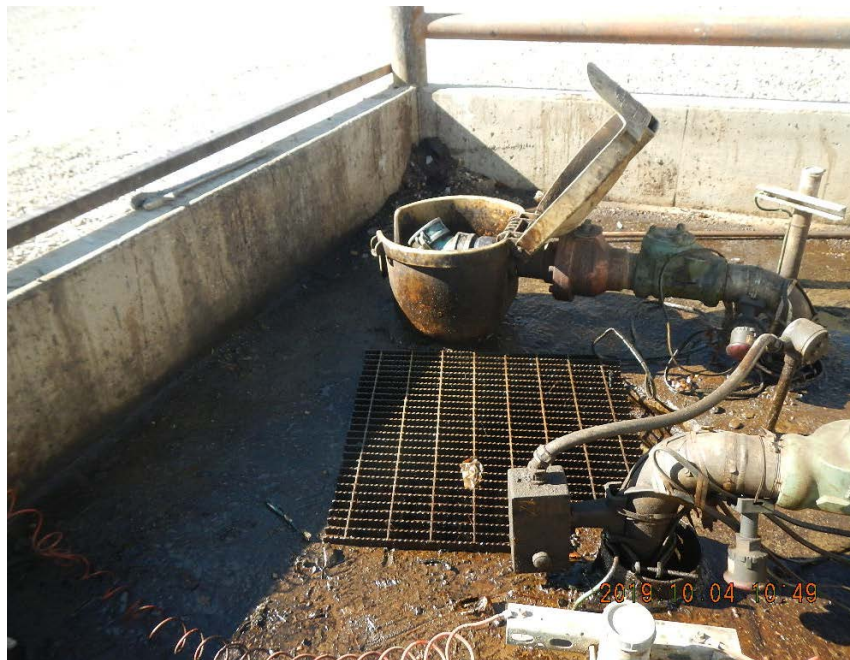
Trash/debris in off load area, impacted by oily waste and is now considered E&P waste.

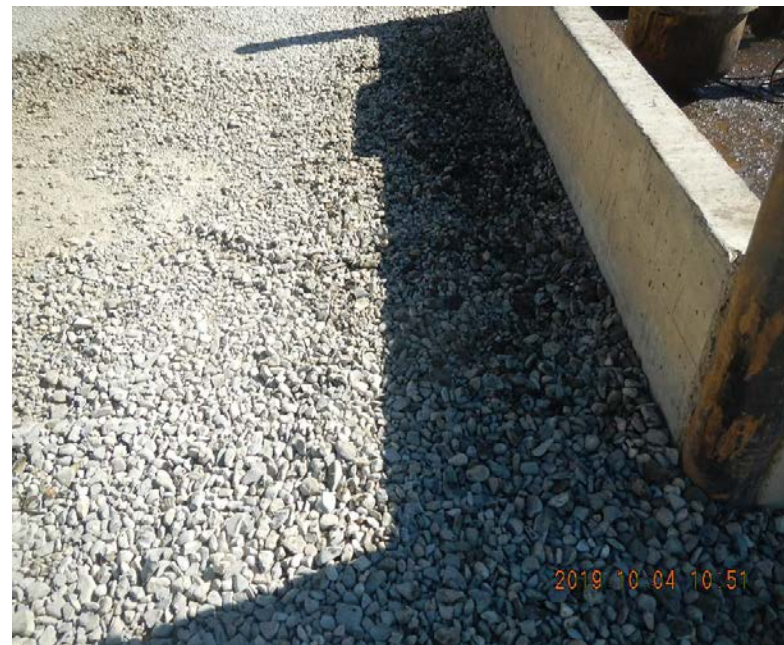
Drips and staining of oil on the recently placed gravel at the load out area.

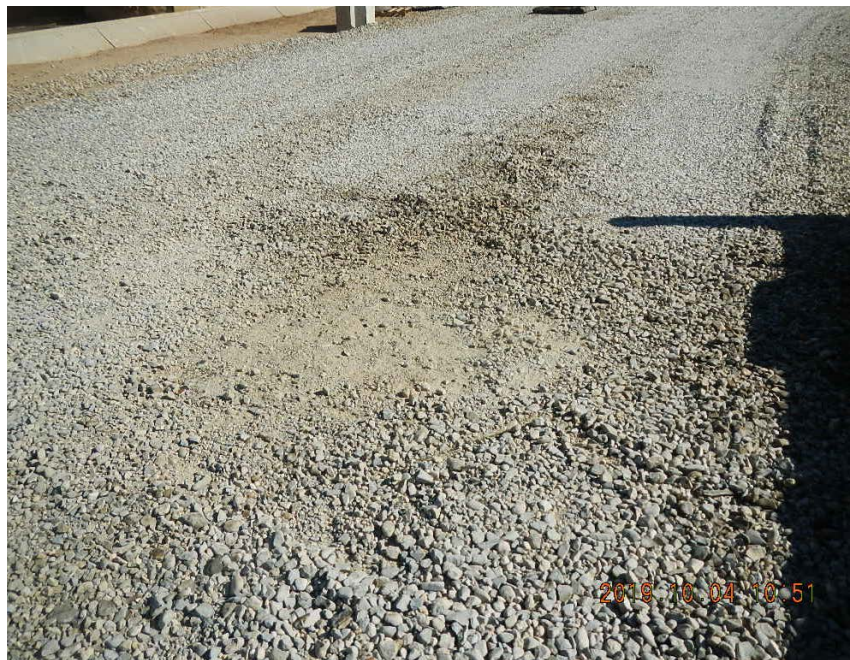
Drips and staining of oil on the recently placed gravel at the load out area.

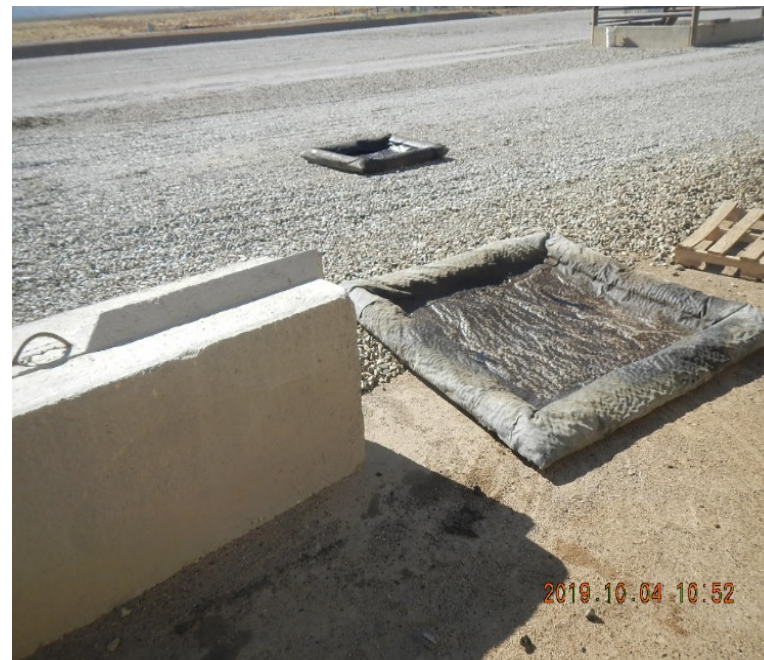
Drips and staining of oil on the recently placed gravel at the load out area and oily soaked catch mats.

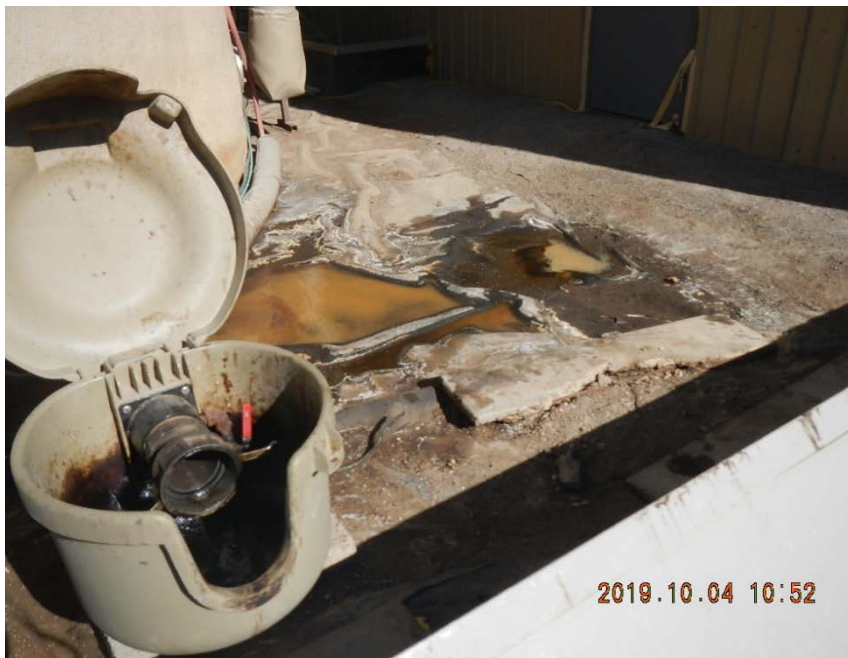
Oily water/fluids pooled on liner in secondary containment.

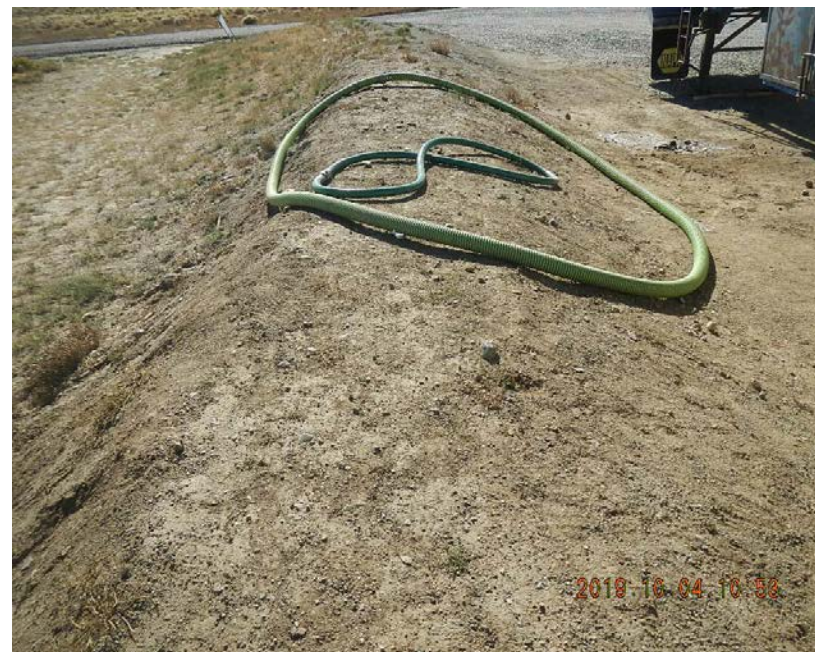
Unused equipment on east berm.

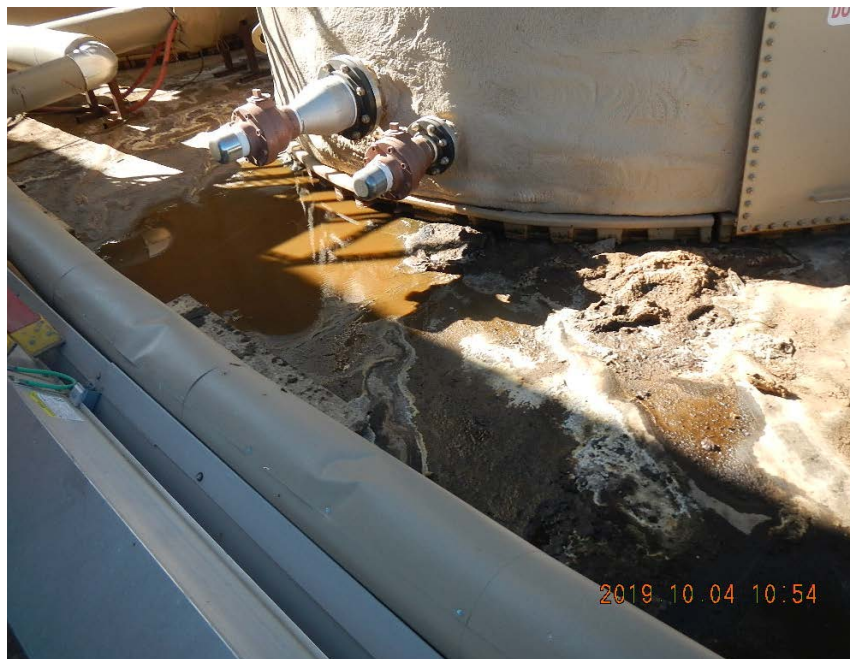
Oily water/fluids pooled on liner in secondary containment and sorbent material.

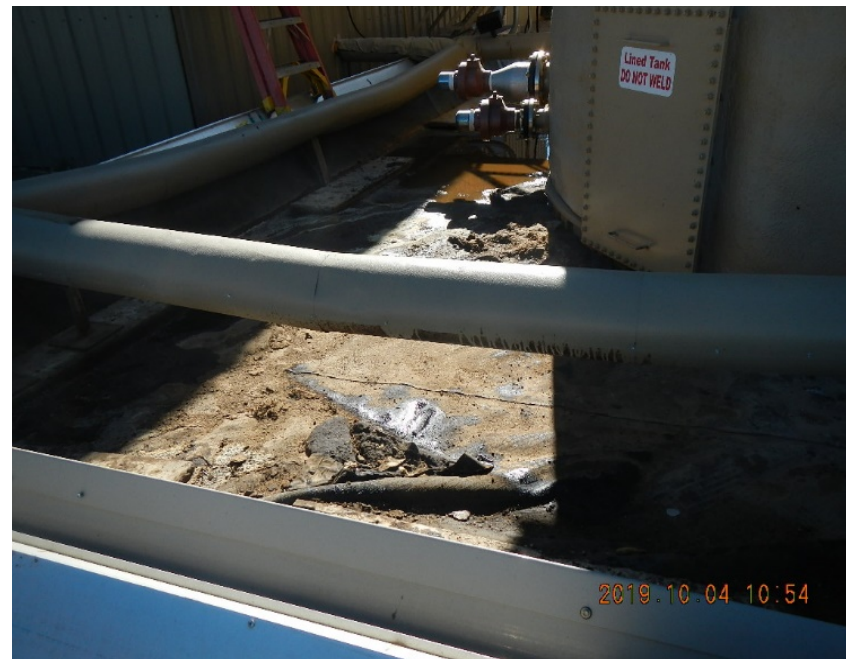
Oily water/fluids pooled on liner in secondary containment and sorbent material.

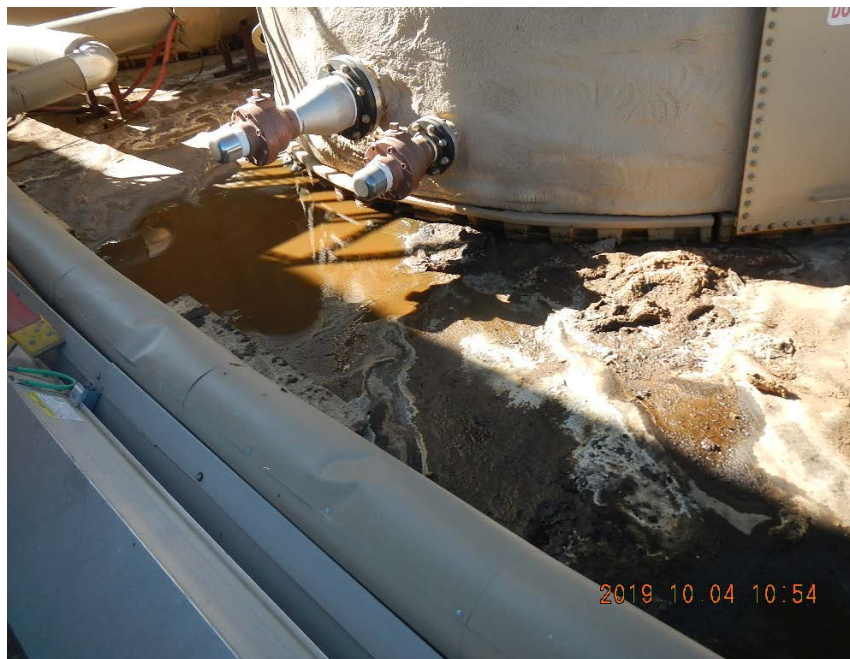
Oily water/fluids pooled on liner in secondary containment and sorbent material.

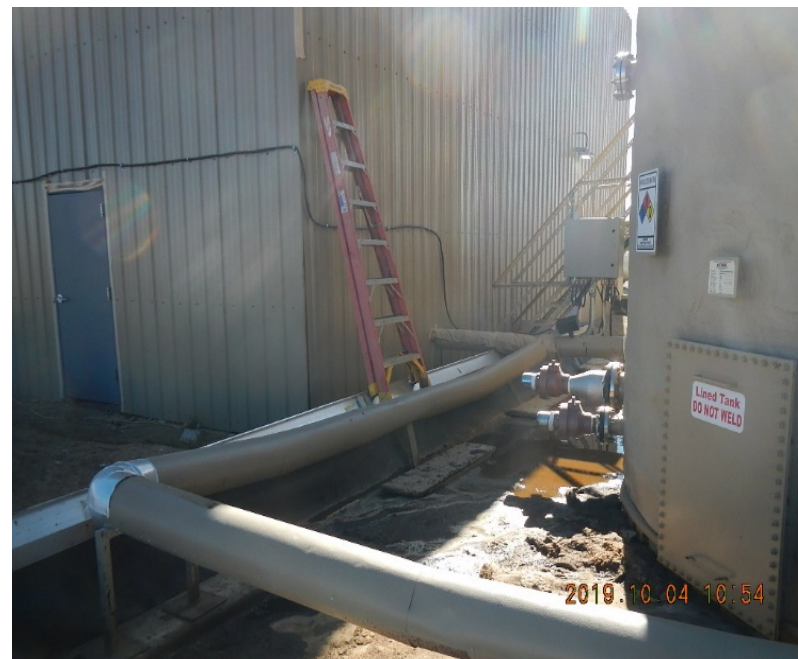
Oily water/fluids pooled on liner in secondary containment and sorbent material. Improper storage of ladder.

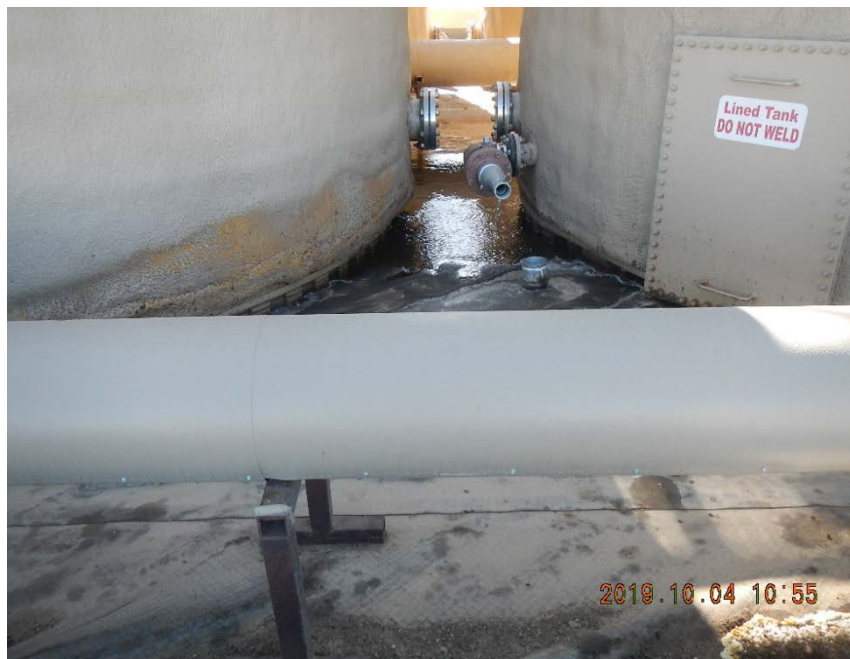
**Oily water/fluids pooled on liner in secondary containment.
Uncapped valve with bull plug on liner.**

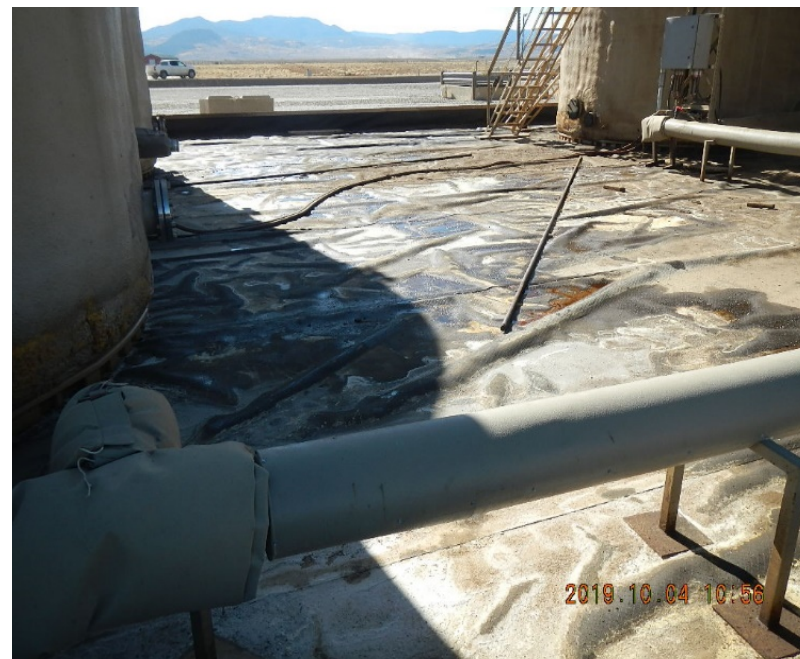
**Oily water/fluids pooled on liner in secondary containment, 1" by
app 30' pipe directly on liner of secondary containment.**

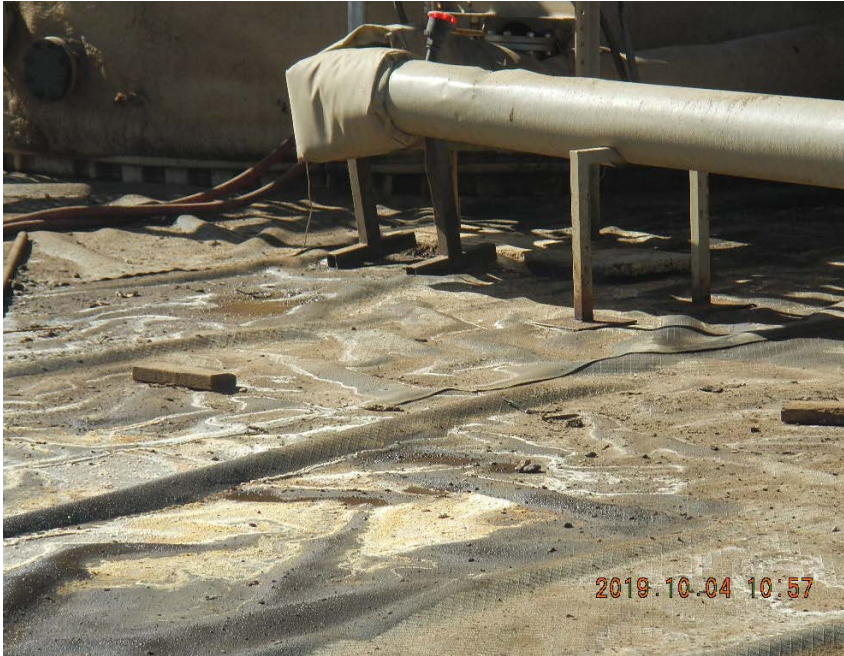
Note pipe supports at an angle which may potentially compromise the liner. Also, debris (wood and metal pipe).

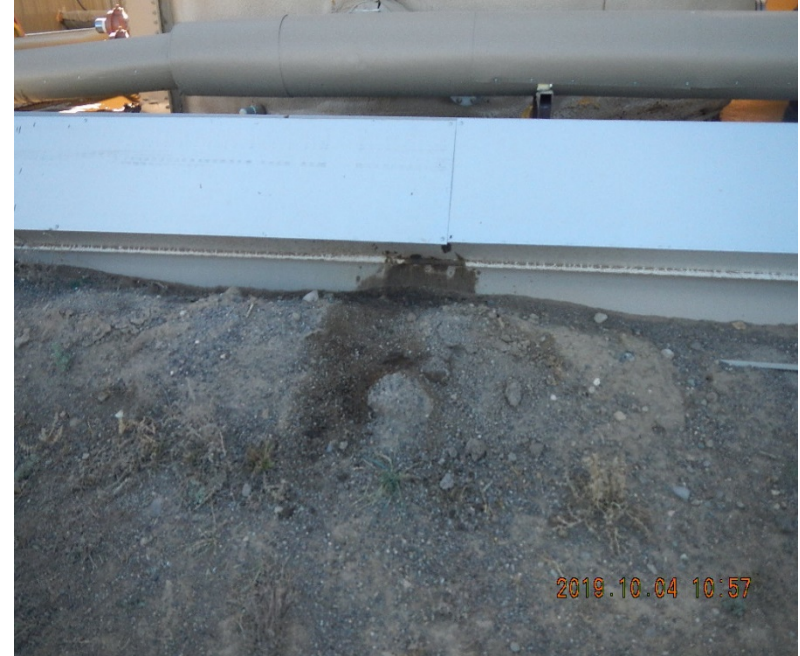
Oily stained soil outside of secondary containment on north side of tank battery.

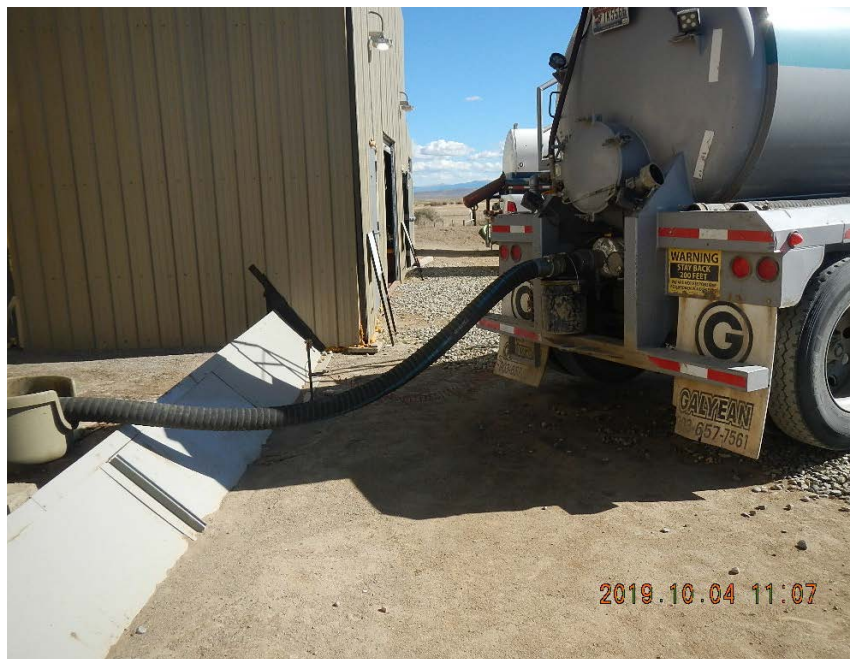
Off loading in 400 bbl tank near DAF. Note: Spill containment bucket under truck valve, but no impervious containment to the ground surface.
