APACHE CANYON 14-01 API# 05-071-06130 – TIMBER CREEK
OGCC OPERATOR NUMBER 10672 - DATE: OCTOBER 14, 2019
CORRECTIVE ACTIONS COMPLETED REGARDING COGCC FIR DOCUMENT # 689901233

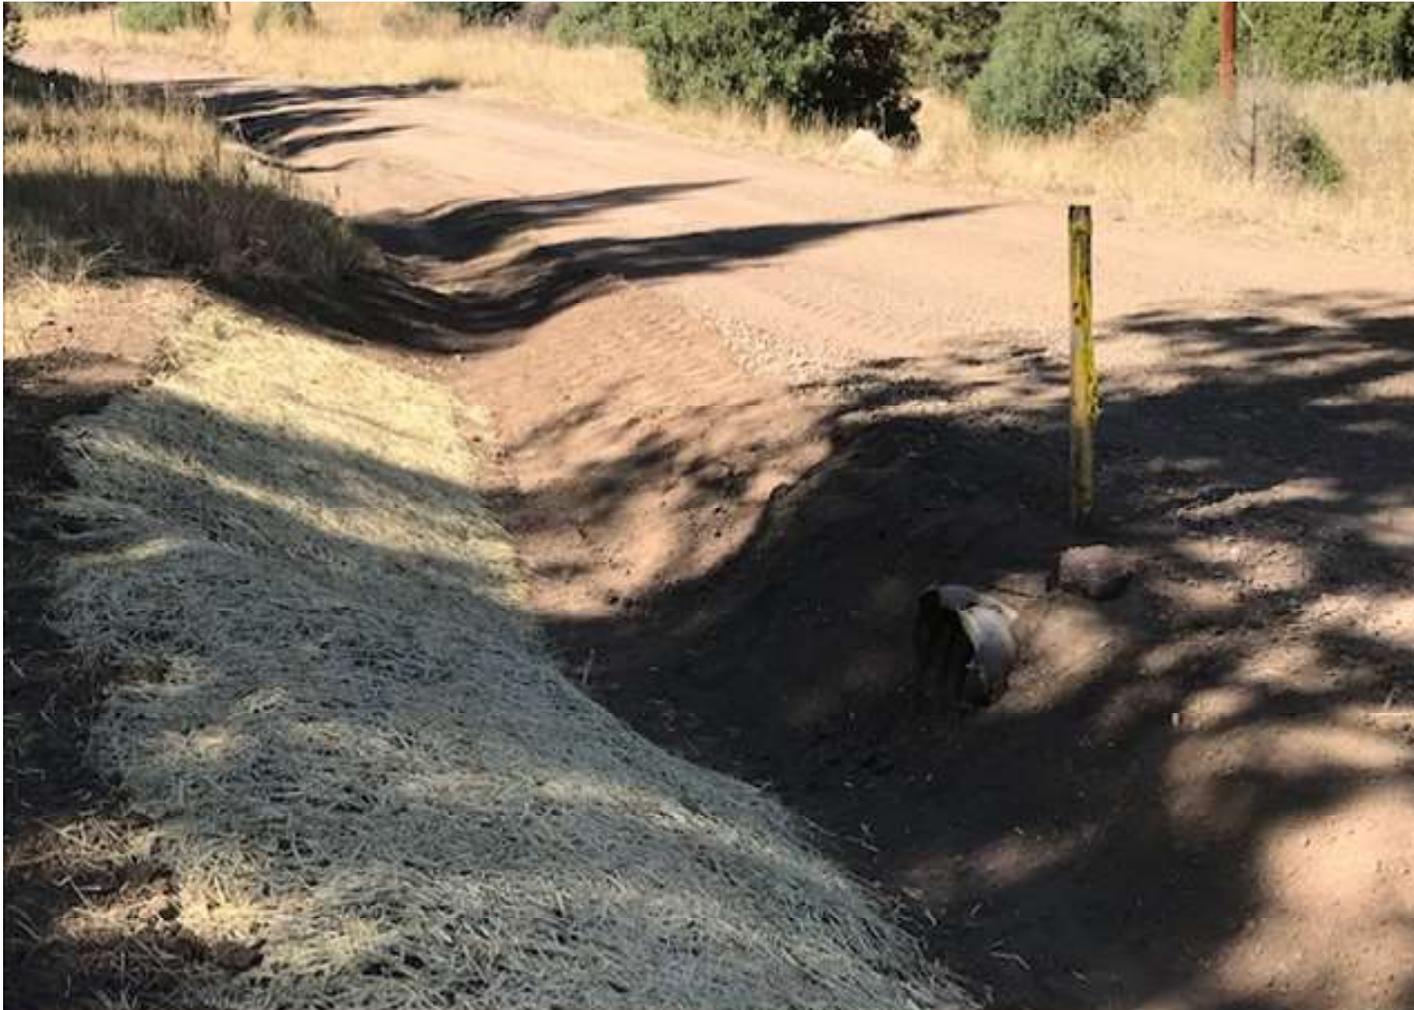
Photo 1: There was no erosion found up gradient of the culvert inlet. It appears that the established vegetation up gradient of the bar ditch was disturbed during the previous maintenance efforts. The sediment in the bar ditch is believed to have come from the earth disturbance. To correct this, the accumulated sediment was removed from the bar ditch. The disturbed soil was hand broadcast with an approved CPW seed mix to promote the establishment of vegetation. Erosion control blankets were installed for sediment control.

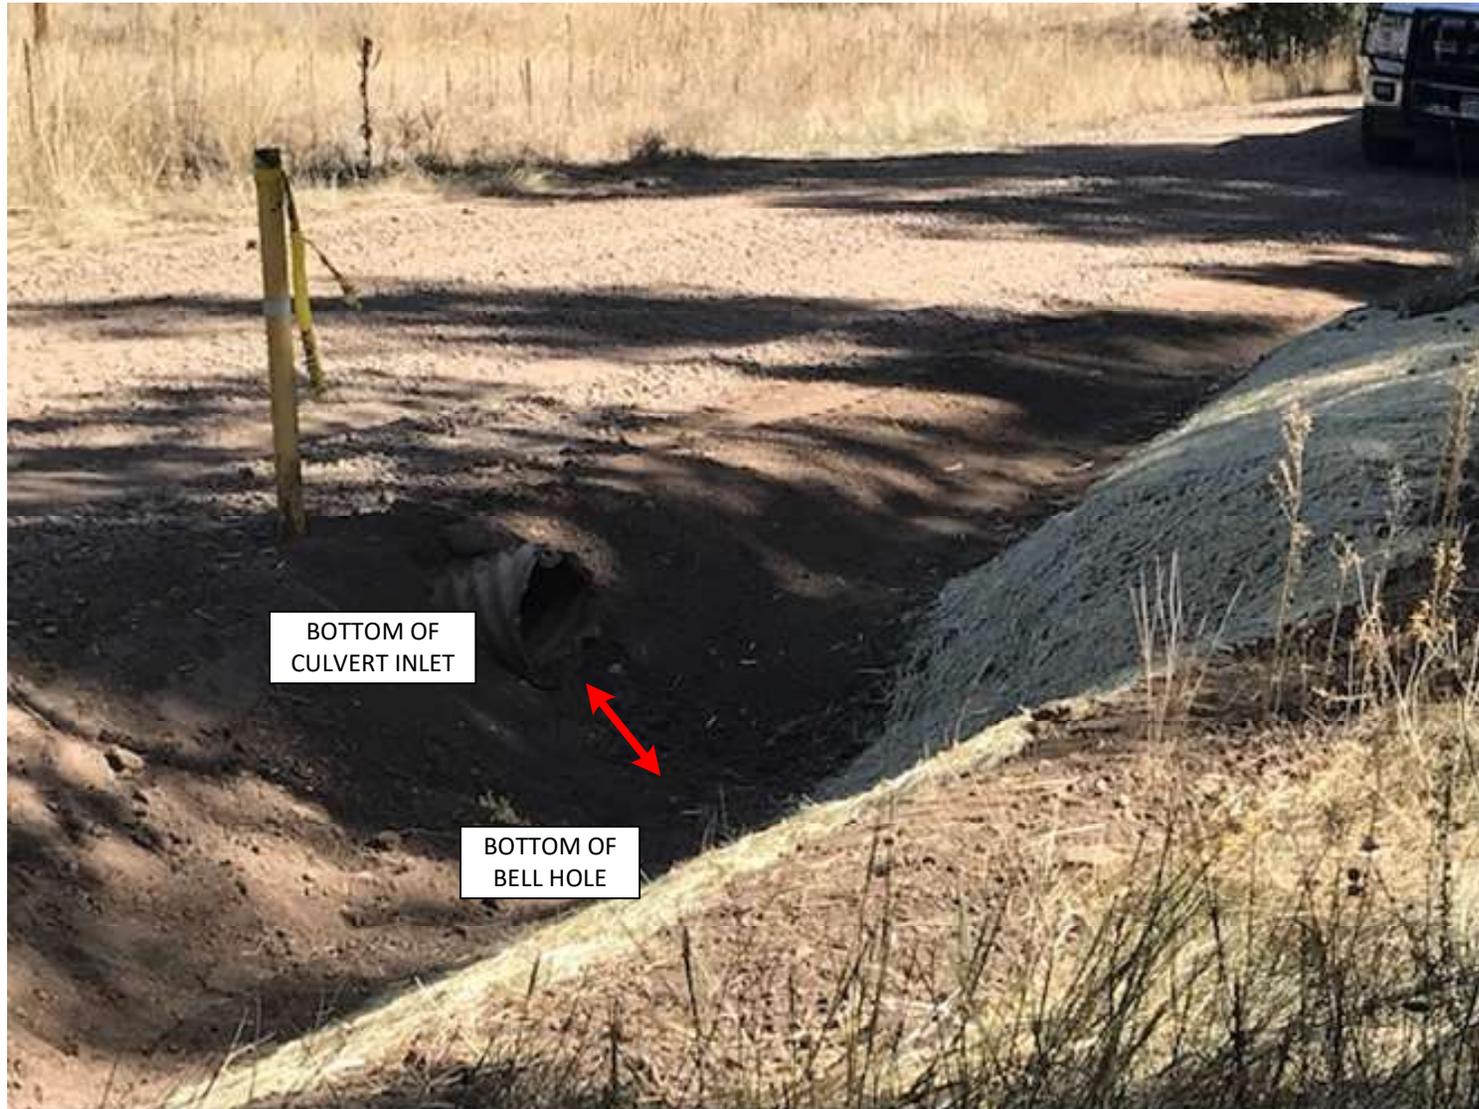
Photo 2: A bell hole was created below the culvert inlet to allow sediment time to drop out before entering the culvert inlet.

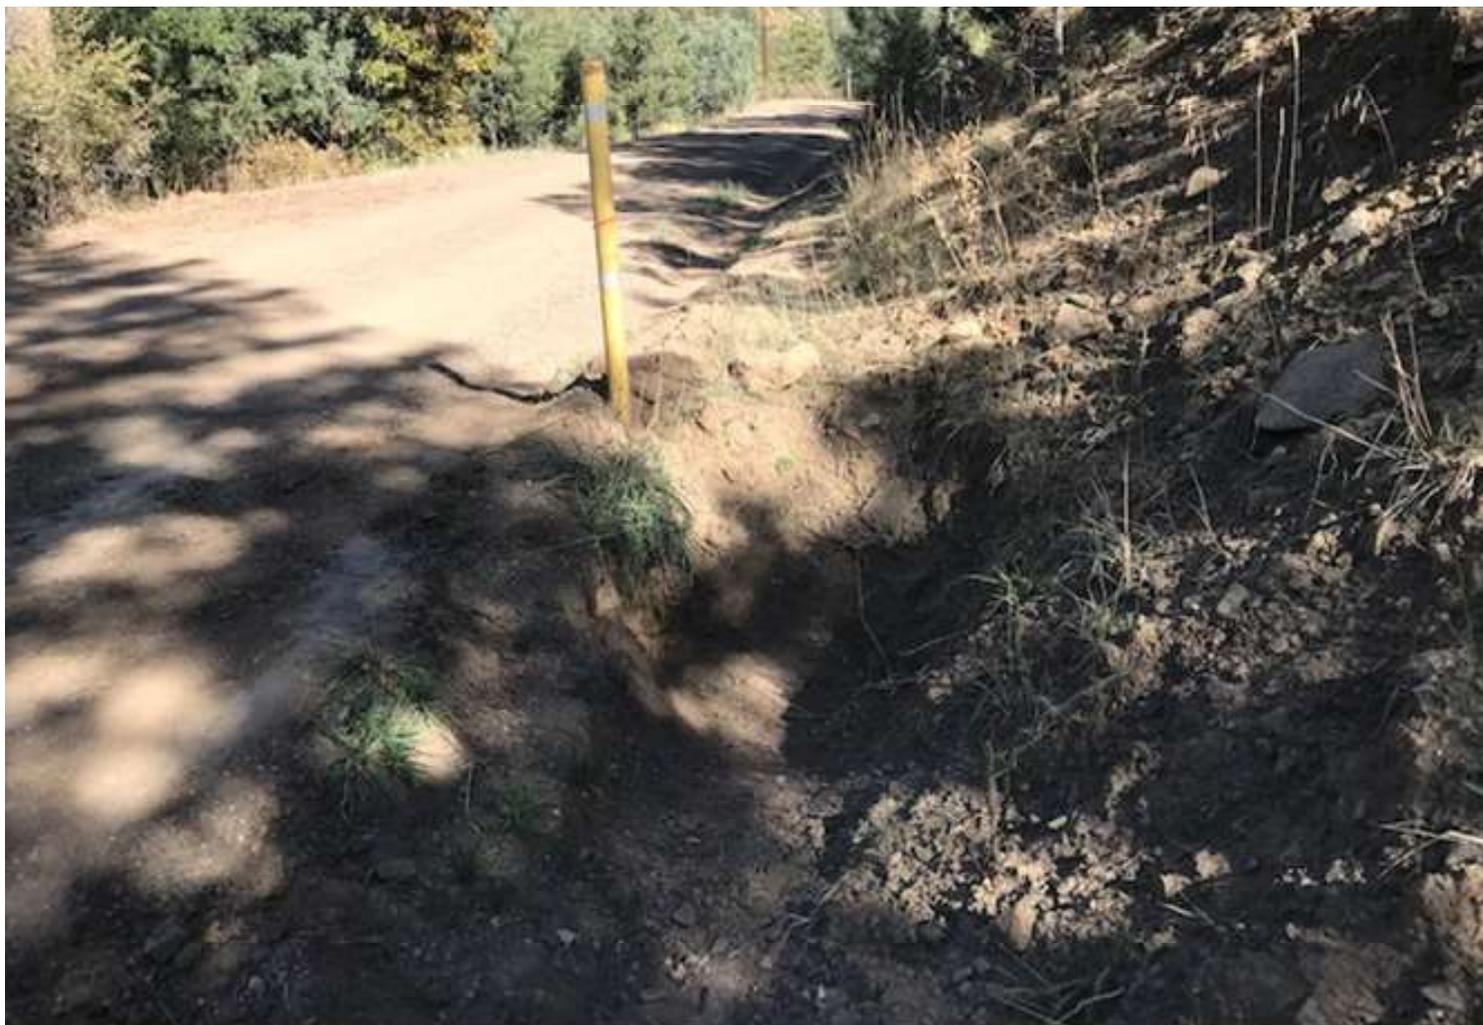
Photo 3: The sediment was removed from the culvert inlet.
