Inspection Photos
Location Name: Edkam #2-23
Location ID: 332669

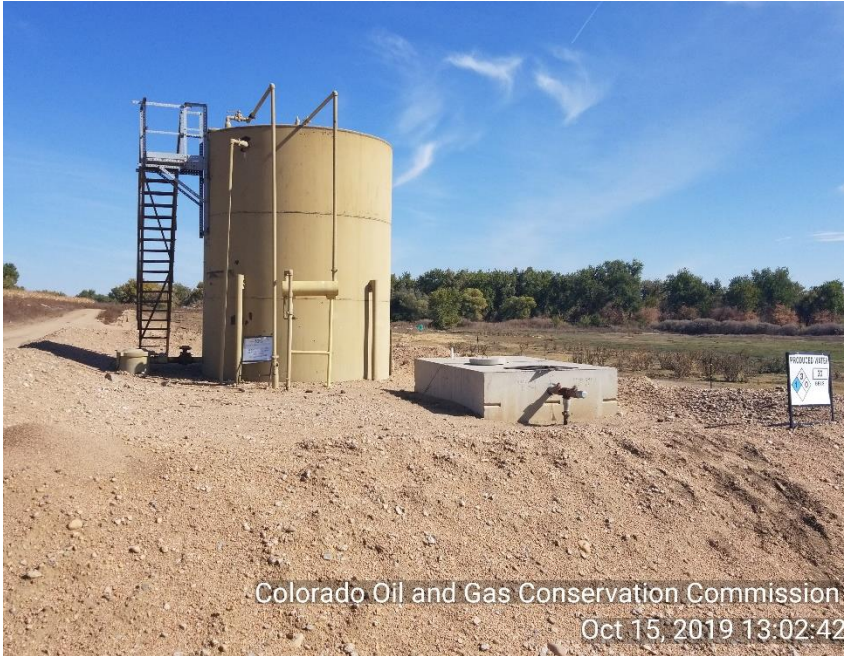
Photo 1 TNK BTRY 300 BBL crude oil tank does not have floodplain anchors. Produced water tank does have anchors.

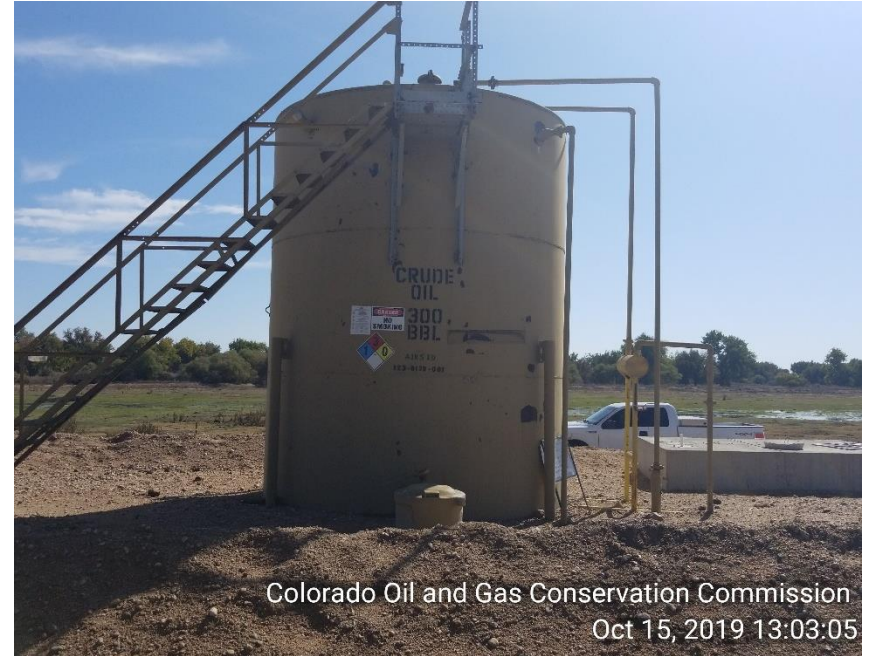
Photo 2 TNK BTRY 300 BBL crude oil tank does not have floodplain anchors. Produced water tank does have anchors.

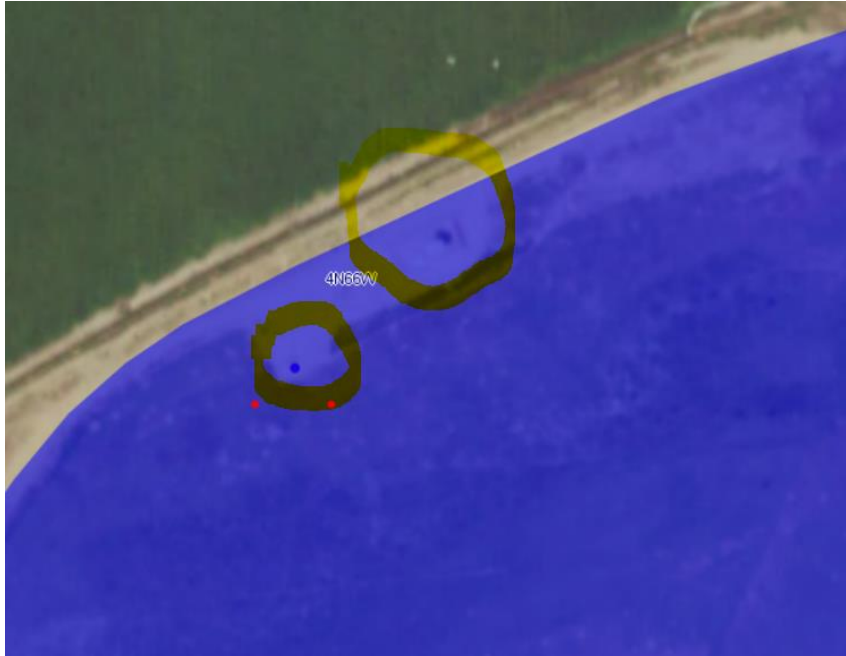
Photo 3 Maps clearly show well head and TNK BTRY are in floodplain.

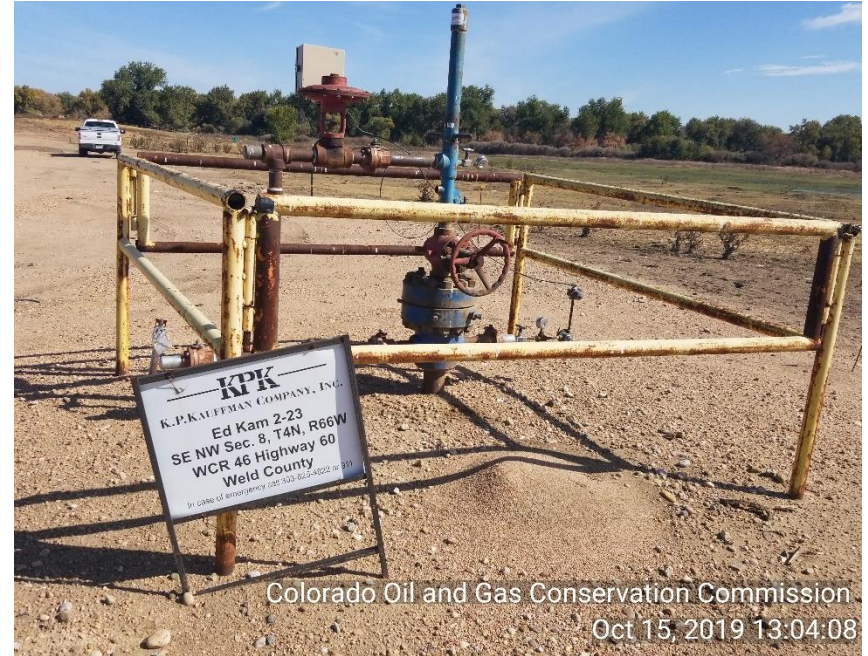
Photo 4 WH Well is SI

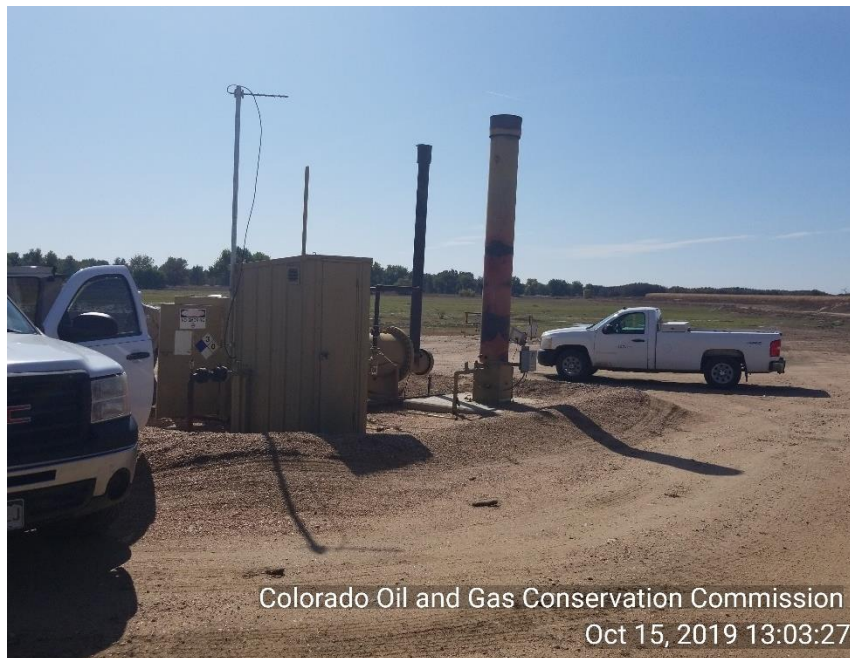
Photo 5 Sep/meter house and ECD. HOZ Sep has floodplain anchors

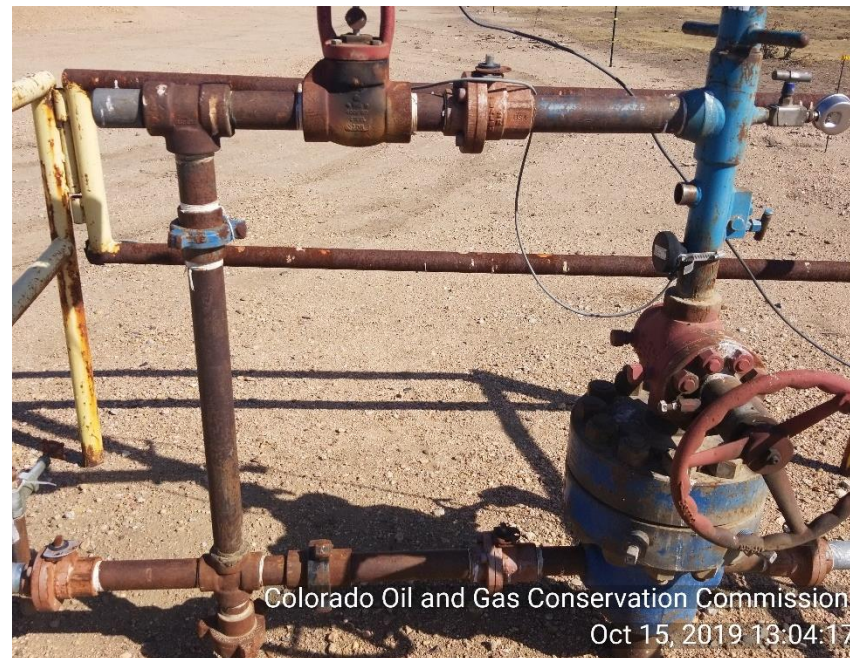
Photo 6 flow line valves are closed off well head
